RM4000 Radio Modem User's Manual and Installation guide

October 1989

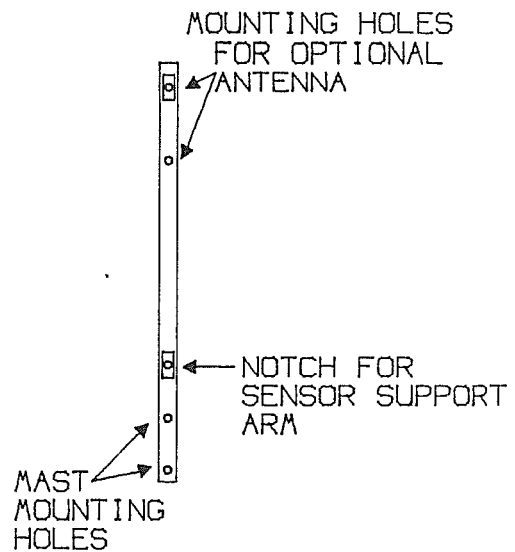
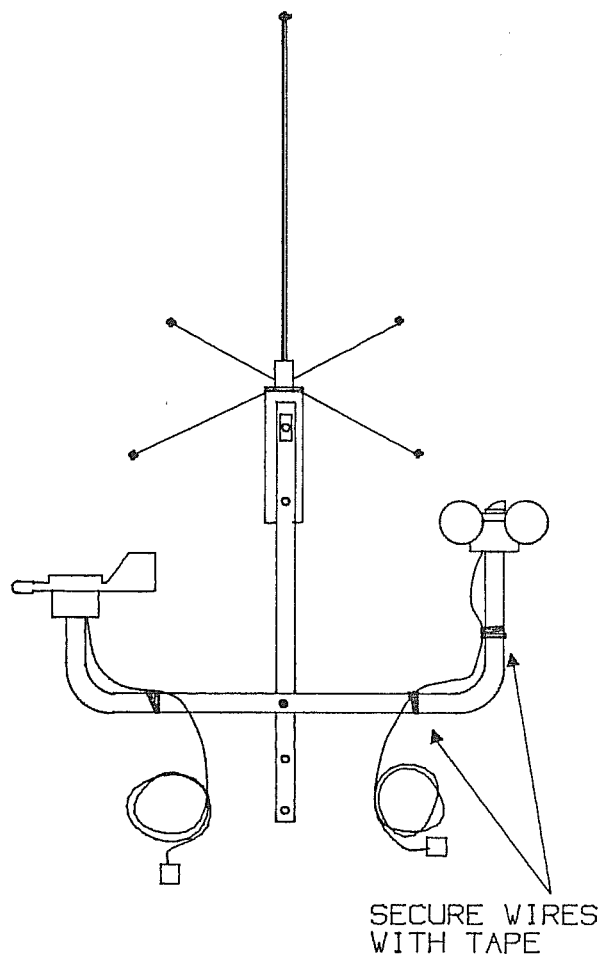
FIGURE 3

MAST EXTENSION

COMPLETE ASSEMBLY

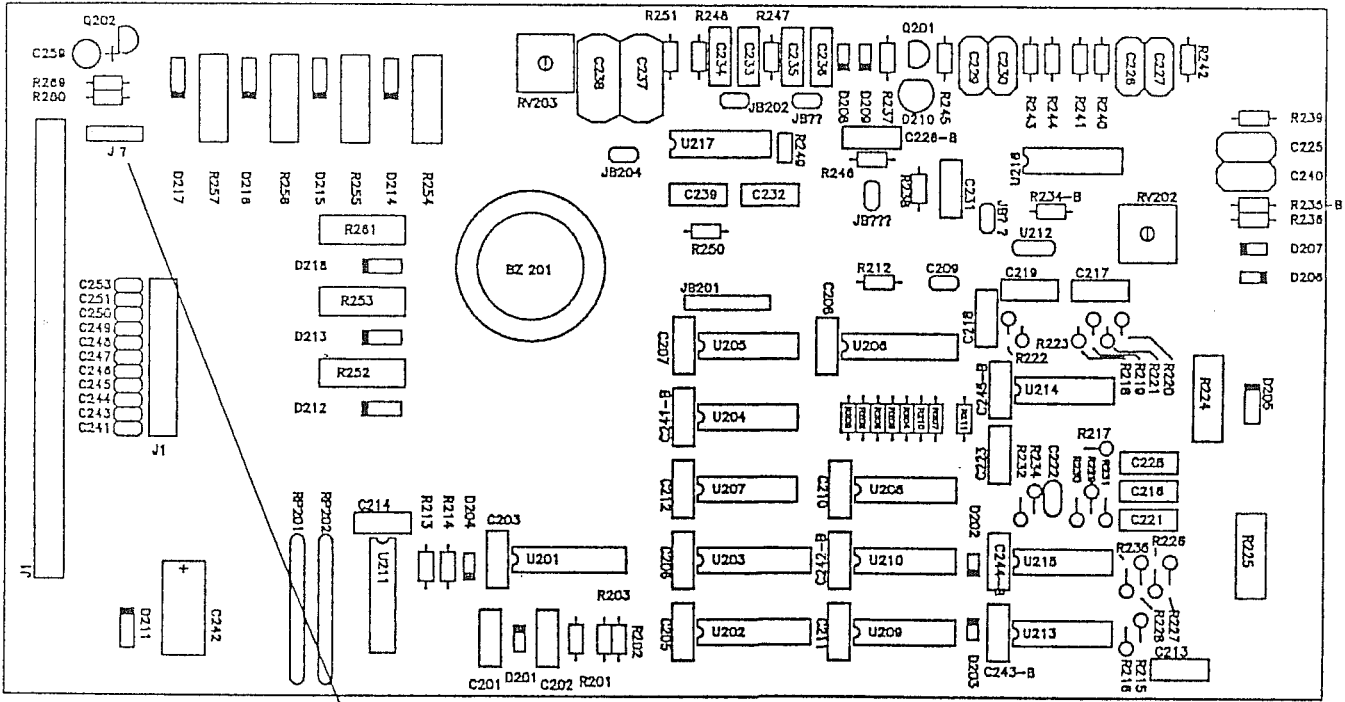
SELFTEST MODE JUMPER BLOCK

NORMAL OPERATION

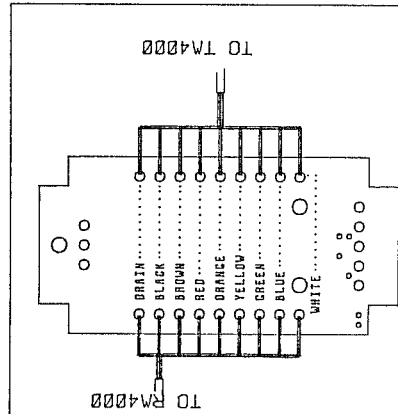
TM4000 OR TM4000CD CONNECTOR 510-14S			
PIN #	TO SELFTEST	TEL CORD	TM4000(CD) FUNCTIONS
P1	N/C	RED	TELEPH RING
P2	ORANGE	GREEN	TELEPH TIP
P3	WHITE	N/C	PWR I/P
P4	GREEN	N/C	NO CONNECT
P5	YELLOW	N/C	DATA I/P (FROM RA)
P6	N/C	N/C	RTS I/P (TO RA)
P7	RED	N/C	DATA O/P (TO RA)
P8	BROWN	N/C	RESERVED I/P
P9	N/C	N/C	EXT CLOCK O/P
P10	BROWN	N/C	RTS O/P (TTL)
P11	N/C	N/C	TELEPH BLACK
P12	BLUE	N/C	DATA I/P (WR)
P13	N/C	N/C	TELEPH YELLOW
P14	BLACK & DRAIN	N/C	CHASSIS GND

NOTE: THIS CABLE CAN BE USED WITH BOTH
TM4000 AND TM4000CD.

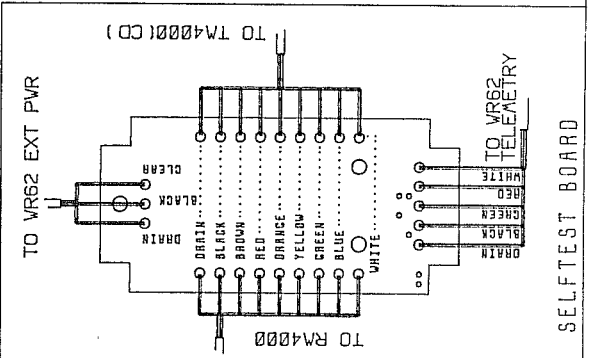
CBL-SP-RM-WR

WR-62 EXTERNAL POWER CONNECTOR 2 PIN FEMALE 530-25	
PIN A	CLEAR
PIN B	BLACK
	PWR I/P
	CHASSIS GND

WR-62 TELEMETRY CONNECTOR 4 PIN MALE 530-4P	
PIN A	RED
PIN B	GREEN
PIN C	WHITE
PIN D	BLACK
	CLOCK I/P
	RTS I/P
	DATA O/P
	CHASSIS GND

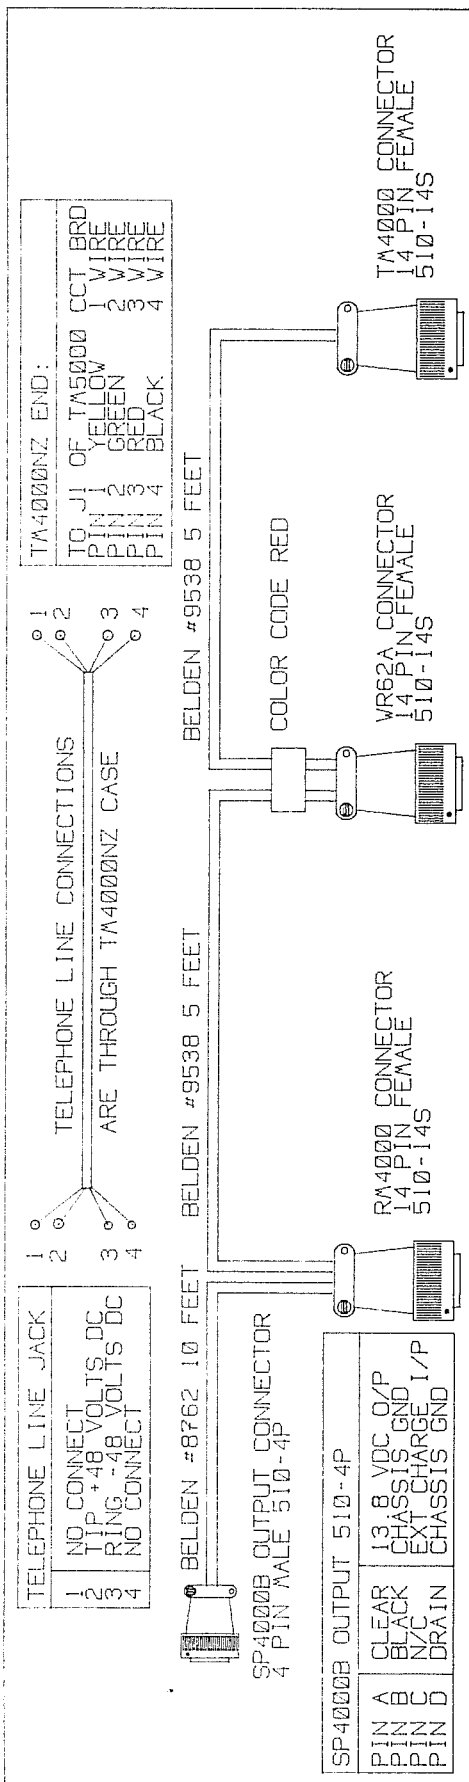
SELFTEST BOARD

RM-4000 CONNECTOR 510-14S		WR-62A TELEMETRY CONNECTOR 510-14S	
PIN #	TO SPB	PIN #	TO RM4000
P1	BROWN	P1	BROWN
P2	N/C	P2	ORANGE
P3	WHITE	P3	RED
P4	GREEN	P4	BLACK & DRAIN
P5	N/C	P5	N/C
P6	N/C	P6	BLACK & DRAIN
P7	BLUE	P7	WHITE
P8	N/C	P8	BLUE
P9	N/C	P9	YELLOW
P10	N/C	P10	N/C
P11	N/C	P11	N/C
P12	N/C	P12	N/C
P13	N/C	P13	N/C
P14	N/C	P14	N/C

RM-4000 CONNECTOR 510-14S		WR-62A TELEMETRY CONNECTOR 510-14S	
PIN #	FUNCTIONS	PIN #	FUNCTIONS
P1	RM AUDIO O/P	P1	AUDIO I/P
P2	RM AUDIO I/P	P2	EXT PWR I/P
P3	RTS DATA O/P	P3	EXT PWR I/P
P4	DSR O/P	P4	CHASSIS GND
P5	SELF TEST I/P	P5	RTS JUNCTION (TO A)
P6	RTS O/P	P6	RM SELF TEST O/P
P7	RTS I/P	P7	DATA JUNCTION (TO H)
P8	DATA I/P	P8	DATA JUNCTION (TO G)
P9	CLOCK O/P	P9	DATA O/P RS232
P10	POWER I/P	P10	DATA JUNCTION (TO N)
P11	CHASSIS GND	P11	NO CONNECT
P12	CHASSIS GND	P12	RTS JUNCTION (TO E)
P13	CHASSIS GND	P13	DATA JUNCTION (TO K)
P14	CHASSIS GND	P14

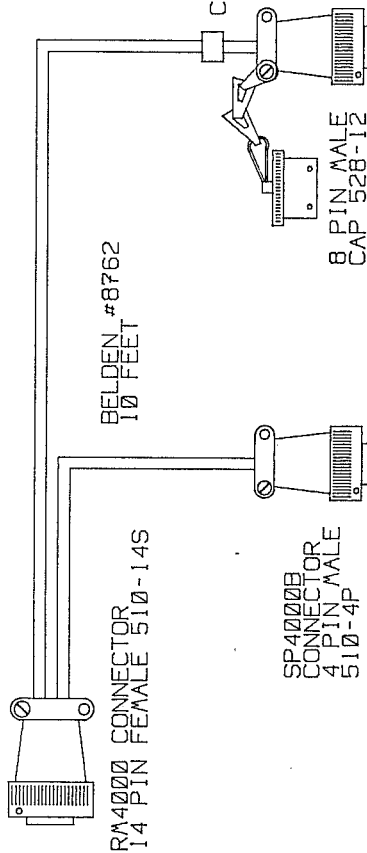
RM-4000 CONNECTOR 510-14S		RM-4000 FUNCTIONS	
PIN #	TO FWS-11 TO SPB		
PIN 1	N/C	RM AUDIO O/P	
PIN 2	N/C	RM AUDIO I/P	
PIN 3	N/C	RTS I/P	
PIN 4	GREEN	TX DATA O/P	
PIN 5	N/C	DSR O/P	
PIN 6	N/C	SELF TEST I/P	
PIN 7	N/C	PTT O/P	
PIN 8	N/C	CTS I/P	
PIN 9	W/PER. K	DATA I/P	
PIN 10	WHITE	CLOCK O/P	
PIN 11	N/C	POWER I/P	
PIN 12	RED	CHASSIS GND	
PIN 13	BLACK	CHASSIS GND	
PIN 14	BROWN	CHASSIS GND	
PIN 15	N/C

BELDEN #8723
5 FEET

SP4000B
CONNECTOR
4 PIN MALE
510-4P

SP4000B OUTPUT 510-4P	
PIN	
PIN A	CLEAR
PIN B	CHASSIS GND
PIN C	EXT CHARGE I/P
PIN D	CHASSIS GND
