PGM-FI System

Troubleshooting Flowchart — Engine Coolant Temperature (ECT) Sensor —

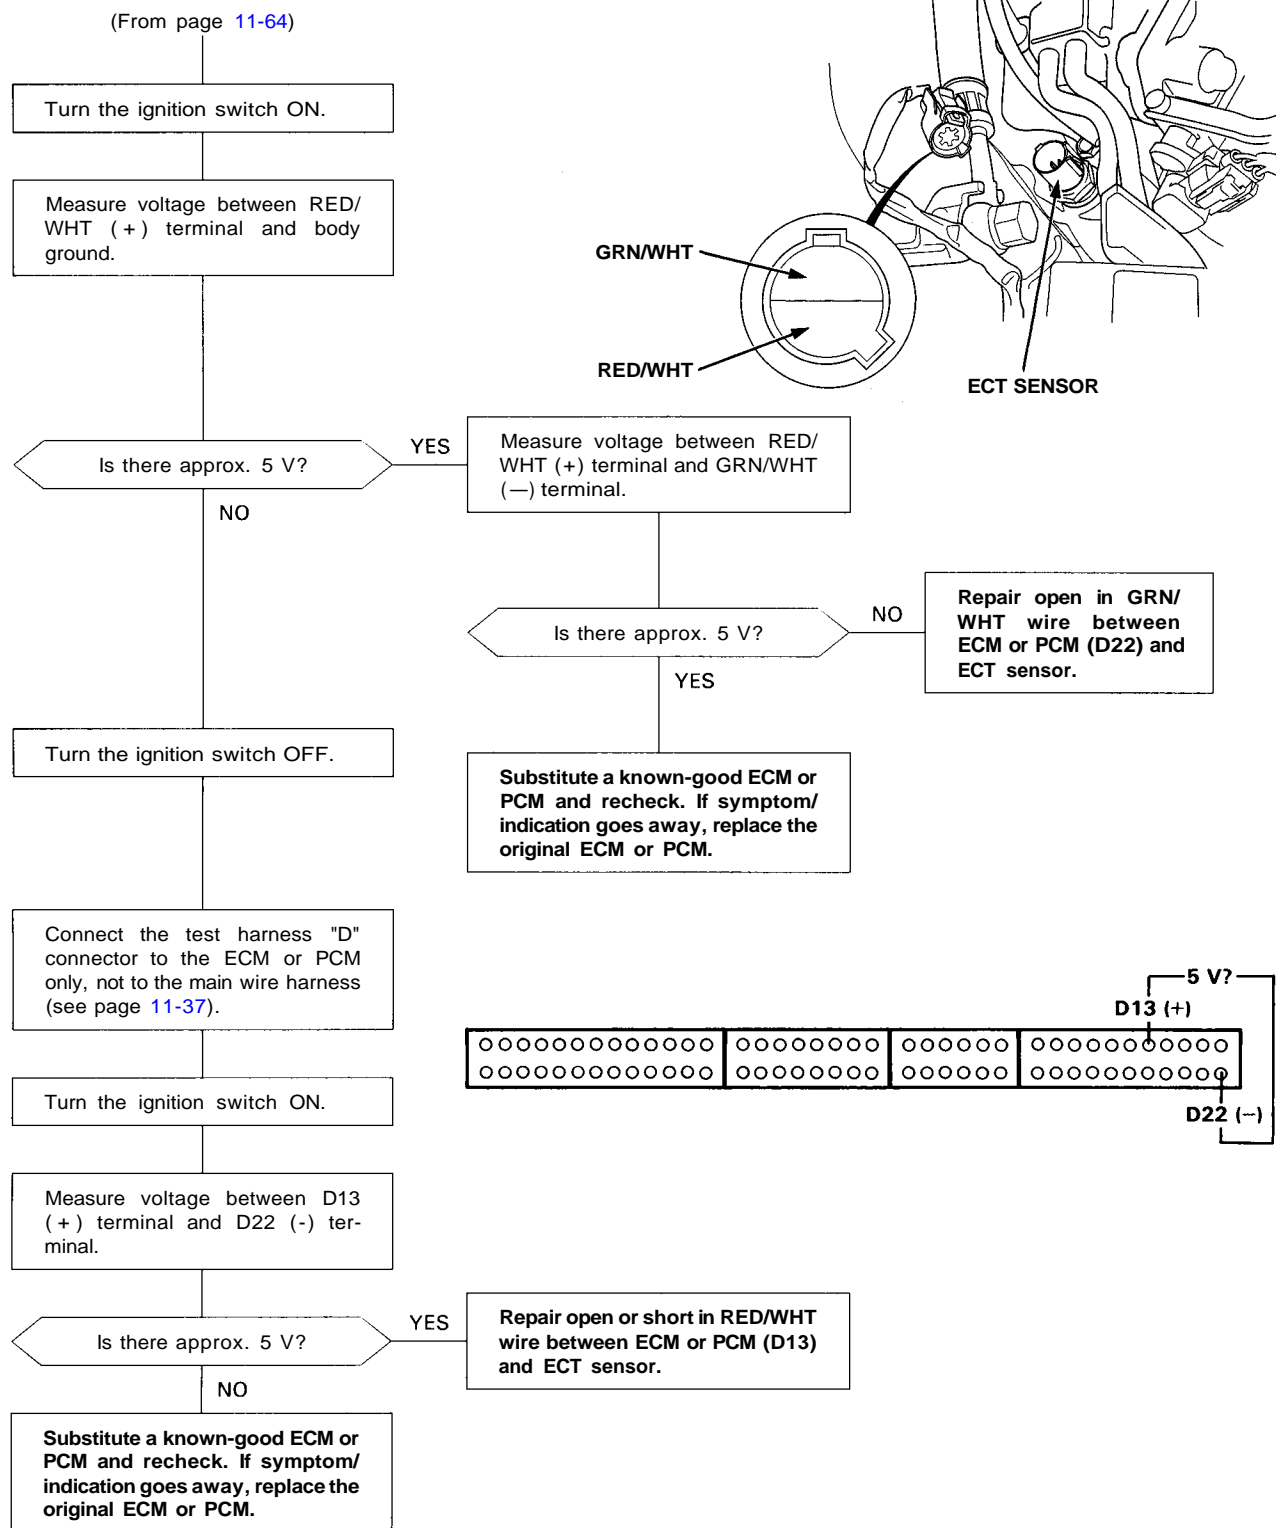
The ECT Sensor is a temperature dependant resistor (thermistor). The resistance of the thermistor decreases as the engine coolant temperature increases as shown below.

THERMISTOR

RESISTANCE
(K Ω)

ENGINE COOLANT TEMPERATURE

Disconnect the 2P connector from the ECT sensor.

Measure resistance between the 2 terminals on the ECT sensor.

Is there 200-400 Ω ?
