# PGM-FI System

## Troubleshooting Flowchart — Throttle Position (TP) Sensor

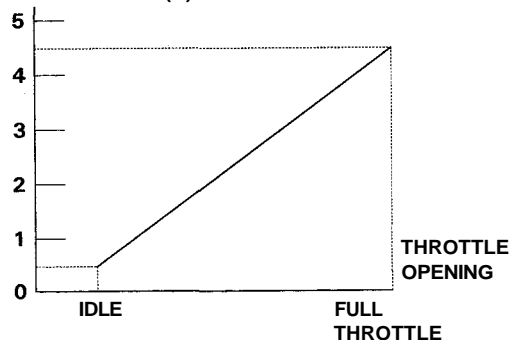
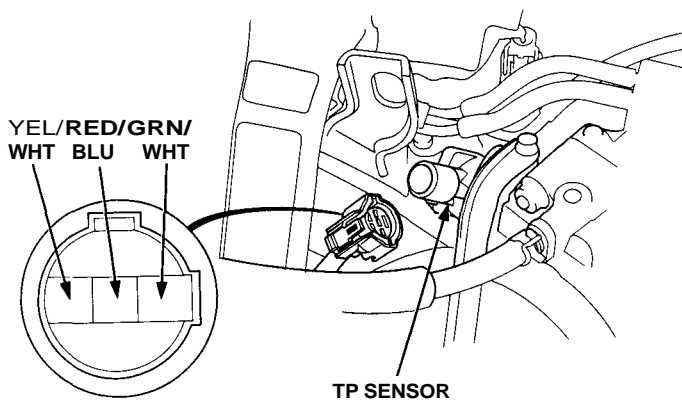
Disconnect the 3P connector from the TP sensor.

Measure voltage between YEL/ WHT (+) terminal and GRN/ WHT (—) terminal.

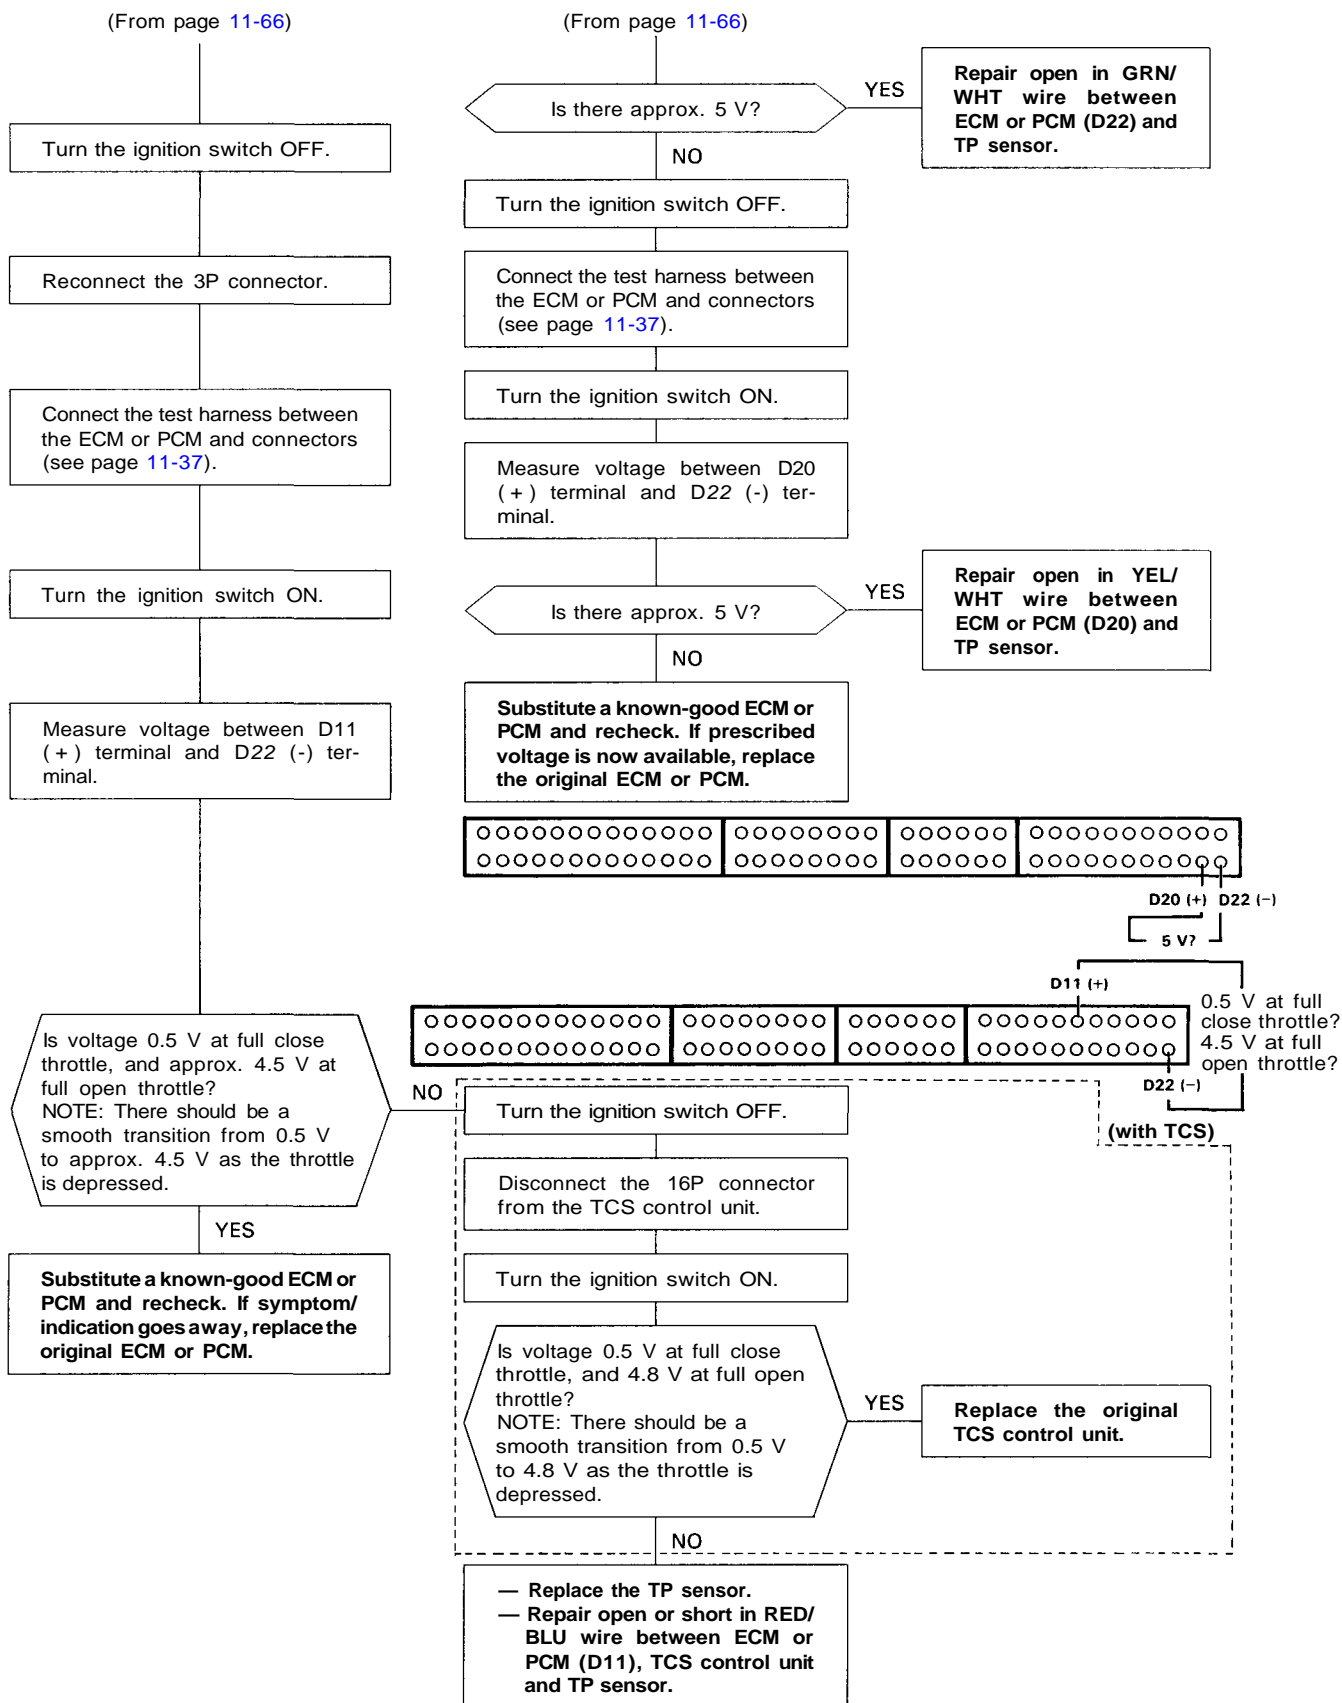
Intermittent failure, system is OK at this time (test drive may be necessary).  
Check for poor connections or loose wires at C355 (located at right shock tower), C108 (TP sensor) and ECM or PCM.

Measure voltage between YEL/ WHT (+) terminal and body ground.
