PGM-FI System

Troubleshooting Flowchart — Intake Air Temperature (IAT) Sensor

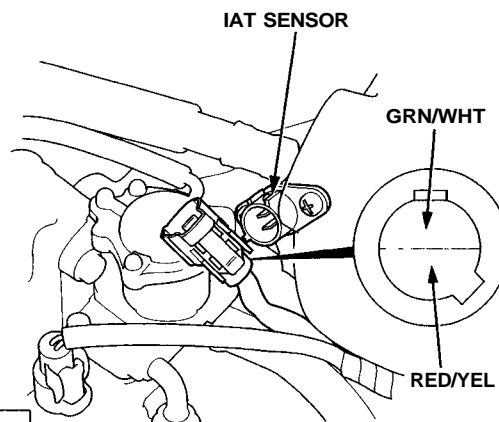
The IAT Sensor is a temperature dependant resistor (thermistor). The resistance of the thermistor decreases as the intake air temperature increases as shown below.

RESISTANCE (k Ω)

INTAKE AIR TEMPERATURE

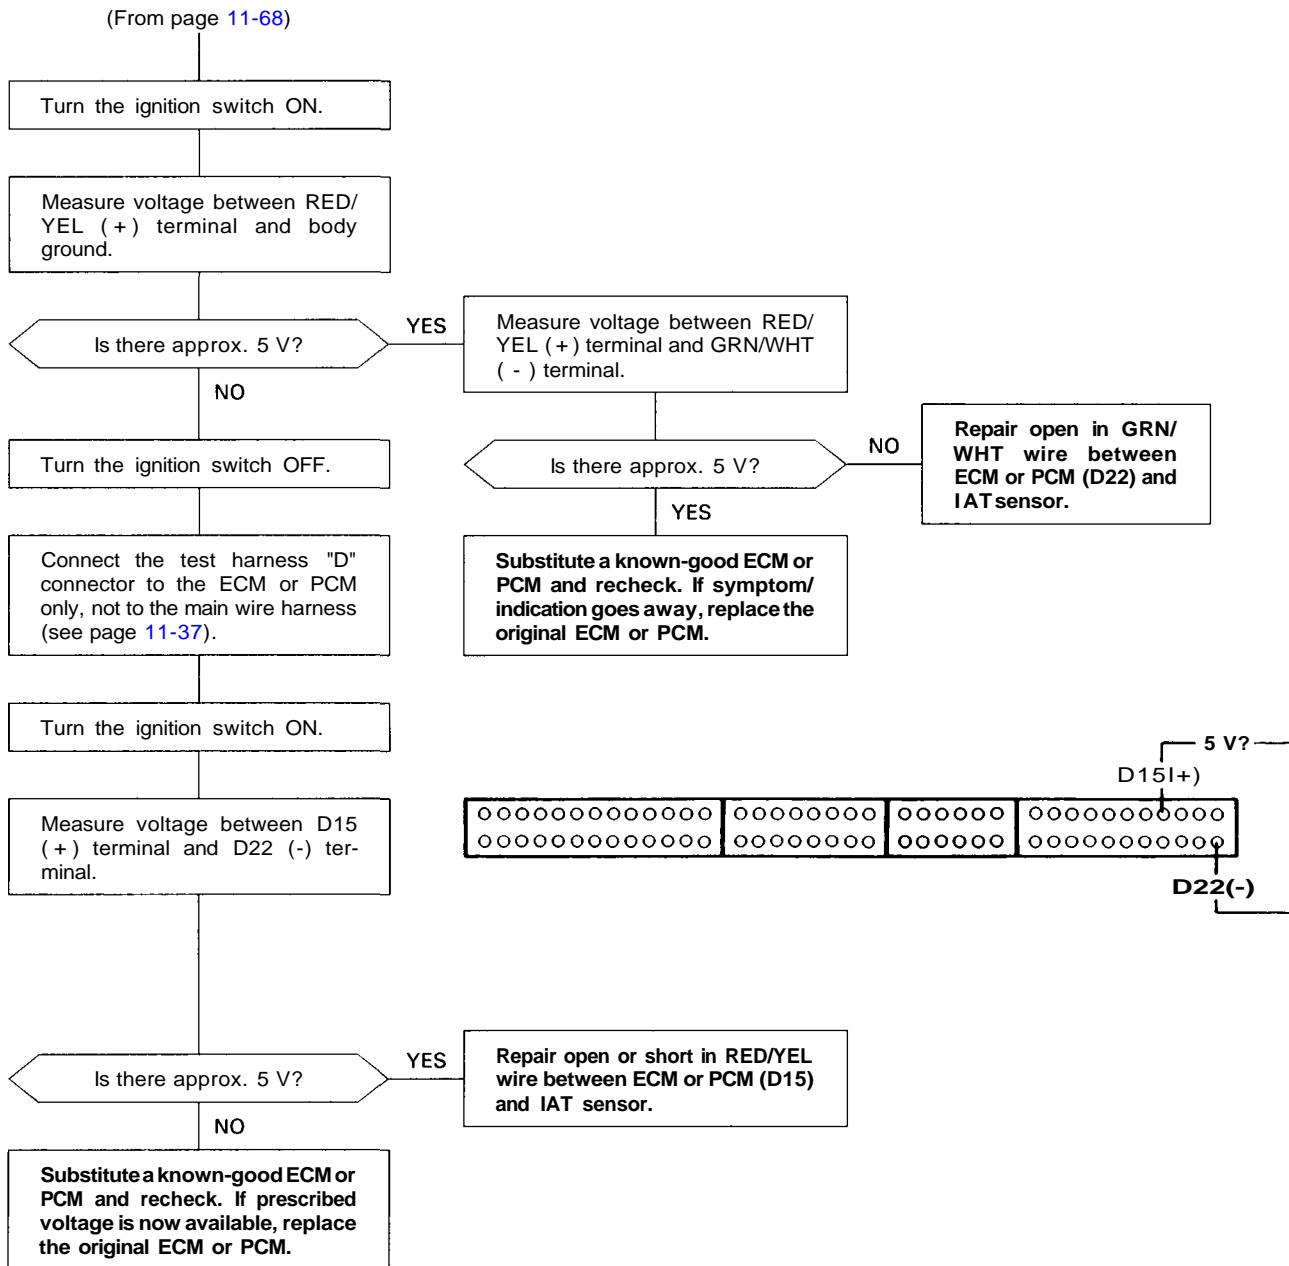
Disconnect the 2P connector from the IAT sensor.

Measure resistance between the 2 terminals on the IAT sensor.

Is there 0.4 — 4.0 k Ω ?
