PGM-FI System

TroubleshootingFlowchart — Knock Sensors (KS)

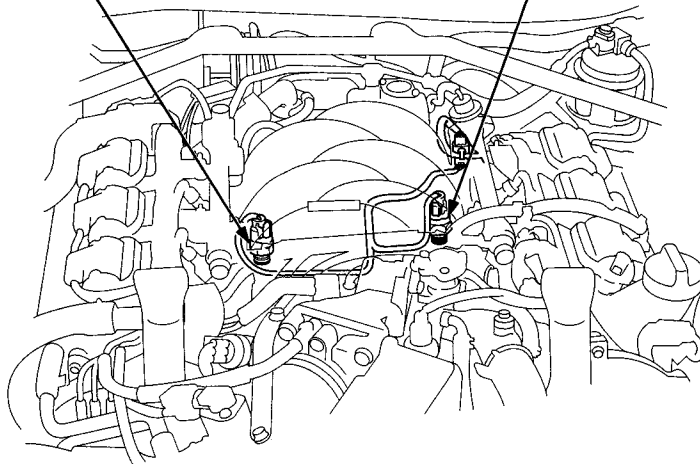
**RIGHT
KNOCK SENSOR (KS)**
32 Nm (3.2 kg-m, 23 lb-ft)

**LEFT
KNOCK SENSOR (KS)**
32 Nm (3.2 kg-m, 23 lb-ft)
