Moonroof

Glass Height Adjustment

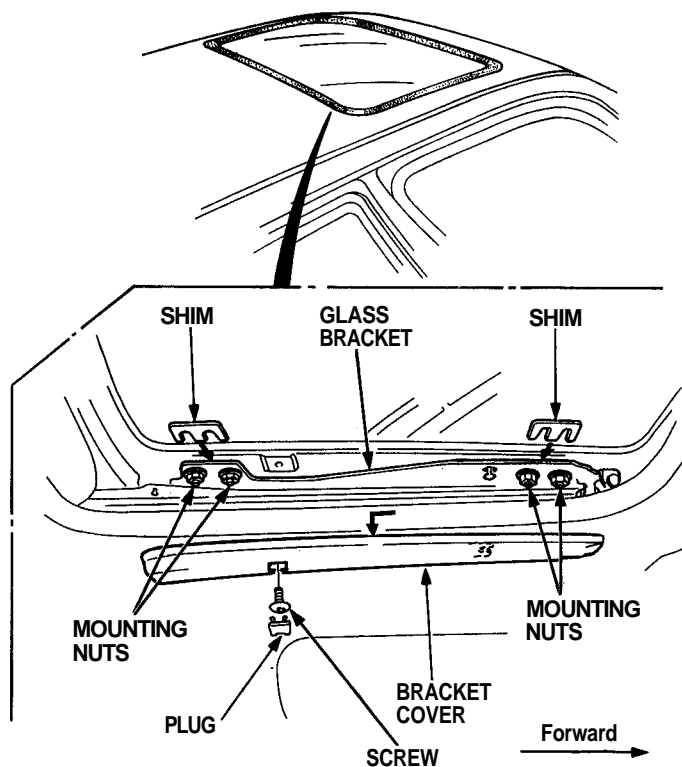
The roof panel should be even with the glass weatherstrip, to within 2 ± 0.5 mm (0.08 ± 0.02 in) all the way around. If not, open the glass fully, and:

3. Repeat on opposite side if necessary.
