# PGM-FI System

## Troubleshooting Flowchart — Throttle Position (TP) Sensor

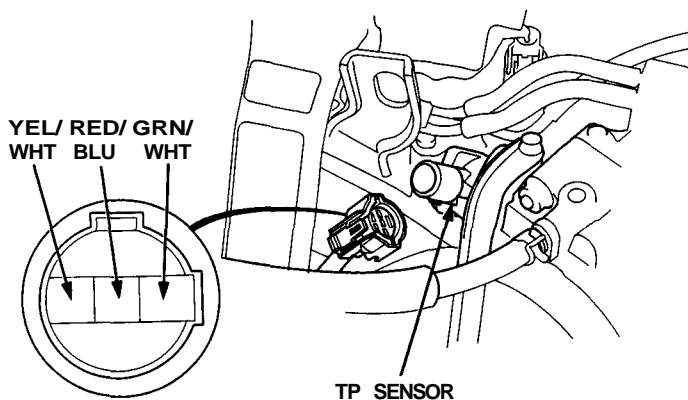
Disconnect the 3P connector from the TP sensor.

Measure voltage between YEL/ WHT (+) terminal and GRN/ WHT (-) terminal.
