PGM-FI System

Troubleshooting Flowchart — Ignition Timing Adjuster

The Malfunction Indicator Lamp (MIL) indicates Diagnostic Trouble Code (DTC) 18: A problem in the Ignition Timing Adjuster circuit.

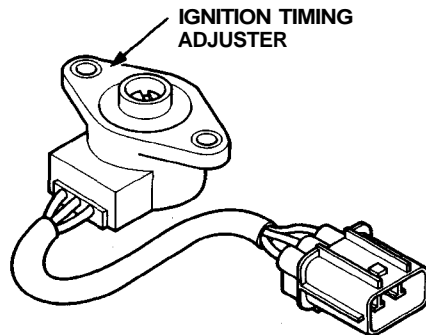
The ignition timing adjuster allows the electronic ignition advance to be set to 15 ° BTDC at idle.

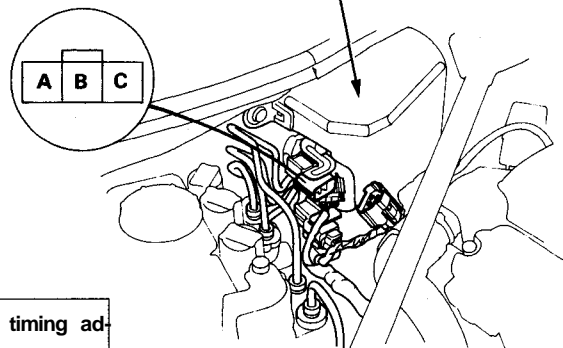
CONTROL BOX

Disconnect the 3P connector from the control box.

Measure resistance between A terminal and C terminal on ignition timing adjuster.

Is there 3.5 — 6.5 k Ω ?
