# Moonroof

## Glass Height Adjustment

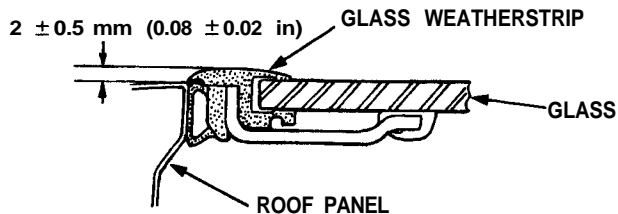
The roof panel should be even with the glass weatherstrip, to within  $2 \pm 0.5$  mm ( $0.08 \pm 0.02$  in) all the way around.

If not, open the glass fully, and:

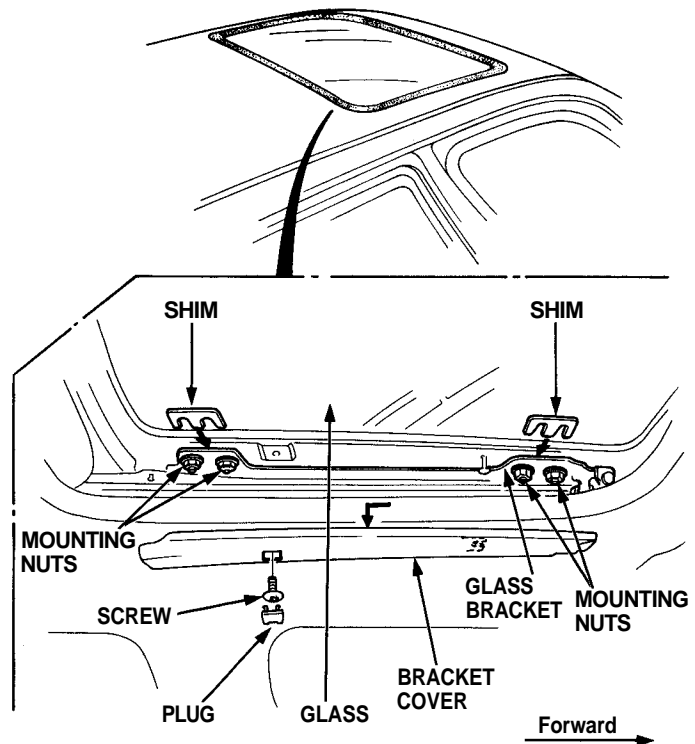
1. Pry plug out of the bracket cover, remove the screw, then slide the bracket cover off to the rear.
2. Loosen the mounting nuts and install the shims between the glass and glass bracket as shown.

**Shim thickness: Max. 2 mm (0.08 in)**

3. Repeat on opposite side if necessary.
