Firmware Enhancements and Upgrade Procedure

Fluke 5320A Multifunction Electrical Tester Calibrator

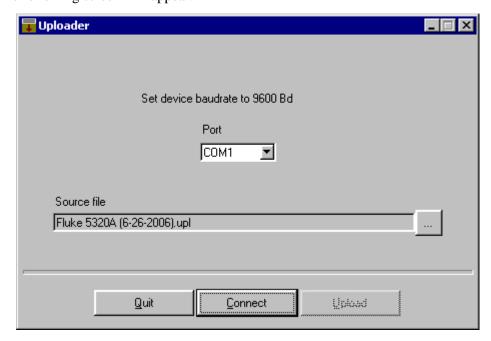
Baud rate 9600
- 2. Connect the Calibrator and the computer with an RS-232 cable. The RS-232 cable required is a straight-through cable. A straight-through RS-232 cable can be purchased at most electronic/computer stores or can be purchased from Fluke as part number 943738.
- 3. Start the Uploader program. "Start->Program files->Uploader->Uploader.exe" The following screen will appear:

Note: The source file in the above screen is an example of a "upl" firmware file. The actual file name for firmware revision 3.06 is different. The version 3.06 file name is "Fluke_5320A_HW2_rel_3_06.upl"

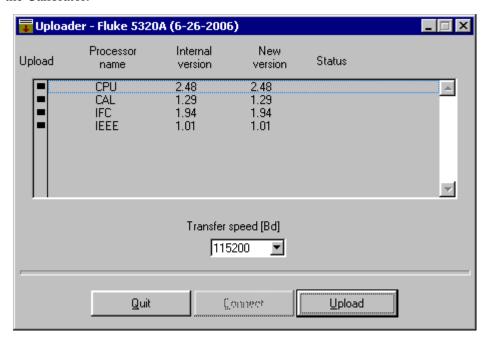
- 4. Select computer's COM port (COM1 ... COM8) for serial transfer. Use the "..." button to browse the computer for the firmware source file. The firmware source file has the extension "upl".
- 5. Press "Connect". The Uploader program displays the firmware version to be installed on the Calibrator.

Note: The "Internal version" firmware on the 5320A may differ from the example screen shown above. The "New version" will have the following firmware numbers: CPU: 3.06, CAL: 1.31, IFC: 2.15, IEEE: 1.01

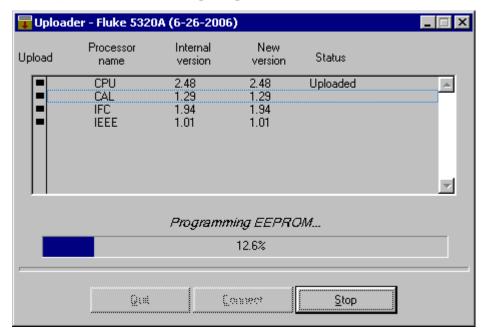
6. Press "**Upload**" to continue the upload process.

7. The Uploader program automatically loads new firmware for the CPU, CAL, IFC and IEEE.

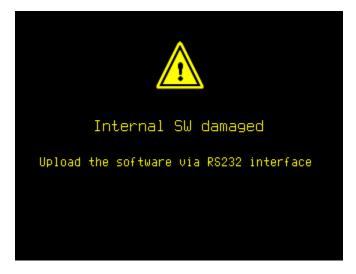
If during the installation a power failure occurs or communication is interrupted, the Calibrator won't have complete firmware. To continue with the firmware upgrade switch the Calibrator's power supply off, wait 10 seconds and switch the power on. The Calibrator will display the following screen:

From the computer, repeat the installation process. The Calibrator is switched to RS-232 communication at 9600 Baud automatically to accept the firmware upgrade file.
