1.0 EXECUTIVE SUMMARY

() was contracted by _____ of Tampa, Florida to conduct a Lead-Based Paint Clearance Inspection on the subject property located at 2517 Texoma Drive, Oklahoma City, Oklahoma. The purpose of conducting the clearance inspection was to determine the success of recently completed interim controls and subsequent specialized cleaning activities associated with the work. The clearance inspection was performed on Tuesday, July 7, 2009, by _____.

The property inspected is a one-story wood frame constructed residential dwelling (occupied). The structure was built in 1953 and is approximately 784 square feet.

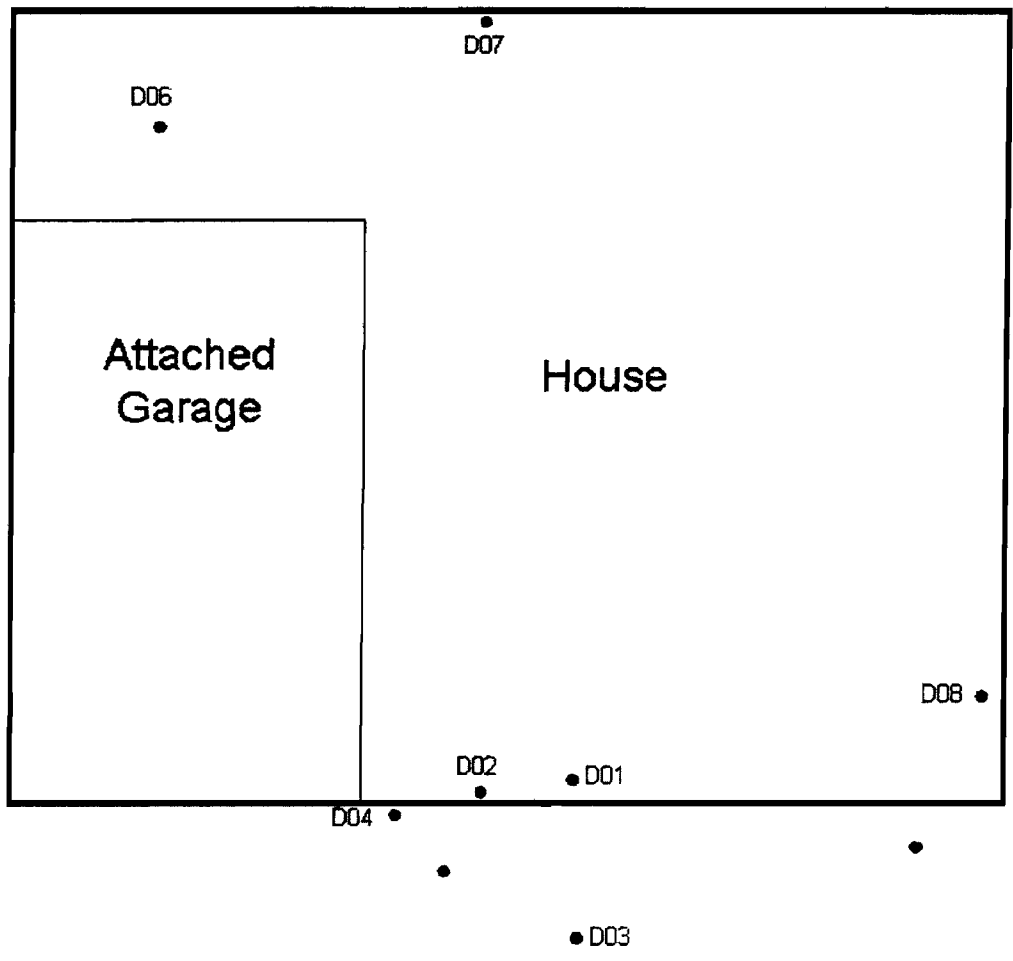
APPENDIX C

<u>Legend</u>	
Dust Sample Locations	•
Soil Sample S01 Grab Locations	•

Soil Sampling Plot can be found in Appendix C
