## Cotton Insights Newsletter

**October 25, 2021**

## Rockshaft Calibration

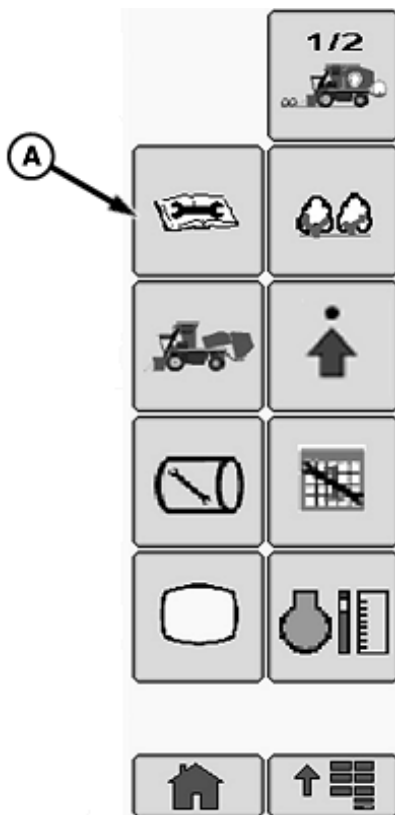
1. Machine must be empty of cotton (accumulator, RMB, and handler)
2. Hydraulic oil temperature >122°F, to warm, run cotton handling system using floor switch, engage cleaner/header drive, and run engine at full speed.
3. Select Diagnostics Screen from Home Screen (A)
