## Introducing Pacifica's Depreciation Report

# 2013 Depreciation Report

Pacifica, 503 West 16th Avenue, Vancouver, BC

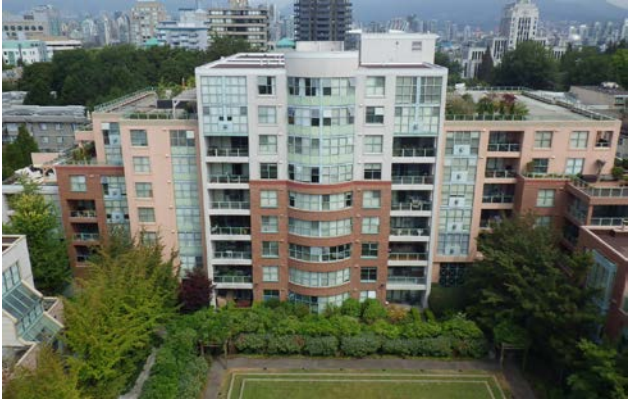
Fig. 2.1.2 Building C and courtyard, looking North.

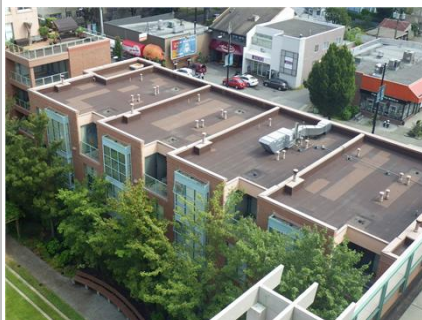
#### Encl 01 - Exposed SBS Membrane - A-G Main Roofs

Mains roofs of Buildings A, B, C, D, E, F, and G.

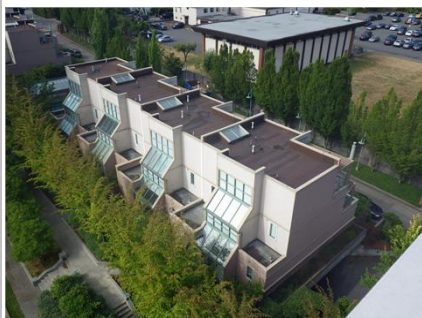
#### Encl 02 - Exposed SBS Membrane - D & E Lower Roofs

Lower roofs of Buildings D and E.

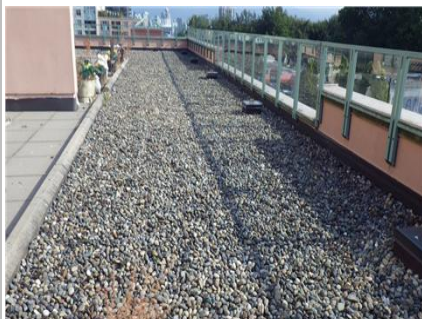
#### Encl 03 - Protected SBS Membrane Roof with Ballast

Various levels on Building B and C.

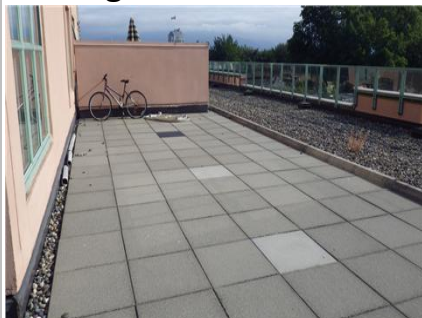
#### Encl 04 - Protected SBS Membrane Roof/Deck (Conventional Assembly) with Traffic-Bearing Surface

Building A terraces, Level 8. Building B and C SBS membrane overlaid with concrete terraces on various levels. Building D and E roof decks. Buildings F & G, Level 2 and 3.

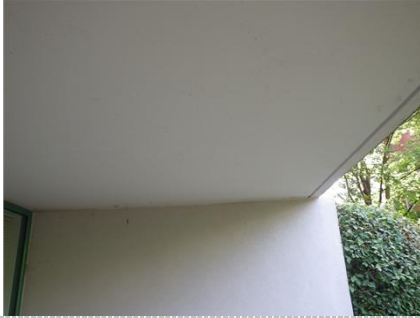
### Encl 05 - Stucco Clad Soffit

Balcony ceilings and above exterior walkways on Buildings B, F, and G.

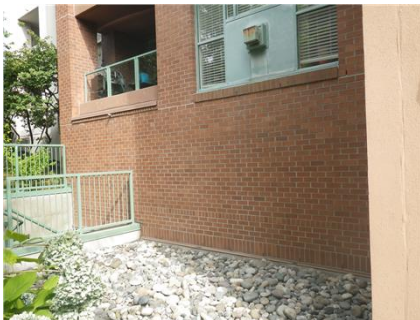
### Encl 06 - Protected Parkade Podium Membrane with Landscaping

(Concealed Asset). Above parkade enclosure and below landscaping throughout the site.

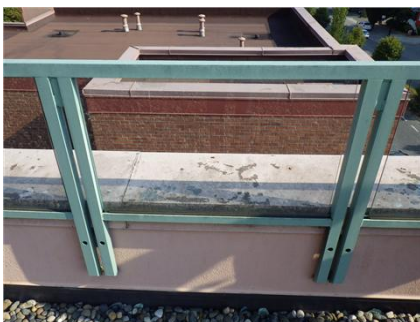
### Encl 07 - Guardrail Glazed Aluminum - Decks & Balconies

Perimeter of all balconies and decks of all buildings.

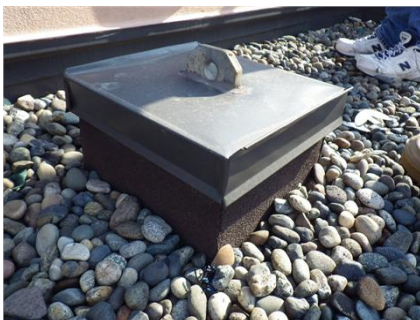
### Encl 08 - Anchor Fall Protection Equipment

Main roofs and roof decks.

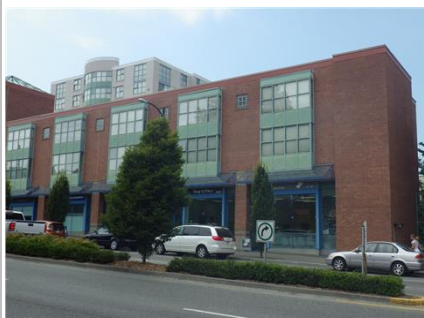
#### Encl 10 - Brick Veneer Wall - F & G

All elevations of Buildings F and G.

Clay masonry units applied as a veneer over exterior sheathing membrane with combustible construction backing wall.

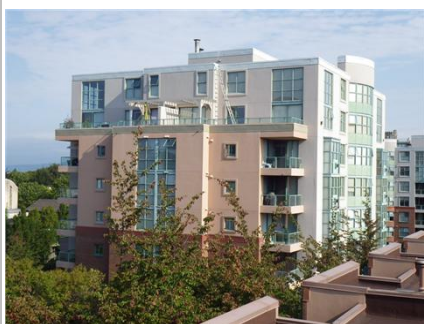
#### Encl 11 - EIFS Clad Wall - Undrained

All elevations of Buildings A, B, and C.

Textured acrylic finish applied over reinforced cementitious lamina applied to insulation board (typically expanded polystyrene foam board). EIFS panel without drainage provisions are applied directly over waterproofing membrane on sheathing. Effective age reflects phased renewal beginning in 2018.

- EIFS cladding at the highrise towers are installed as undrained (face-sealed assemblies). While the Strata Corporation has an ongoing maintenance and repair program to extend the life of these Assets, undrained EIFS typically does not perform well when exposed to regular wetting. As part of the long term maintenance and renewals program, the Strata Corporation should consider commissioning a more detailed condition assessment.

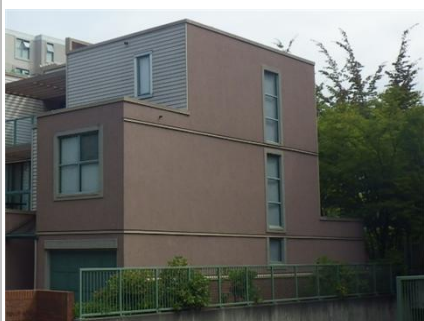
#### Encl 12 - Stucco Clad Wall - Rainscreen

All elevations of Buildings D and E.

Acrylic coated stucco applied on furring to create a drained cavity over the exterior sheathing membrane.

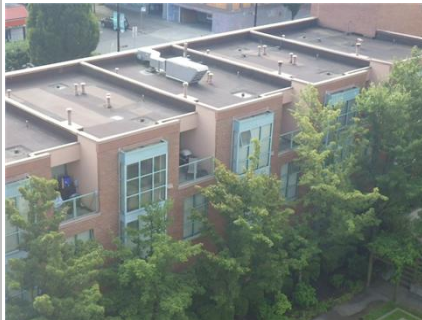
### Encl 13 - Stucco Clad Wall - Undrained

Walls of west-facing decks of residential units on Buildings F and G.

Acrylic coated stucco applied directly over exterior sheathing membrane. Effective age reflects replacement in 2018 due to age and exposure conditions.

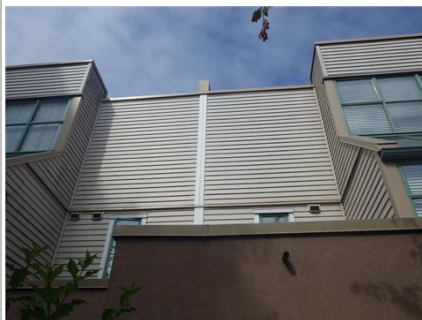
### Encl 14 - Vinyl Siding Wall - Rainscreen

All elevations of Buildings D and E.

Vinyl siding applied on furring to create a drained cavity over the exterior sheathing membrane.

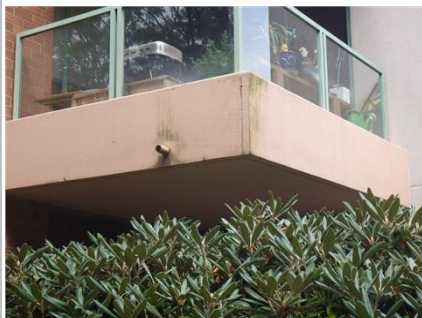
### Encl 15 - Architectural Concrete

Exposed balcony edges on Buildings A, B, and C.

Painted concrete spandrel panels.

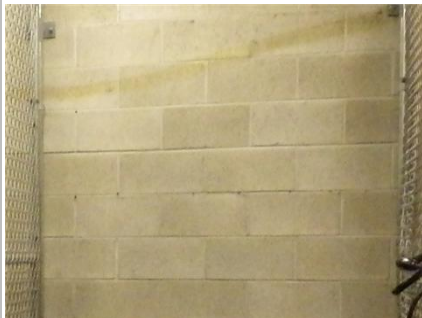
### Encl 16 - Concrete Masonry Unit Wall

Throughout underground parking garage.

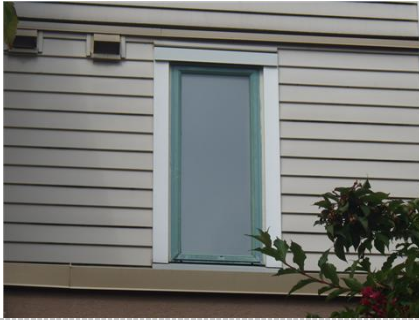
### Encl 17 - Wood Trim

Around windows in vinyl cladding on Buildings D and E.

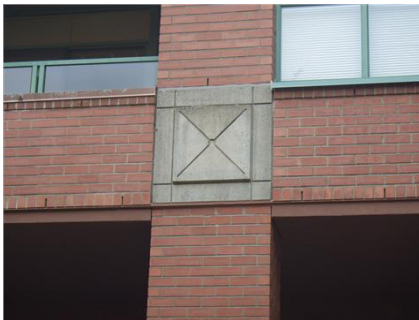
### Encl 18 - Precast Concrete Panels

Various locations on elevations of Buildings B, C, F, and G.

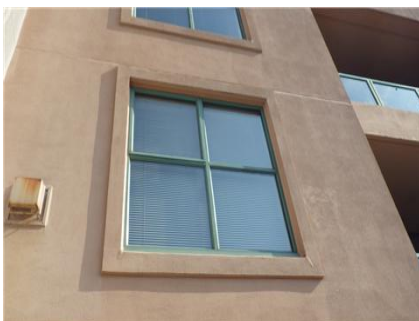
### Encl 20 - Aluminum Framed Window - Punched

All levels on all elevations of all buildings.

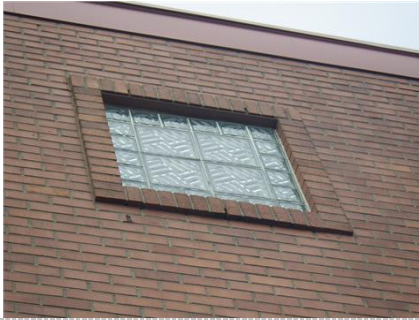
### Encl 21 - Glass Block Window - Exterior

East elevation of Buildings B, F, and G

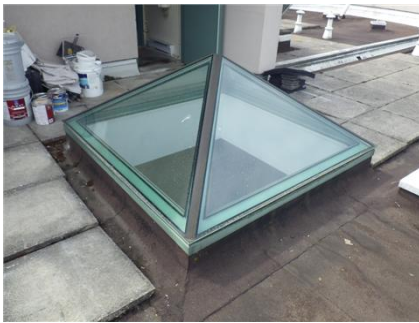
### Encl 22 - T-Bar Skylight (A & B)

Roofs of Buildings A and B.

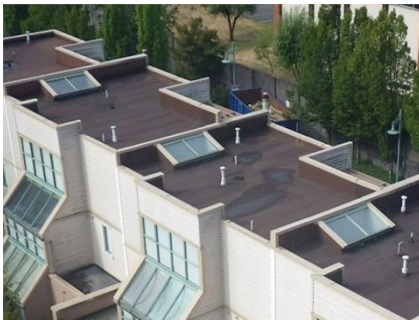
### Encl 23 - T-Bar Skylight (D & E)

Building D and E roofs and east elevation integrated sloped glazing.

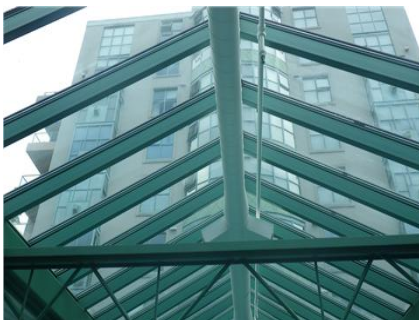
### Encl 24 - Pressure Cap Skylight

Pool roof, Building A.

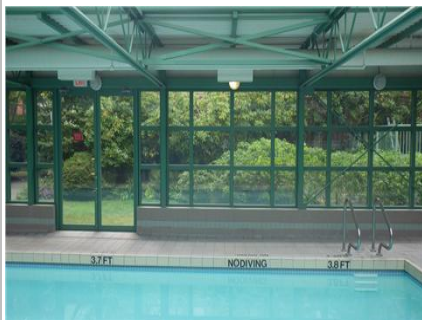
### Encl 25 - Aluminum Storefront - Residential

Pool enclosure, Buildings F & G lobby entrances, and Building B meeting room.

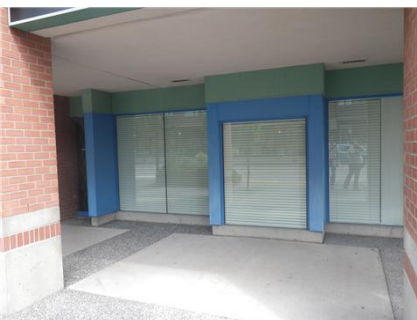
### Encl 26 - Aluminum Storefront - Commercial Units

Building B, C, F, &, G commercial units.

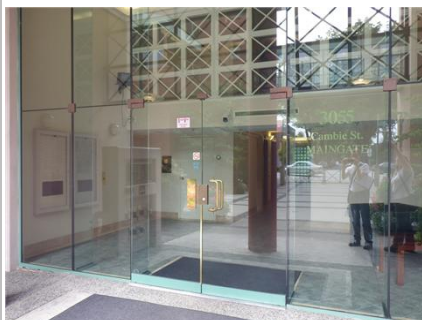
### Encl 27 - Structural Glazing

Entrance of Buildings A, B, and C.

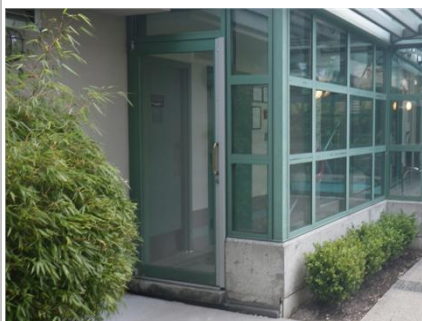
### Encl 28 - Aluminum Frame Glazed Swing Door

Various patios on Buildings A, B, & C, and pool enclosure.

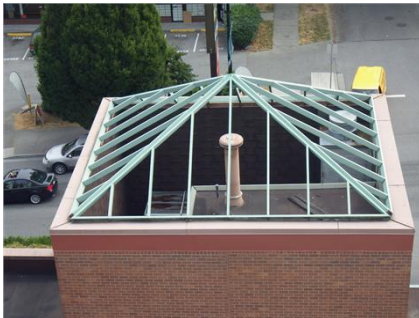
#### Encl 33 - Architectural Steel Elements

Tower roof of Buildings F and G, and steel canopy around perimeter of pool enclosure on Building A.

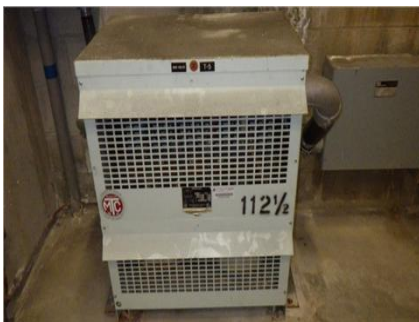
### Elec 01 - Distribution Transformer - Interior

Electrical rooms throughout the parkade.

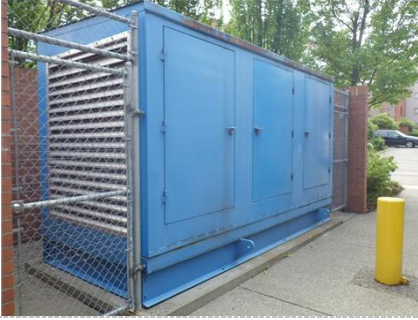
### Elec 02 - Emergency Generator

West side of site, between buildings D and E.

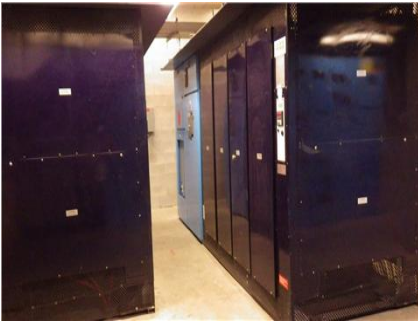
### Elec 03 - Unit Substation

Main electrical room in parkade.

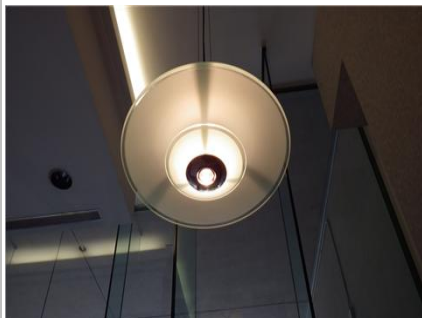
### Elec 05 - Interior Light Fixtures

Mounted to walls and ceilings throughout all common areas and service rooms.

A variety of fixture types, including fixed surface (pendant, track and sconce) and recessed (pot, troffer and cove). A variety of lamp types, including fluorescent, compact fluorescent, halogen, incandescent, LED, etc. for interior direct, indirect and accent lighting applications. A variety of light fixture controls, including switches, motion sensors, timers, dimmers and photocells. All sconces and pendant lights throughout replaced as part of 2013 interior renovation project. Additionally, in Buildings F & G, various ceiling lights in residential hallways also being replaced. No track lighting or cove lighting replaced.

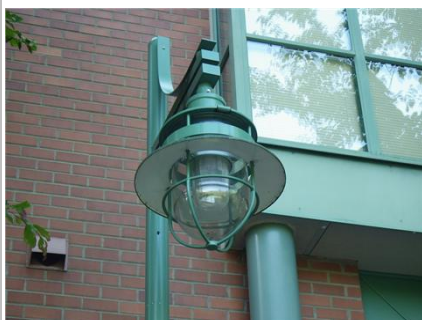
### Elec 06 - Exterior Light Fixtures

Building exteriors and throughout the site.

A variety of fixture types, including wall, pole and post mounted, street, pathway and recessed soffit pot lighting. A variety of lamp types, including incandescent, halogen, LED, and metal halide. Used for exterior direct, indirect and accent lighting applications. A variety of light fixture controls, including switches, motion sensors, timers and photocells. Wall mounted halide light fixtures replaced in 2003. Wall mounted fixtures replaced again in 2010/2011.

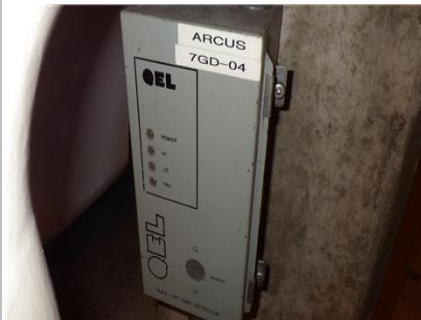
##### Mech 02 - Gas Detection - Parking Garage

Various stalls throughout the parking garage.

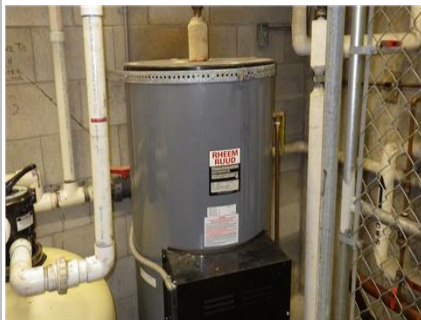
##### Mech 03 - Tank - DHW - Large Service Electric

Pool mechanical room and womens change room.

Rheem Ruud EQB5C15 and EGS85C-15, mounted, electric boiler, for domestic water heating. Men's HWT replaced 2010, women's 2004.

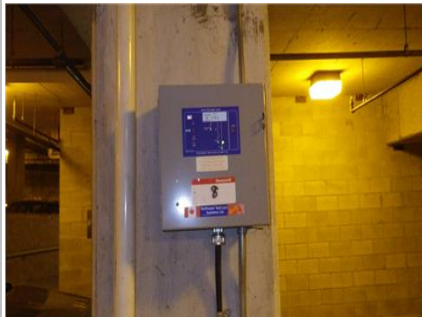
## Mech 09 - Sump Pumps

Parkade stalls 49 and 172.

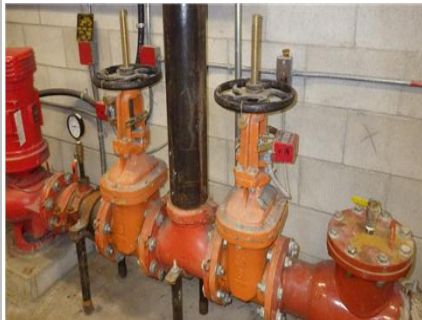
### Mech 13 - Valves - Cross Connection & Backflow Prevention

Building G mechanical room, Level 3 in Buildings F & G, Level 8 in Buildings A, B, & C, and parkade mechanical room.

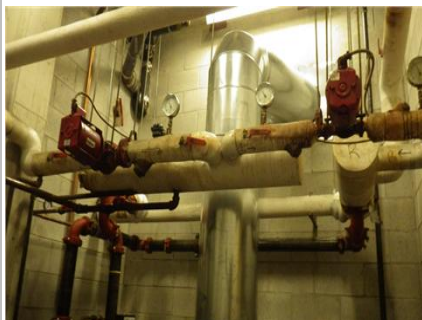
### Mech 14 - Hydronic Distribution

Throughout the buildings.

Hydronic heating and cooling water supply and return system.

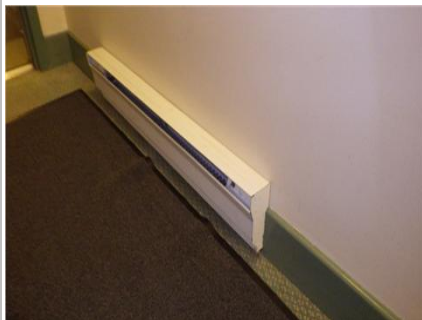
### Mech 15 - Baseboard - Electric

Amenity rooms, elevator vestibules and service rooms throughout the buildings.

Standard grade, wall mounted, electric convector baseboard heaters with electrical fins for localized space heating and integral thermostat control.

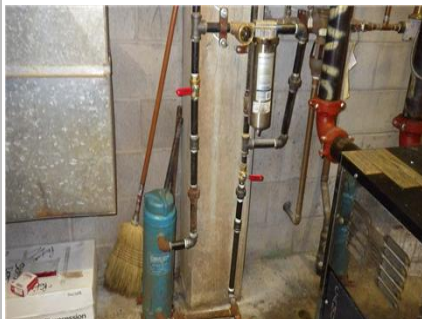
### Mech 16 - Chemical Treatment Equipment

Mechanical room in parkade.

Pot feeder, chemicals such as biocide, scale, corrosion and oxygen inhibitor, glycol, metering pumps and other associated equipment to provide corrosion protection to boilers, loops and piping, frost and microbial mitigation in cooling tower.

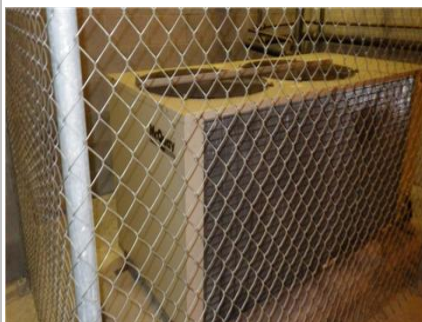
## Mech 18 - Condensing Unit

McQuay ALP021C packaged unit intended to work in conjunction with the Air Handling unit to provide to condition air to main electrical vault.

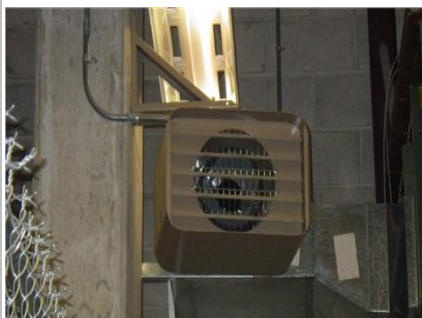
## Mech 19 - Unit Heater - Electric

Electric unit heaters, mounted with, fans and louver.

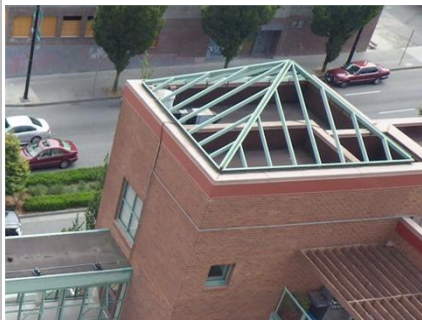
## Mech 20 - Cooling Tower

Baltimore F1742K evaporative fluid cooling device. Provides cooling to chilled water loop. Waiting on Carrier report for technical information and renewal recommendations.

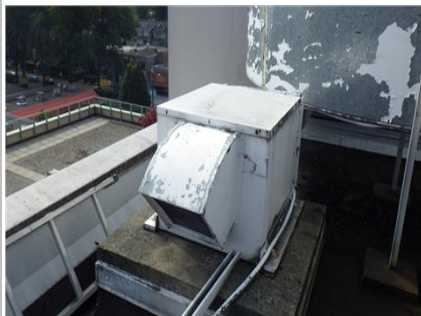
**Mech 21 - Exhaust Fan**

Direct drive fans, ceiling and cabinet fans, and centrifugal inline blower fans.

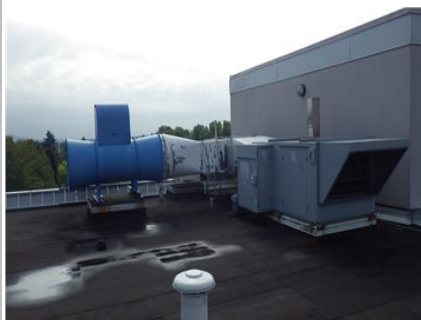
**Mech 22 - Outdoor Air Handler - Makeup Air - Gas**

EngAir S0200-0 (Bldg A, replaced 2009), DJ-40-0 (Bldg B, original), DJE4010 (Bldg C, replaced 2013), Greenheck IGX109H12HZ (Bldg F & G, installed 2009) 4600 and 5700 CFM outdoor rooftop unit, belt-driven, centrifugal fan with natural gas fired heating to supply tempered make-up air to the interior spaces.

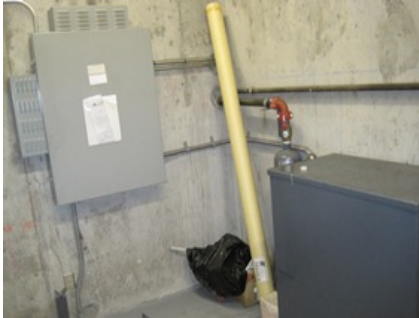
#### Elev 02 - Hydraulic Elevator, Double Bottom (Building G)

Richmond Elevator direct acting hydraulic elevator with a buried double bottom cylinder (not protected from corrosion), RAM PLC/Relay control system, submersed pump unit, Maxton (UC-4M/UC-1A) valves, 900/1360kg capacity, ~100 fpm (estimated) rated speed.

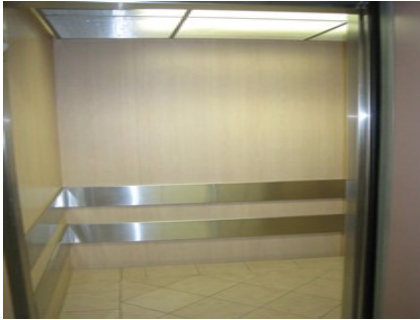
## Elev 04 - Elevator Cabs & Hoistway (Building G)

Single speed side opening doors, plastic car and hall pushbuttons, one (1) car operating panel (stainless steel), infrared door protection, GAL MOML door operator, wood laminate door, door header, front return, and walls, egg crate ceiling, tile flooring, flat bar stainless steel handrails on all walls (not compliant with disabled persons access for 13330 unit), no firefighter's emergency operation, no standby power, hand-held voice communication devices, no seismic provision. Cab to receive new wood laminate panels over steel reveals, floor tile, and ceiling to match updated elevator cabs in other buildings as part of 2013 interior renovation.

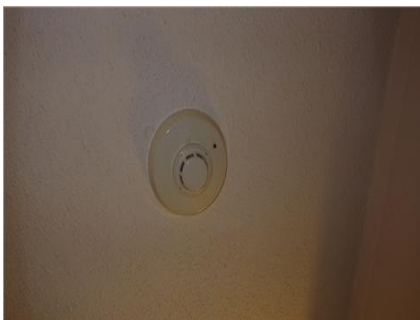
## Fire 02 - Fire Detection & Alarm

Smoke detectors, heat detectors, flow switches, tamper switches, horns, pull stations and other fixed apparatus field devices to detect fire and smoke conditions and initiate timely response.

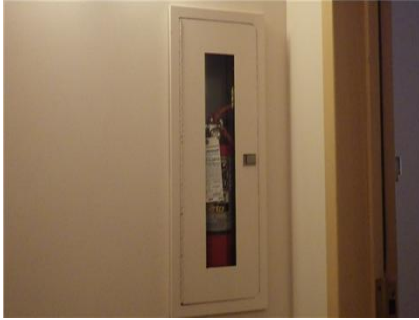
### Fire 07 - Portable Fire Extinguisher

Wall mounted, manually operated, 5lbs and 10lbs ABC type, pressurized vessels for controlled discharge of chemicals to extinguish small fires.

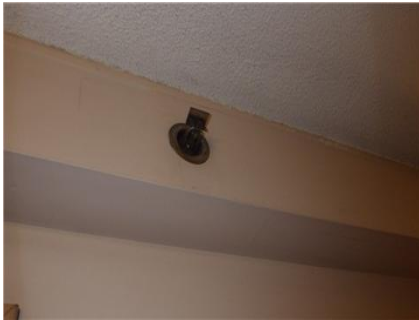
### Fire 08 - Sprinkler & Standpipe - Wet

Standard upright, pendant sidewall sprinkler heads, flow switches and indicating devices, gauges, steel distribution lines.

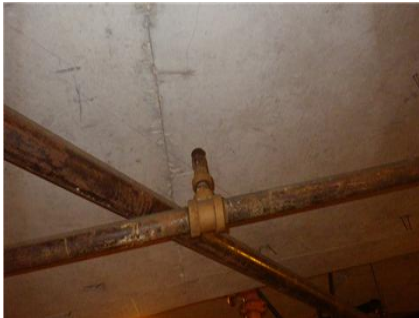
### Fire 09 - Sprinkler System - Dry

Exposed dry sprinklers, upright and sidewall sprinkler heads, steel piping.

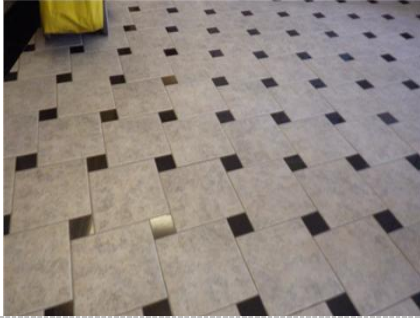
### Finish 04 - Porcelain Floor Tile

Porcelain floor tile on thin set mortar with grout. Assume replaced during 2013 interior renovation.

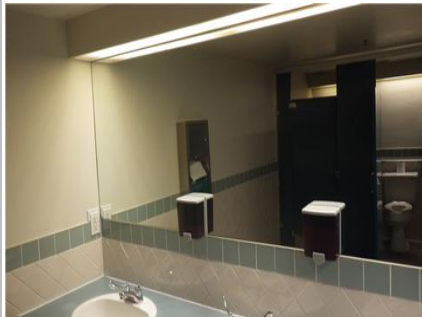
### Finish 08 - Mirror

Mirrored glass with structural fasteners to the substrate.

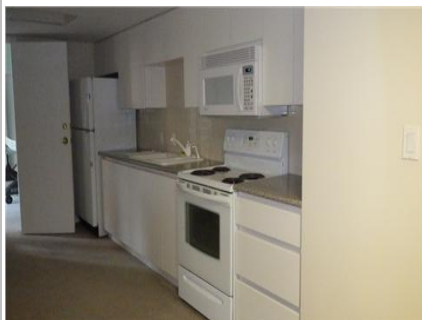
##### Amen 03 - Domestic Appliances

Refrigerator, microwave oven, dishwasher of miscellaneous brands. Amenity room range and microwave replaced 2010. (Asset age averaged).

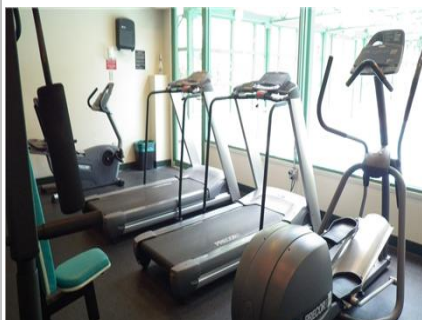
##### Amen 04 - Fitness Equipments

Various fitness machines and equipment; treadmill, elliptical and weight machines. All equipment replaced 2006; rowing machine replaced 2013.

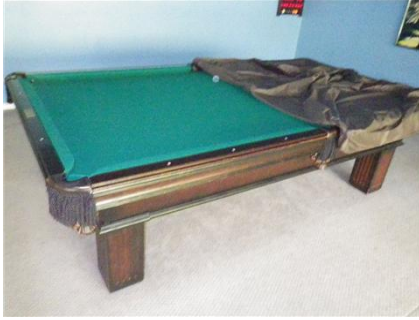
### Amen 09 - Pool Table

Pool table with felt on high density substrate, bumpers, pockets and frame. Protective cover, pool cues and other miscellaneous accessories.

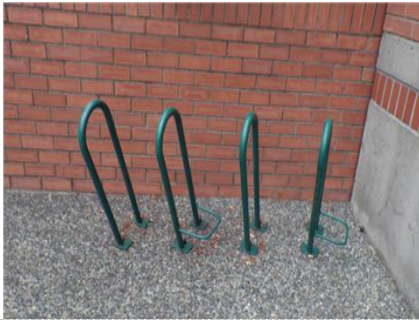
### Amen 10 - Bicycle Rack

Floor or wall mounted, steel bicycle rack.

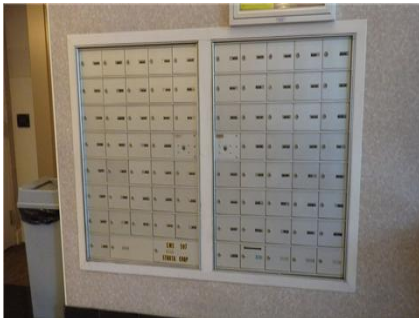
### Amen 11 - Central Mailboxes

Flush mounted, front loading, brushed aluminum finish, extruded aluminum trim.

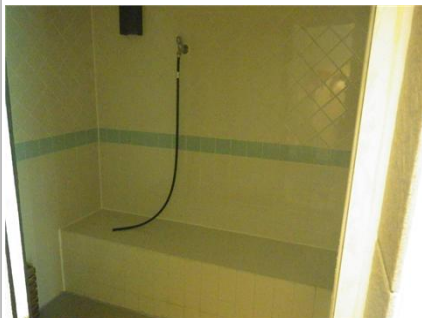
### Amen 14 - Steam Room

Tiled room with tiled bench. Rebuilt 2009; walls and floors repaired 2013.

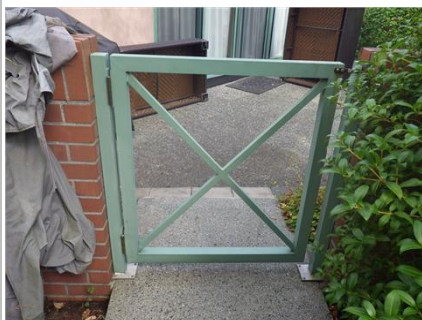
### Site 12 - Metal Screen Gate - 3'

Building B southwest corner of site. Building Painted metal screen fencing with gate and D and E patio entrances. Between Buildings gate hardware, 3' high.

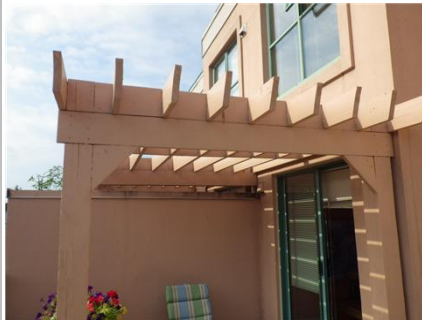
## Site 17 - Wood Trellis - Balconies and Decks

Timber framed with wood cross pieces. Trellises not replaced in 2011 at C802, C803, F305 and G305.

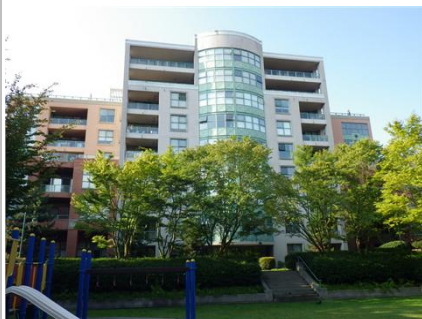
### Site 20 - Electrical Site Services

(Concealed Asset). From individual pad mounted transformers to building electrical rooms.
