[Docket No. FAA-2014-1083; Directorate Identifier 2014-CE-036-AD]

Airworthiness Directives; Various Aircraft Equipped with Wing Lift Struts

ACTION: Notice of proposed rulemaking (NPRM).

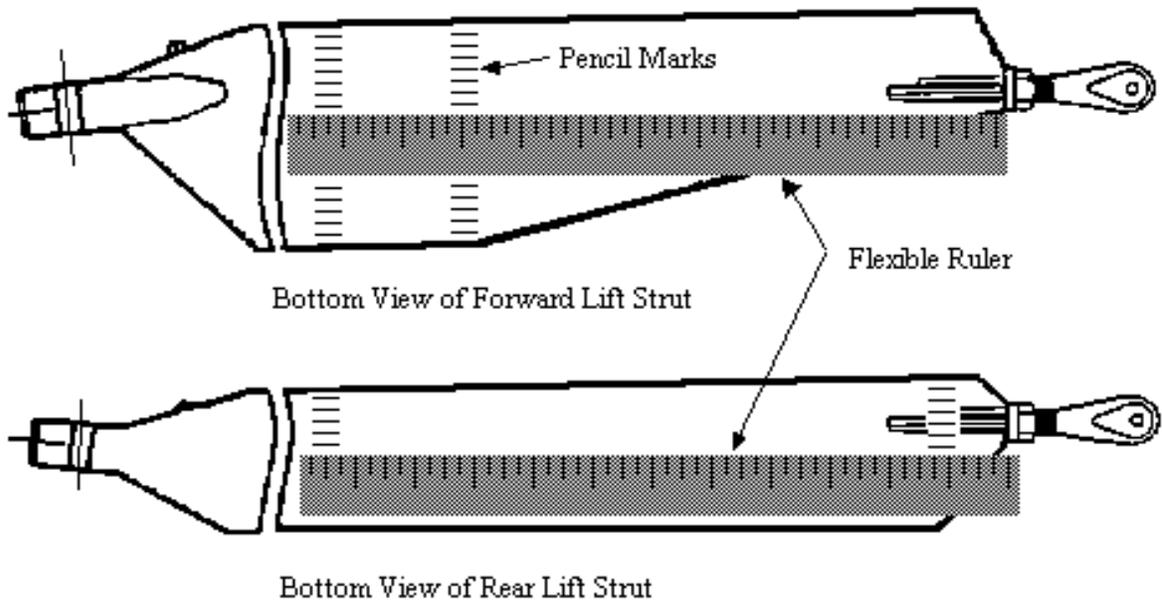
Figure 1

2. Using a flexible ruler, draw a 1/4-inch grid on the surface of the first 11 inches from the lower end of the strut as shown in Piper MSB No. 528D, dated October 19, 1990, or Piper MSB No. 910A, dated October 10, 1989, as applicable. This can be done using a soft (#2) pencil and should be done on both faces of the strut. As an alternative to drawing a complete grid, make two rows of marks spaced every 1/4-inch across the width of the strut. One row of marks should be about 11 inches from the lower end of the strut, and the second row should be several inches away where the strut starts to narrow. Lay the flexible ruler between respective tick marks of the two rows and use tape or a rubber band to keep the ruler in place. See Figure 1.
