## EXECUTIVE SUMMARY

Montana Exploradora de Guatemala, S.A. (Montana) is a legally incorporated Guatemalan company dedicated to the exploration and mining of precious minerals in Guatemala and is the owner of Marlin Mine (the Mine). In September 2003 the Ministry of Environment and Natural Resources (MARN) approved the Social and Environmental Impact Assessment Study (EIA & S Study) of the Mine by Resolution No. 779-2003/CRMM/EM.

Gold and silver have been mined at the Marlin I Pit, using conventional open pit mining methods. Currently there are no more mineral reserves at the pit; therefore the technical closure of this facility needs to be implemented. Montana has developed a new proposal for the technical closure of this facility, based on new technologies and hydro-geological, hydrological, geotechnical, geochemical and environmental studies of the Area of Direct Influence (ADI) of the mine. This updated Closure Plan includes the objective to provide the best possible closure format, for the benefit of the communities and the environment, simultaneously avoiding and/or eliminating the disadvantages of the original 2003 Closure Plan.

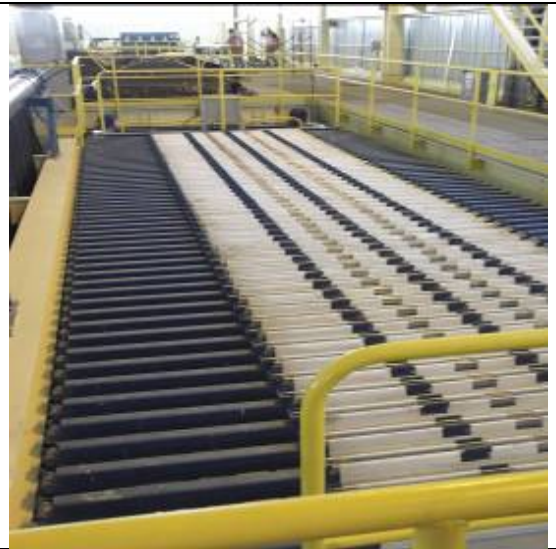
Photo 2.1. Marlin Mine Filter Plant.

The Updated Closure Plan (the Plan) is based on the optimization of tailings handling of the leaching process (mineral processing plant), previously treated by INCO process to neutralize the cyanide. The leaching optimization includes thickening and filtering at the mine filtering plant (Photo 2.1). In this phase, the filtered liquid will be re-circulated to the process; the tailings will be transported to temporary storage piles via a conveyor belt.

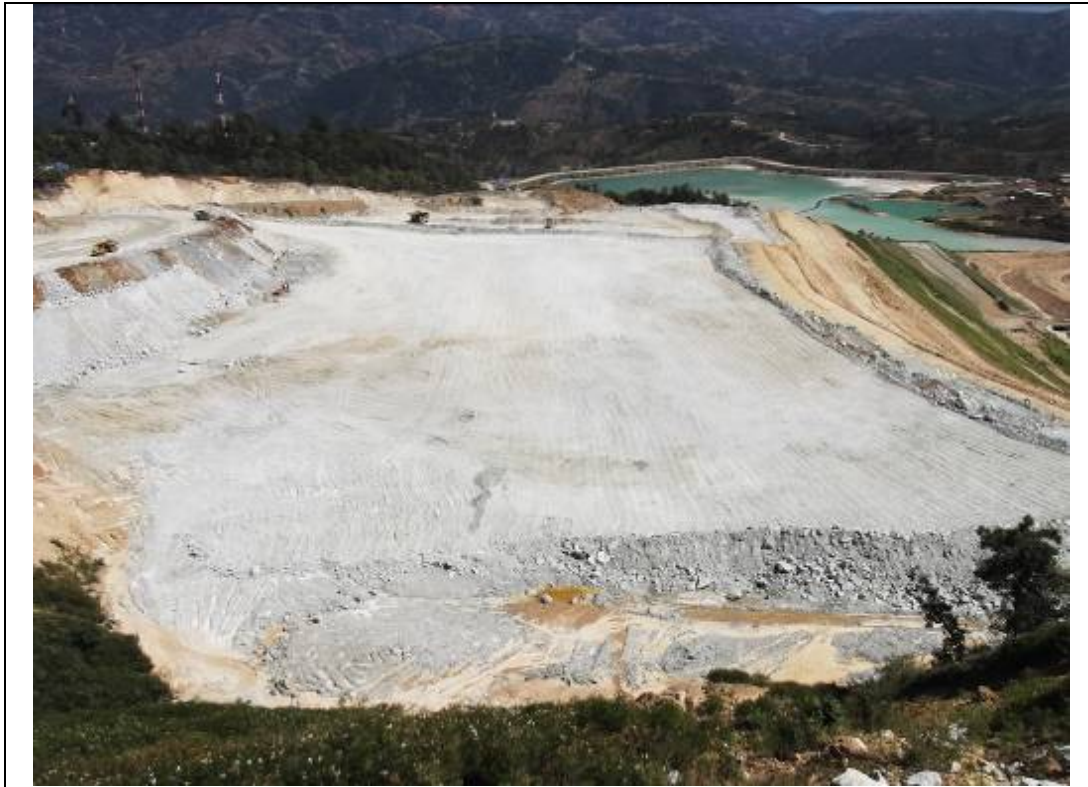
Photo 2.2. Dump of the Marlin Mine SE – NW view

For its use at the dump, the waste rock from the underground mine and the Cochís Pit will be mixed with the filtered tailings in a 3:1 proportion of waste rock and filtered tailings respectively. The placing of waste rock and filtered tailings mix will be completed in designated areas at the back of the dump, through cut and fill blockage methods. The piles of available material created for the blockage dumping will be flattened with a tractor and will be compacted by haul truck traffic. The use of tractors over the stacks of dump material will mix the material and will provide a surface suitable for traffic.

The last layer of the dump will be comprised by organic soil and will be revegetated using grains. It is anticipated that the mix of filtered tailings with waste material will provide enhancement to the stability of the dump slopes and will increase the impermeability of its surface, contributing to a reduction in the infiltration and thus create a greater drain of the runoffs.

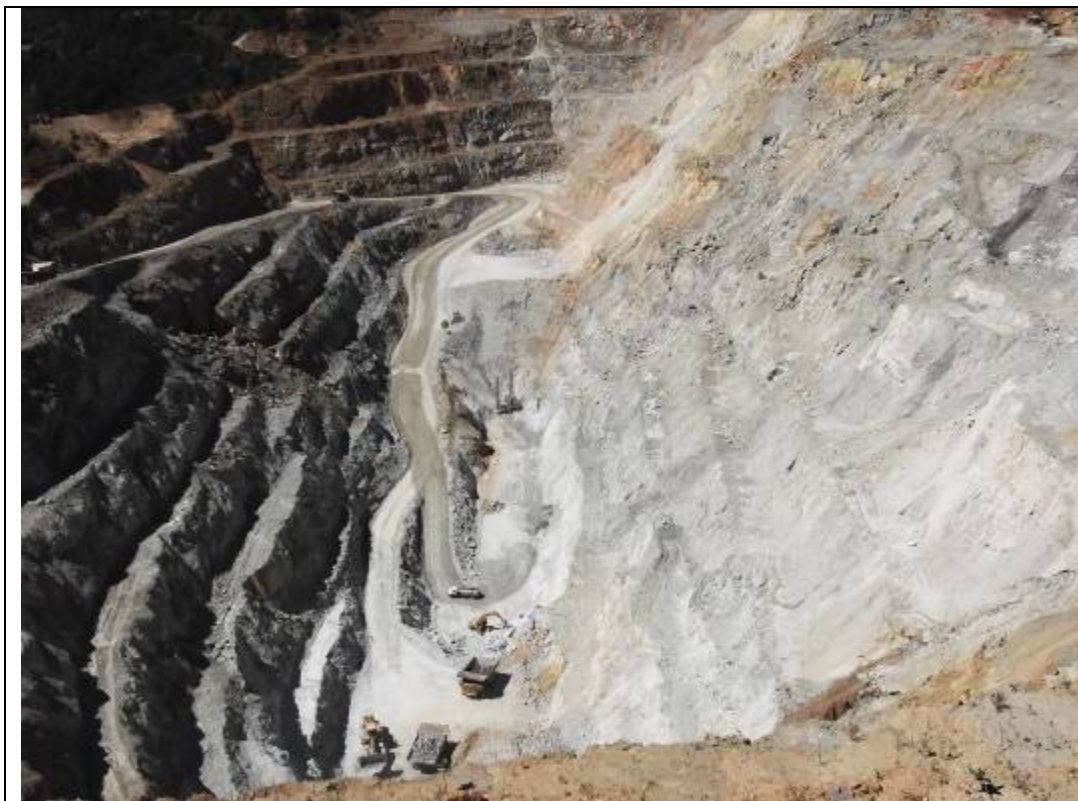
Photo 2. 3. Marlin Pit East West view.

In the case of the pit backfill, filtered tailings mixed with lime and/or cement will be used (during the initial stages of the backfill or when geotechnical conditions require it), in order to increase the carrying capacity of the tailings, as the dump trucks and other machinery will have to circumvent the filling. In accordance with the tests and trials, enough shear resistance may be obtained without drainage for light traffic by adding 1% to 3% of cement and/or lime. After the mixture is laid down, it is estimated that the minimum shear resistance will be of 100kPa. The mixture ratio will have to be increased in the areas of heavier traffic in order to reach greater a shear resistance without drainage of 250kPa, sufficient to allow heavy traffic circulation over the backfill.

The pit backfill will be carried out in a cut-and-fill sequence. This implies that a layer of approximately 250mm will be placed over an existing layer consecutively until it reaches the expected backfill level. As each layer placement progresses the material will be compacted using a conventional compactor. After the material is compacted it is expected to reach a density of 1.5 tons/m<sup>3</sup>.

When the backfill and re-contouring of the Marlin Pit are finished, a layer of organic soil will be placed; this will be obtained from the deposit of this material inside the Mine. The pit reclamation has not been determined yet, however, some options that include agro-forestry projects, development projects and/or conservation projects may be considered.

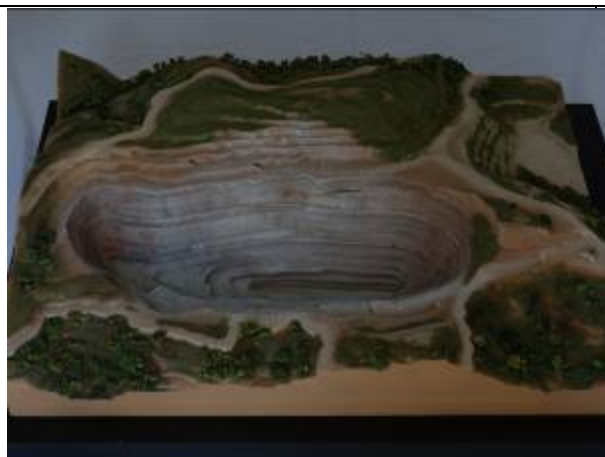
Photo 2. 4. Marlin Pit current state.

One of the most positive impacts is the landscape recovery, caused by backfill, configuration and revegetation of the Marlin pit. The best method to represent the effect of the pit closure is presented by a mock up prepared as a tool for a public participation process (Photos 2.4 and 2.5). These photos illustrate the current state of the pit and its projection at the conclusion of the closure and reclamation activities.

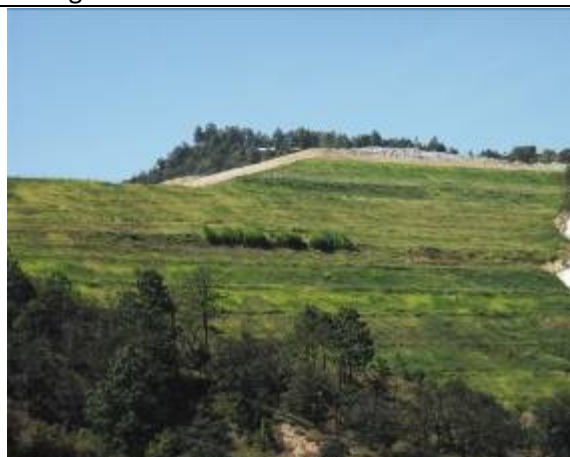
Photo 2. 6. View of the dump.

A positive high-level impact is expected regarding the dump because this structure will have a geoform that will mitigate the visual impact caused by the depression where it is being built and the re-vegetation of grains will also provide a better landscape appearance of the affected area. Photo 2.6 shows a view of the dump from an angle where the hillsides have already recovered and re-vegetation can be seen.
