PRESERVATION STAFF REPORT

Site: 59 Cross Street

Petition: Somerville Hispanic Association for Community Development, Owner, seeks permission from the Somerville Historic Preservation Commission (HPC) to alter north side entry and walkway to meet ADA requirements.

SOMERVILLE HISPANIC CHURCH
89 CROSS STREET, SOMERVILLE, MA 02145

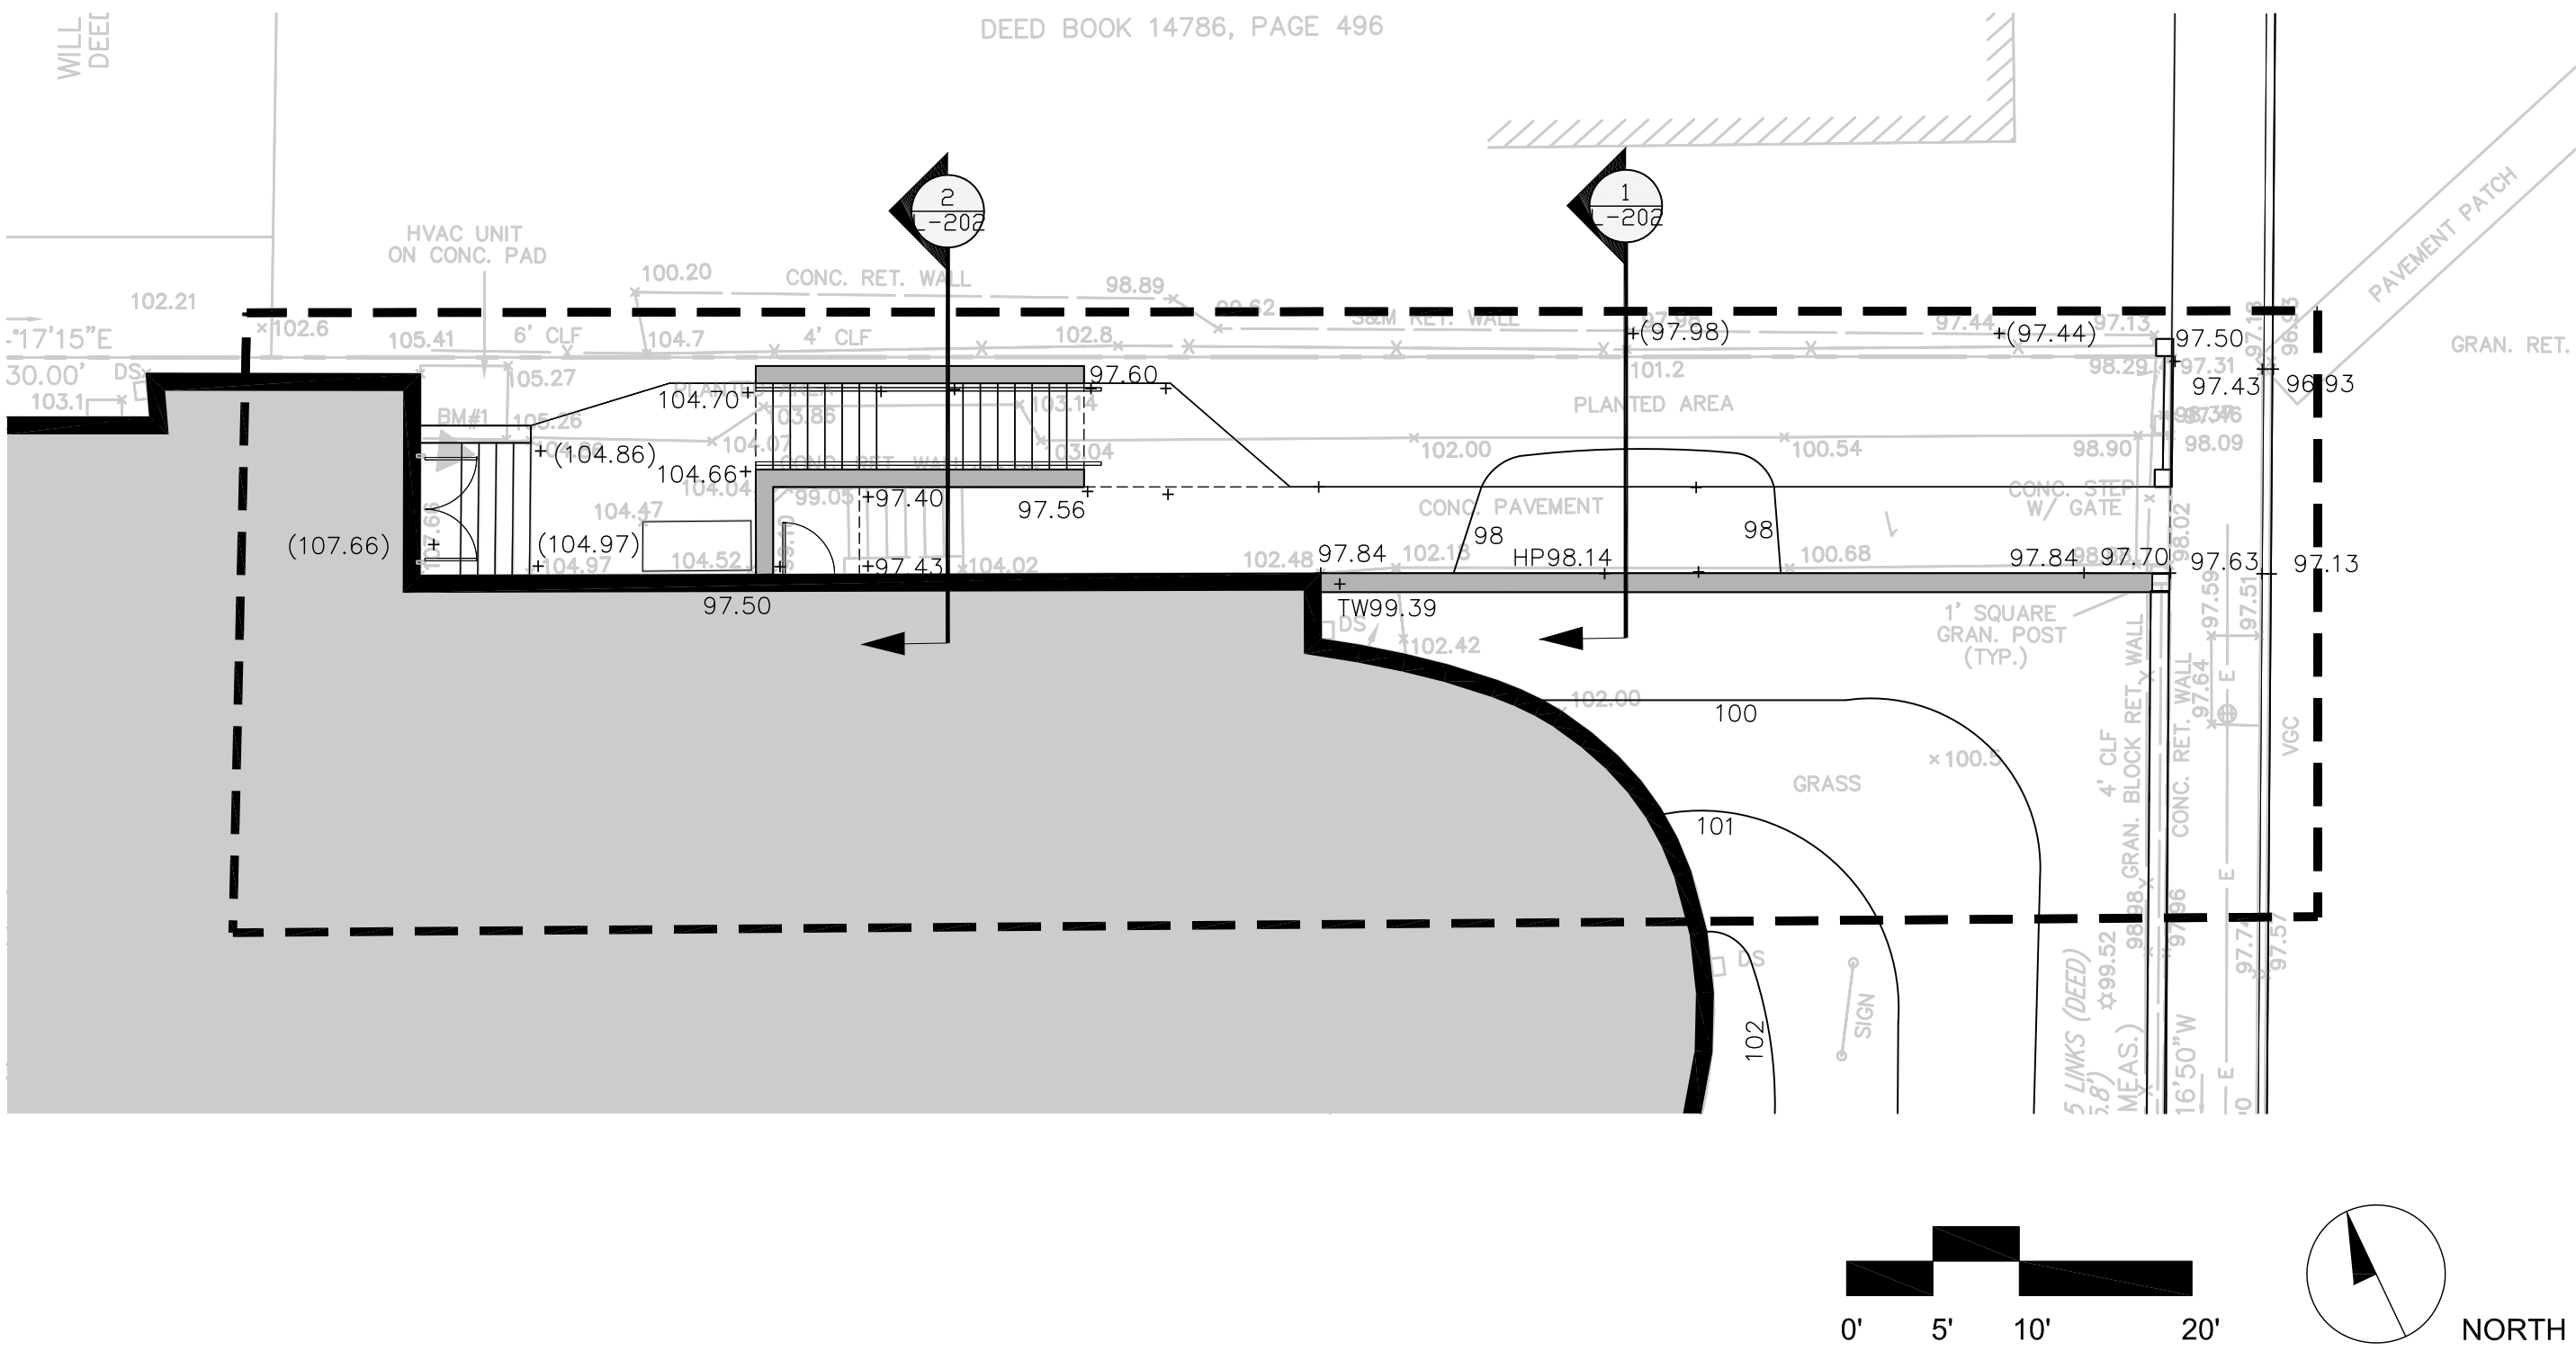
2 GRADING PLAN

- CONTRACTOR SHALL MAINTAIN POSITIVE DRAINAGE AWAY FROM PROPOSED BUILDING, STRUCTURES, AND PLANTING BEDS.
- MAXIMUM SLOPE WITHIN DISTURBED AREAS SHALL NOT EXCEED 3:1, UNLESS OTHERWISE NOTED.

- PROTECT AND MAINTAIN EXISTING ON-SITE DRAINAGE STRUCTURES AND PIPES UNLESS OTHERWISE NOTED. REFER TO CIVIL DRAWINGS.
- WHERE PROPOSED GRADES MEET EXISTING GRADES, CONTRACTOR SHALL BLEND GRADES TO PROVIDE A SMOOTH TRANSITION BETWEEN EXISTING AND NEW WORK. PONDING AT TRANSITION AREAS WILL NOT BE ALLOWED.

- CONTRACTOR SHALL MAINTAIN POSITIVE DRAINAGE AWAY FROM ALL BUILDING FOUNDATIONS, STRUCTURES AND PLANTING BEDS.
- CONTRACTOR SHALL VERIFY EXISTING GRADES AND NOTIFY LANDSCAPE ARCHITECT OF ANY DISCREPANCIES.

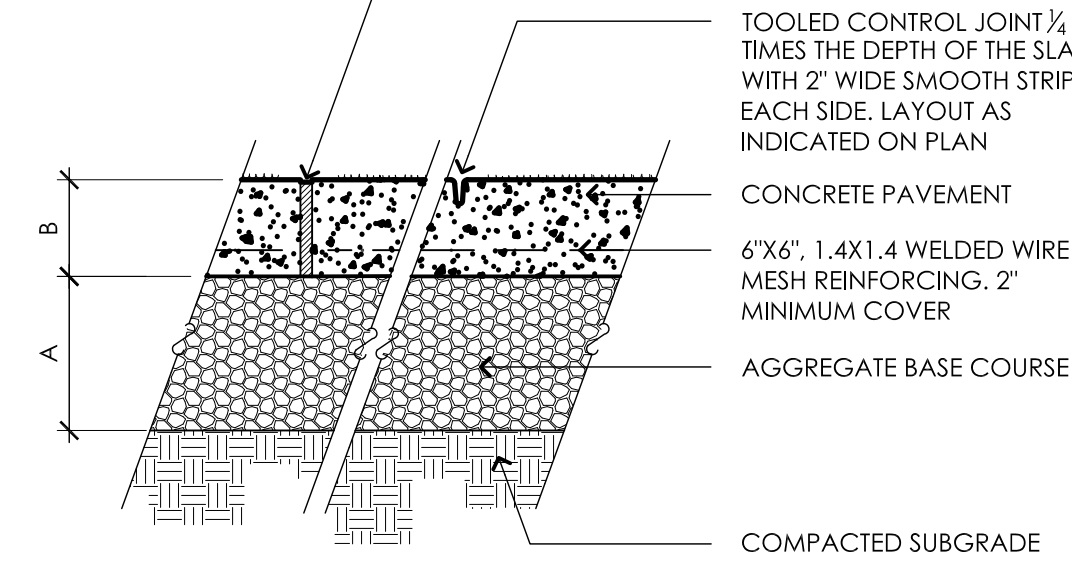
CONCRETE WALK
HEAVY DUTY FVM
*SUBJECT TO FINAL
GEOTECHNICAL
RECOMMENDATIONS

NOTES:
PROVIDE LIGHT BROOM FINISH PERPENDICULAR TO THE TRAFFIC FLOW UNLESS
OTHERWISE NOTED

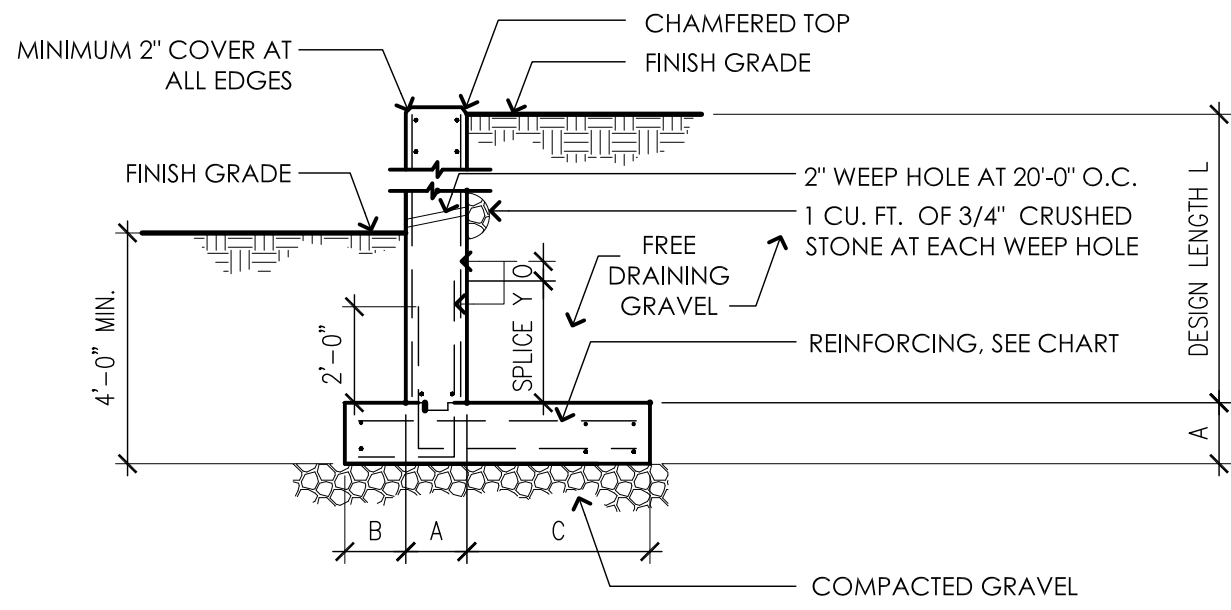
DESIGN HEIGHT	CONCRETE DIMENSIONS	REINFORCING
4'-1" TO 6'-0"	1'-0" 1'-2" 2'-0"	#4@12 2'-0"
6'-1" TO 8'-0"	1'-6" 1'-2" 2'-6"	#5@12 2'-6"
8'-1" TO 10'-0"	2'-0" 1'-2" 3'-0"	#6@12 3'-0"
10'-1" TO 12'-0"	2'-4" 1'-2" 3'-8"	#6@8 3'-0"
12'-1" TO 14'-0"	2'-4" 1'-2" 4'-6"	#8@12 5'-0"
14'-1" TO 16'-0"	2'-10" 1'-2" 5'-0"	#8@8 5'-0"

NOTE: THIS DETAIL PROVIDED FOR
PRICING ONLY. SEE
STRUCTURAL DETAILS.

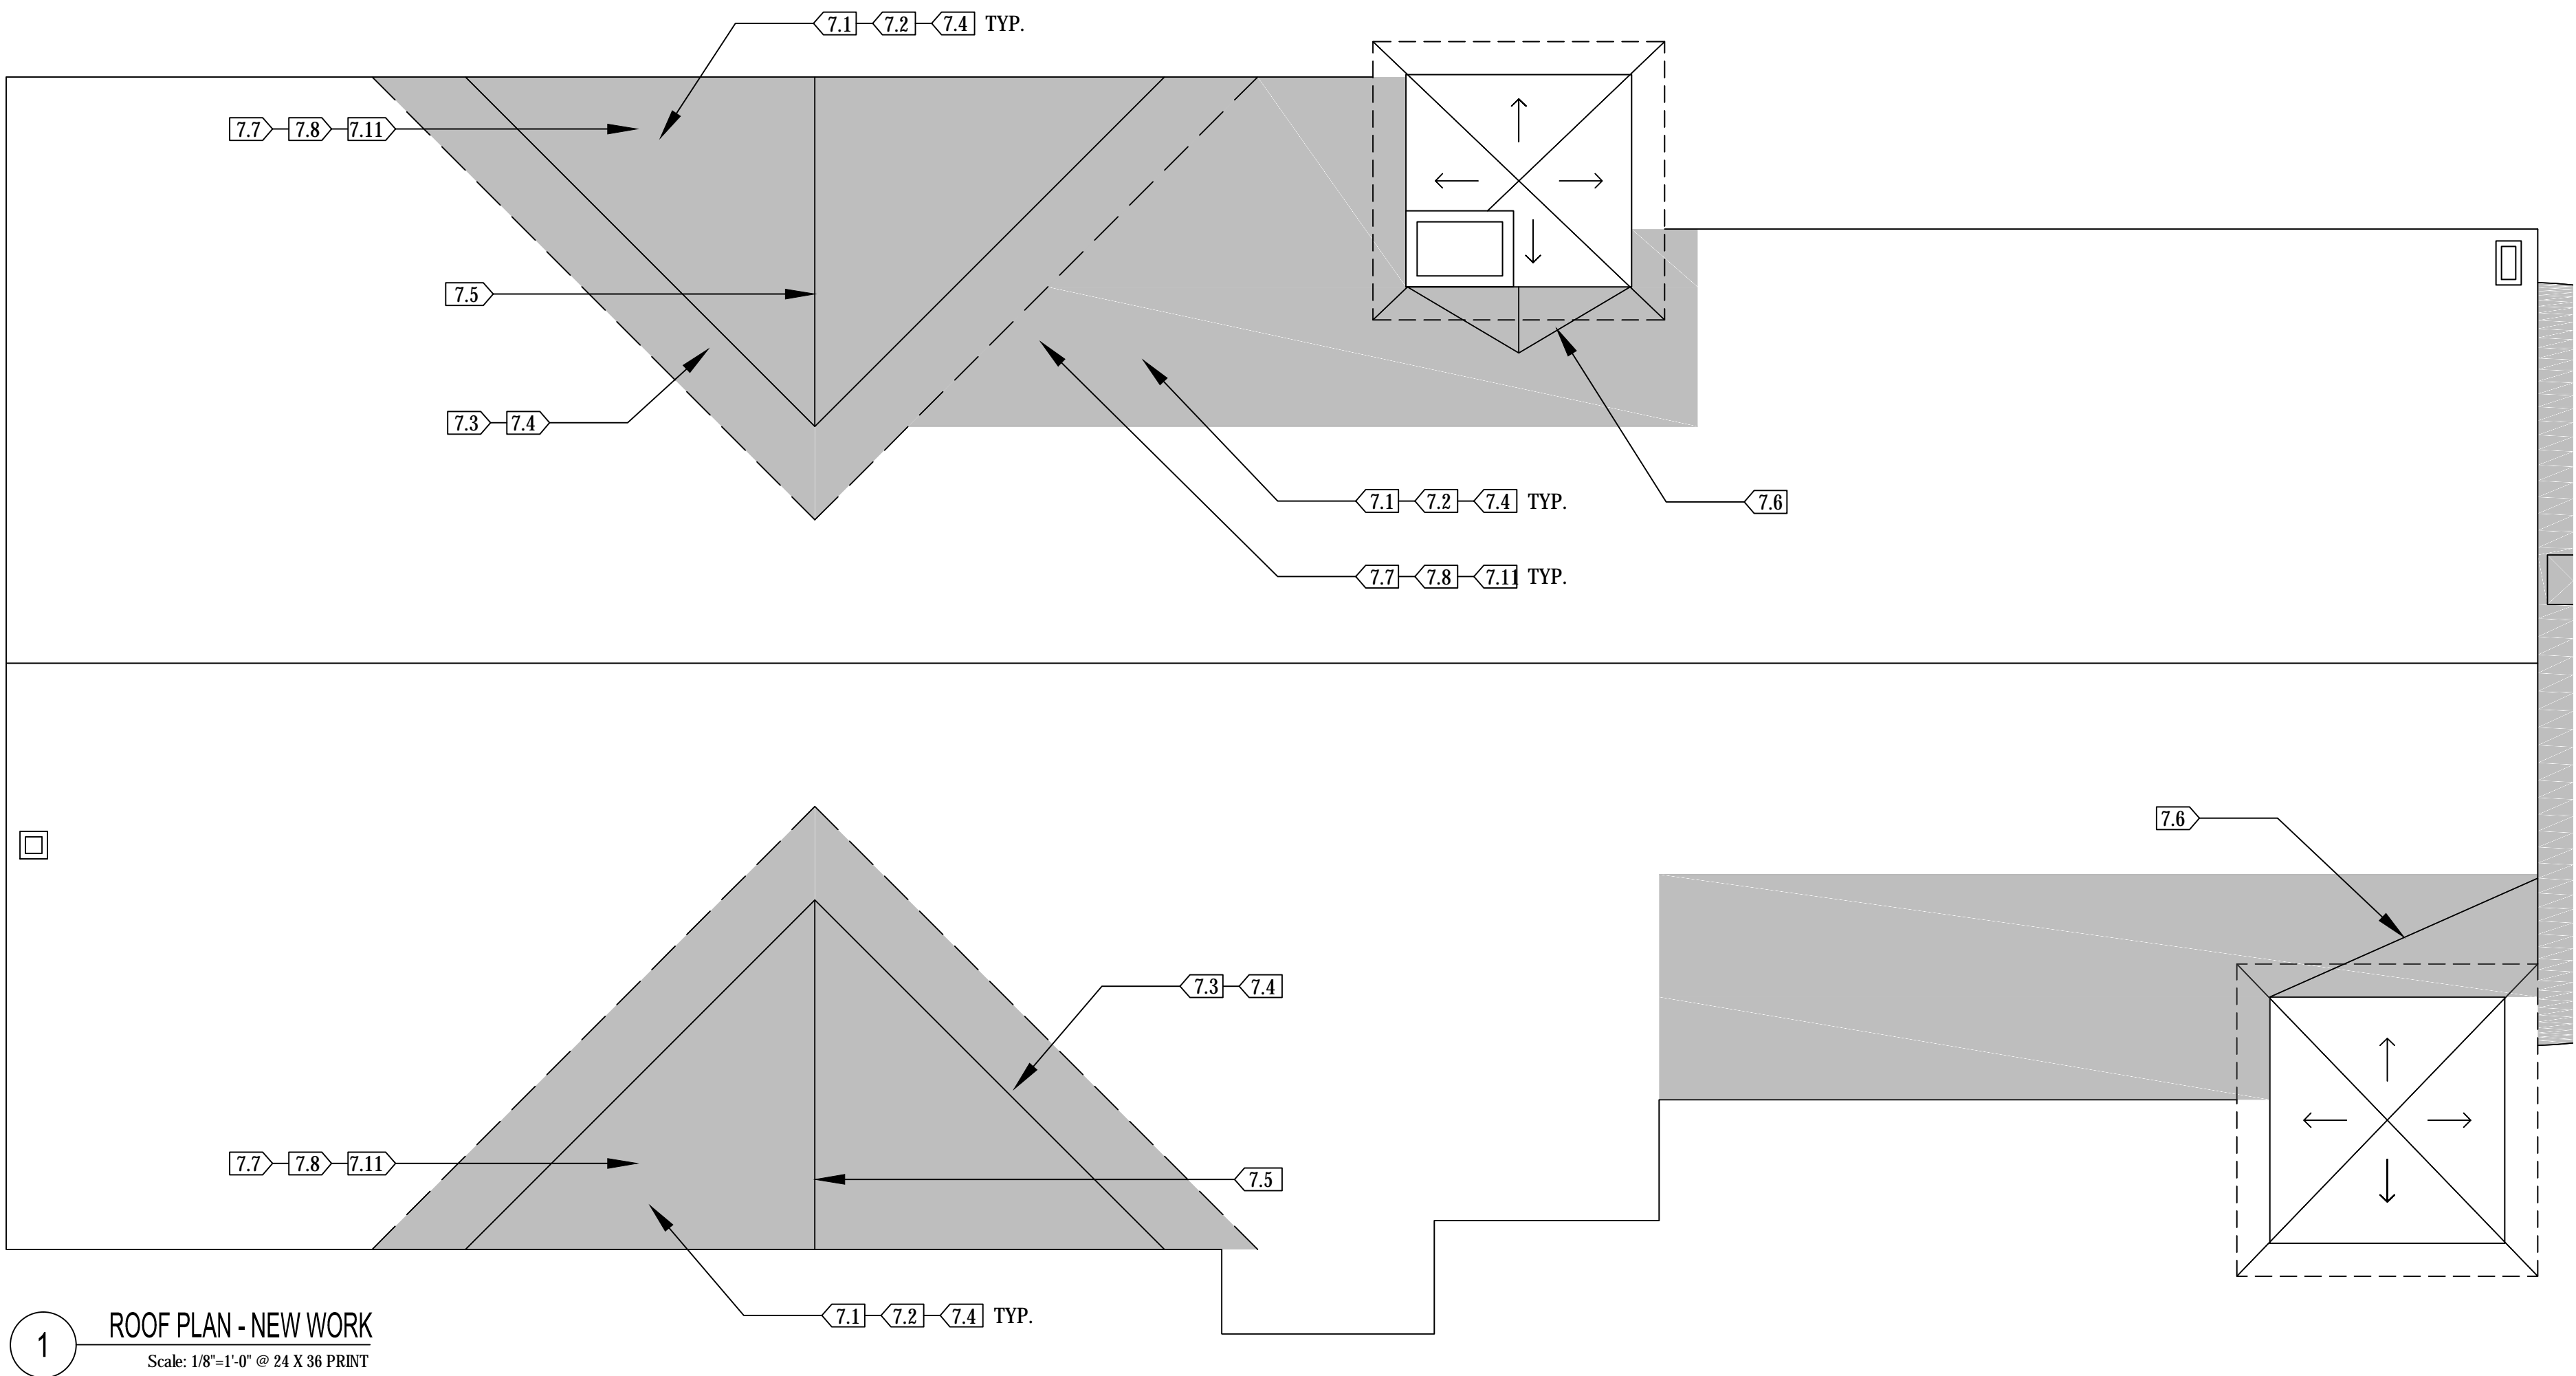
Proposed Scope of Work for Exterior Envelope - New Work:

- 4.1 Rebuild brick masonry surrounding projecting roof drain at north wall face roof sheathing with in-kind materials.
- 4.2 Perform isolated repointing of selected wall areas on all three exposed sides.

- 4.3 Rebuild and/or repoint spandrel panels between masonry openings of windows.
- 4.4 Repair stepped crack in arch over entry doors to shelter and sanctuary.

- 7.5 Provide new red copper ridge flashing at both cross gables.
- 7.6 Replace any deteriorated wood framing and sheathing at existing crickets where tower wall meets roof.

- 7.12 Provide new aluminum downspouts

- 7.13 Install copper flashing at lower edge of round window.
- 7.14 Replace missing downspouts at three locations, each side.
- 7.15 Provide new roofs and flashing over both bulkheads.
- 7.16 Clean-out cast iron receivers and interior drains of all downspouts.
- 7.17 Provide lead flashing at tops of all four steel buttresses.
- 7.18 Provide new red copper base flashing, edge flashing, and built-in gutters.
- 8.1 Replace louvered vents in all openings with glazed window sashes.
- 8.2 Replace sheet metal covering with laminated glass in wood frame.
- 8.3 Replace all existing storm windows, all building elevations, including arched transoms.
- 8.4 Remove and replace broken glass in storm windows.

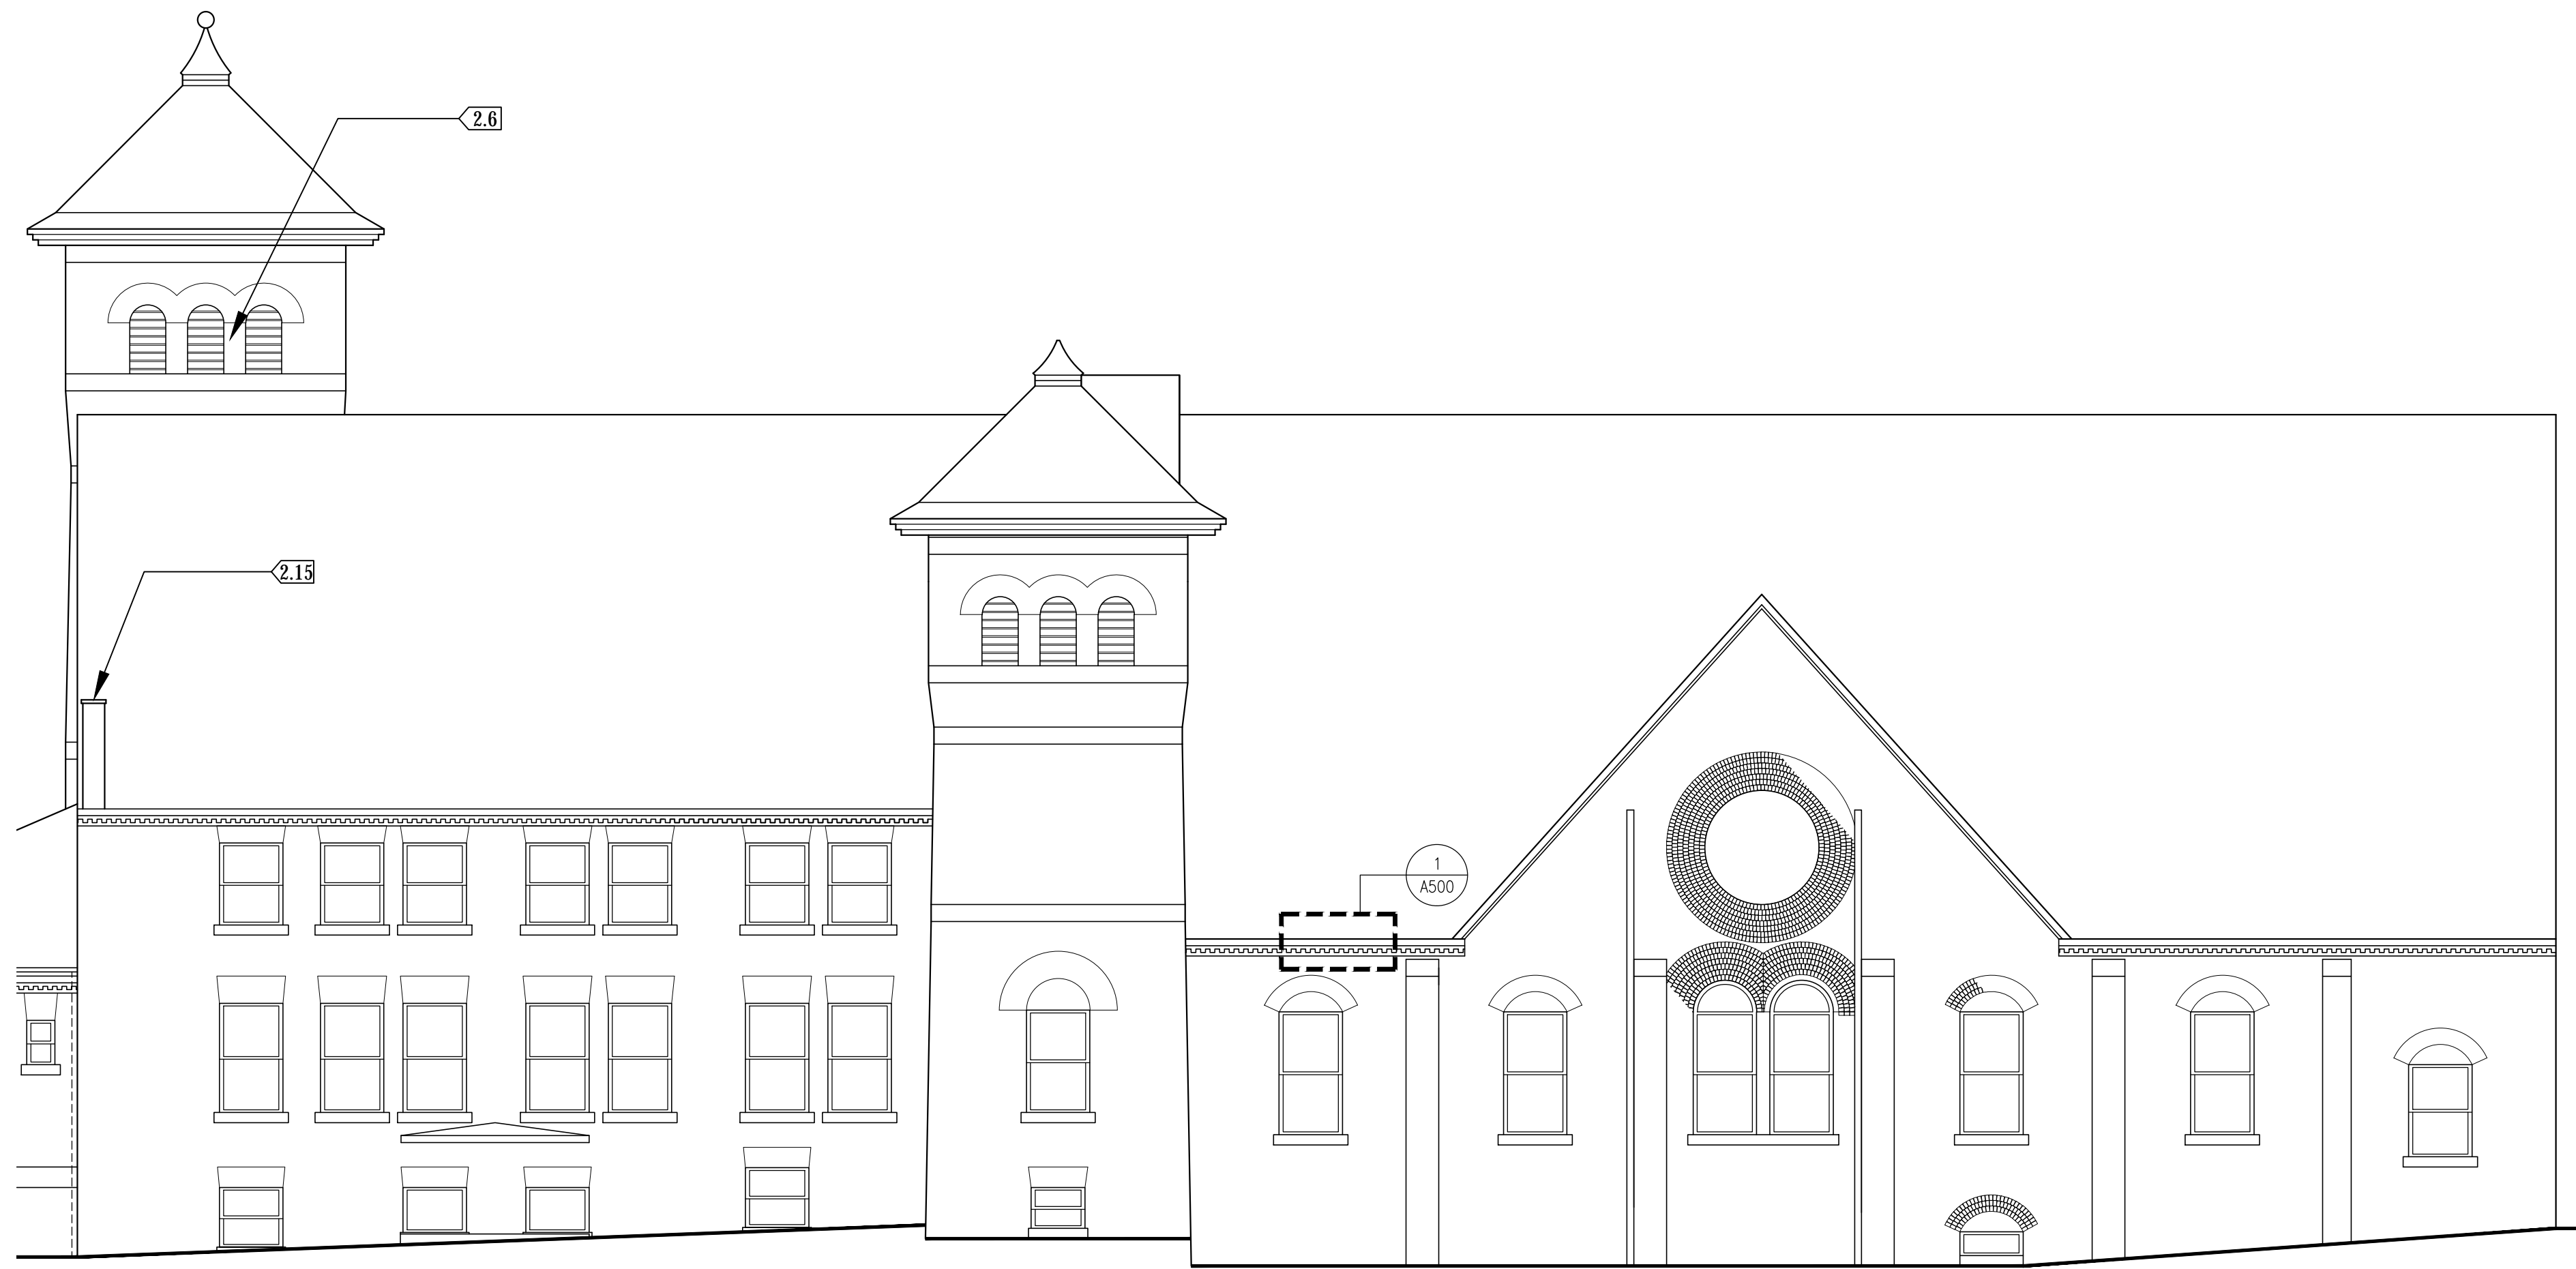
1 NORTH ELEVATION - DEMOLITION
Scale: 1/8"=1'-0" @ 24 X 36 PRINT

- 2.3 Remove existing copper valley flashing and any underlayment materials.
- 2.4 Replace any deteriorated wood roof sheathing with in-kind materials
- 2.5 Remove black asphalt roofing sealer from all brick masonry abutting main roof.

- 2.10 Not used.
- 2.11 Remove spalled brick masonry and replace with new bricks to match existing.
- 2.12 Remove asphalt sealant from brick masonry below round window.

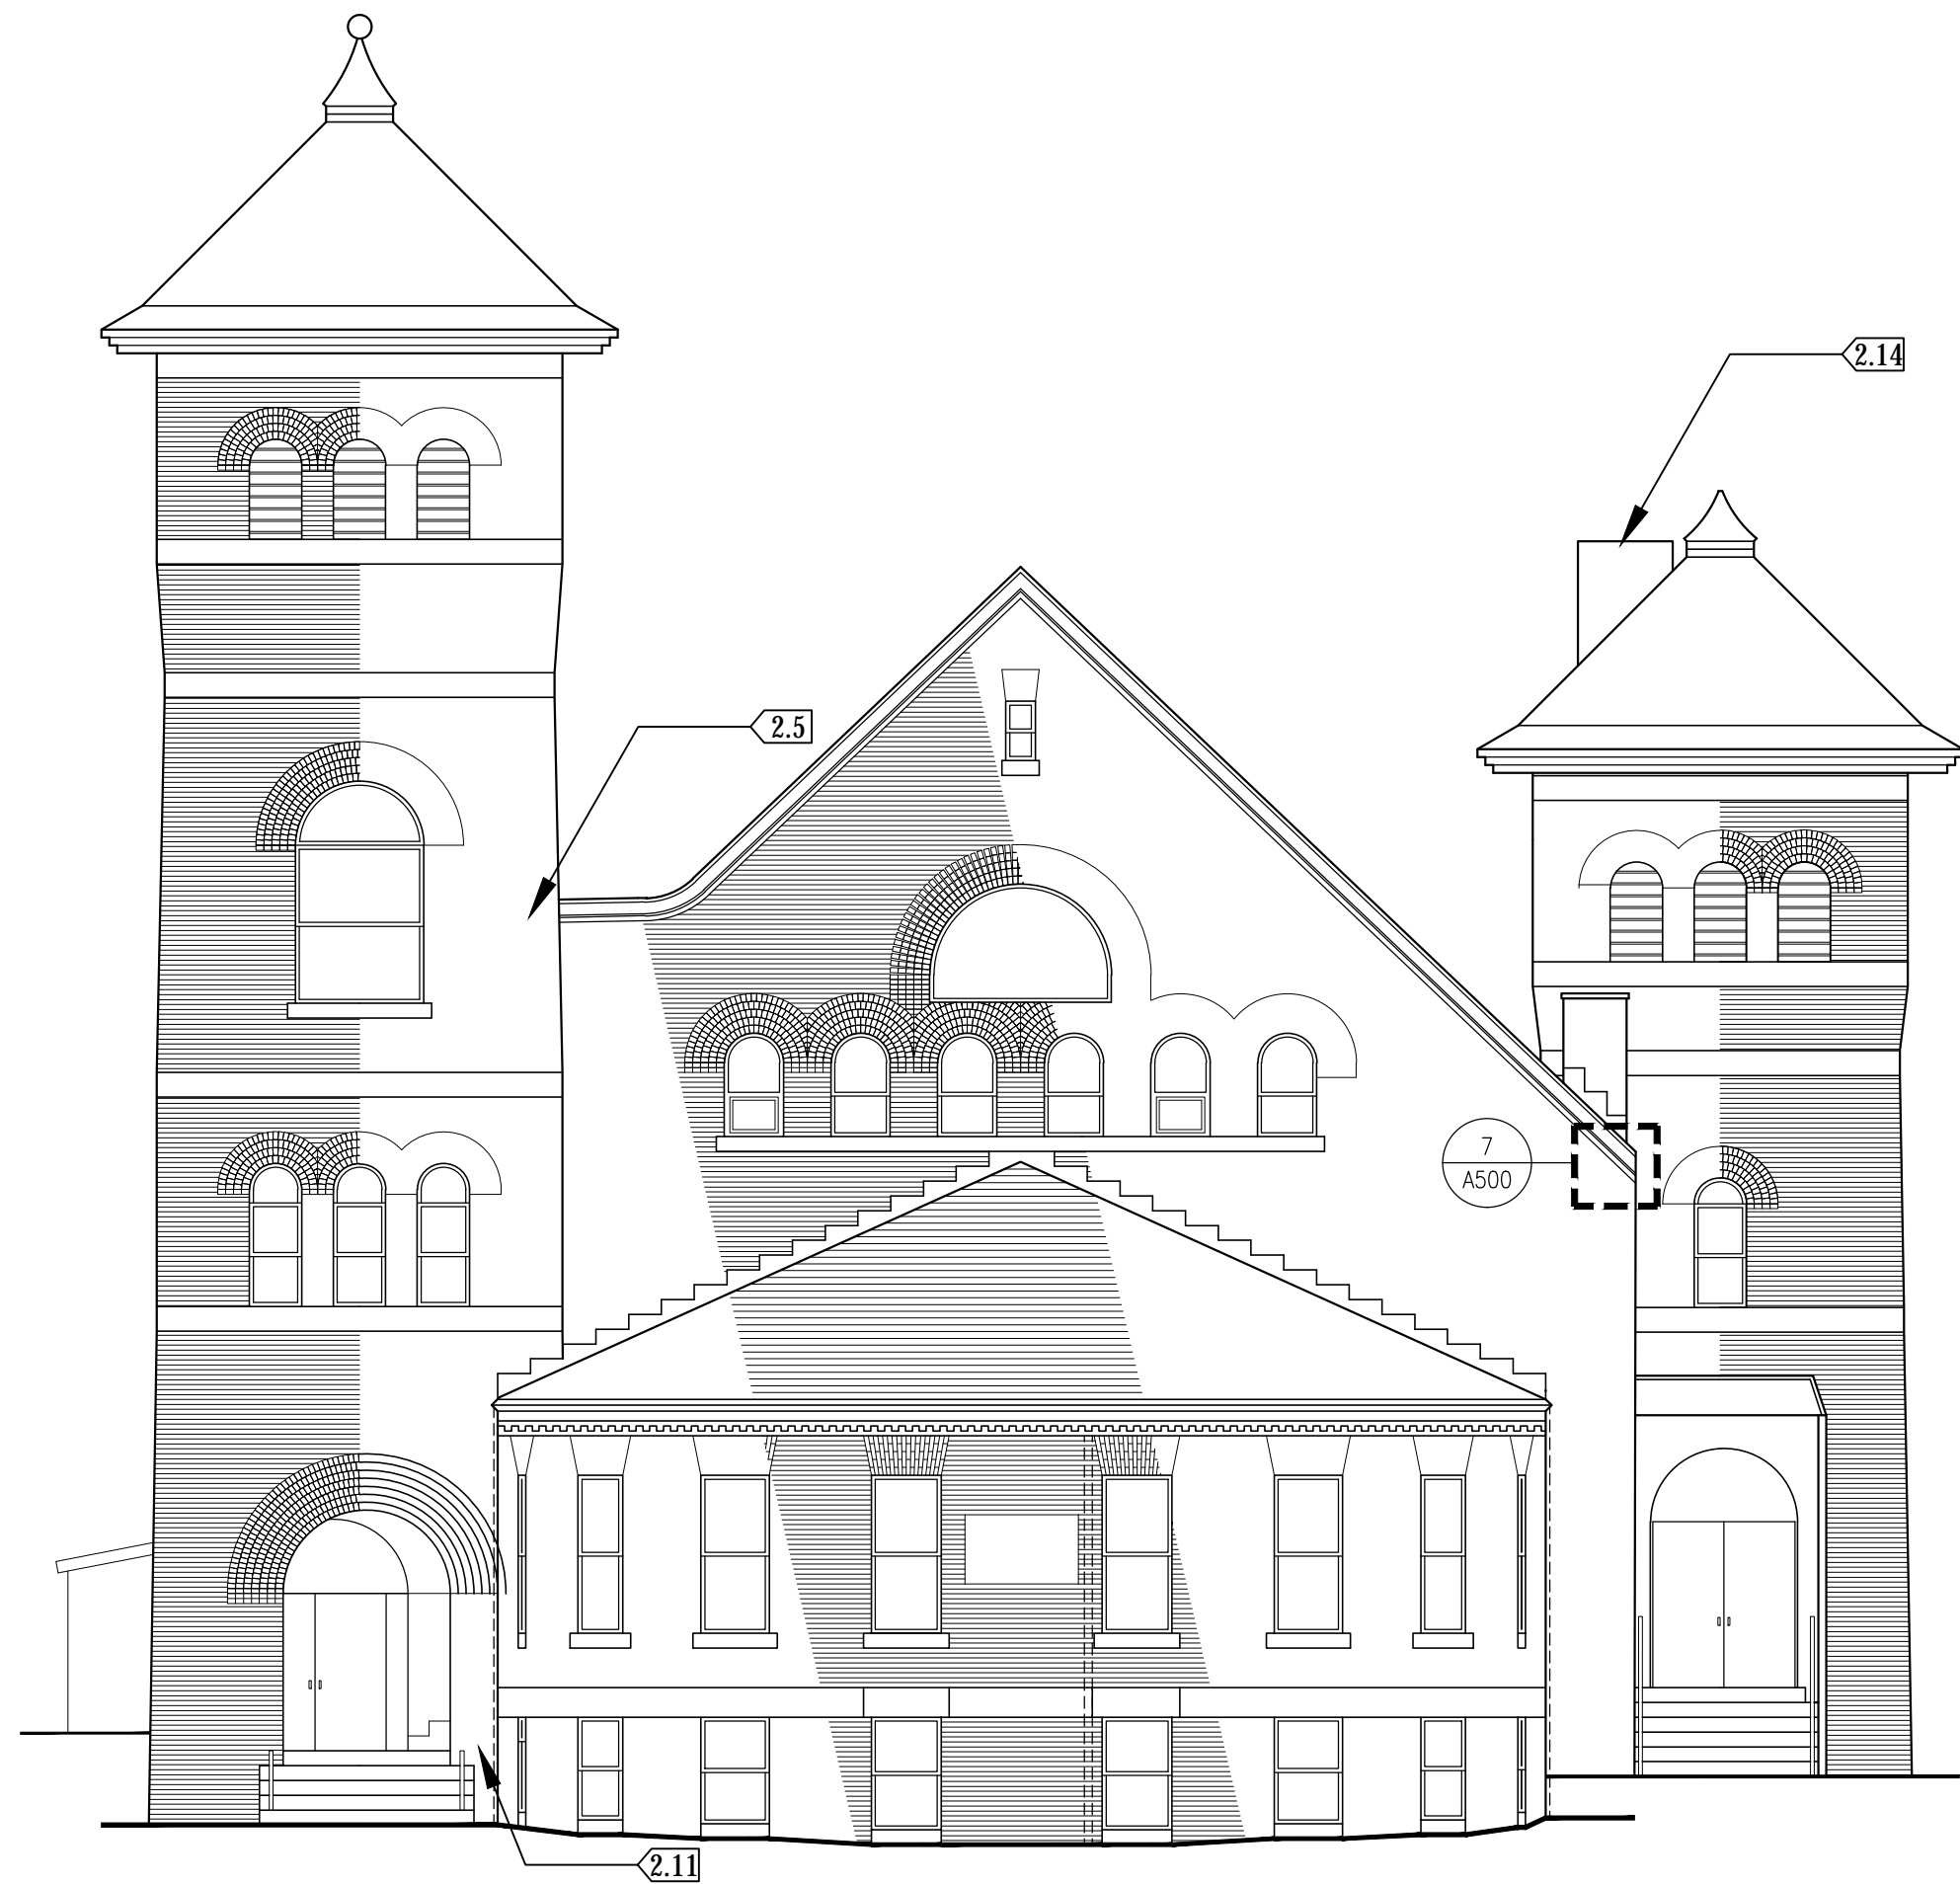
1 EAST ELEVATION - DEMOLITION
Scale: 1/8"=1'-0" @ 24 X 36 PRINT

- 2.3 Remove existing copper valley flashing and any underlayment materials.
- 2.4 Replace any deteriorated wood roof sheathing with in-kind materials
- 2.5 Remove black asphalt roofing sealer from all brick masonry abutting main roof.

- 2.10 Not used.
- 2.11 Remove spalled brick masonry and replace with new bricks to match existing.
- 2.12 Remove asphalt sealant from brick masonry below round window.

- 2.13 Remove asphalt sealant at counter-flashing of two bulkheads.
- 2.14 Disassemble brick masonry down ten (10) courses; salvage brick for rebuilding.

- 2.15 Disassemble brick masonry down to roof level; salvage brick for rebuilding.

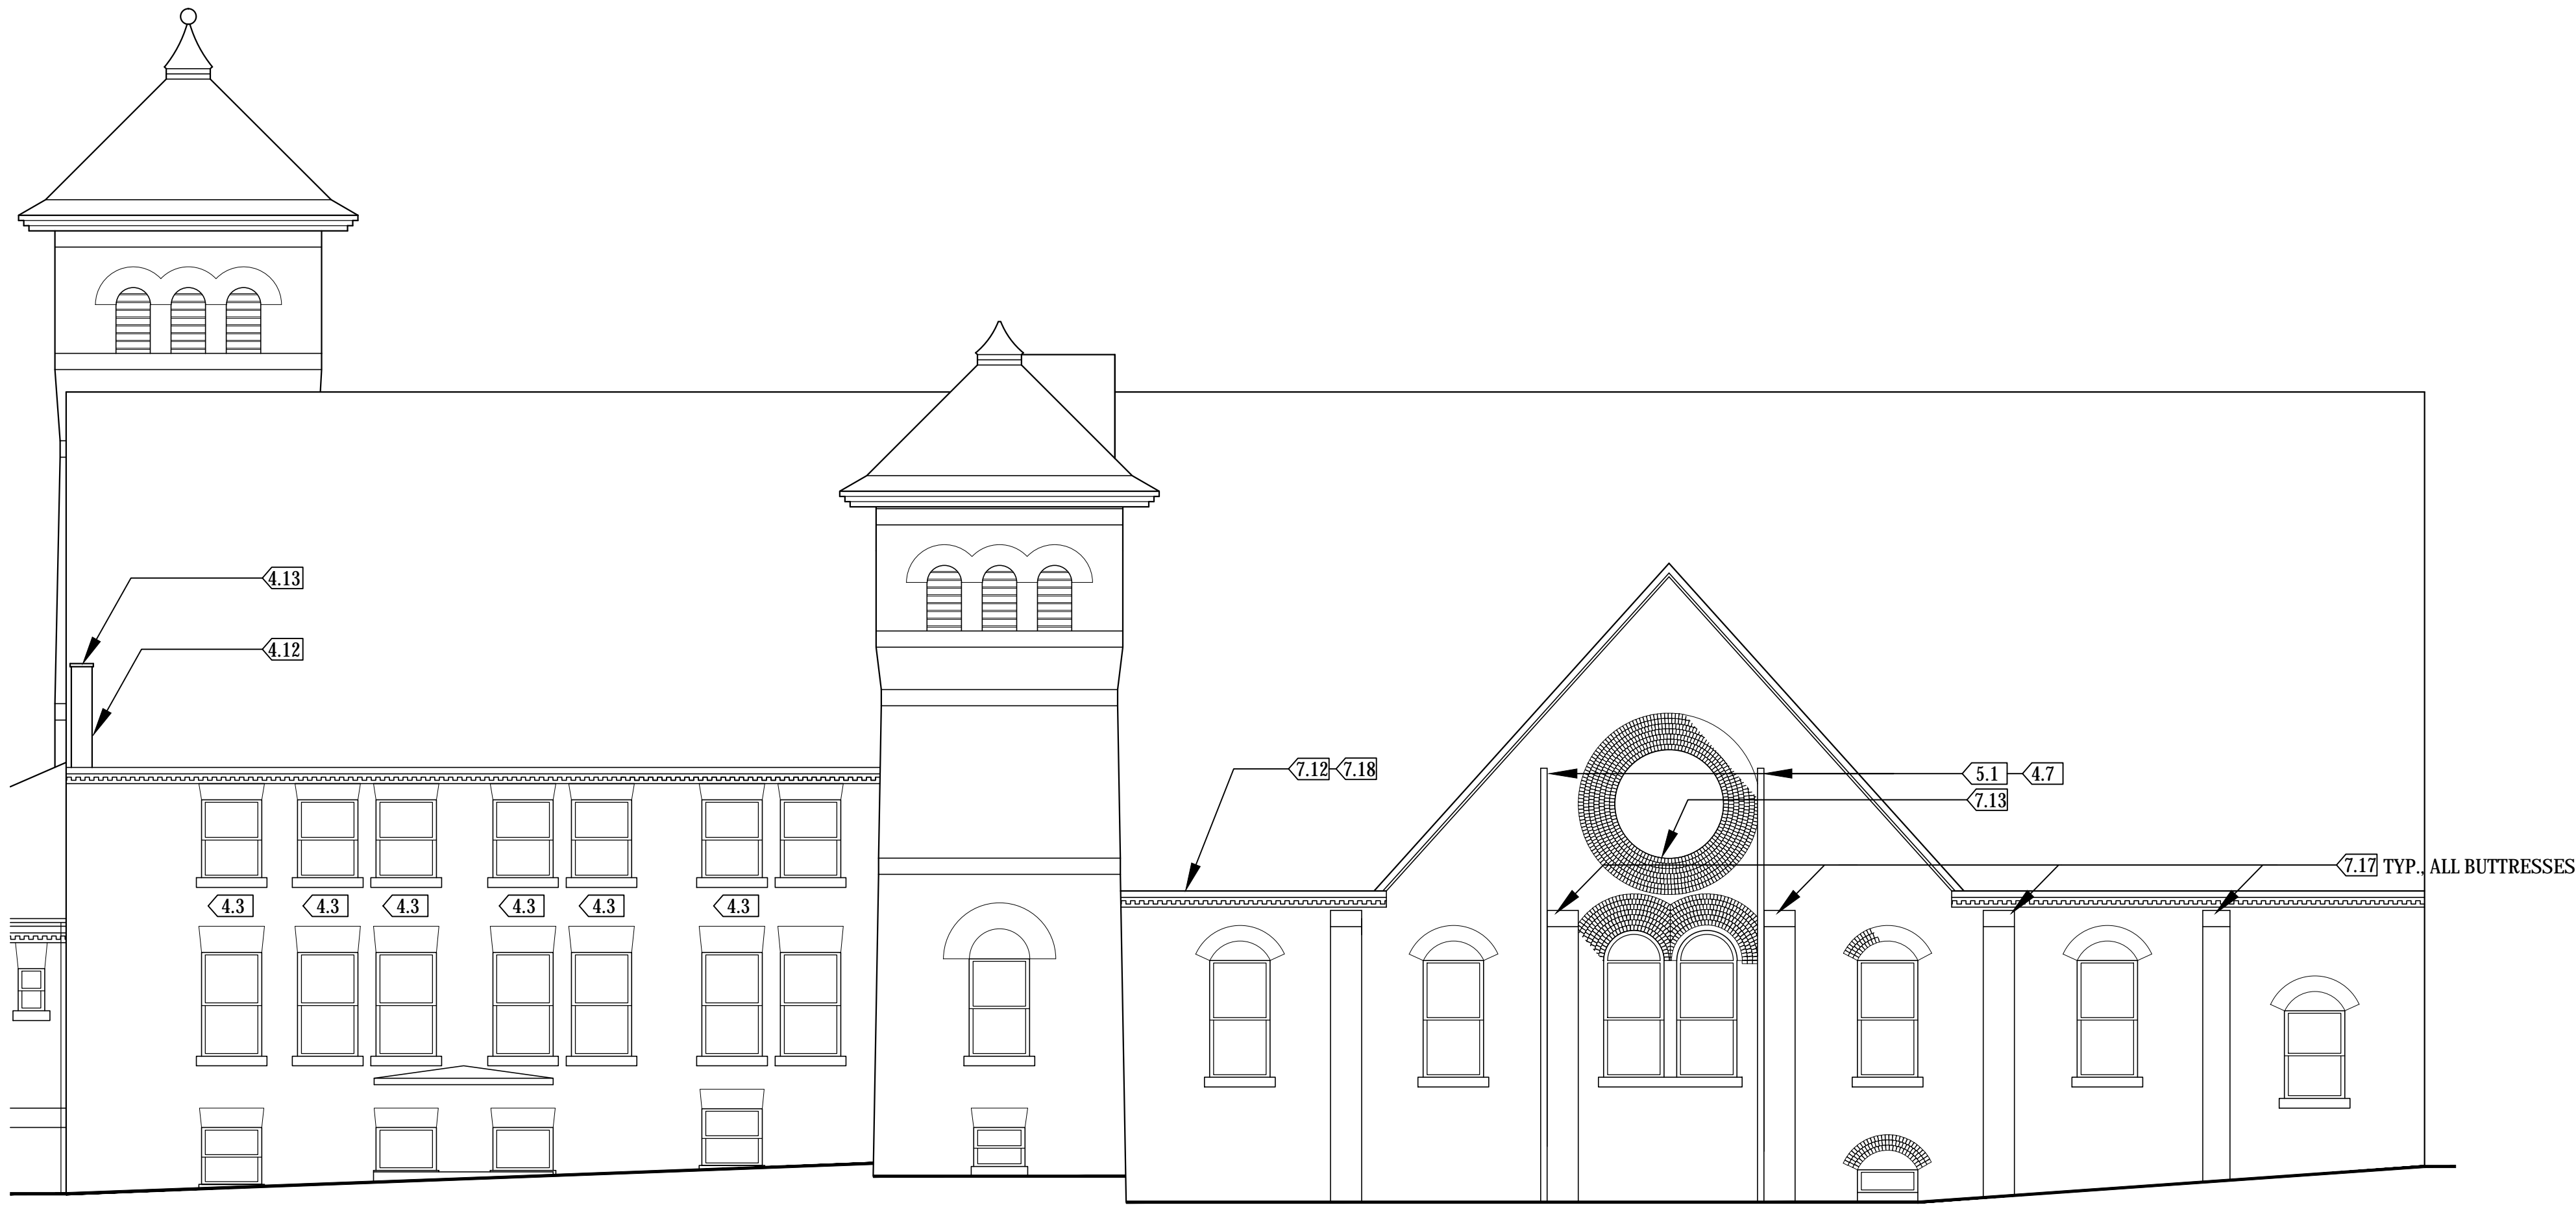
1 NORTH ELEVATION
Scale: 1/8"=1'-0" @ 24 X 36 PRINT

Proposed Scope of Work for Exterior
Envelope - New Work:

- 4.3 Rebuild and/or repoint spandrel panels between masonry openings of windows.
- 4.4 Repair stepped crack in arch over entry doors to shelter and sanctuary.

- 7.6 Replace any deteriorated wood framing and sheathing at existing crickets where tower wall meets roof.
- 7.7 Cover existing and new roof sheathing with roofing felt underlayment.

- 7.14 Replace missing downspouts at three locations, each side.
- 7.15 Provide new roofs and flashing over both bulkheads.
- 7.16 Clean-out cast iron receivers and interior drains of all downspouts.
- 7.17 Provide lead flashing at tops of all four steel buttresses.
- 7.18 Provide new red copper base flashing, edge flashing, and built-in gutters.
- 8.1 Replace louvered vents in all openings with glazed window sashes.
- 8.2 Replace sheet metal covering with laminated glass in wood frame.
- 8.3 Replace all existing storm windows, all building elevations, including arched transoms.
- 8.4 Remove and replace broken glass in storm windows.

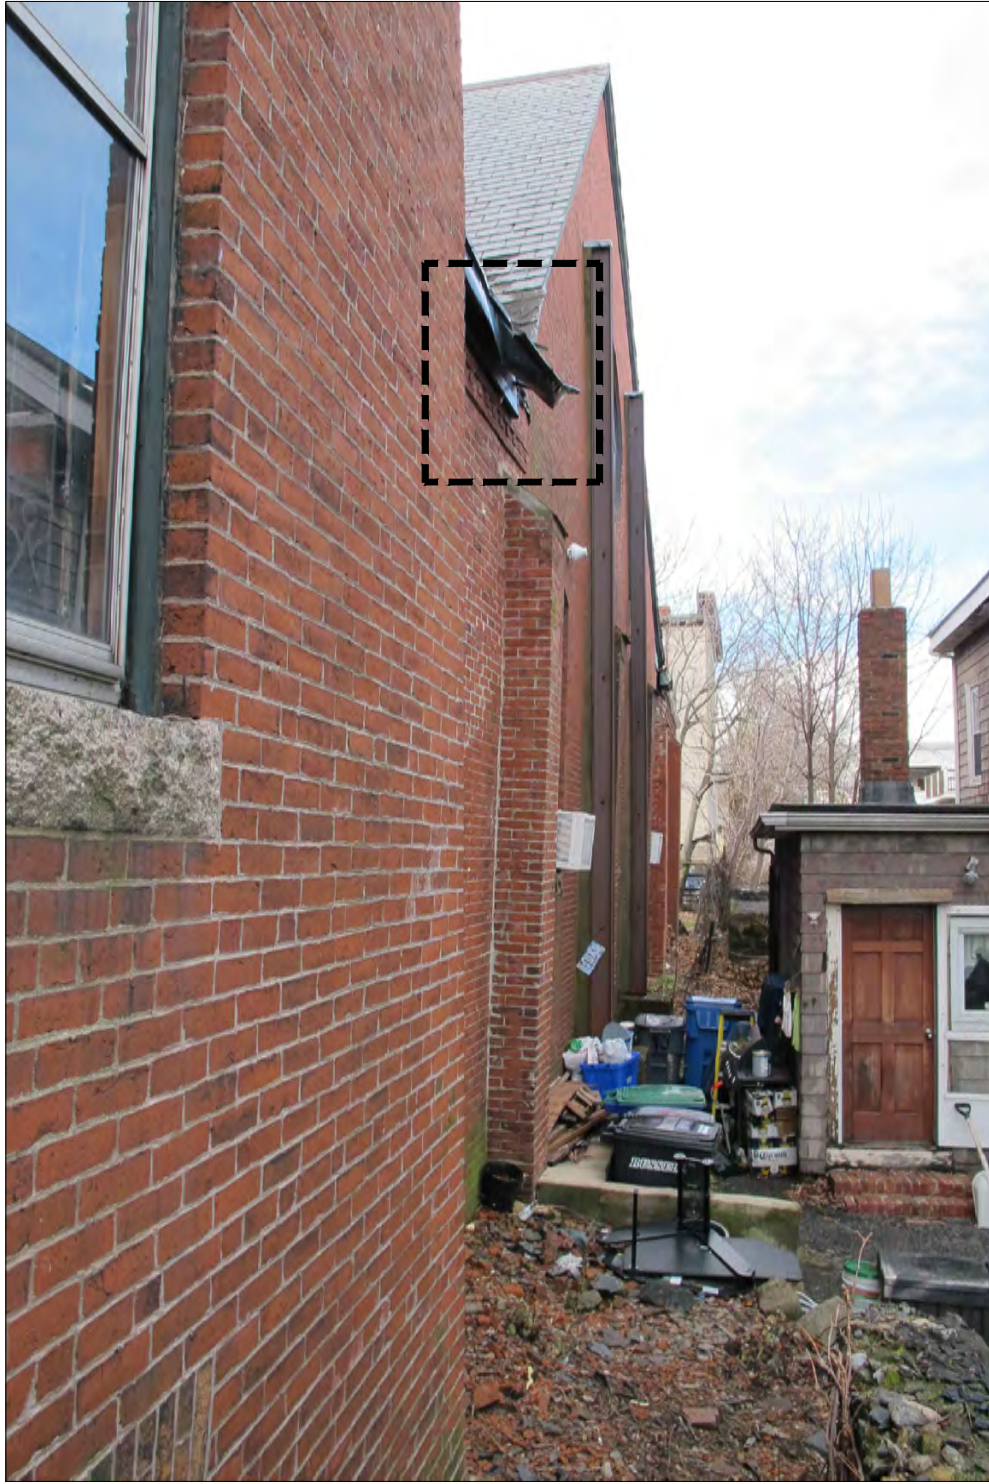
PHOTO 1/DRAWING D-200: Damaged flashing and gutter adjacent to cross-gable at the north elevation.

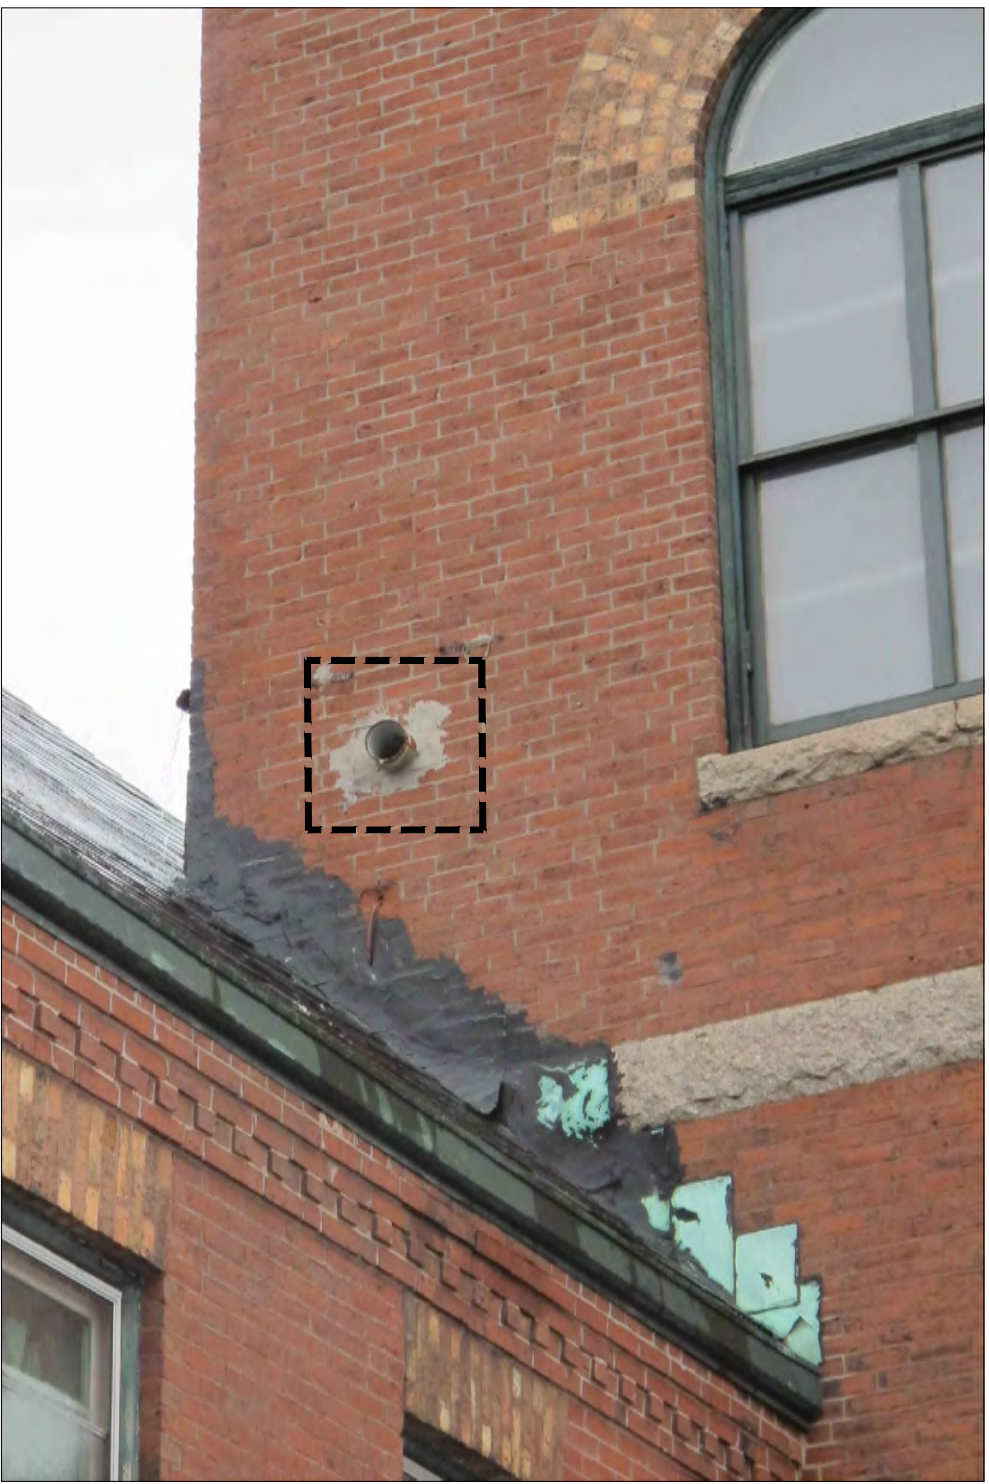
PHOTO 2/DRAWING D-201: Damaged masonry and projecting roof drain at northeast elevation.
