PRESERVATION STAFF REPORT

Site: 59 Cross Street

Petition: Somerville Hispanic Association for Community Development, Owner, seeks permission from the Somerville Historic Preservation Commission (HPC) to alter north side entry and walkway to meet ADA requirements.

SOMERVILLE HISPANIC CHURCH
89 CROSS STREET, SOMERVILLE, MA 02145

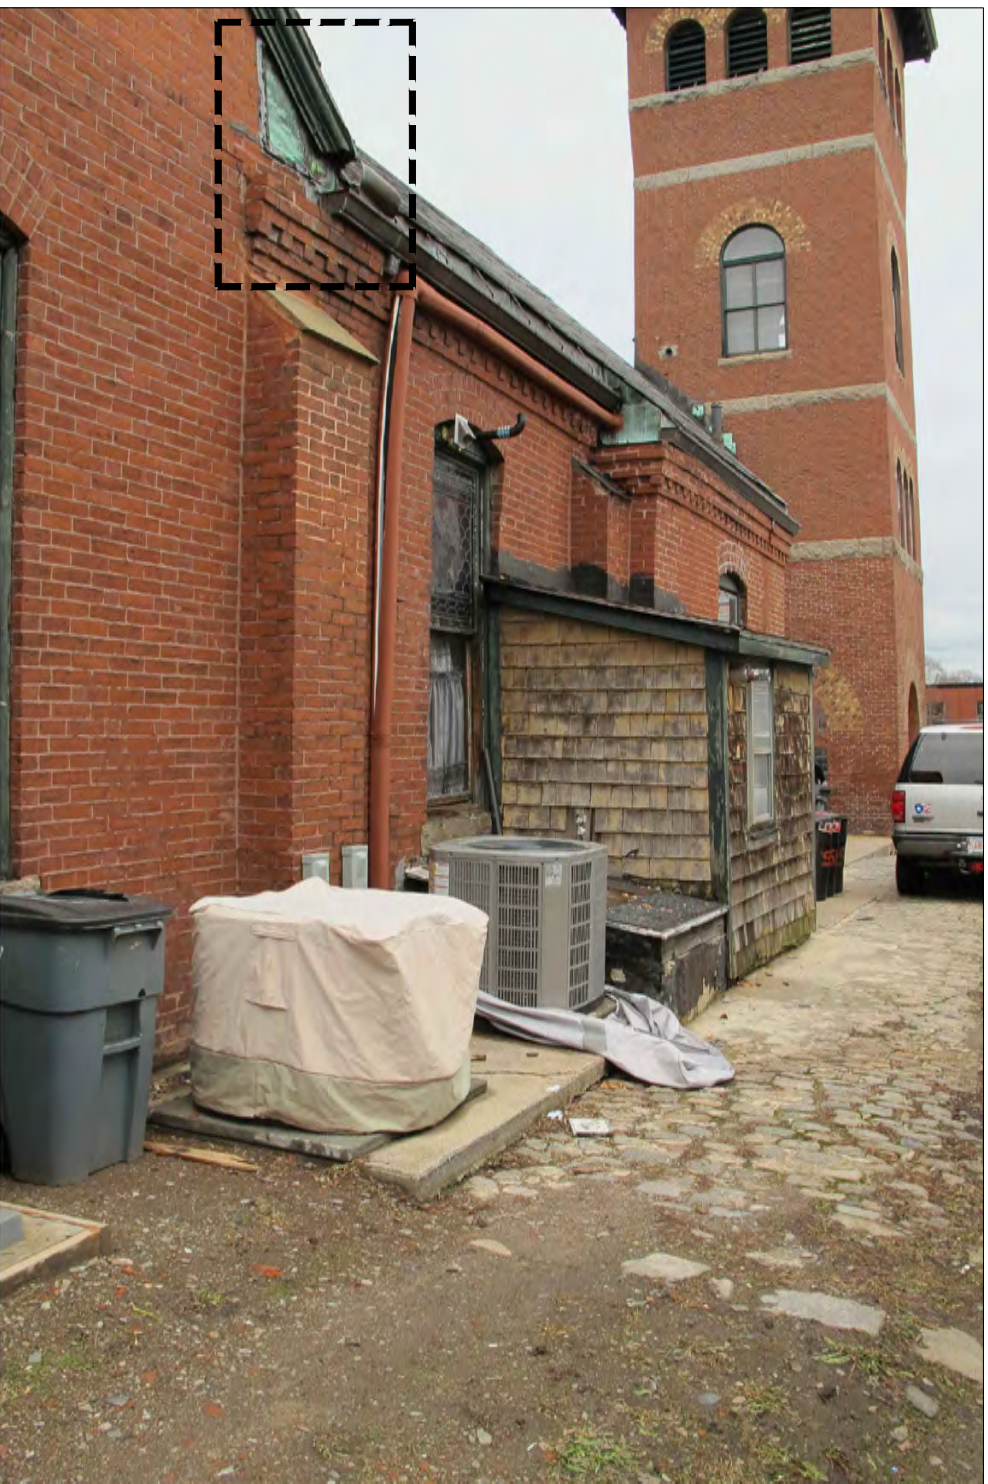
PHOTO 3/DRAWING D-200: Missing roof rake return and gutter.

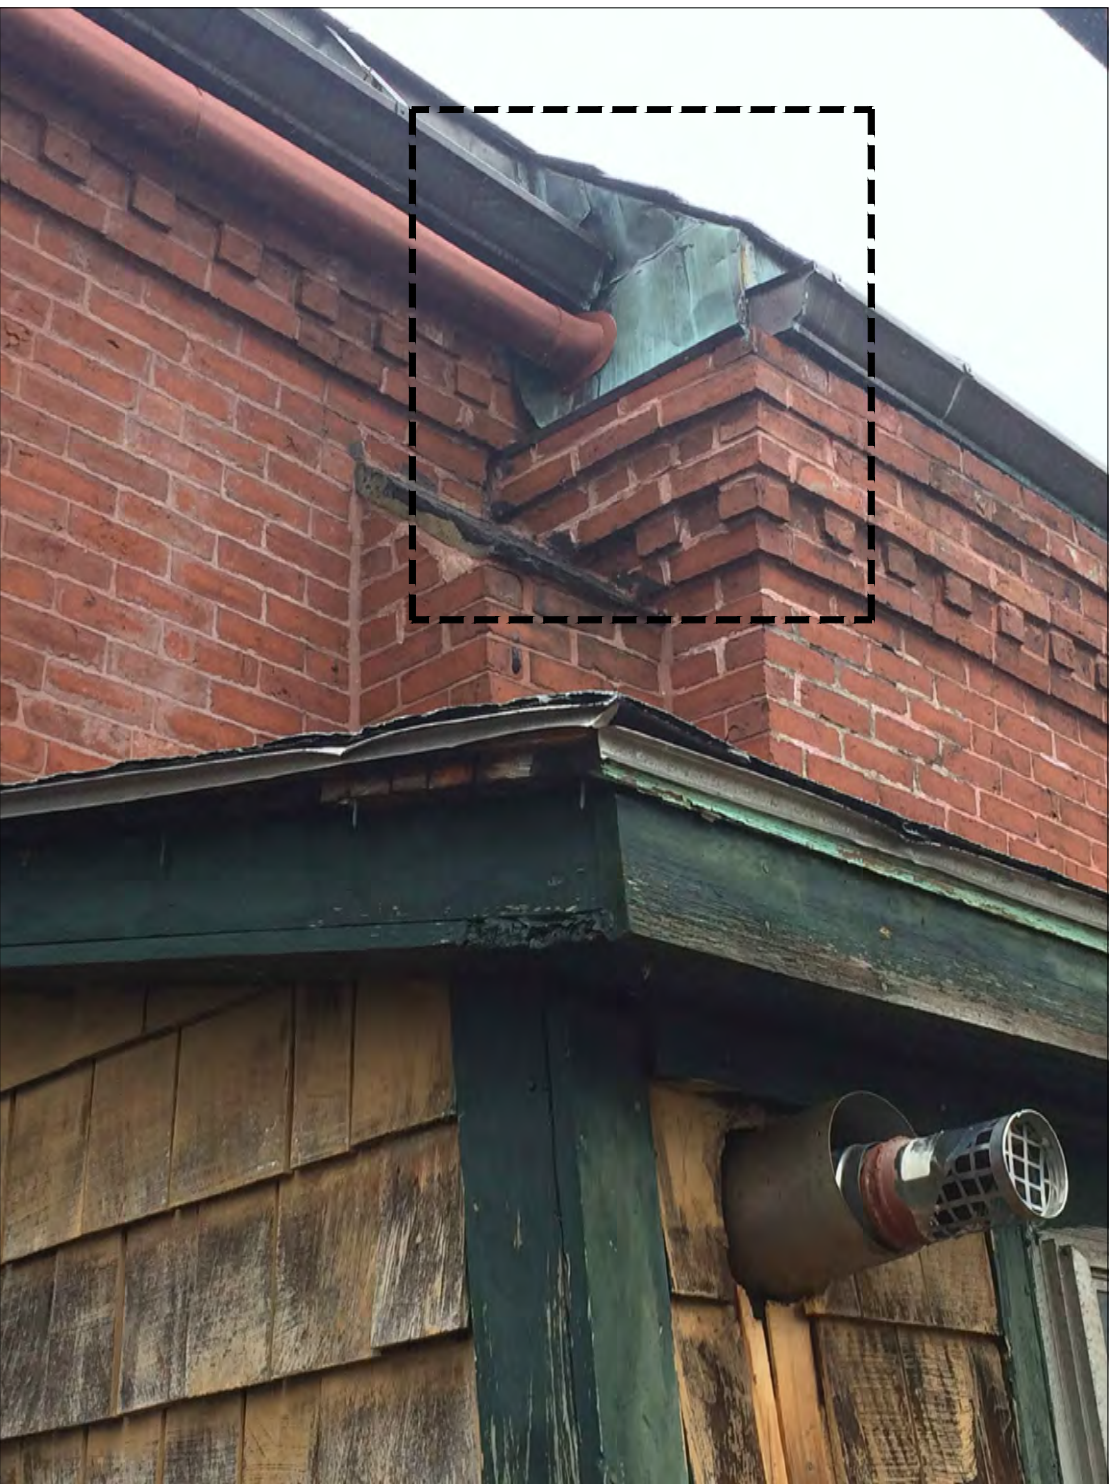
PHOTO 4/DRAWING D-200: Note different gutter and corbel heights at south elevation above bulkhead.

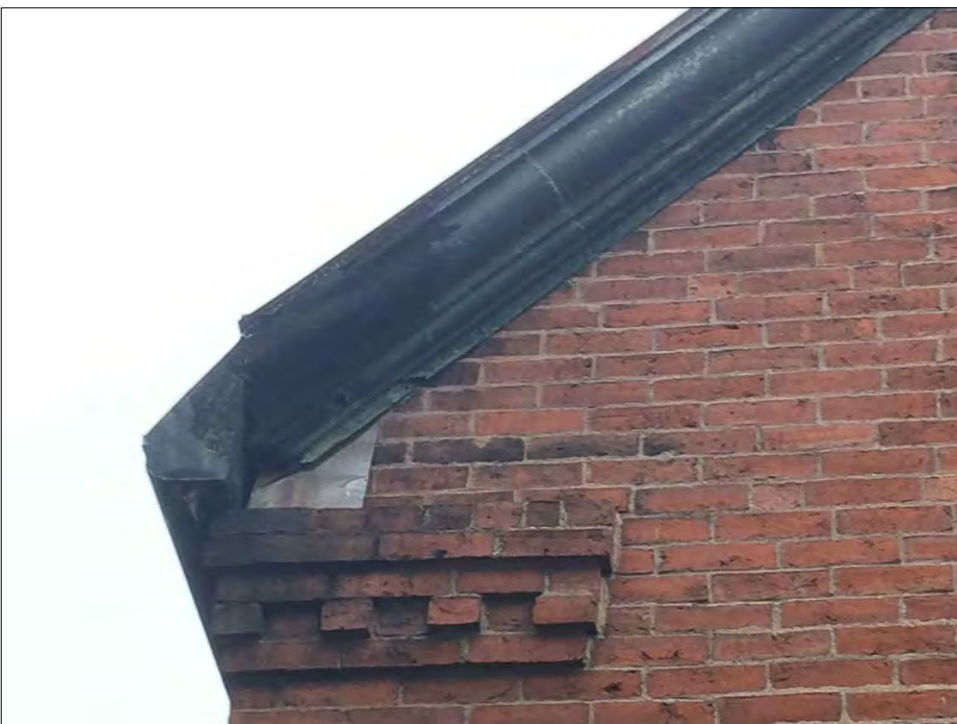
PHOTO 5/DRAWING D-201: Missing roof rake return at west elevation, (left hand side).

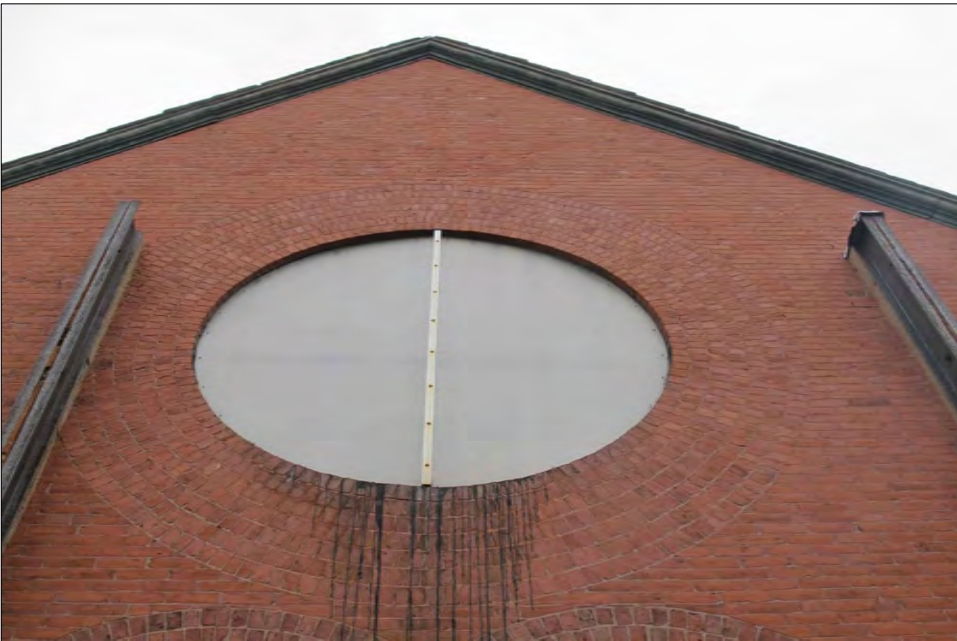
PHOTO 6/DRAWING D-200: Asphalt sealant stained masonry below circular window.

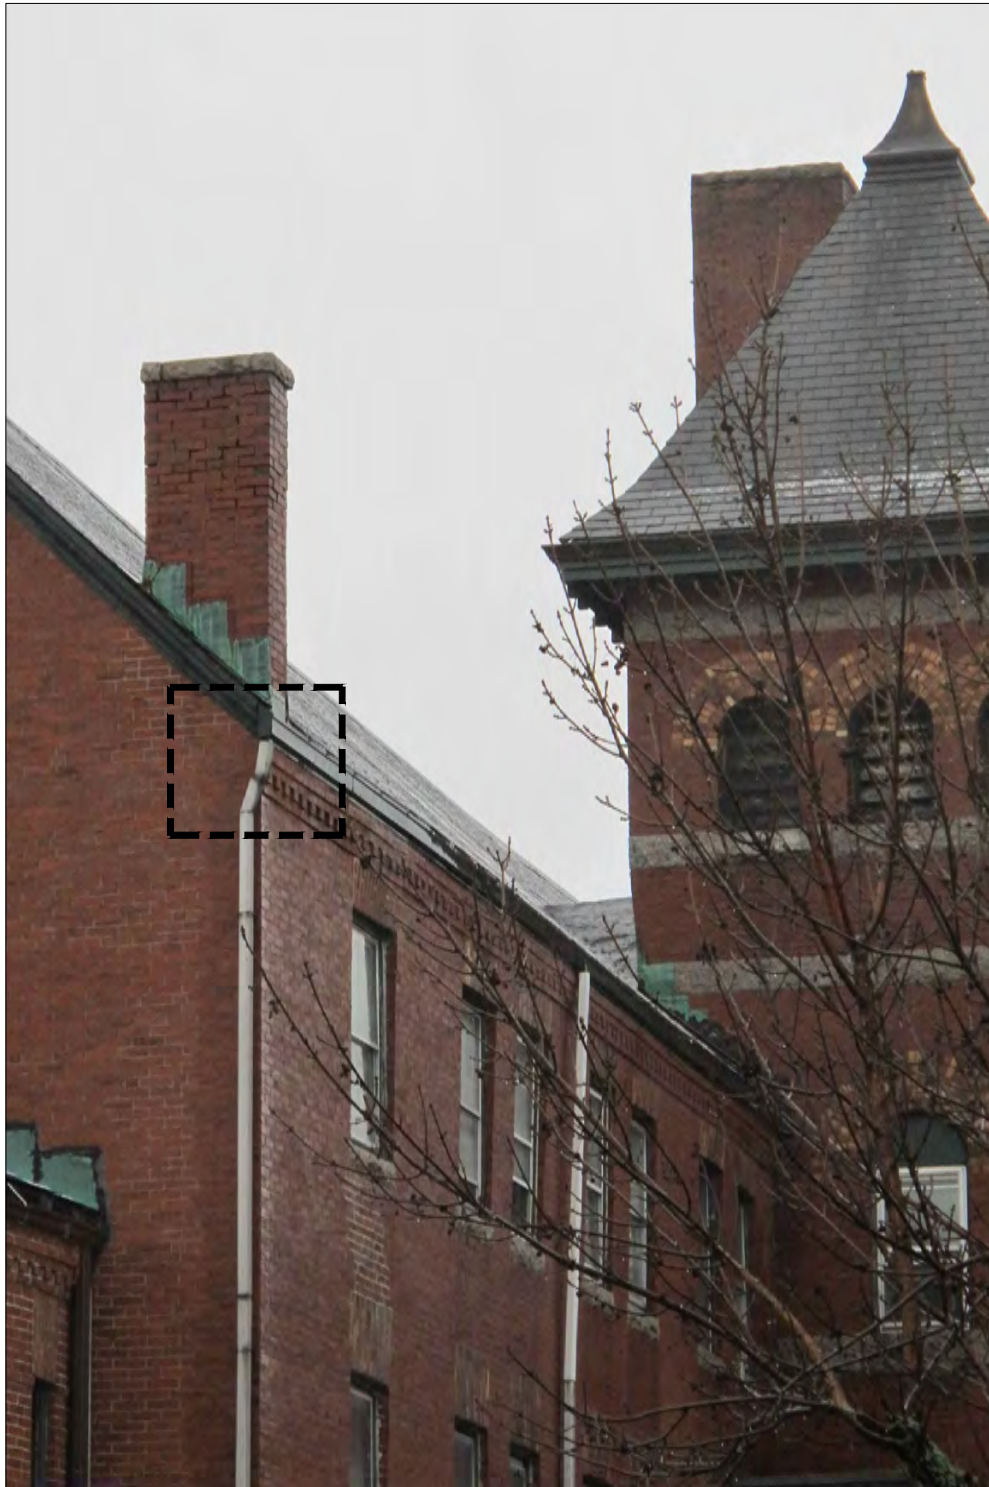
PHOTO 7/DRAWING D-201: Rake to gutter transition at northeast corner of building.

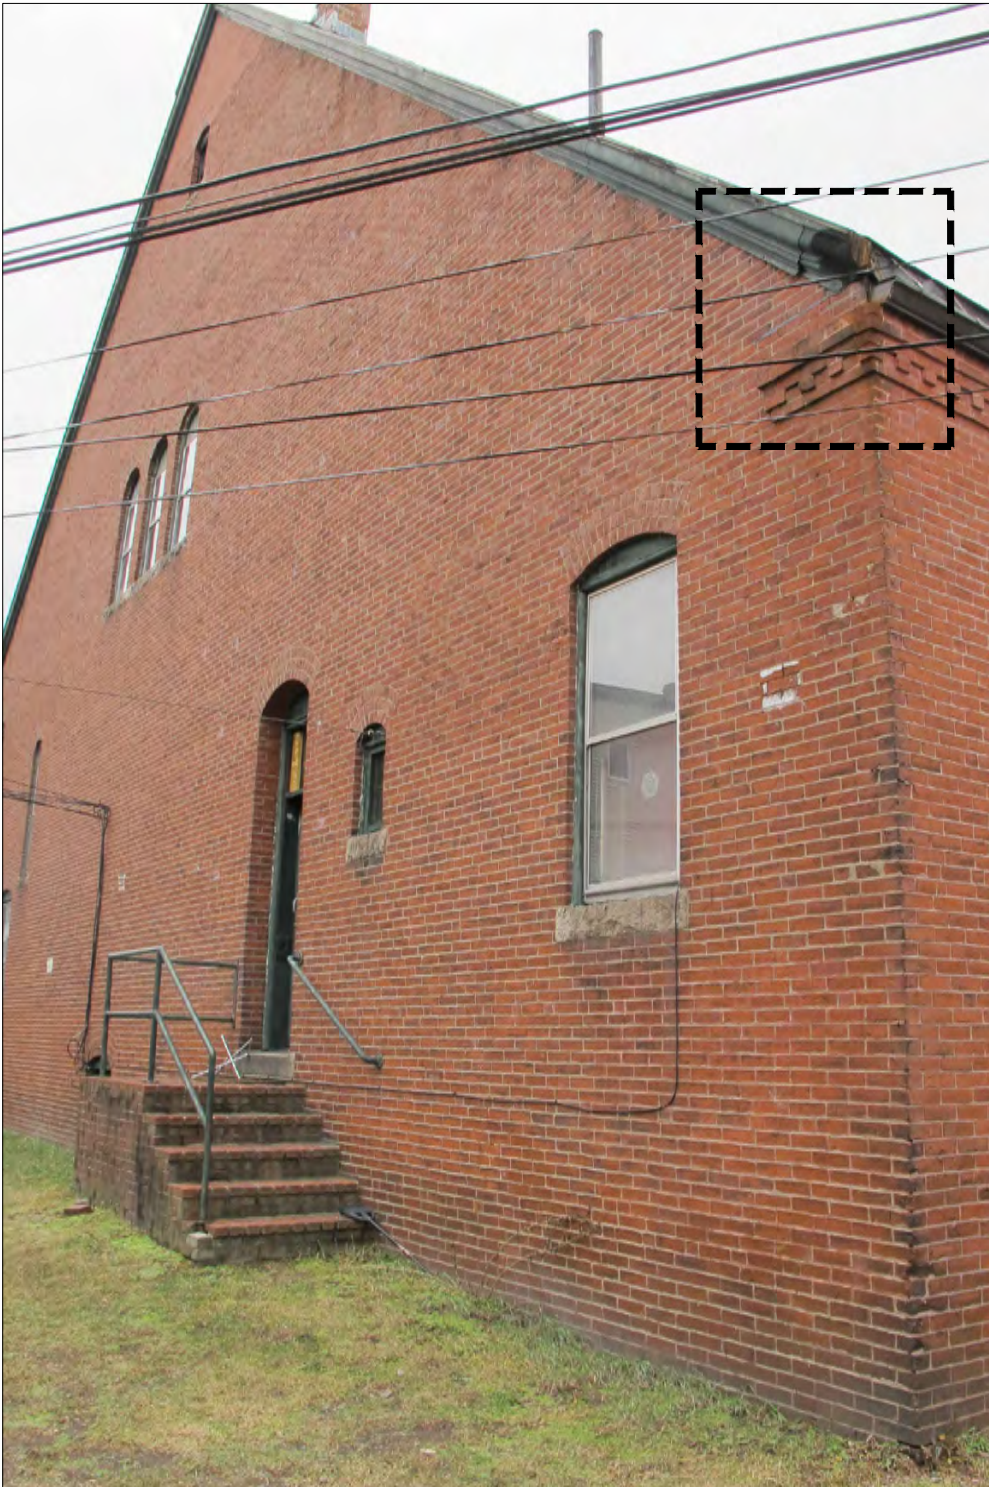
PHOTO 8/DRAWING D-201: Missing roof rake return at west elevation, (right hand side).

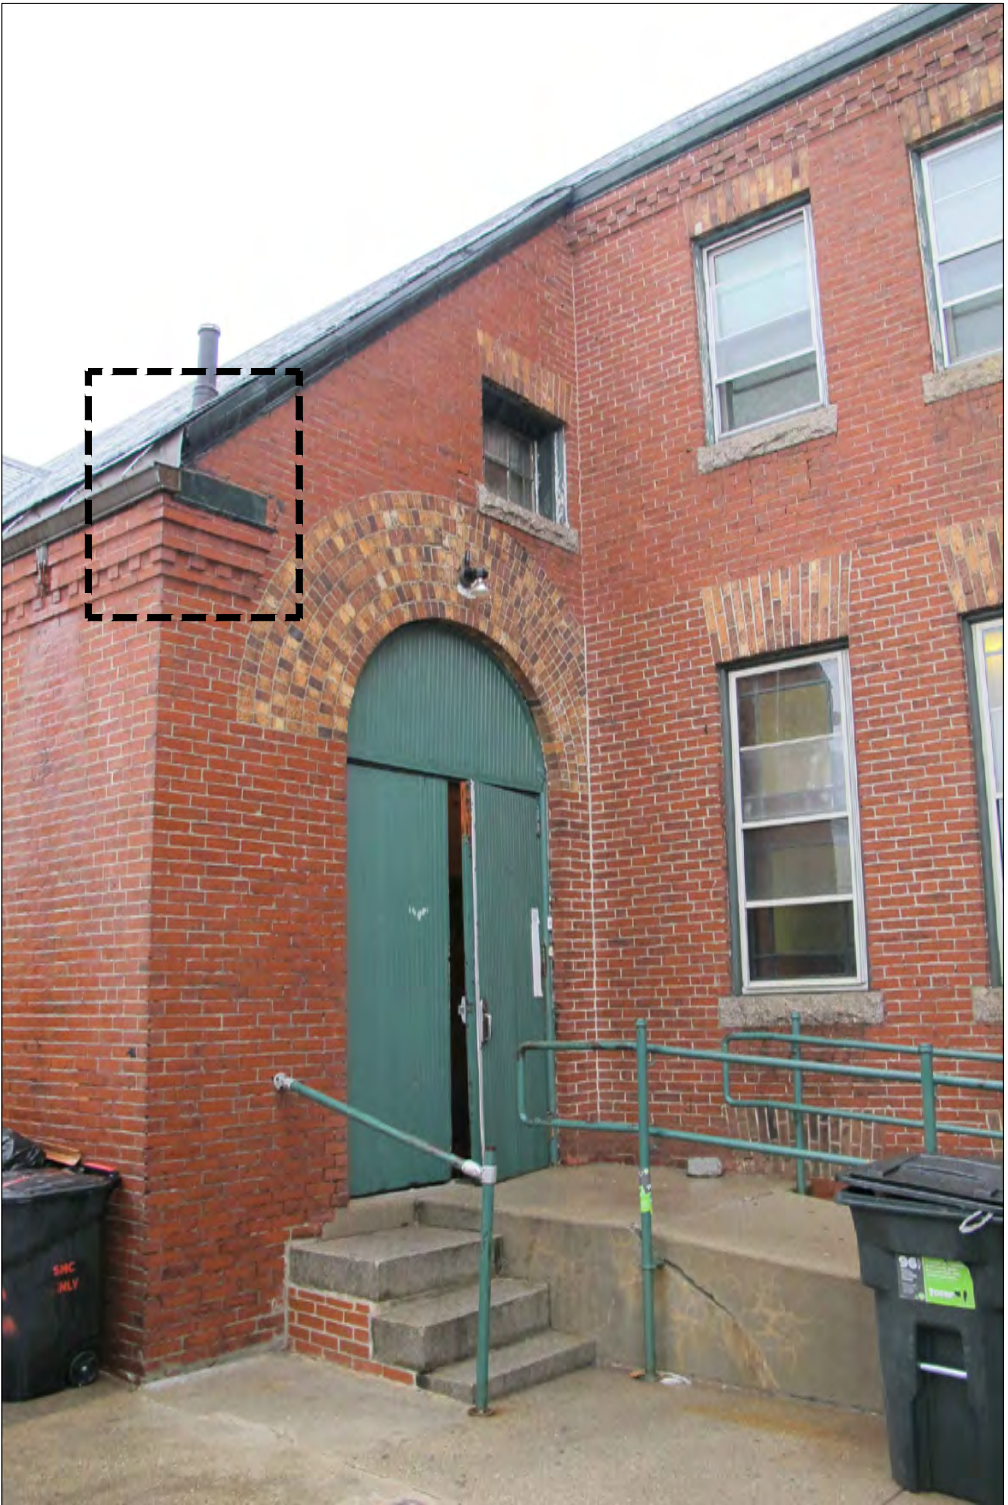
PHOTO 9/DRAWING D-201: Missing roof rake return at southeast elevation.

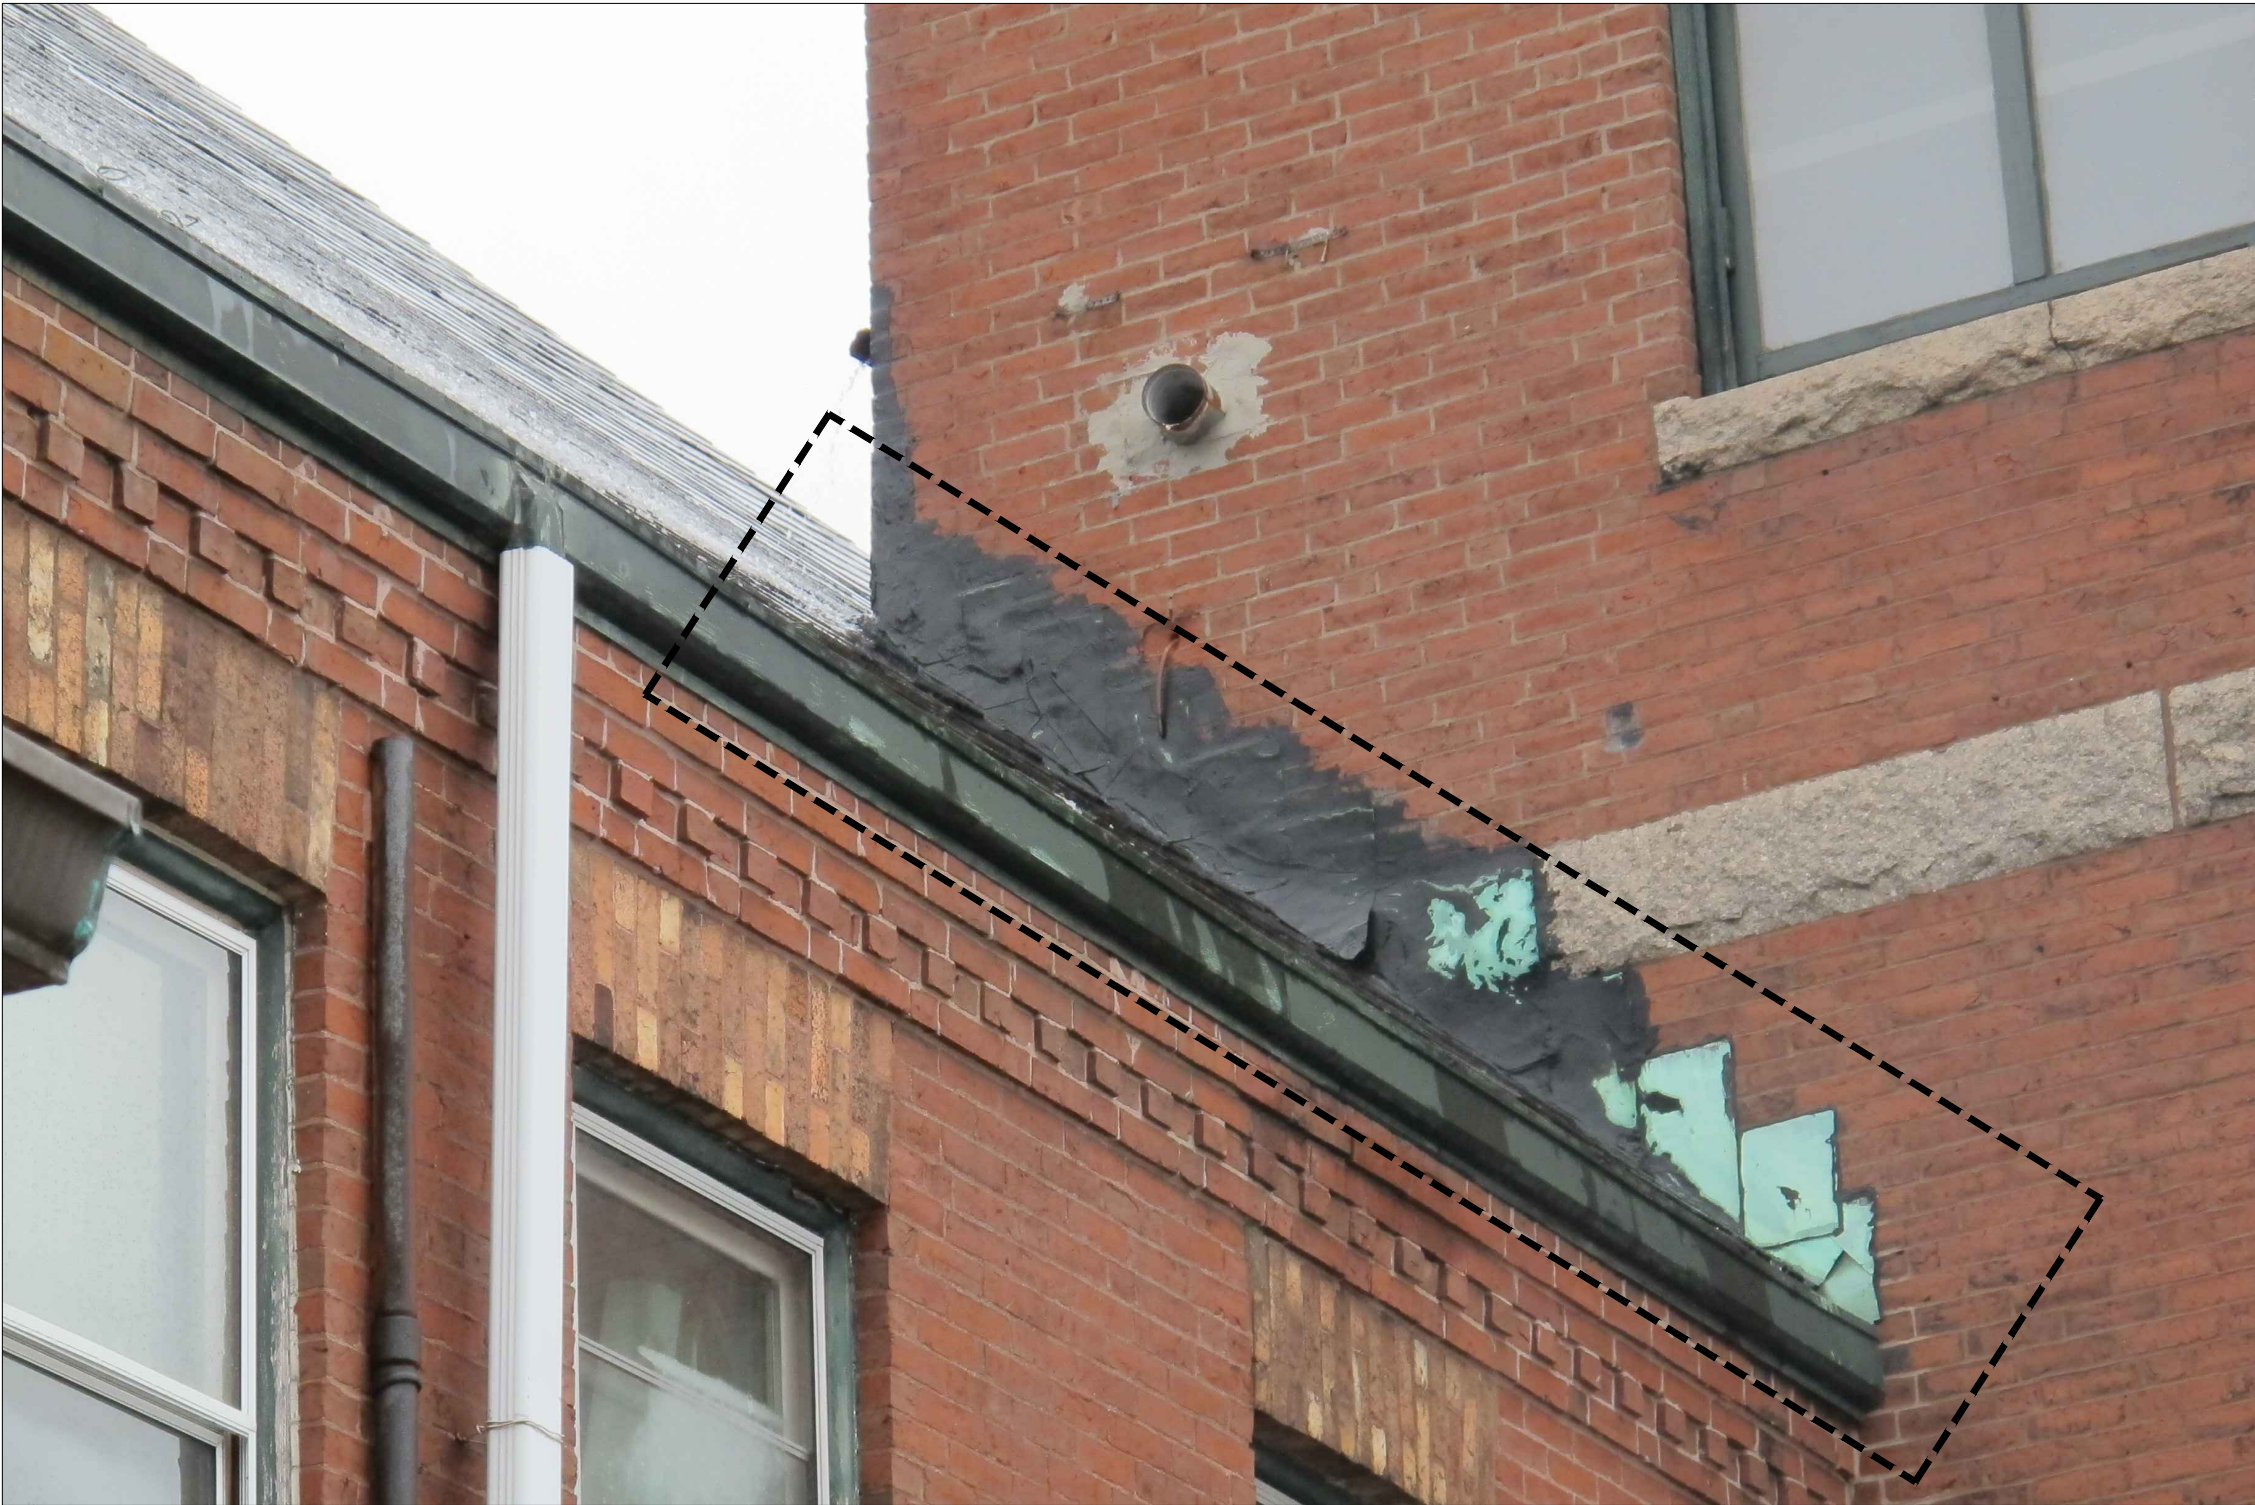
PHOTO 10/DRAWING D-201: Asphalt roofing sealer and step flashing at northeast elevation.

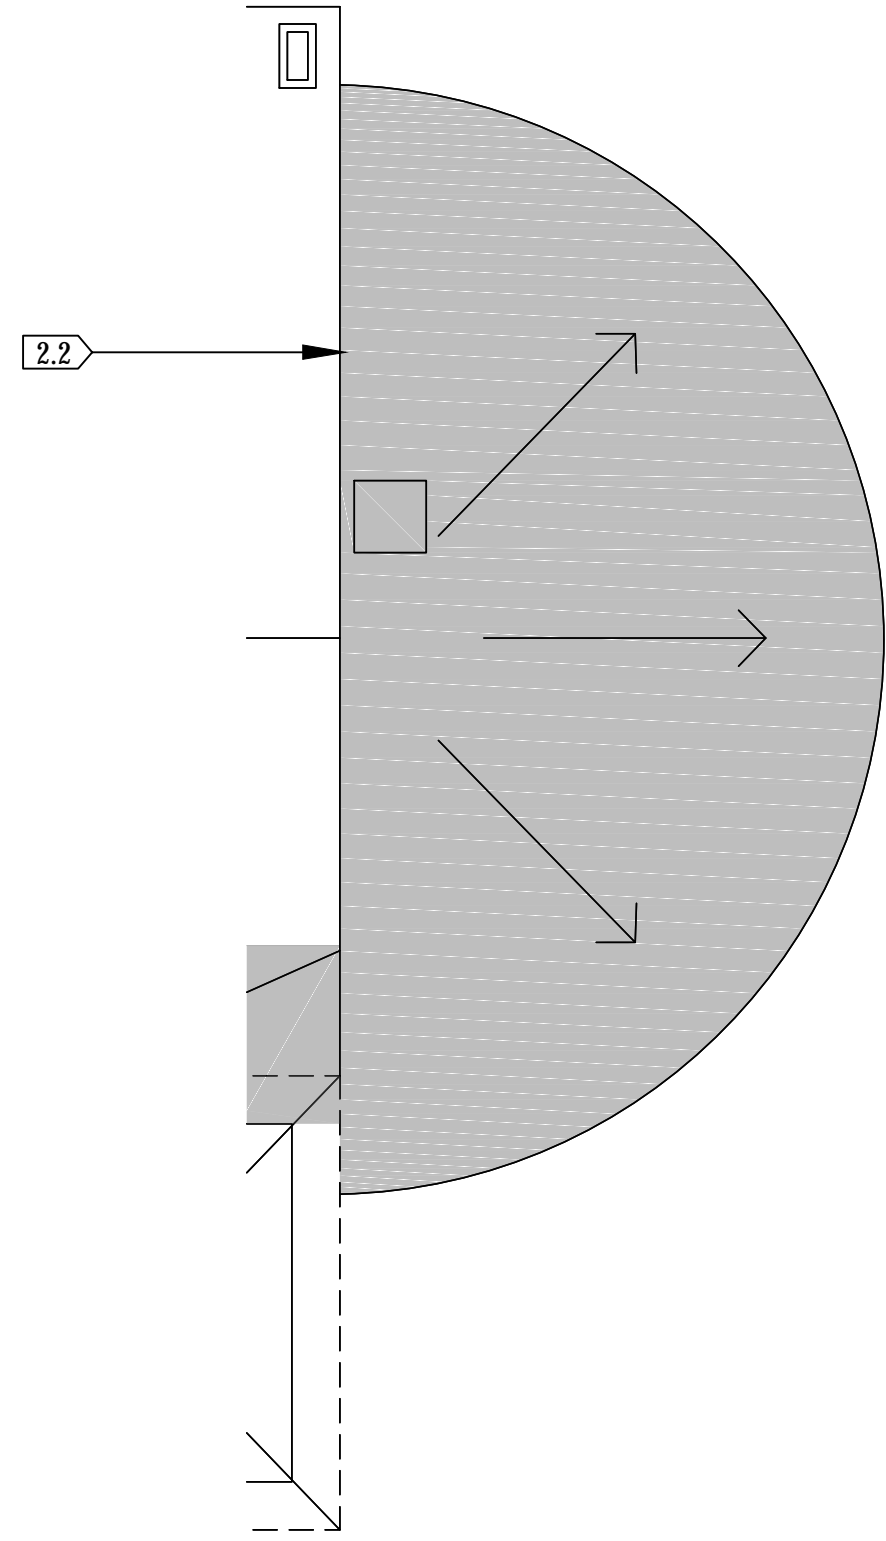
1 APSE ROOF PLAN - DEMOLITION
Scale: 1/8"=1'-0" @ 24 X 36 PRINT

- 2.1 Remove all existing slate shingles.
- 2.2 Remove all existing copper base and counter-flashing at abutting walls.
- 2.3 Remove all existing eave flashing and adjacent copper gutters and downspouts.
- 2.4 Replace any deteriorated wood roof sheathing with in-kind materials.
- 2.5 Remove metal covering at window.

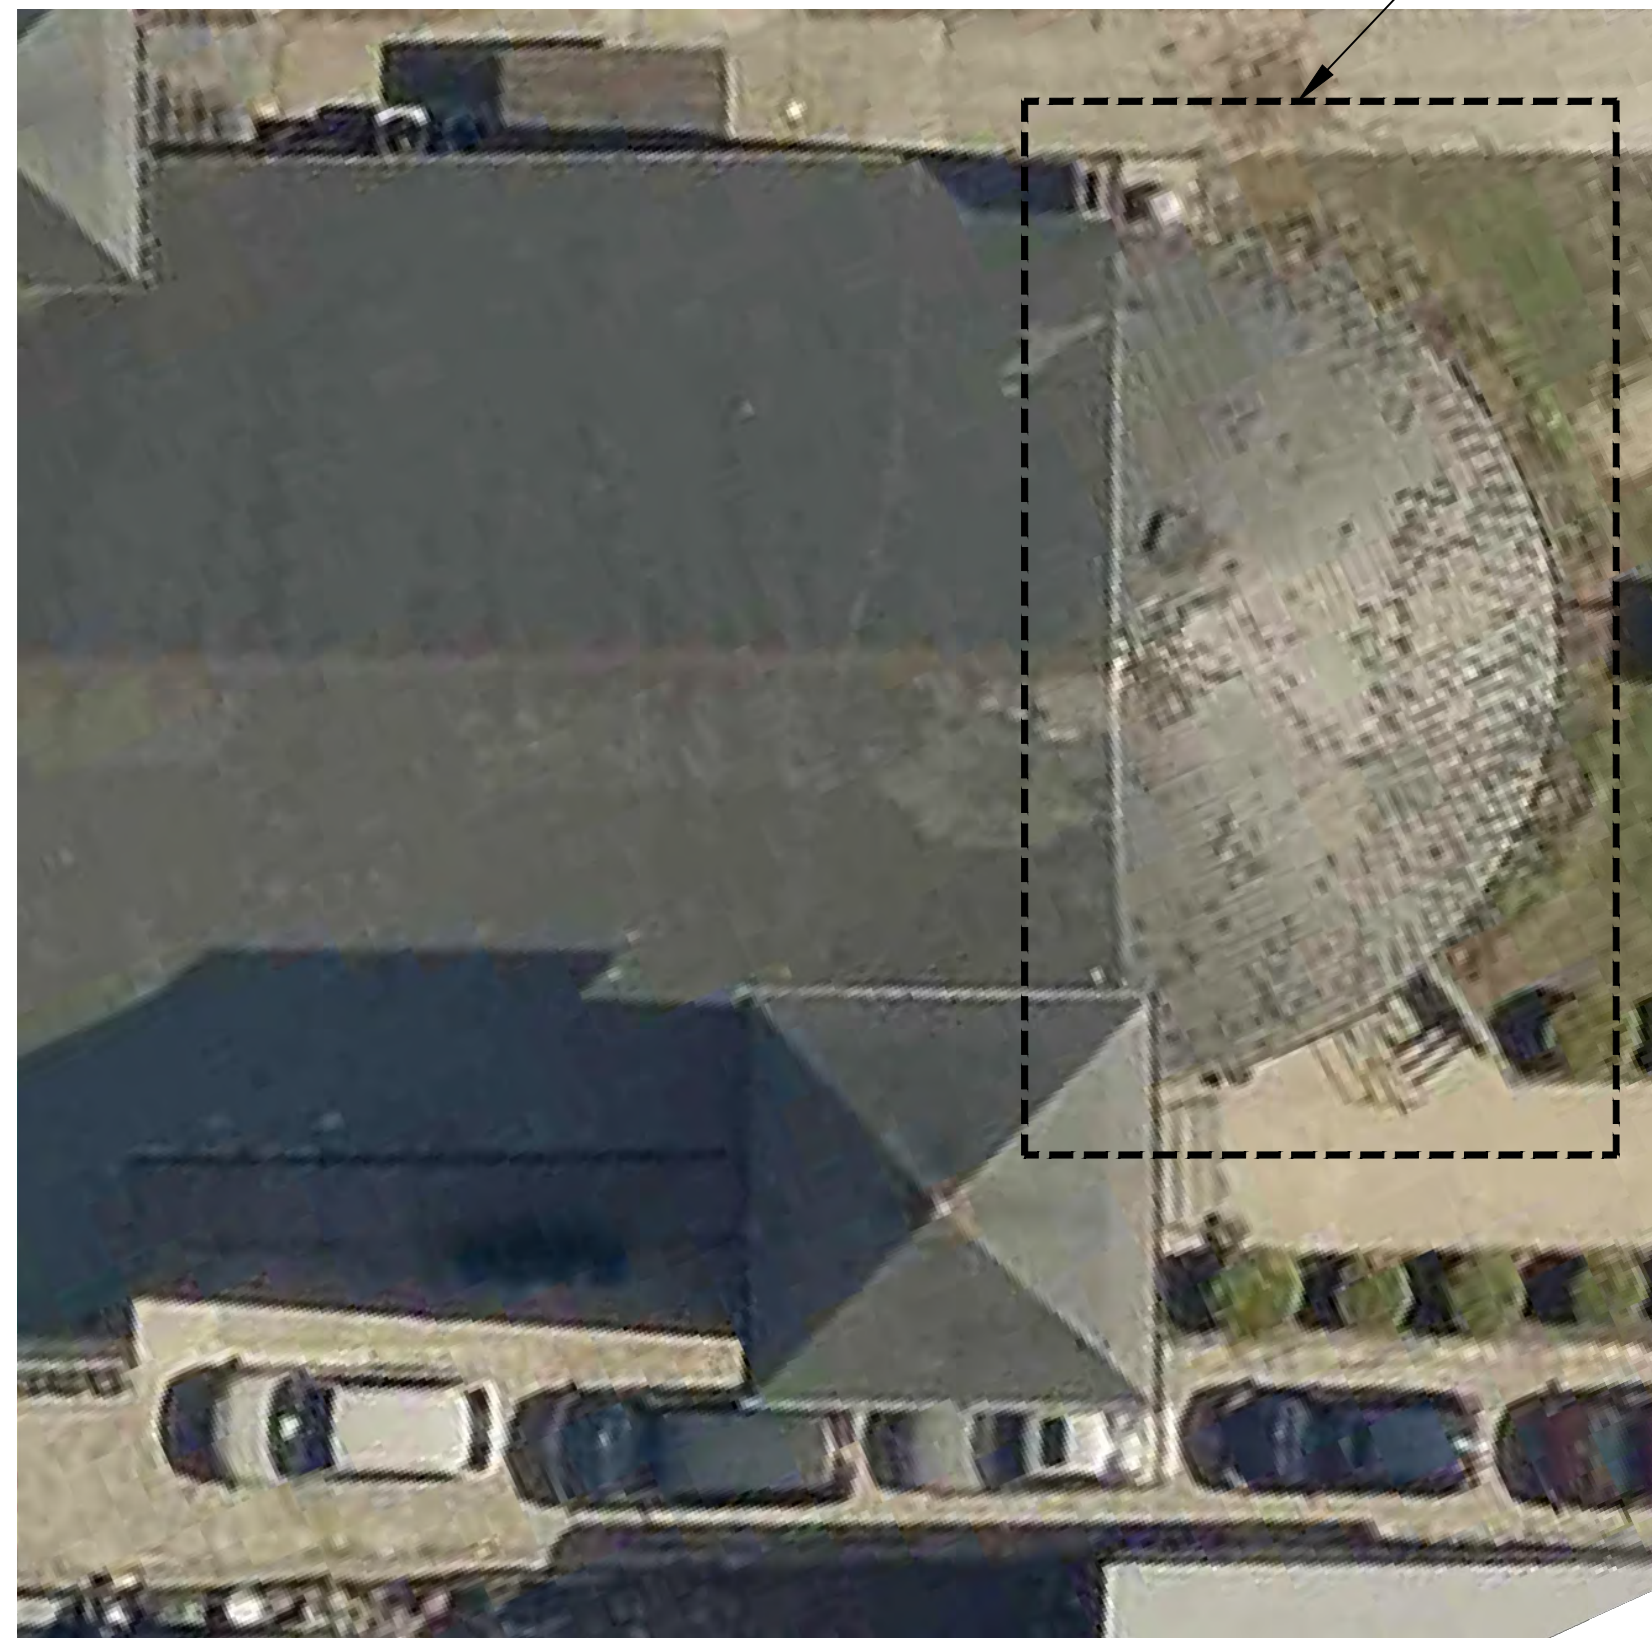
2 PHOTOGRAPH OF EXISTING APSE ROOF

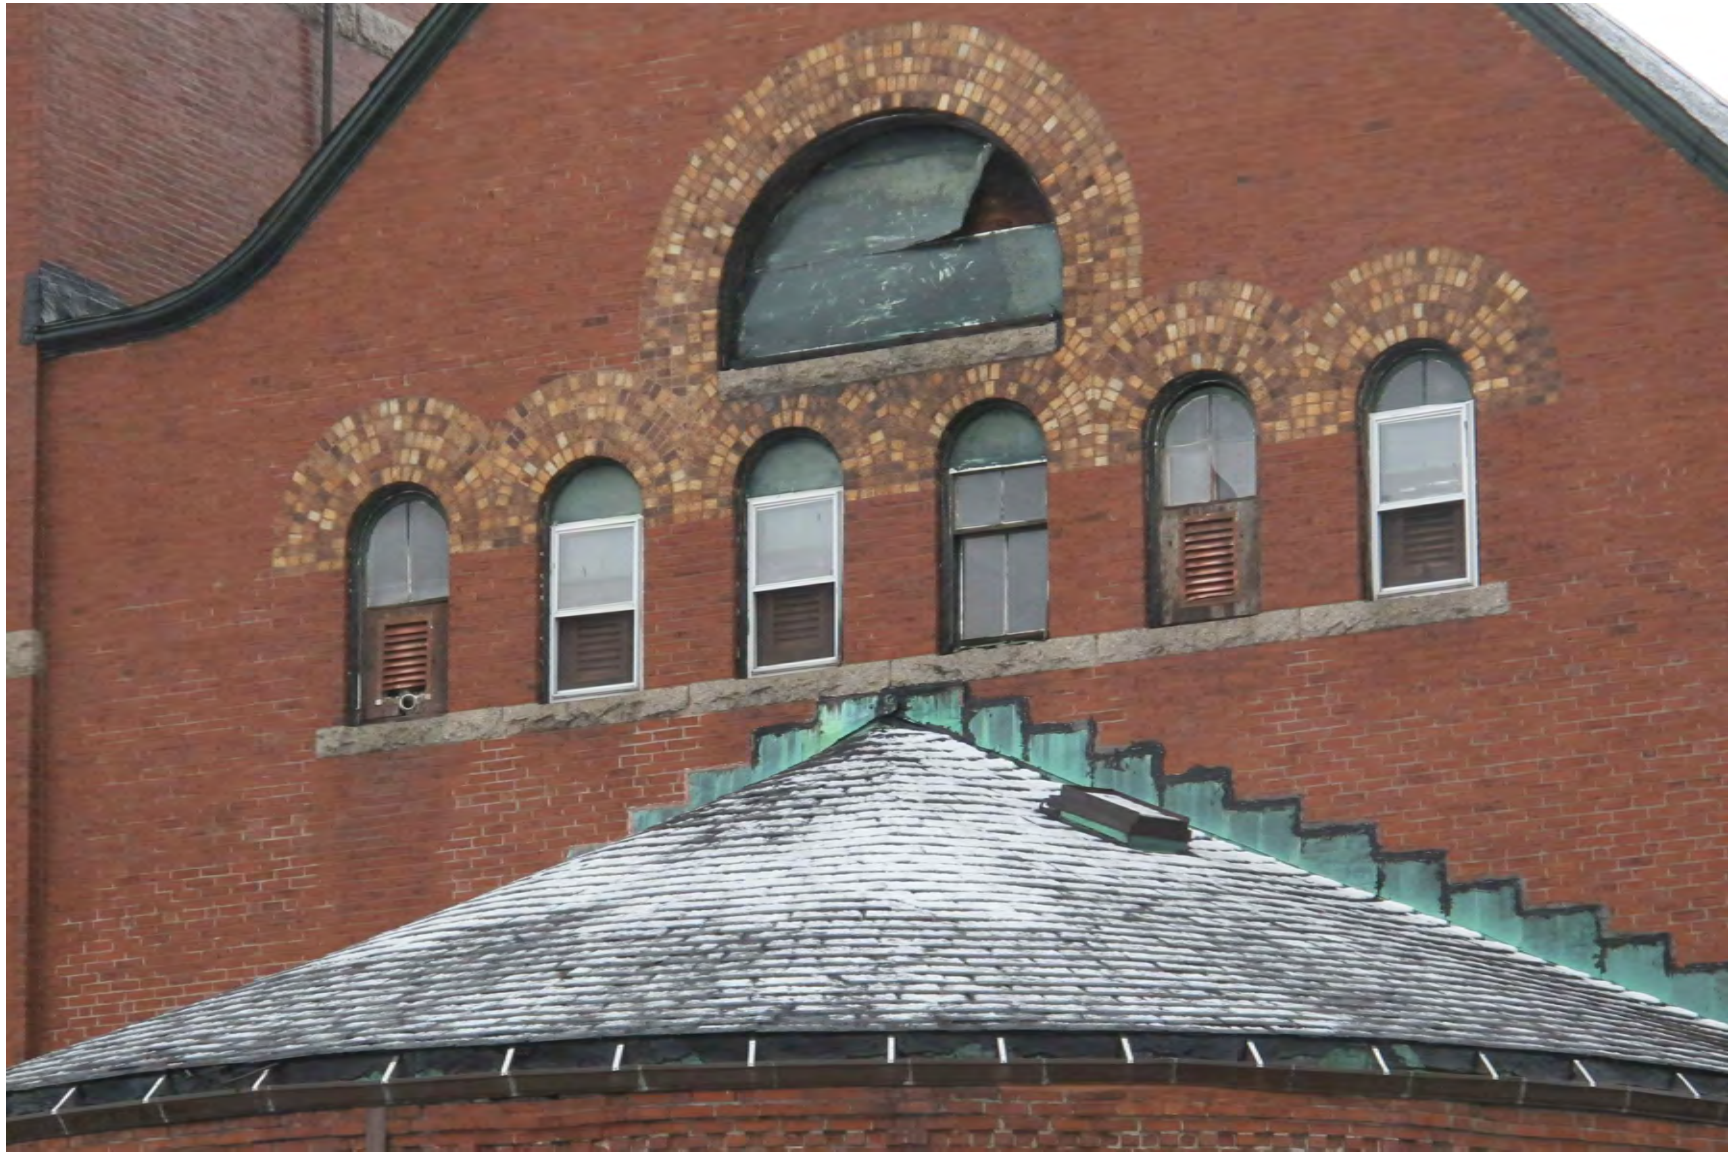
1 APSE ROOF

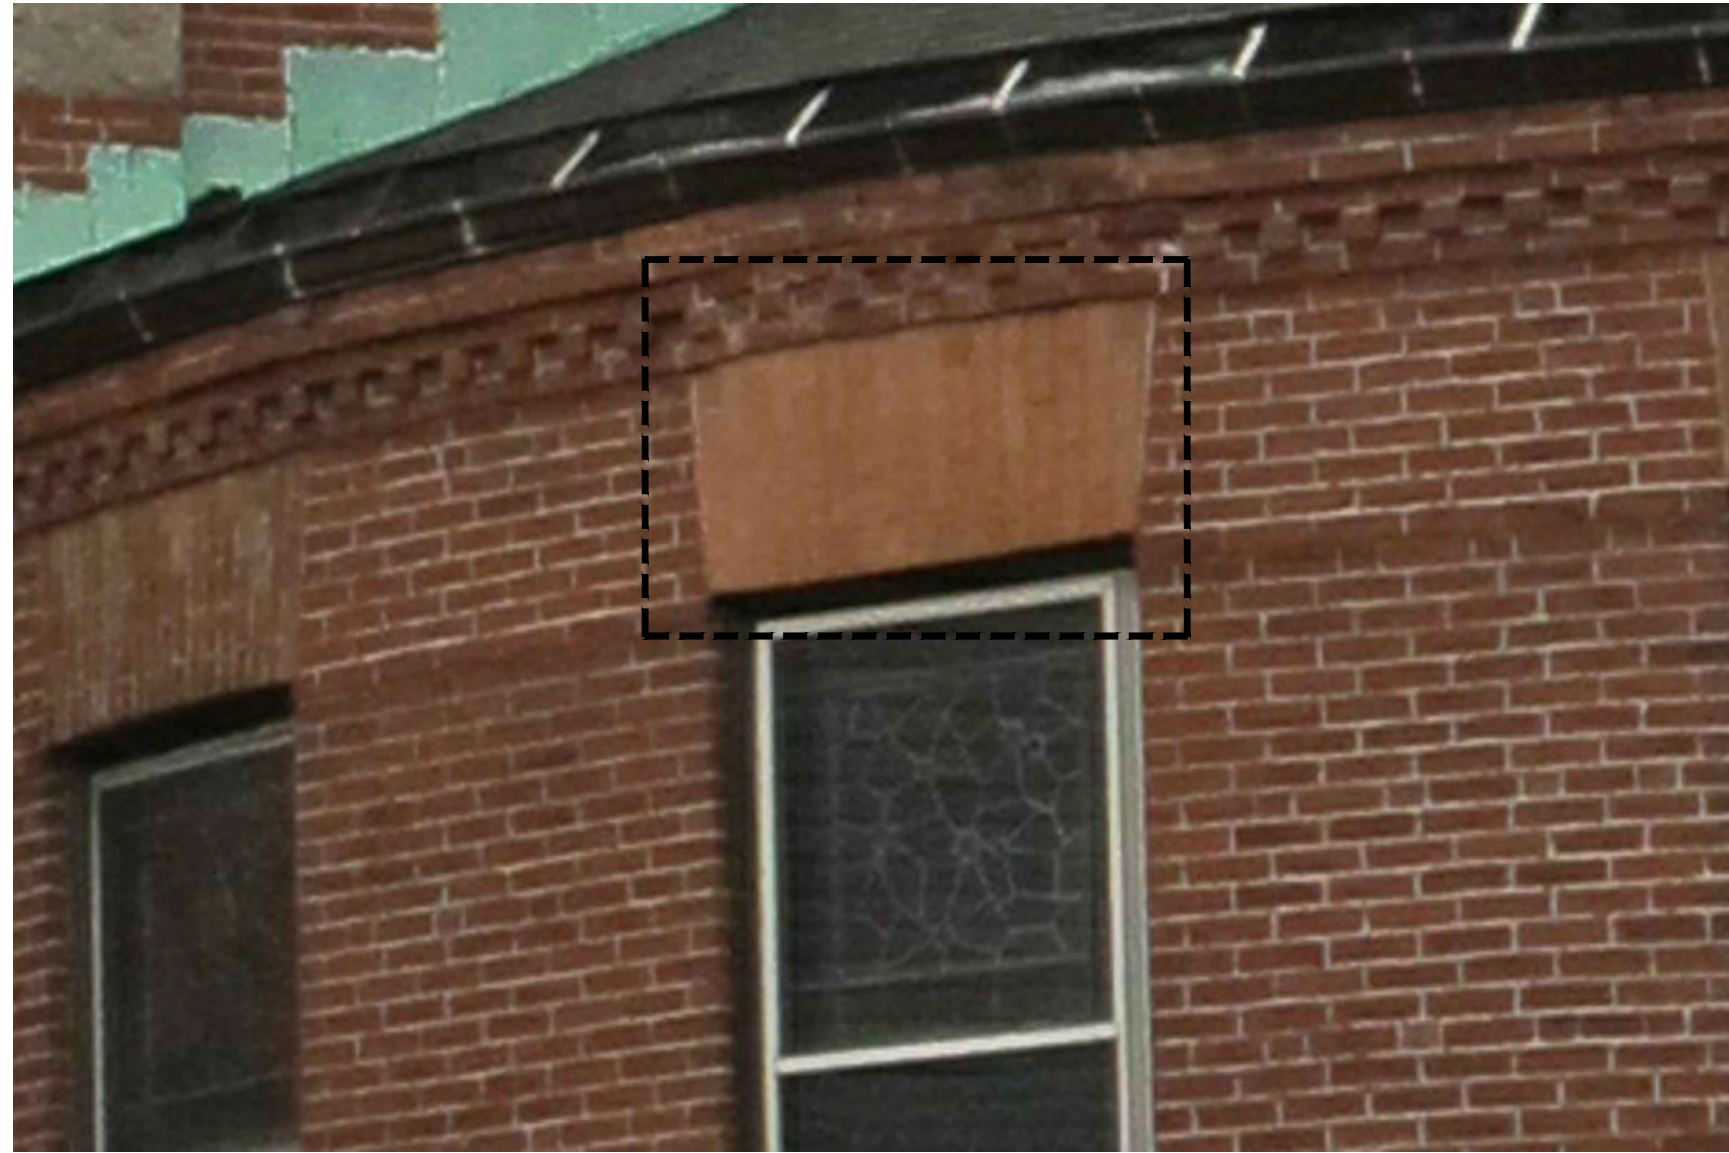
2 MISMATCHED BRICK AT FLAT ARCH - SOUTH ELEVATION (AREA INDICATED)

- 4.1 At three window openings, replace flat arch bricks with new bricks of correct color and size. Match original flat arch appearance. (Alternate # 1)

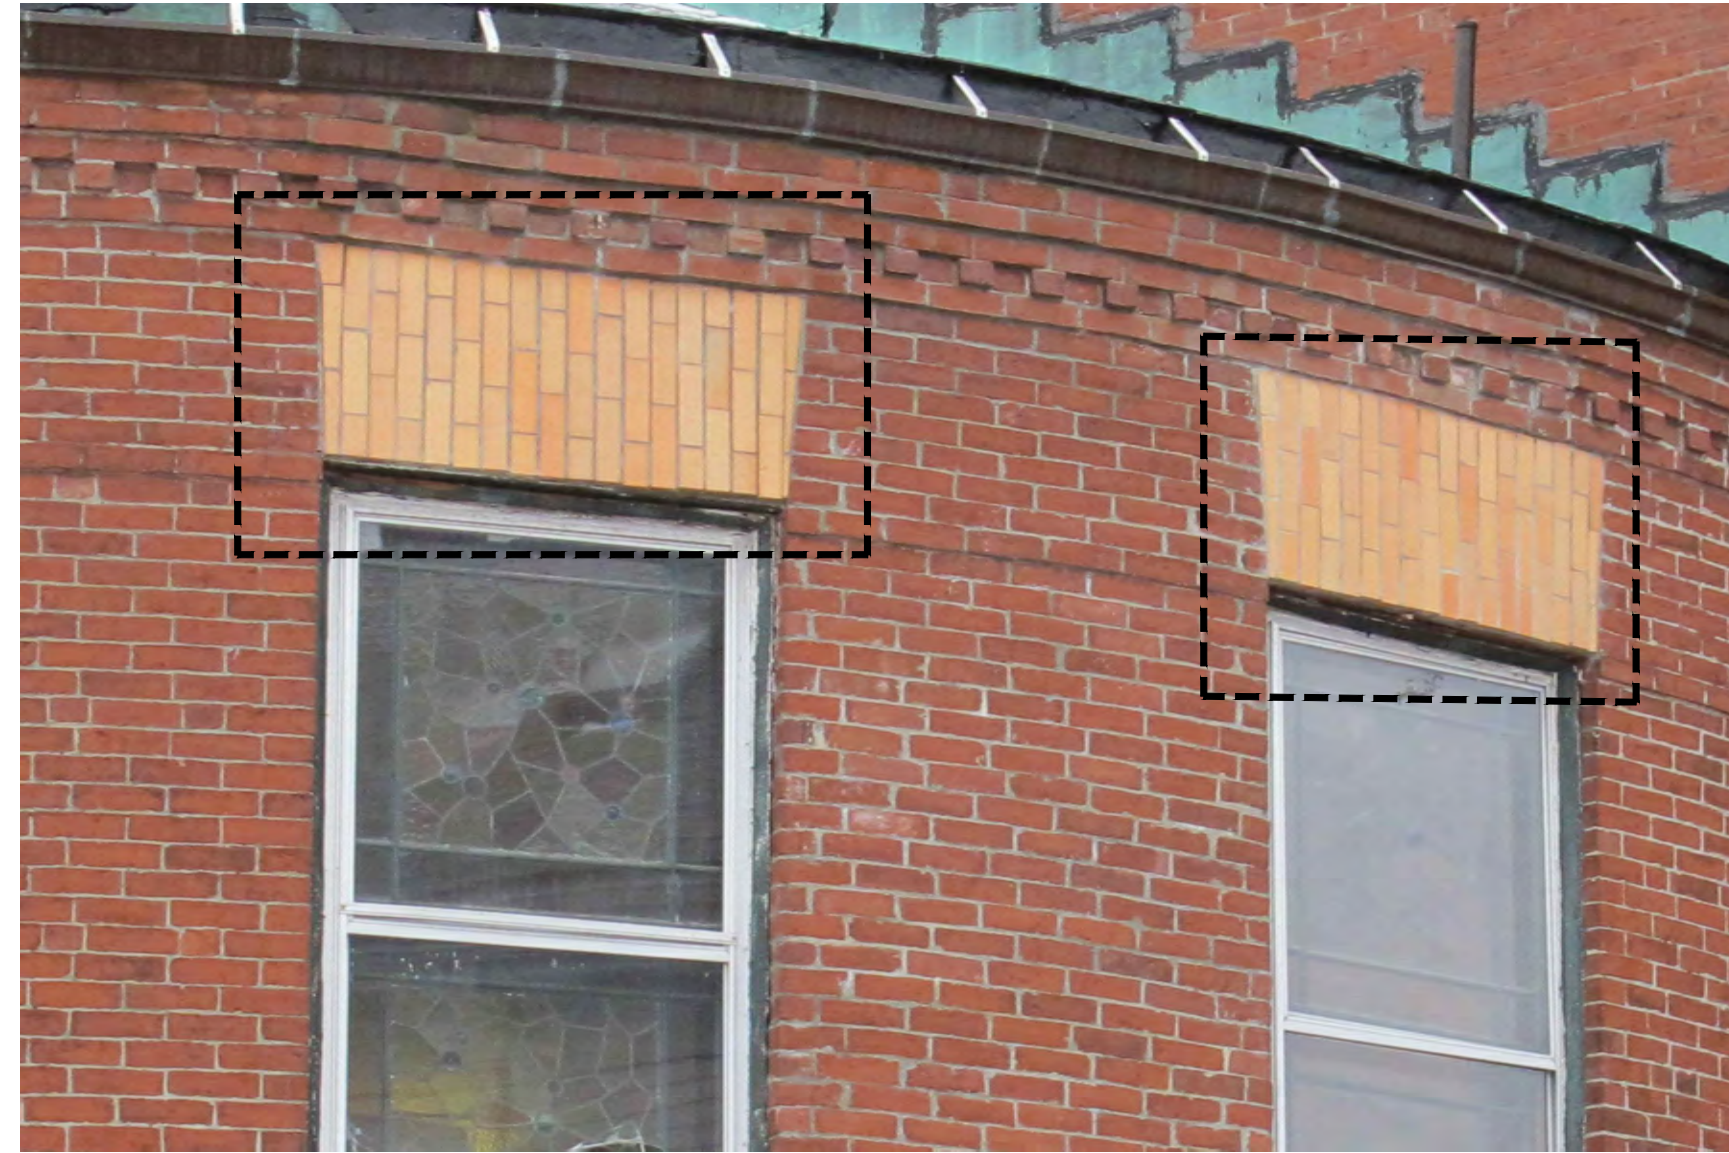
3 MISMATCHED BRICK AT FLAT ARCH - NORTH ELEVATION (AREA INDICATED)
