PRESERVATION STAFF REPORT

Site: 59 Cross Street

Petition: Somerville Hispanic Association for Community Development, Owner, seeks permission from the Somerville Historic Preservation Commission (HPC) to alter north side entry and walkway to meet ADA requirements.

SOMERVILLE HISPANIC CHURCH
89 CROSS STREET, SOMERVILLE, MA 02145

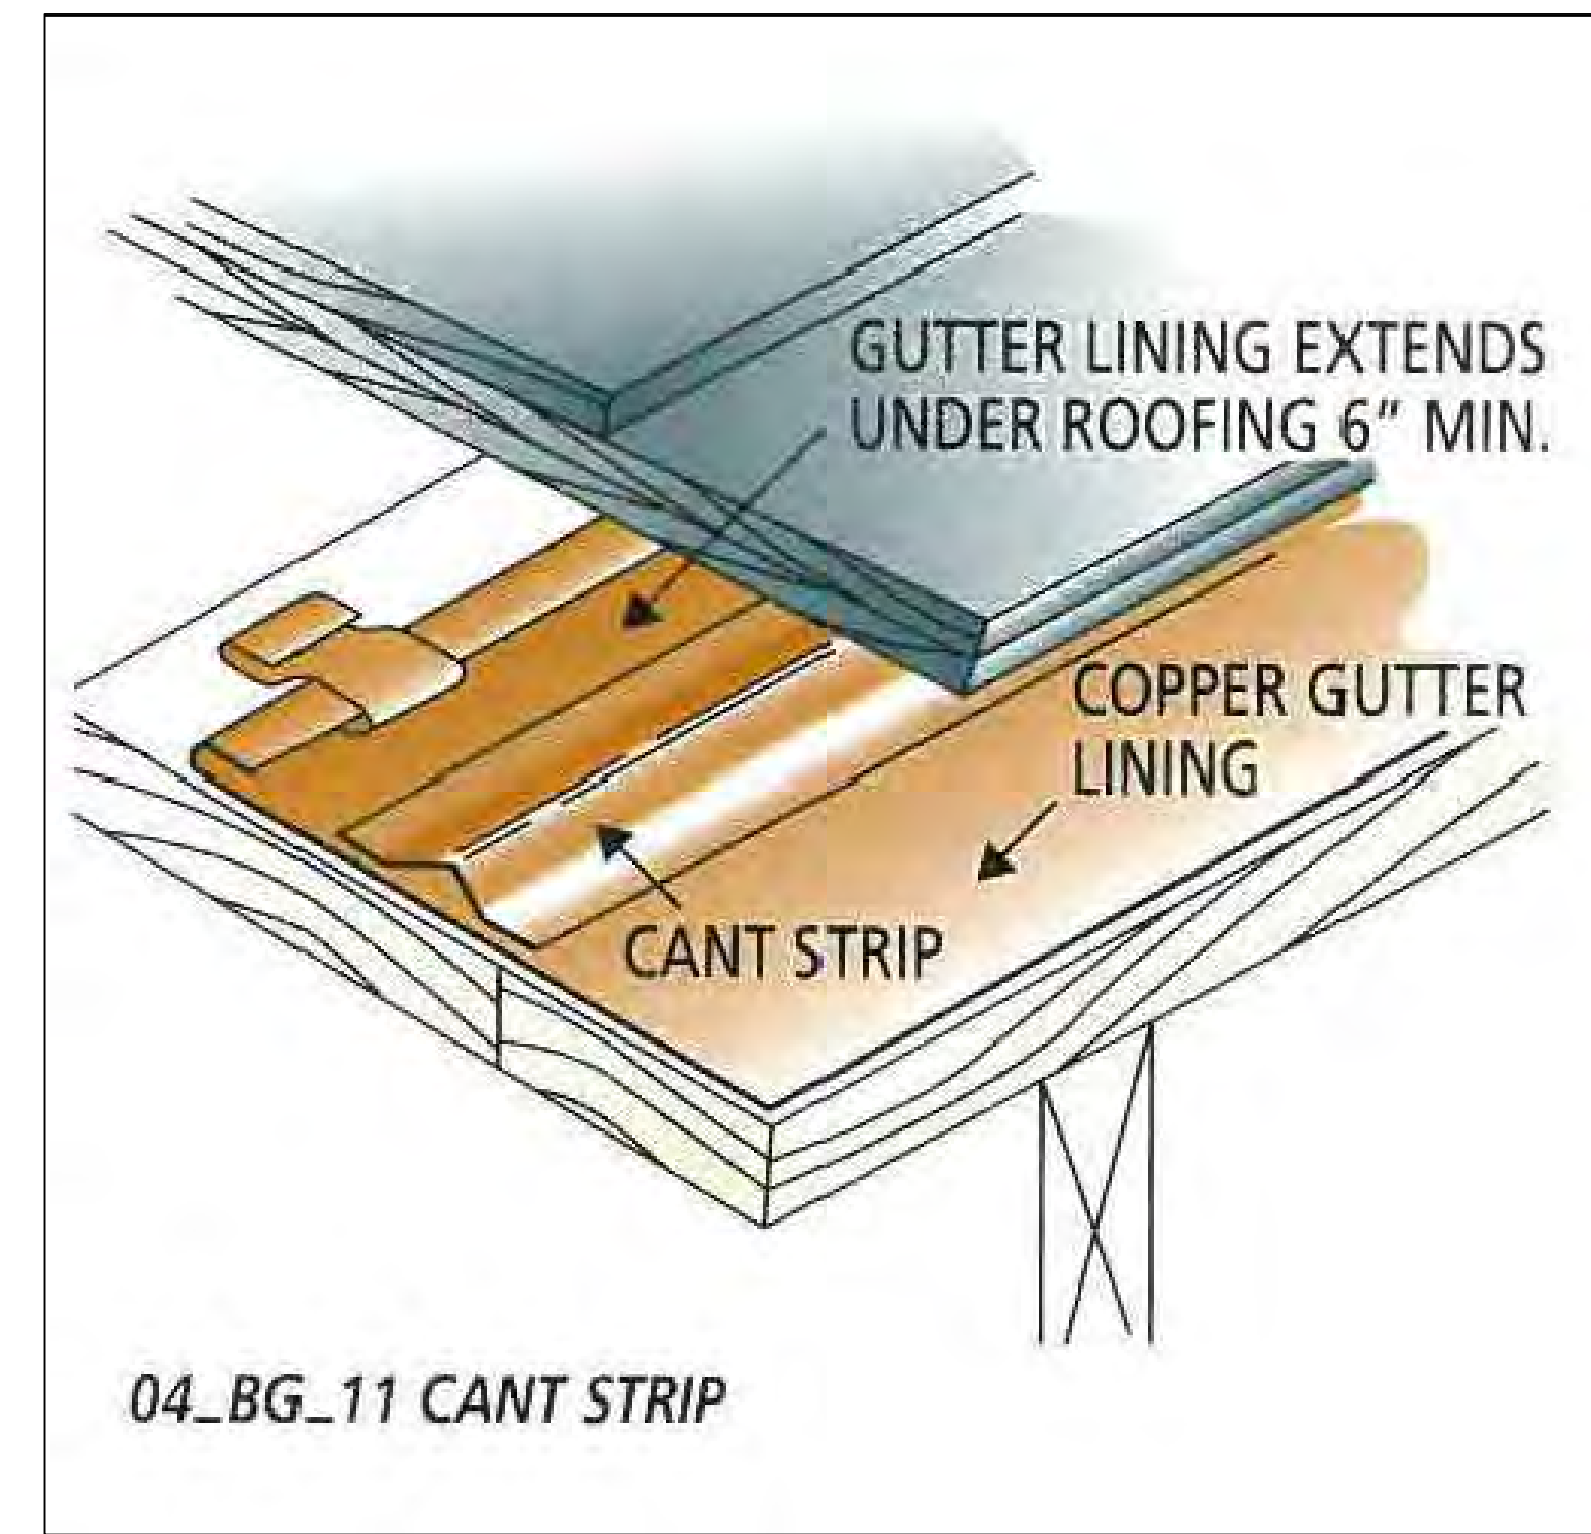
5 CANT STRIP DETAIL
NOT TO SCALE

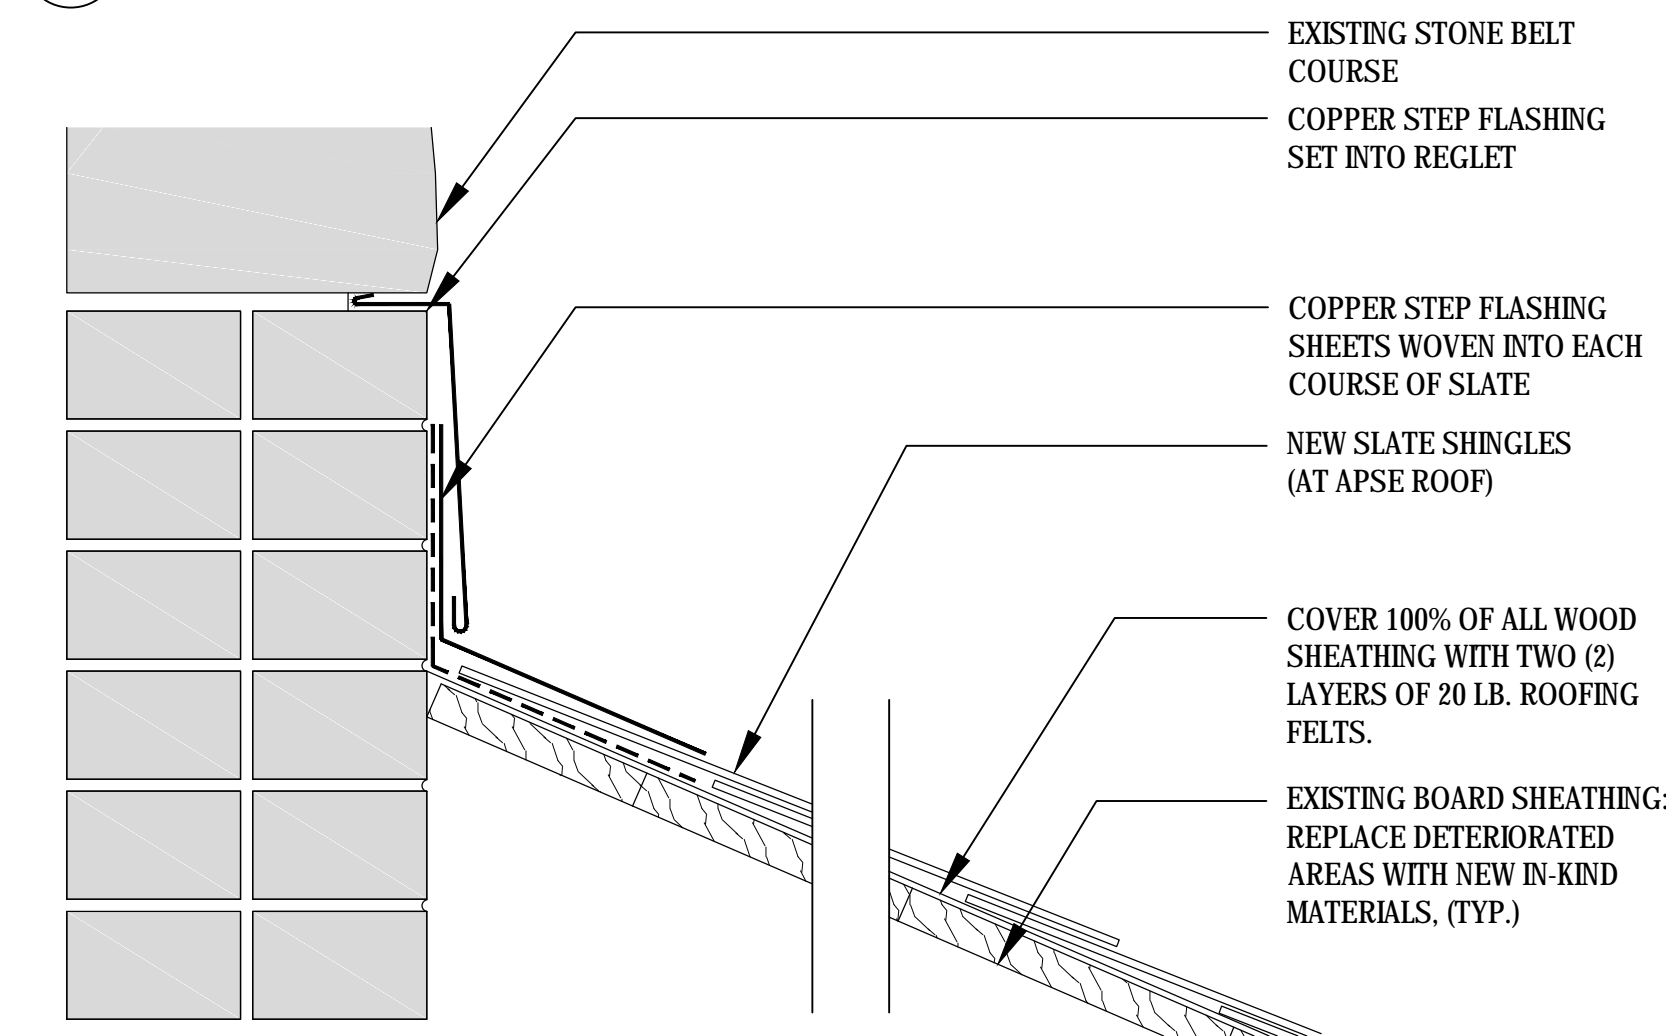
6 FLASHING DETAIL - APSE ROOF TO MAIN BUILDING
Scale: 3"=1'-0" @ 24 X 36 PRINT

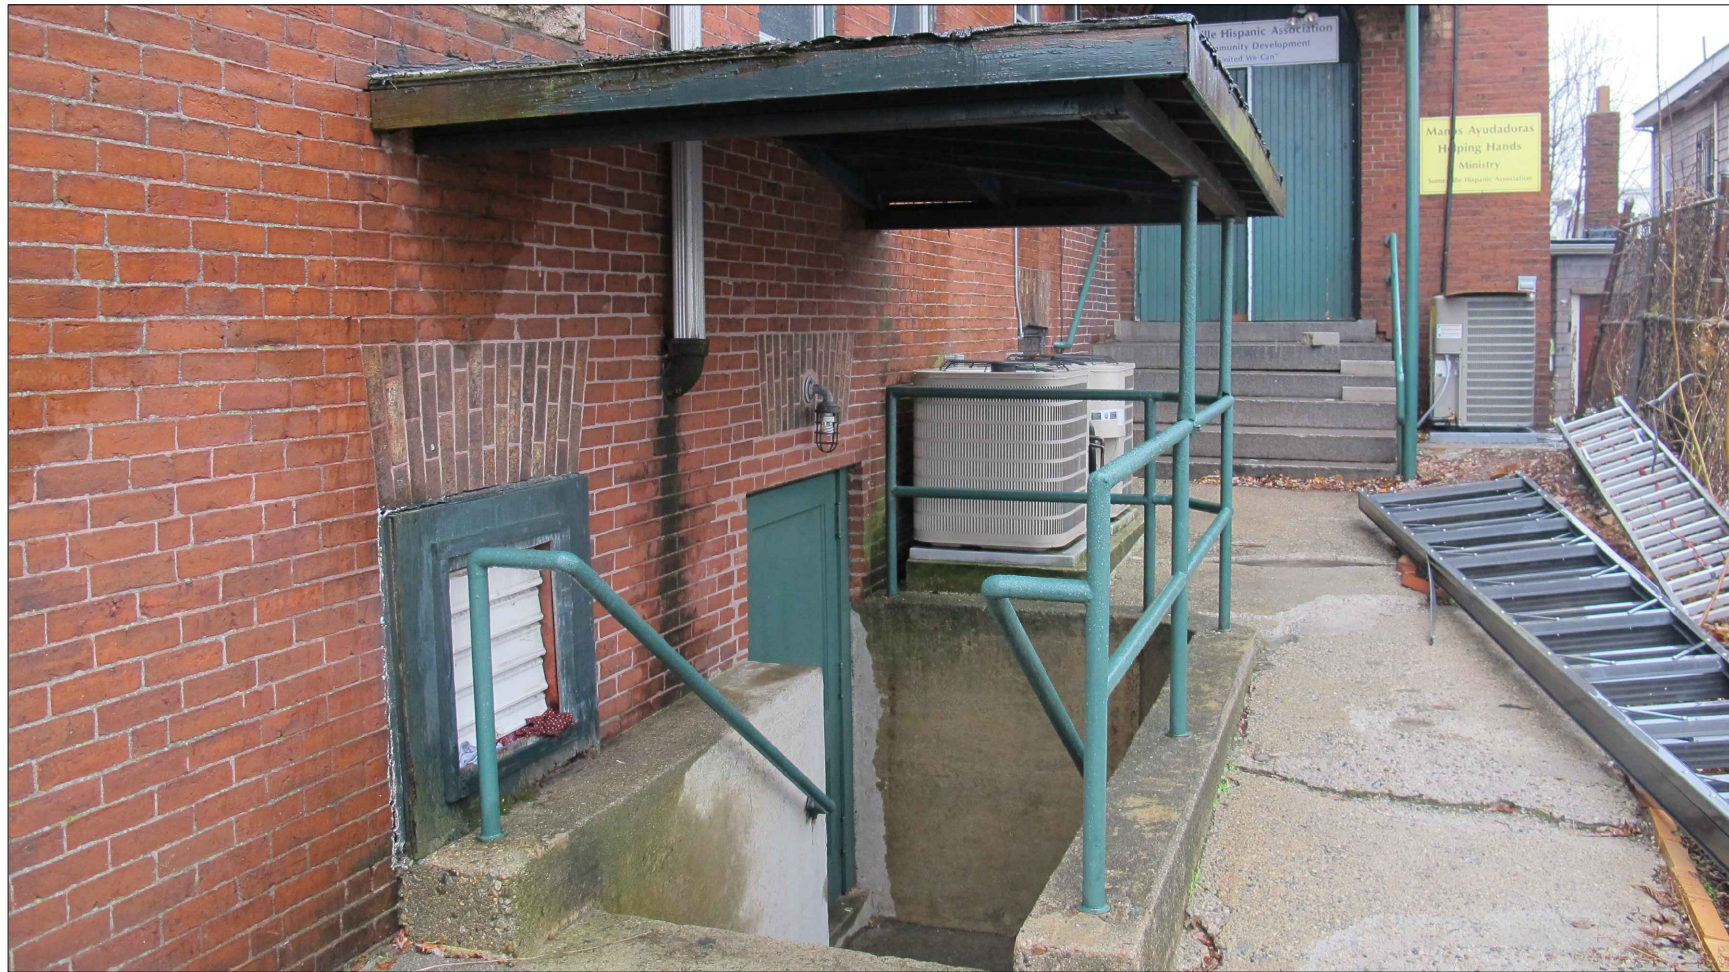
PHOTO 1: Existing stair where new accessible entrance is to be located. Note: stairs up to Sanctuary beyond.

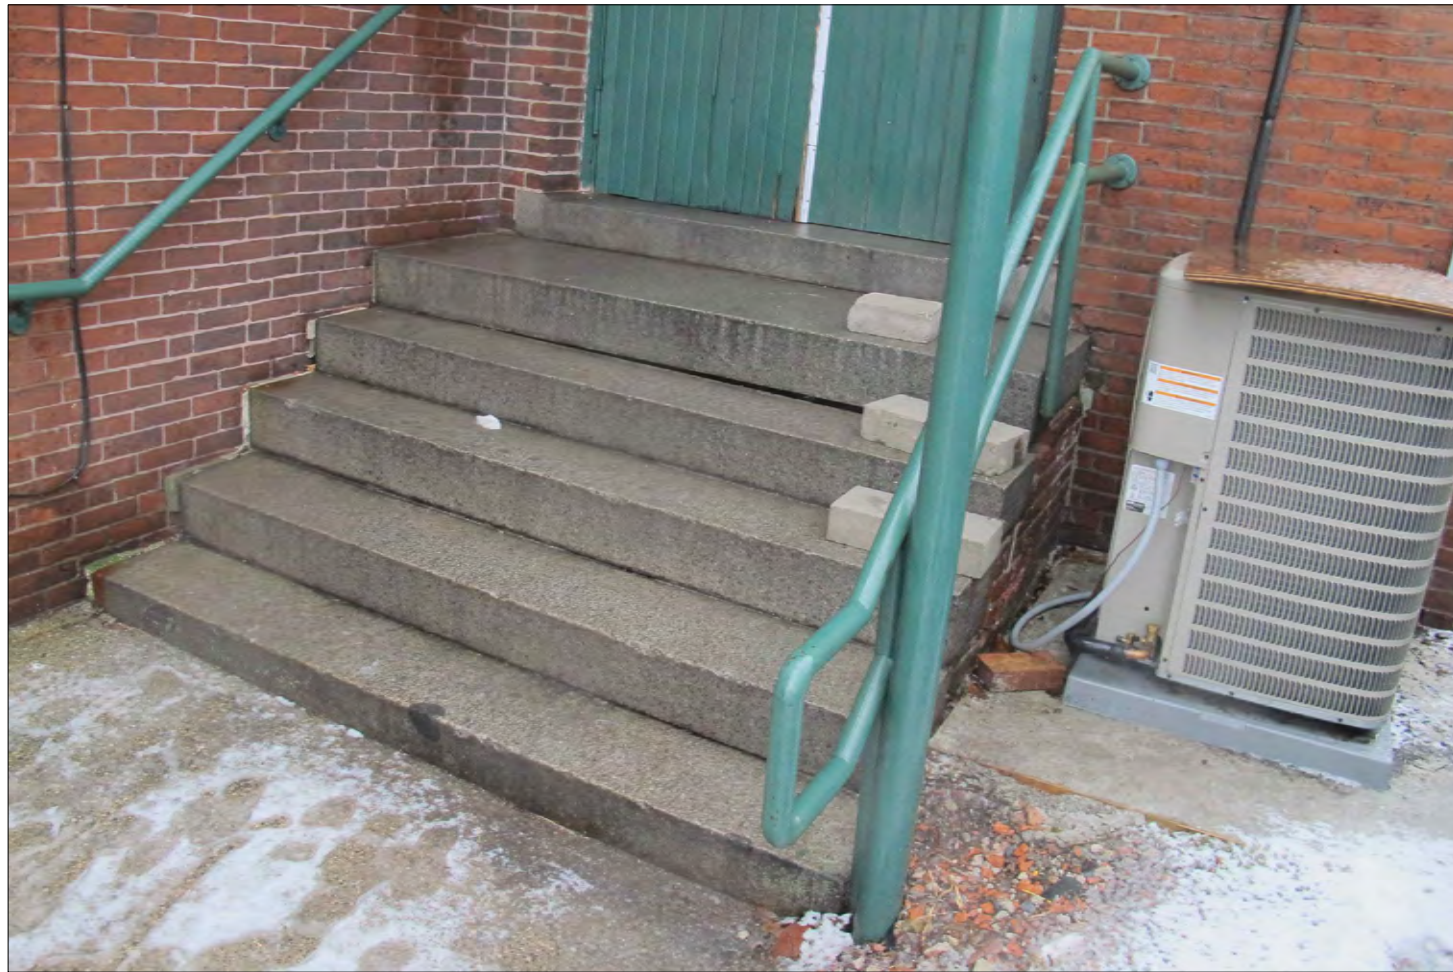
PHOTO 2: Existing granite stair to remain at Sanctuary entrance.

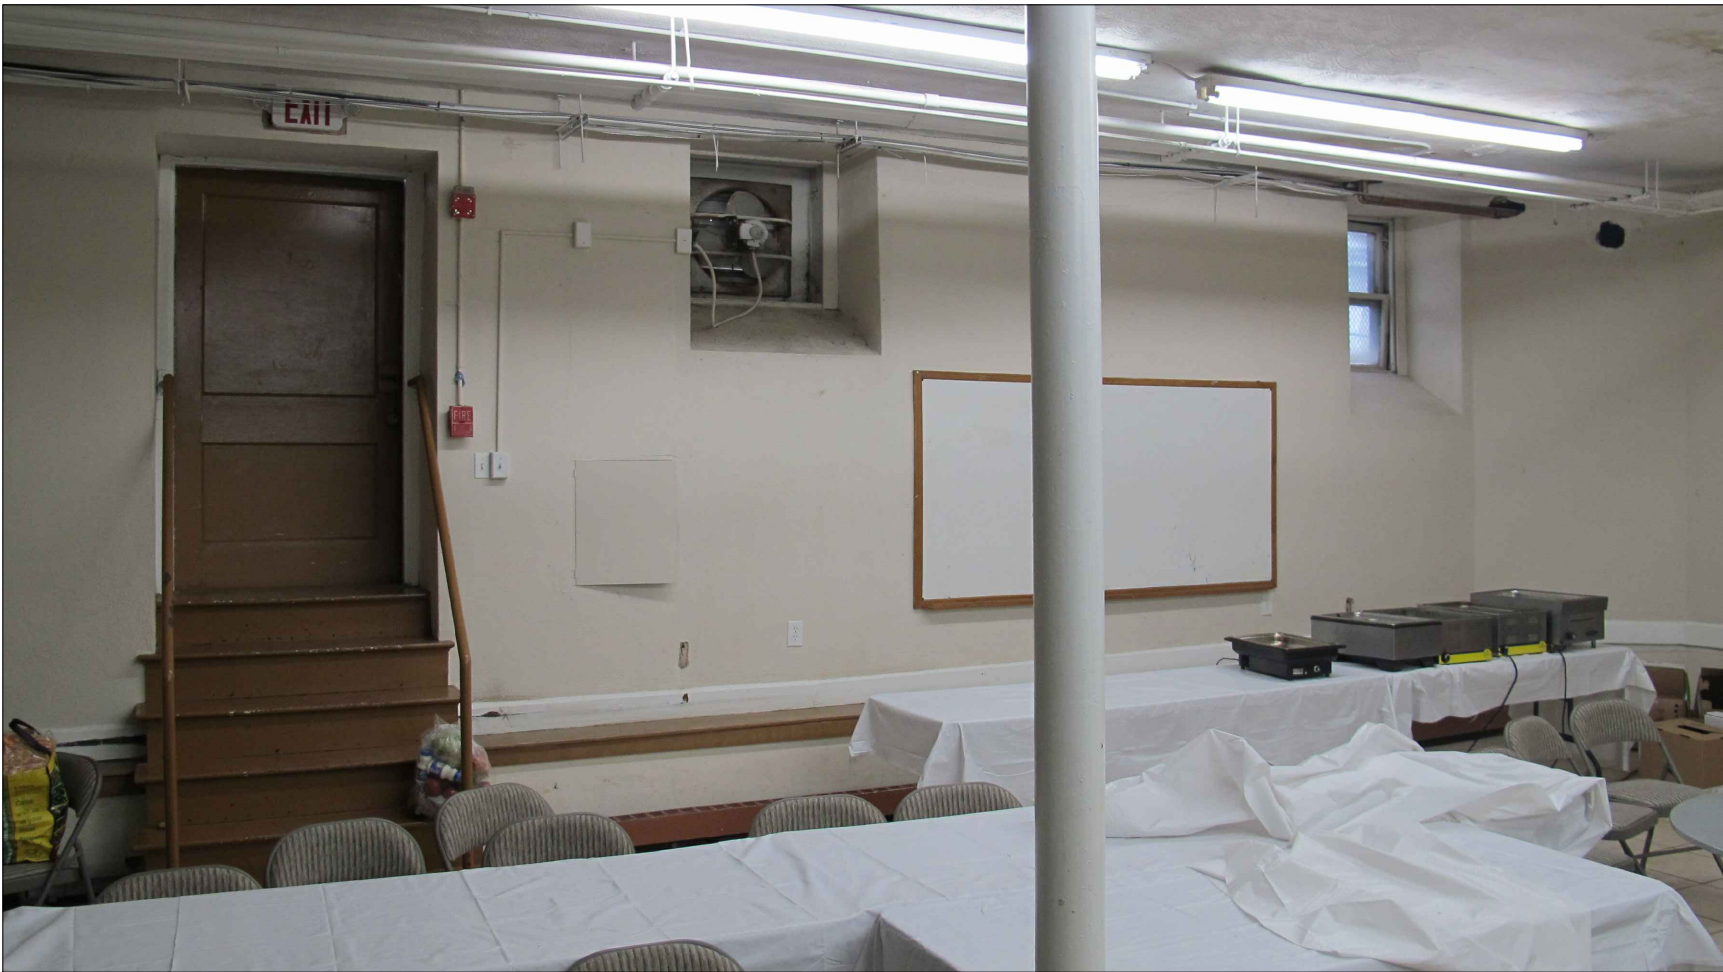
PHOTO 3: Existing Social / Dining area at basement. The existing floor elevation will be raised to match adjacent Kitchen and Stage floor elevations.

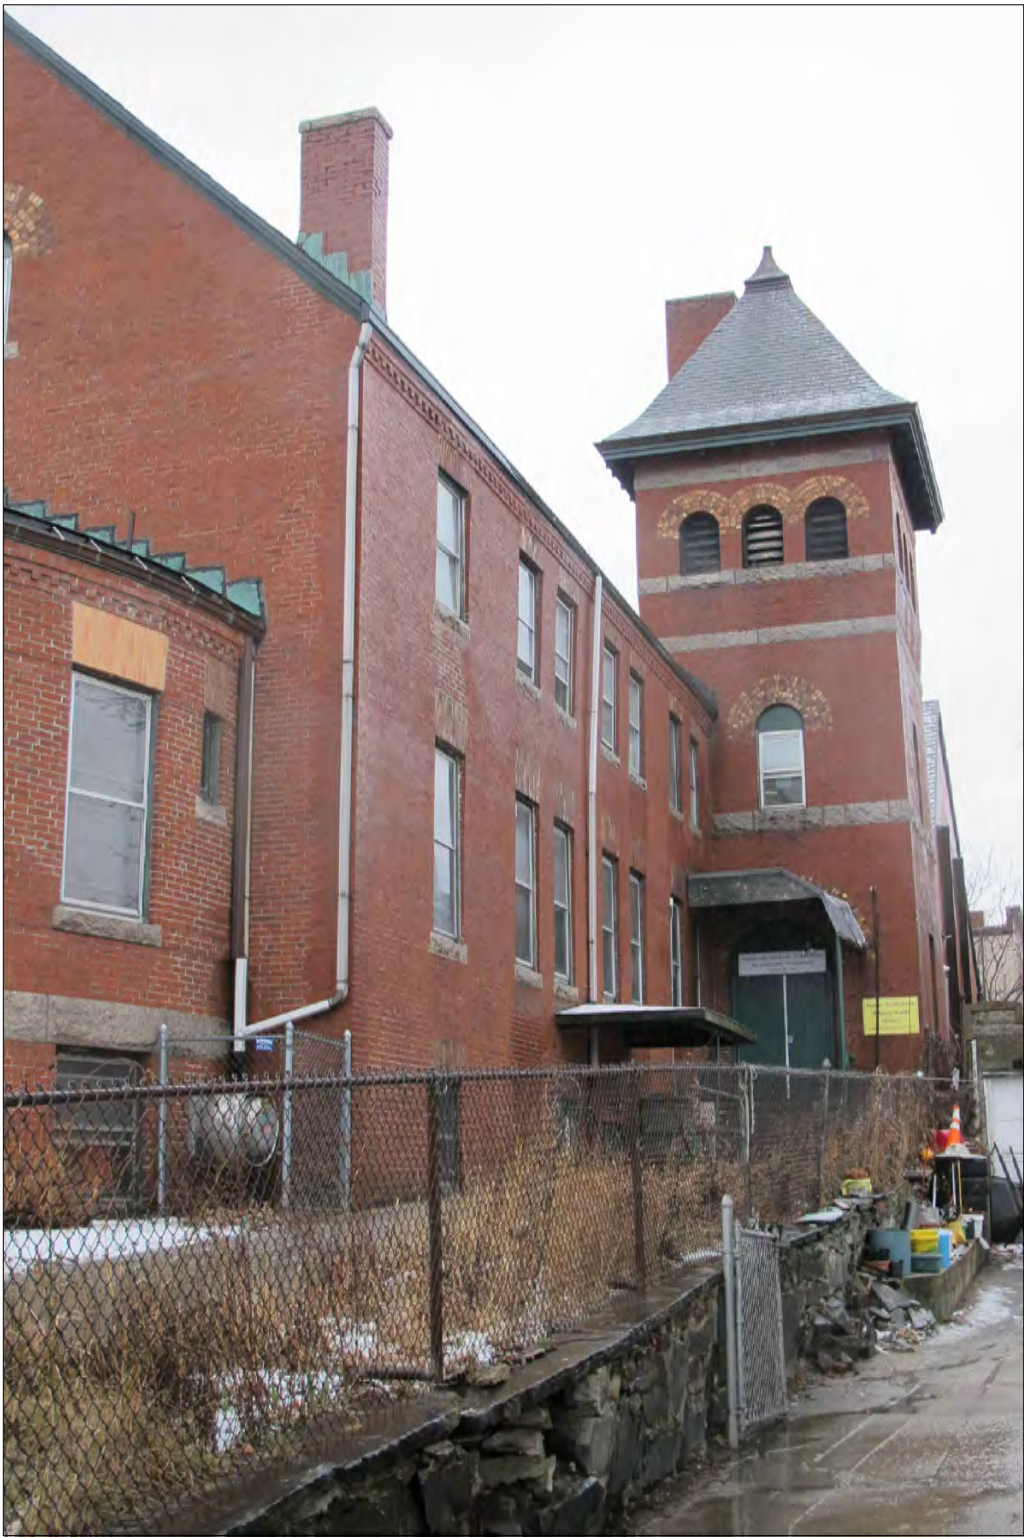
PHOTO 4: Existing area between Somerville Hispanic Church and neighbor's property. Note: new walkway and accessible entrance to be built at this location.

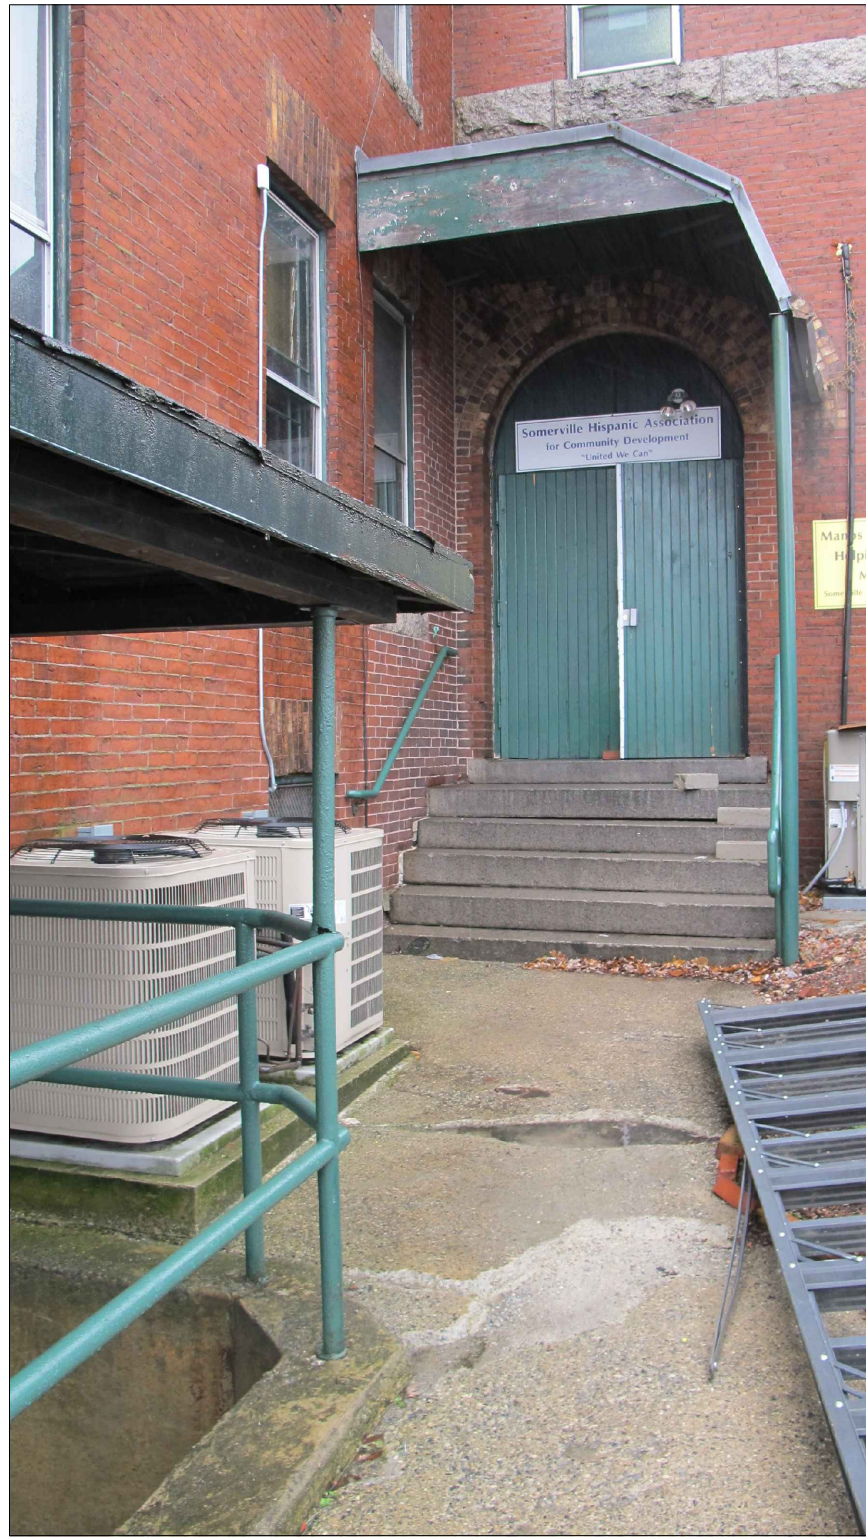
PHOTO 5: Existing door and stairs at Sanctuary entrance.

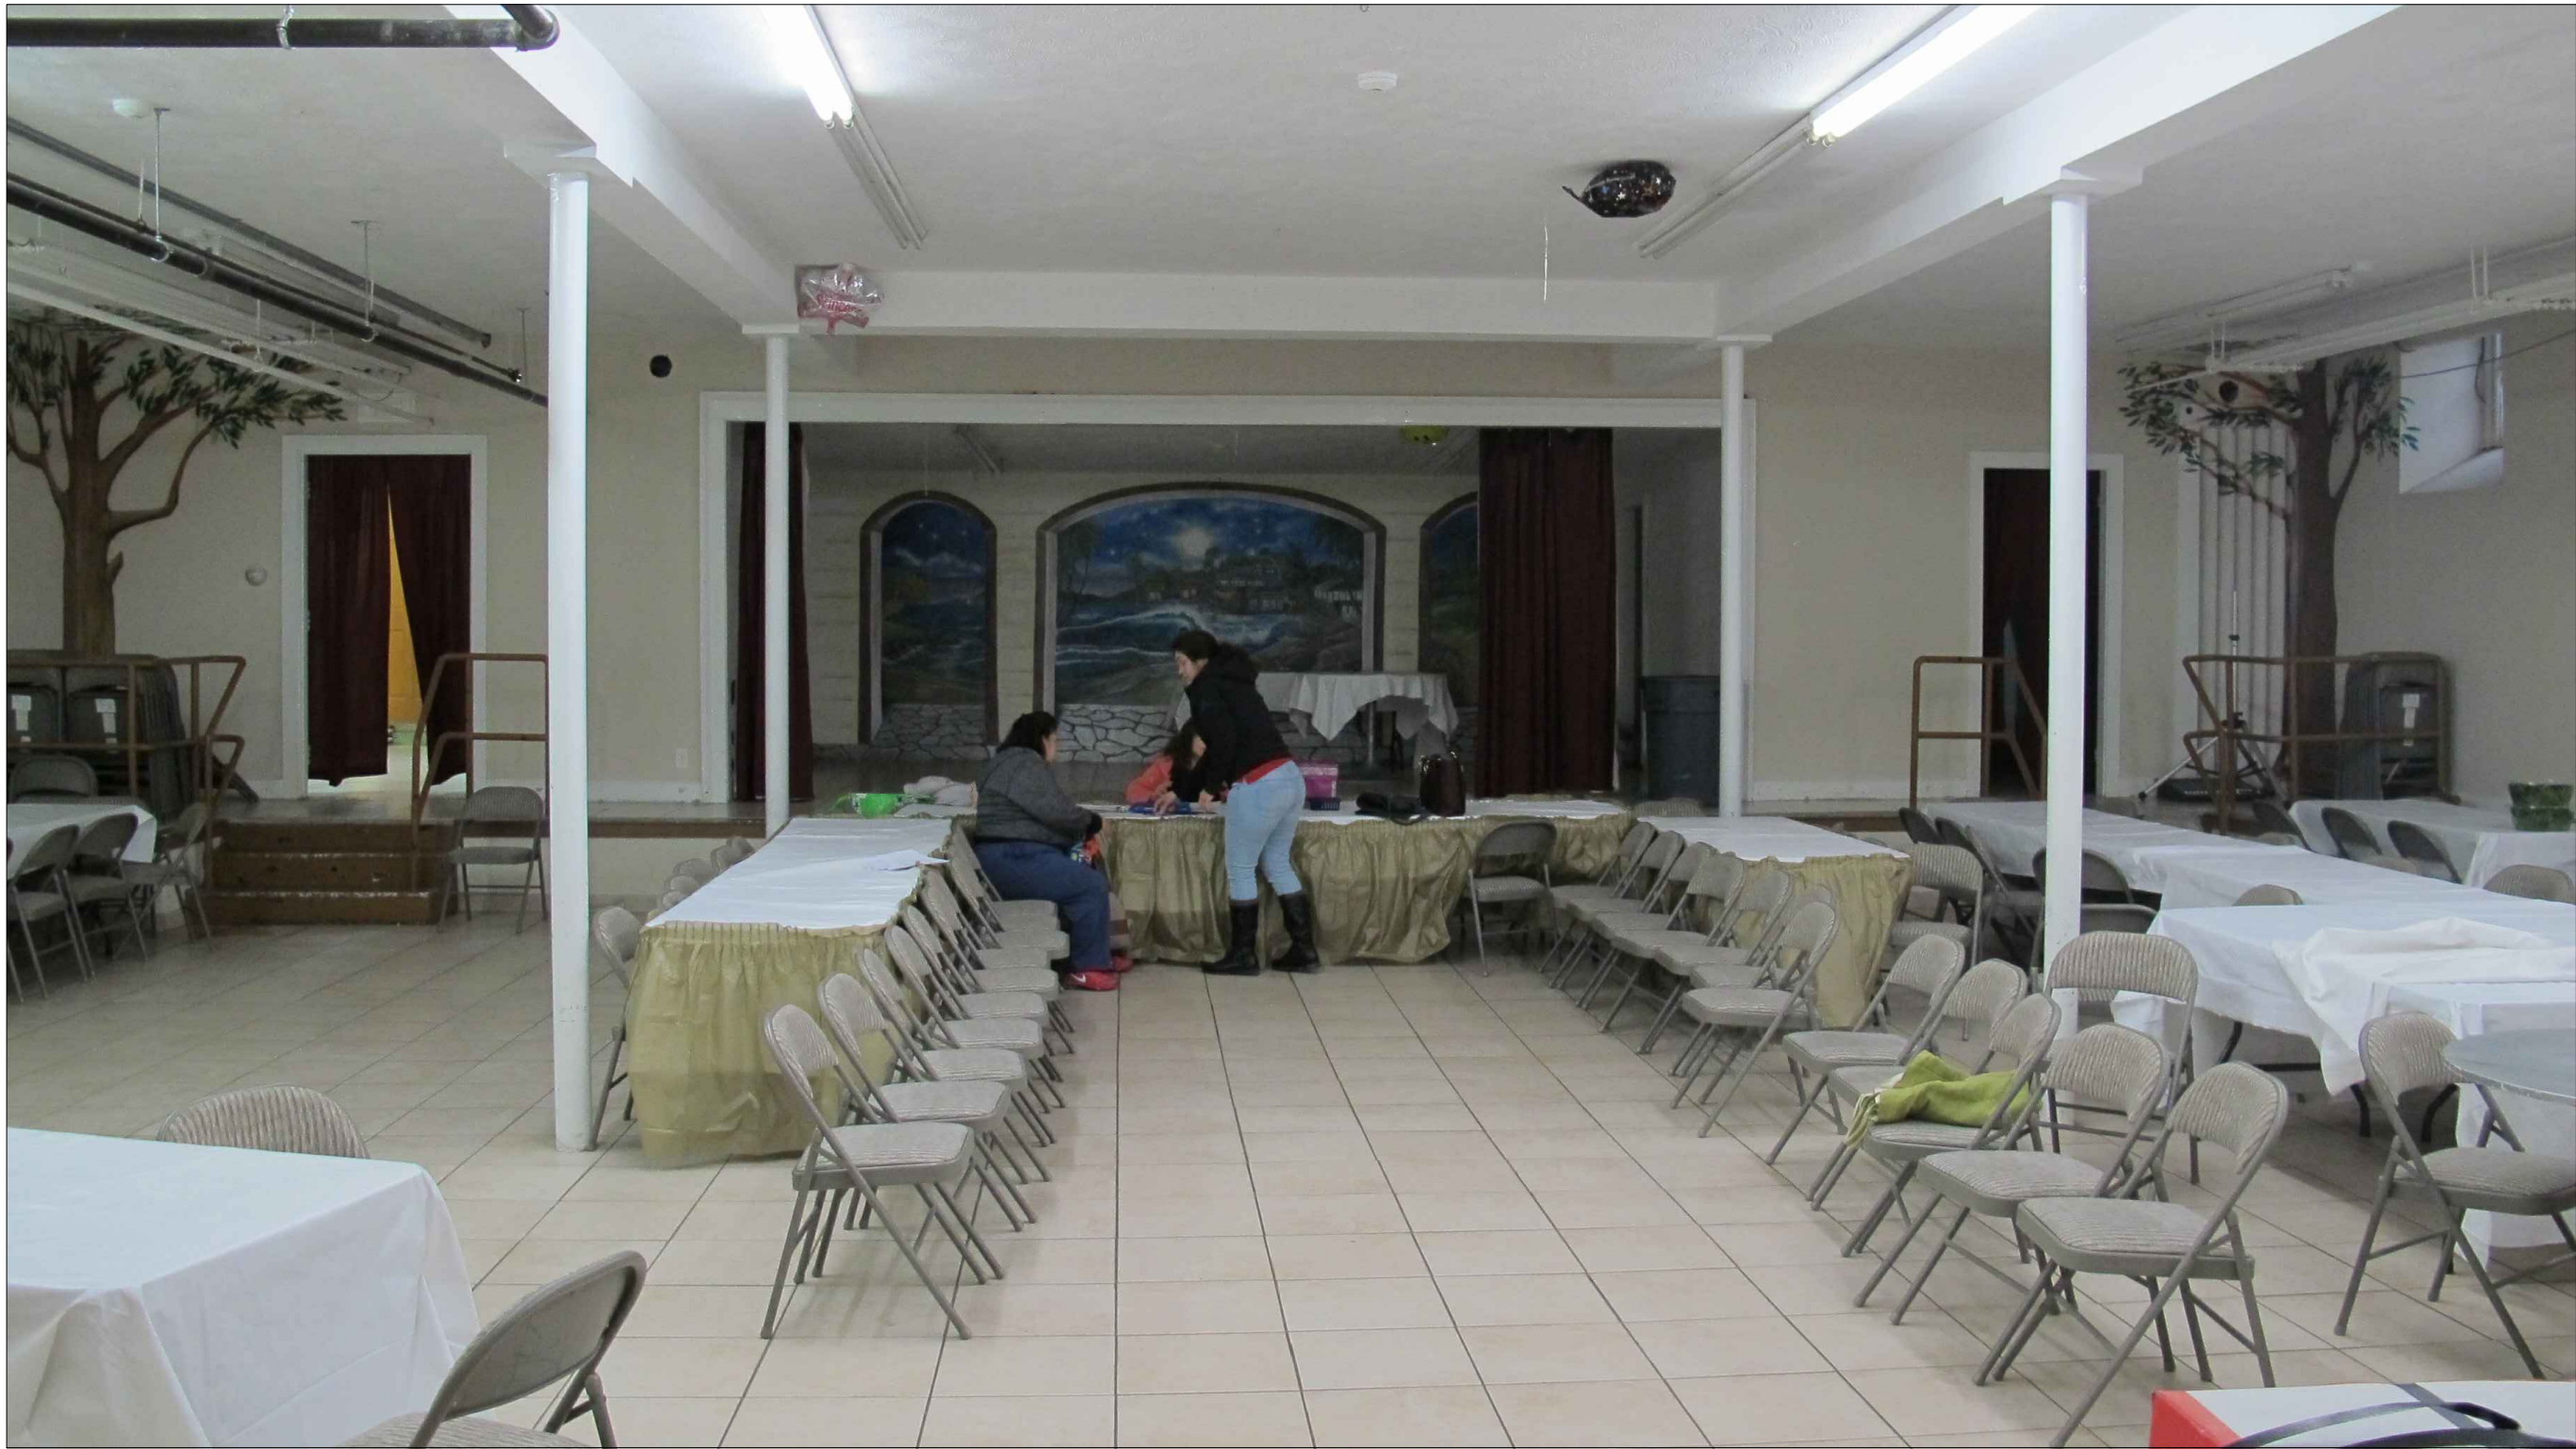
PHOTO 6: Existing Social / Dining room in basement. Floor to be raised to match the elevation of the stage area beyond.
