# **UNSTABLE AREAS ASSESSMENT**

**Per Requirements of 40 CFR §257.64**

**Montour SES Ash Landfill 3  
Washingtonville, Pennsylvania**

Project Number ME1207A

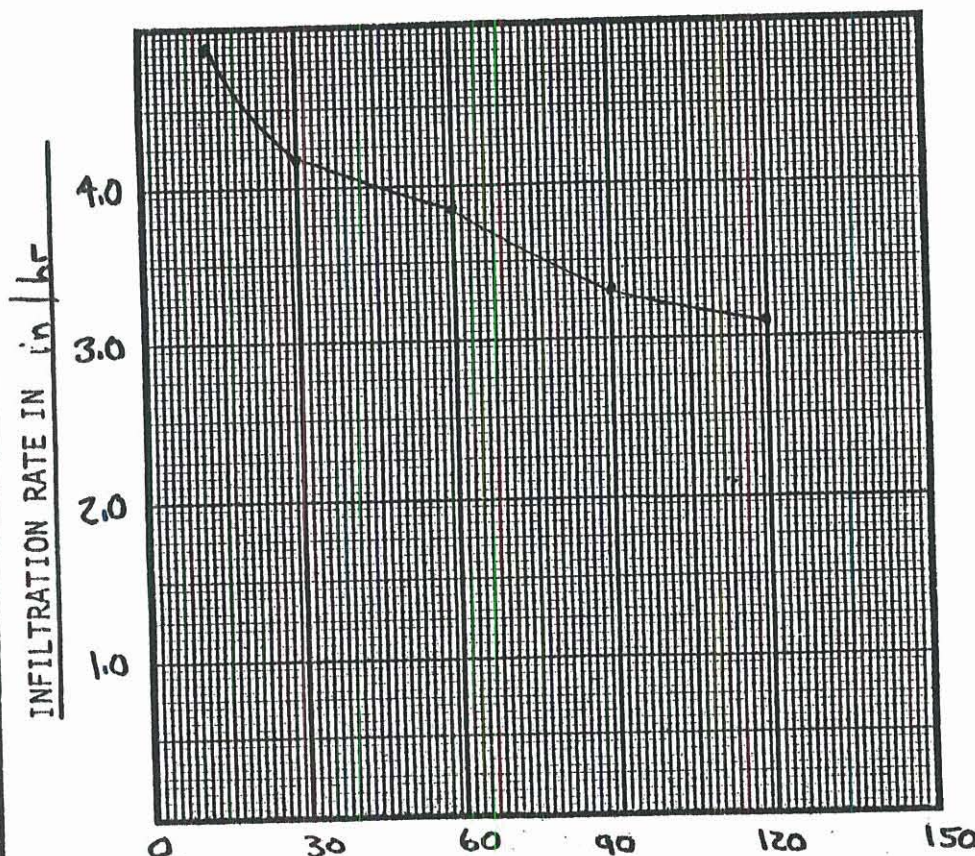
### CROSS-SECTION OF MOIST AREA AND GRAPH OF INFILTRATION RATE

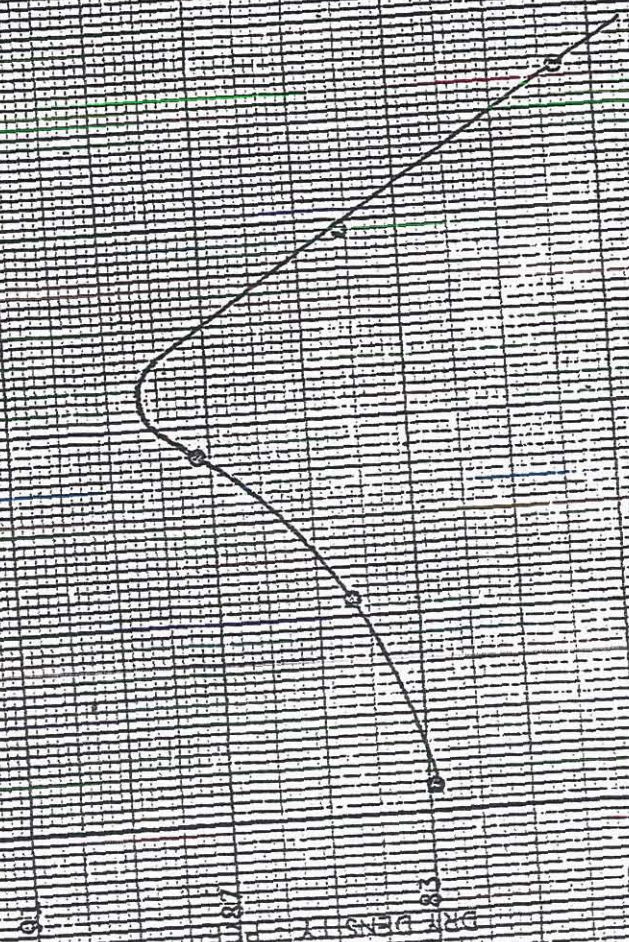
MONITOR SES  
 AREA NO. 2 EXPANSON  
 ASST STORAGE  
 PSN NO 180230-002  
 STATION: J. 1444  
 OFFSET: 3-6 (S-2)  
 SAMPLE LOCATION: 1111

MAX DENSITY 88 4 pcf  
 OPT MOISTURE 21 0.5  
 STD 50  
 MOD 11  
 SYM-D-698  
 Method N

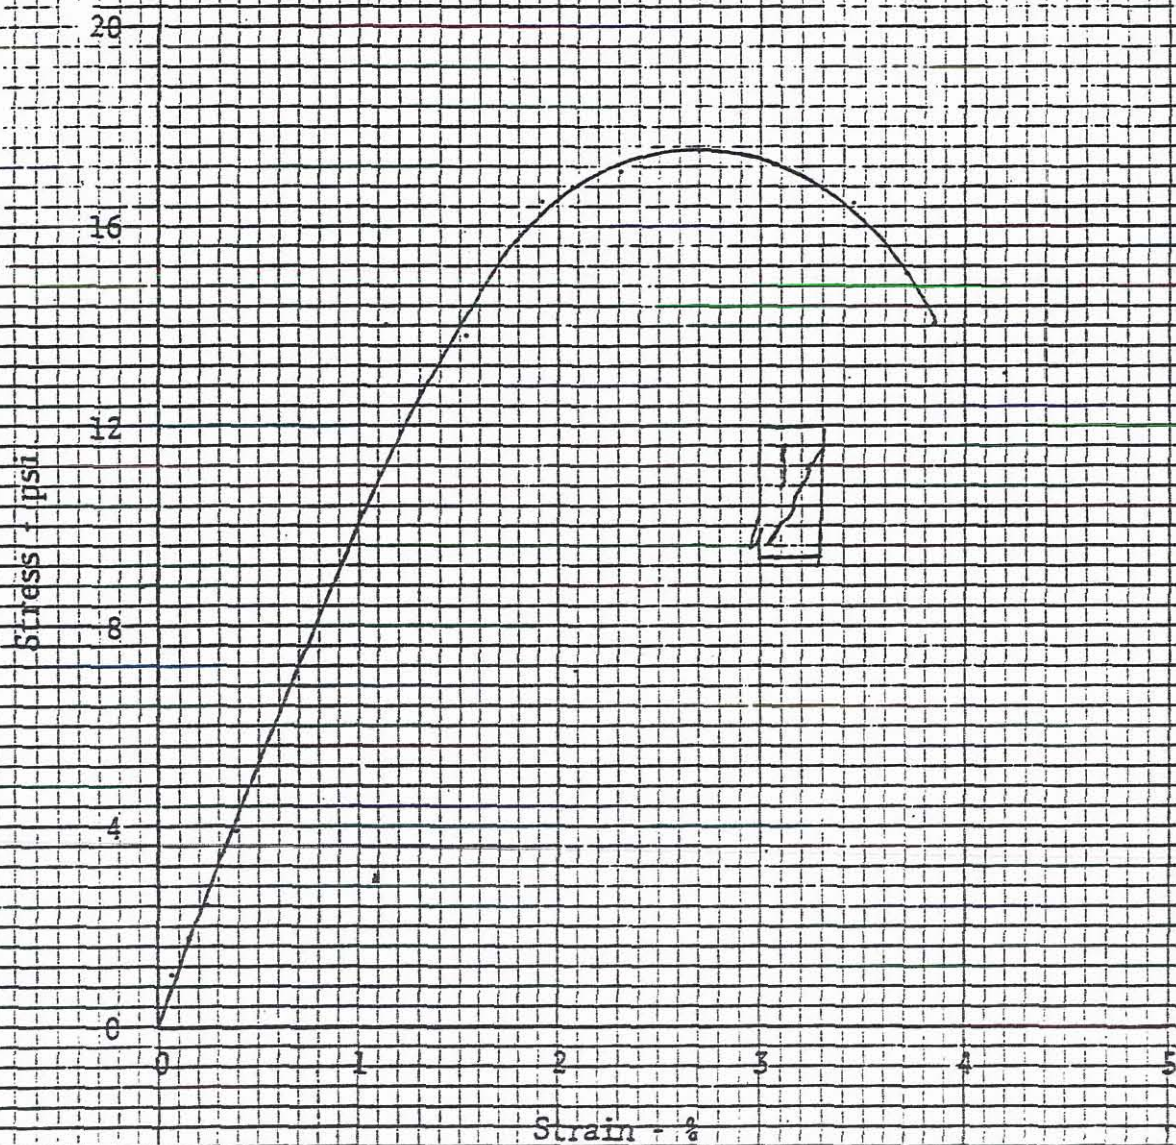
Shelby Tube Sample: 5-6-E  
Depth: 1.5' - 2.5'

Sample Height: 6.5"  
Sample Diameter: 2.87"  
Wet Density: 125.6 pcf  
Moisture Content: 13.6%  
Dry Density: 110.5 pcf

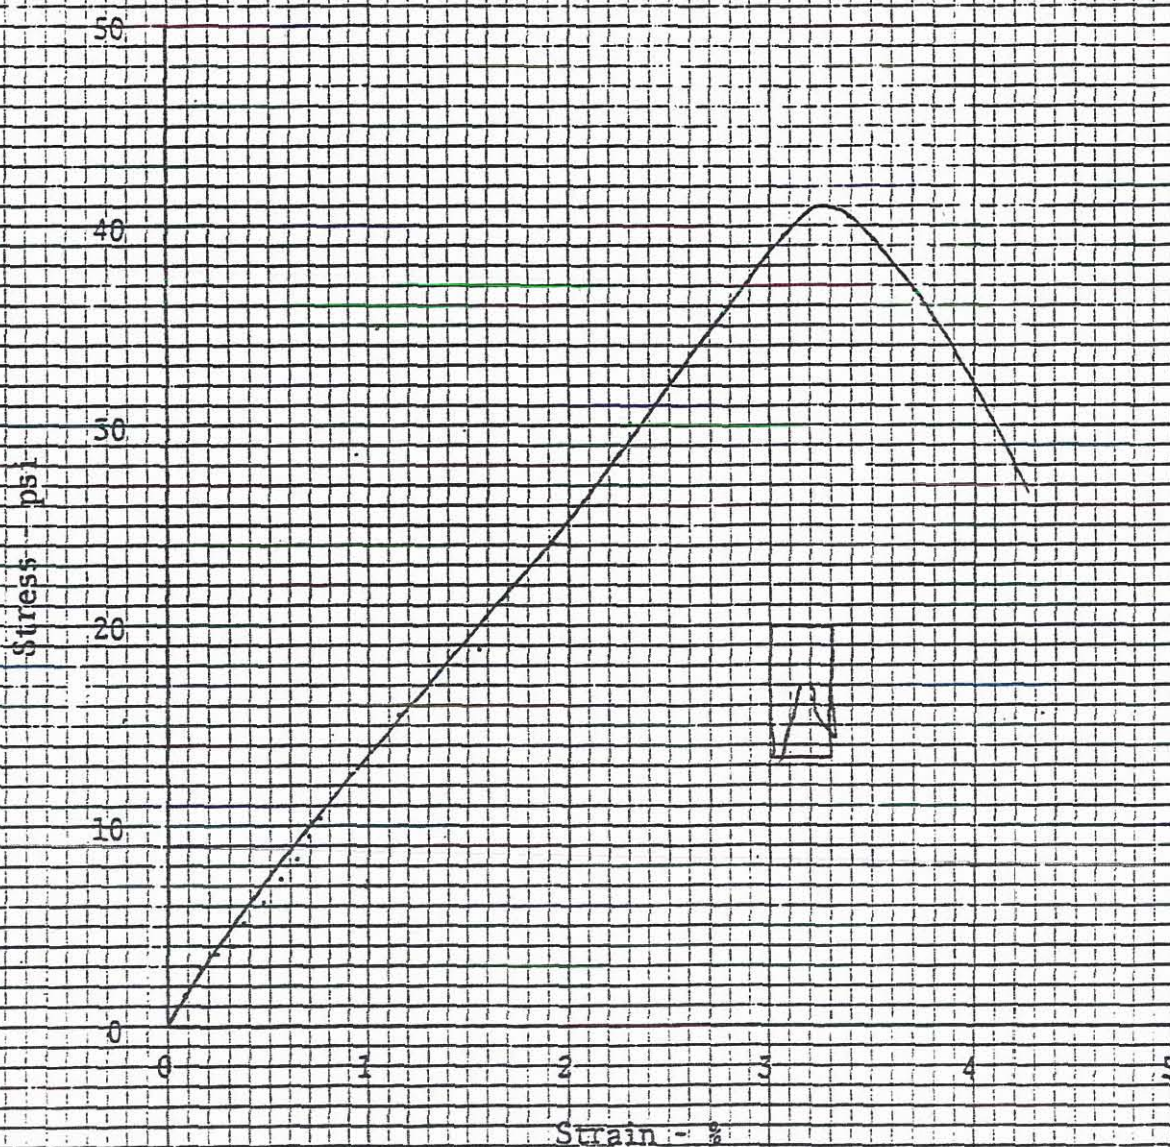
Shelby Tube Sample: S-6-D  
Depth: 0.5' - 2.5'

Sample Height: 6.5"  
Sample Diameter: 2.87"  
Wet Density: 119.4 pcf  
Moisture Content: 16.4%  
Dry Density: 102.7 pcf

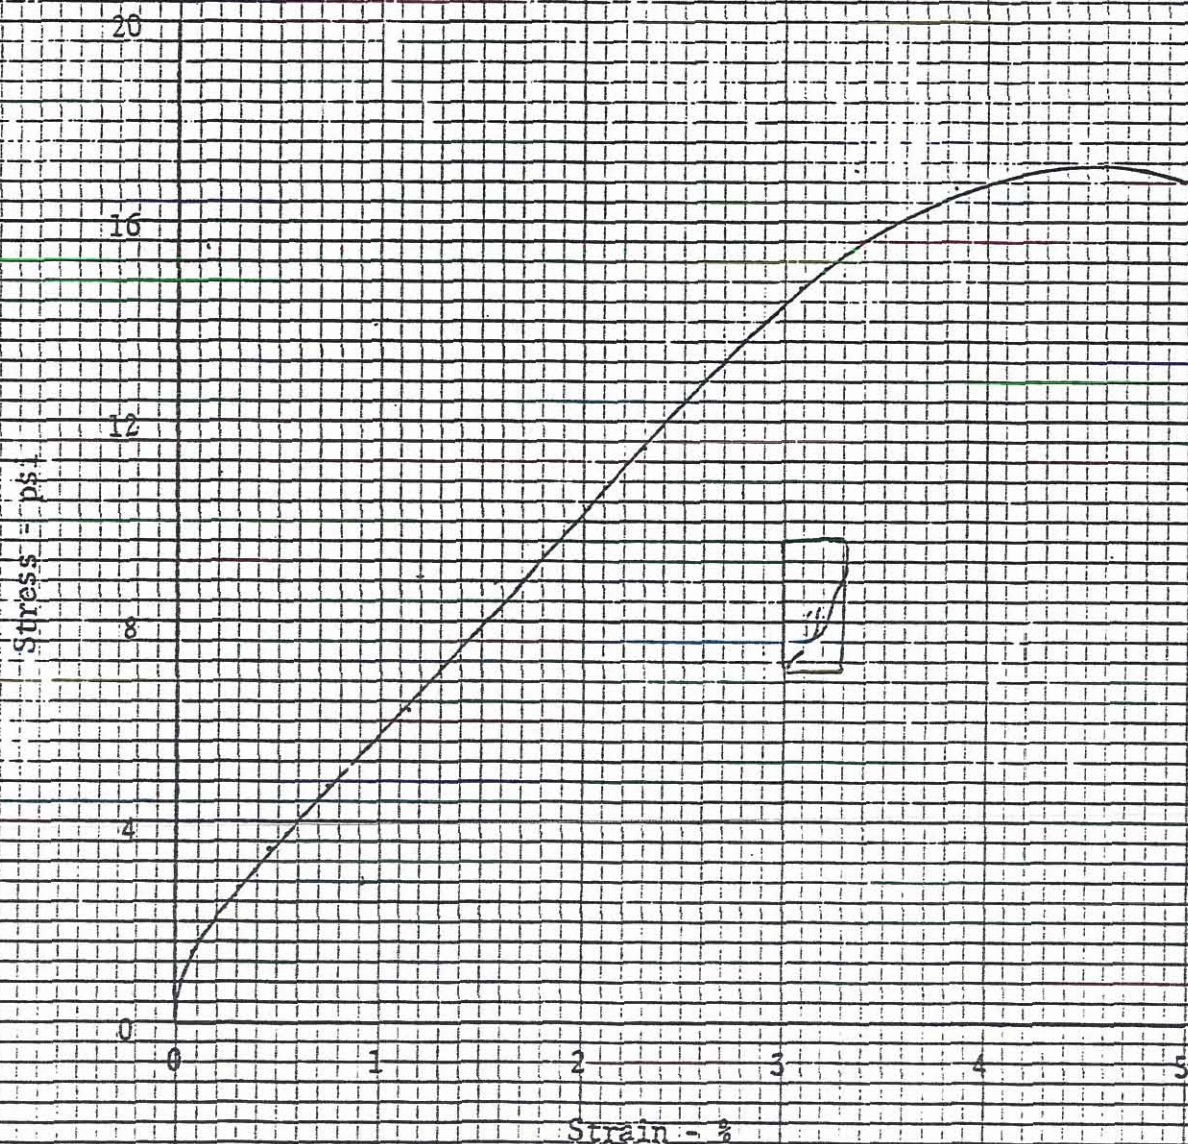
Shelby Tube Sample: S-6-B  
Depth: 3.0' - 4.5'

Sample Height: 6.5"  
Sample Diameter: 2.87"  
Wet Density: 127.6 pcf  
Moisture Content: 20.2%  
Dry Density: 106.2 pcf

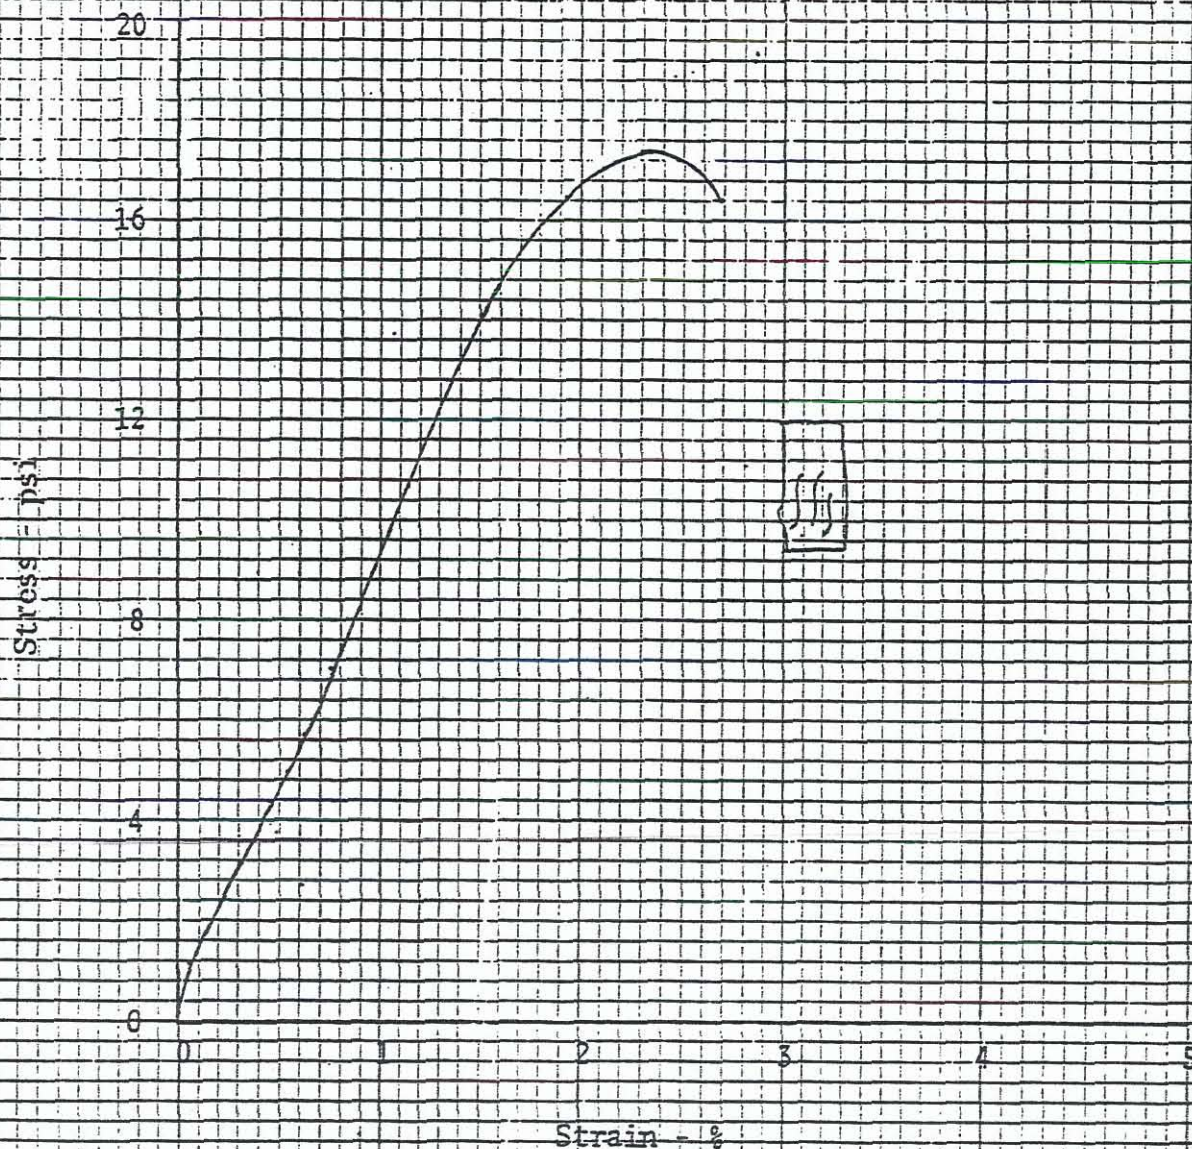
Shelby Tube Sample: 5-G-35-1A  
Depth: 1.5'-3.0'

Sample Height: 6.5"  
Sample Diameter: 2.87"  
Wet Density: 104.7 pcf  
Moisture Content: 22.8%  
Dry Density: 85.3 pcf

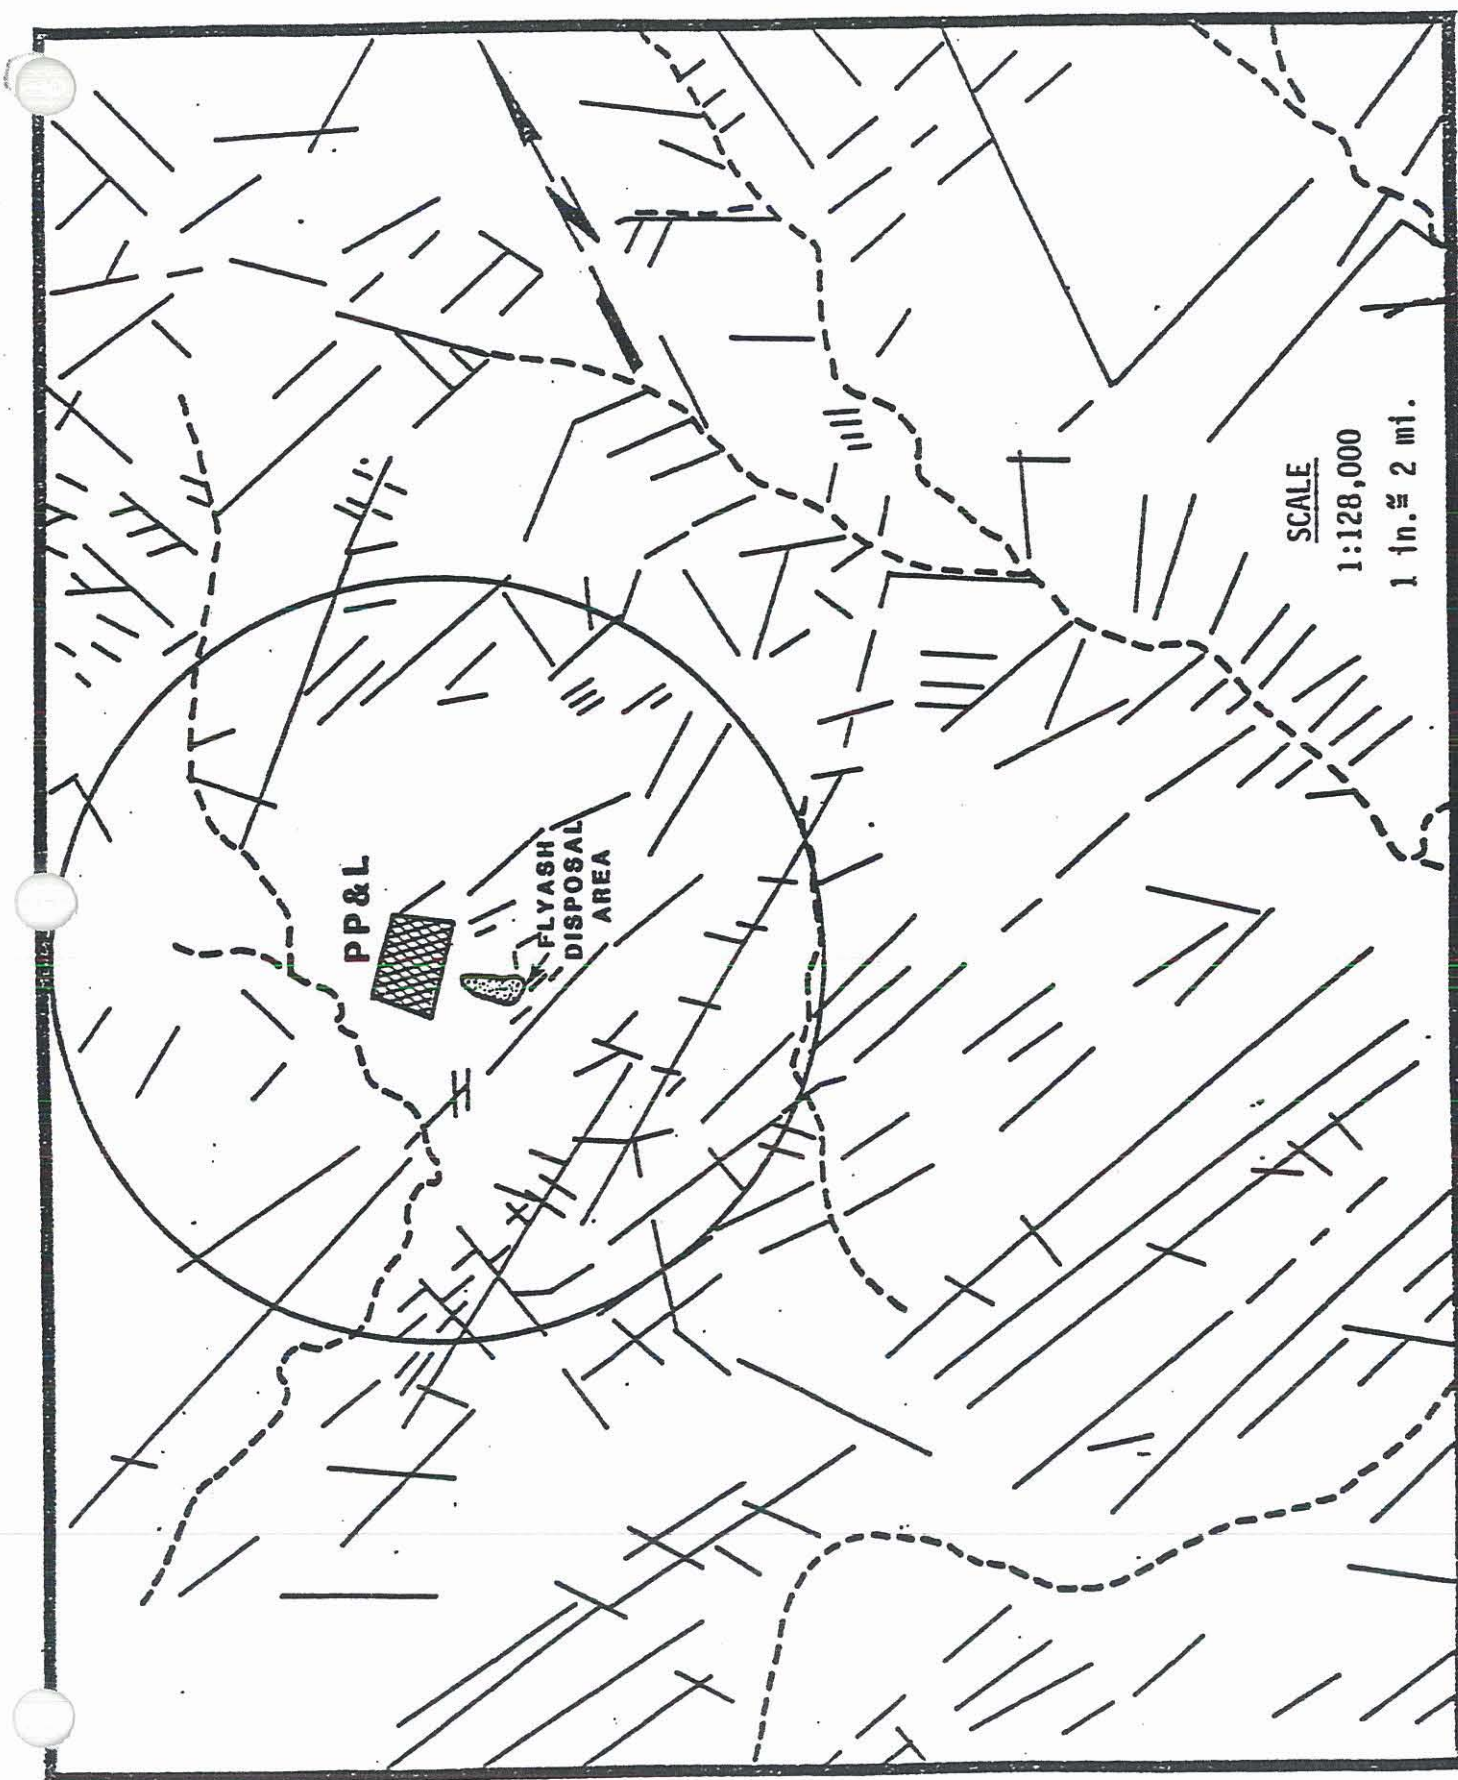
Figure 1. Fracture trace and lineament map for PP&L Montour Station.

A NASA aircraft false color infrared photograph in 1:128,000 scale was examined using stereo viewing methods to locate fracture traces and lineaments. These surface features were then transposed to a sheet of tracing paper for analysis. (Figure 1)

All lineaments from the photograph were plotted. Only the more obvious fracture traces were plotted, except for an area eight miles in diameter around the Montour Station Power plant. This area was analyzed in detail in order to locate all lineaments and fracture traces. Care was taken as

In the review of the fracture trace and lineament map, a few major and minor directional trends can be noticed. The major lineaments such as those formed by the dominant mountain ridges all show a distinct directional trend of northeast to southwest; in fact, nearly all the lineaments show the same directional trend. This uniformity of lineament directional trends is easily explained by the structural geology of the area.

By examining the fracture traces, it can be seen that the majority of these either are parallel to the major lineaments or are perpendicular to the major lineaments. The northeast-southwest trending fracture traces are simply a reflection of the underlying geology, as explained previously. The majority of the perpendicular fracture traces appear to be in areas of stream incision through various ridges. It is likely that these incisions may have obtained their direction by finding the weakest path of flow through perpendicular jointing in the sedimentary ridges.

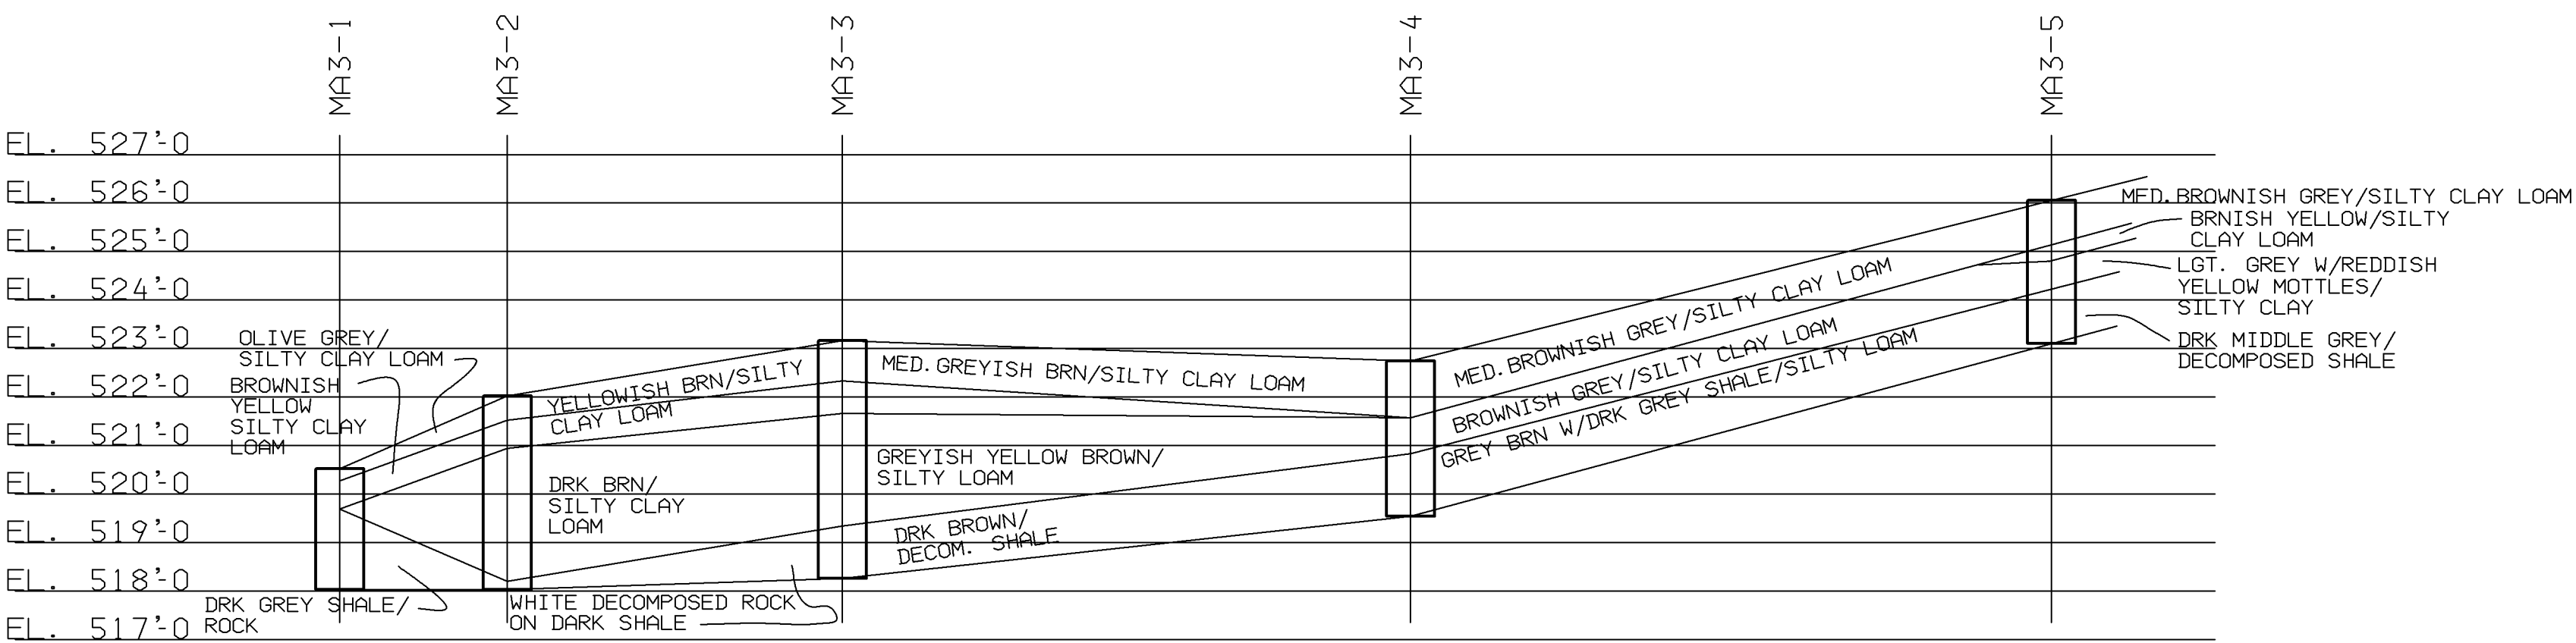
SECTION D-D

SCALE    HORZ. 1"=100'  
          VERT. 1"= 3'
