# PERMITTING SETBACK REQUIREMENTS FOR WIND TURBINES IN CALIFORNIA

*Prepared For:*  
**California Energy Commission**  
Public Interest Energy Research Program

*Prepared By:*  
**California Wind Energy Collaborative**

November 2006  
CEC-500-2005-184

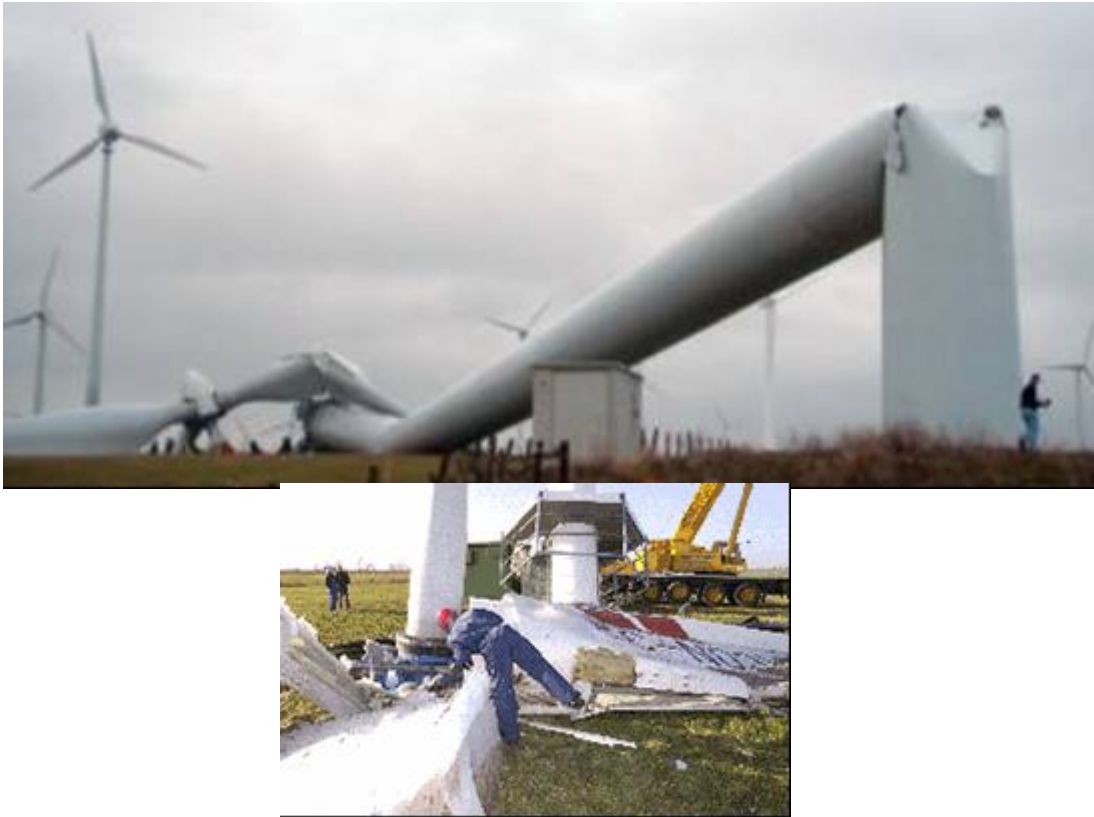
**Fig. 2.1: Two examples of incidents that pose possible danger to the surrounding area.**

In many cases it appeared difficult to indicate exactly whether a turbine had indeed lost parts as in Fig. 2.1, or was just heavily damaged as in Fig. 2.2. The final results from the selection of risk involved incidents are given in Table 2.2. The total can be seen in Table 2.3. This table includes the total number of operating years for each type. This number is obtained by summing the number of turbines in operation per year over all the years.

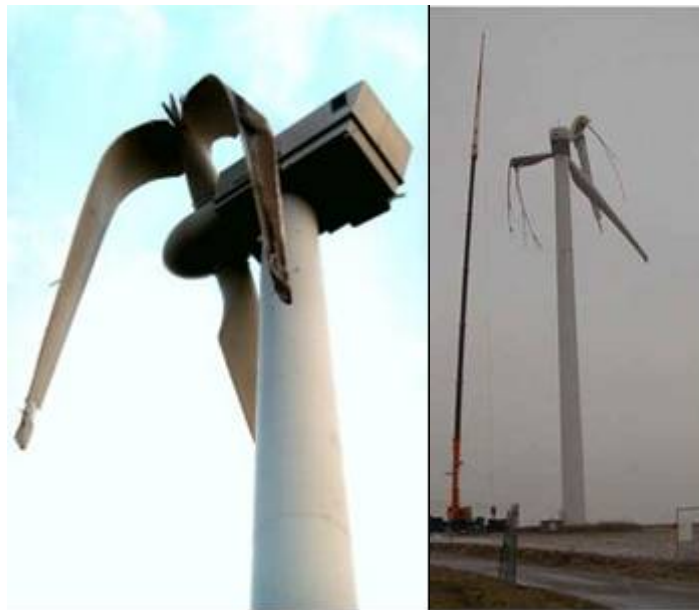
- Most incidents are poorly documented, and the actual number of risk-involved incidents cannot be determined for certain. EMD uses codes to indicate which component failed, the reason for failure, and whether parts were thrown from the turbine. From the codes it is difficult to determine the size of the thrown object, the distance thrown, and the order of events. In some cases this information is included in the comments. Between 1993 and 2000 the code was expanded. Between 1984 and 1992, the code was severely restricted. It was seldom even noted whether a compromised turbine had done damage to the surrounding area. This made it possible for a turbine that had a complete failure and lost many parts (see Fig. 2.1) to be reported exactly like a turbine that had a complete failure and posed no risk to the surrounding area (see Fig. 2.2).

**Fig. 2.2: Two examples of turbines that failed, but caused no danger to their surroundings.**
