Part 3

# Reviving the Palos Verdes Reservoir

The Palos Verdes Reservoir (**Figure 1**) in Los Angeles County provides an exemplary case. The site has served the region for nearly 80 years. Its massive 360-million-gallon (1.36-billion-L) cell is nearing the end of a long and carefully planned process to revitalize the reservoir and greatly extend its service life.

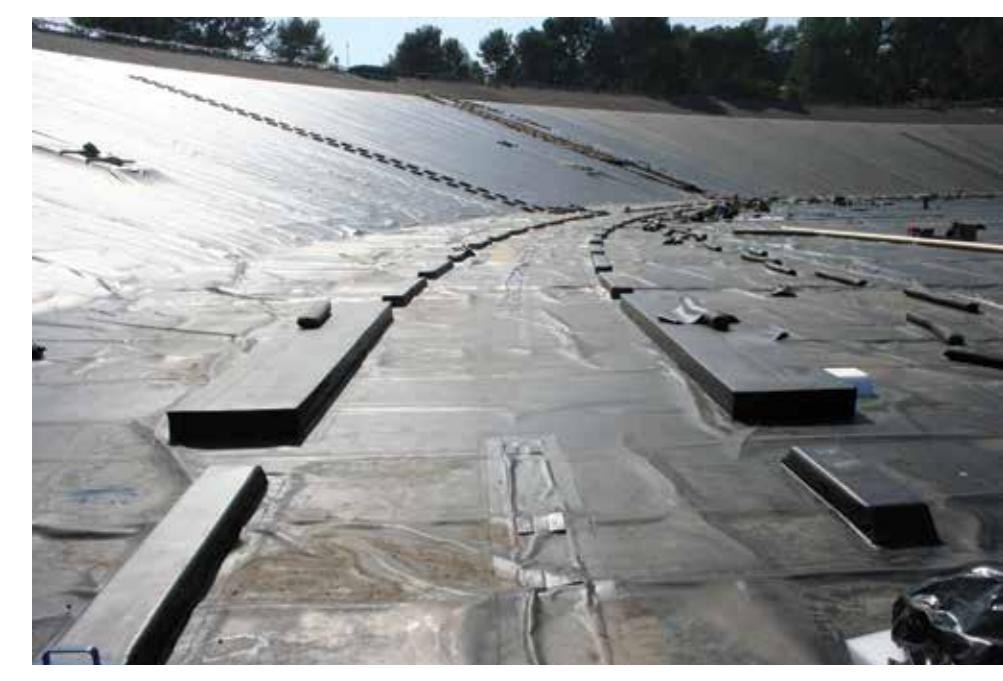
FIGURE 2 Cover installation showing floats and sand tube straps

The project was delayed numerous times. While waiting for the subgrade work to be completed, the team used a smaller crew to achieve a safe installation. They began with bolting 4,300 linear feet (1,311 m) of material at the top of the reservoir. Additional staging at a safe storage facility helped the crew plan for efficient deployment of the 1.2 million square feet (111,000 m<sup>2</sup>) of 60-mil (1.5-mm) chlorosulfonated polyethylene (CSPE) geomembrane for the lining system and the same amount of 45-mil (1.1-mm) CSPE for the floating cover. They also adjusted the execution plan for the 1.2 million square feet (111,000 m<sup>2</sup>) of geocomposite material for the cell, sand tubes, float wraps/hatches, the rain collection trough (RCT) system and vents (Figure 2).

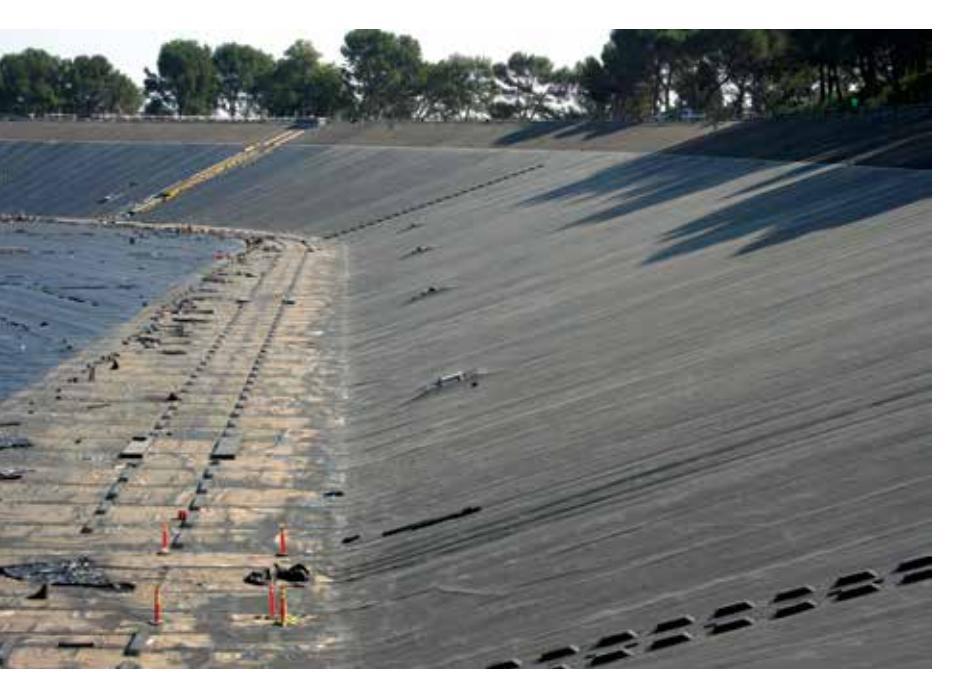
FIGURE 3 South wall with rain collection troughs and hatches

All access going forward will be done by walking down the 200-foot (61-m) slope to the base of the reservoir (**Figure 3**). Special care during this phase is required so there is no damage to the 60-mil (1.5-mm) liner or the 45-mil (1.1-mm) cover panels.

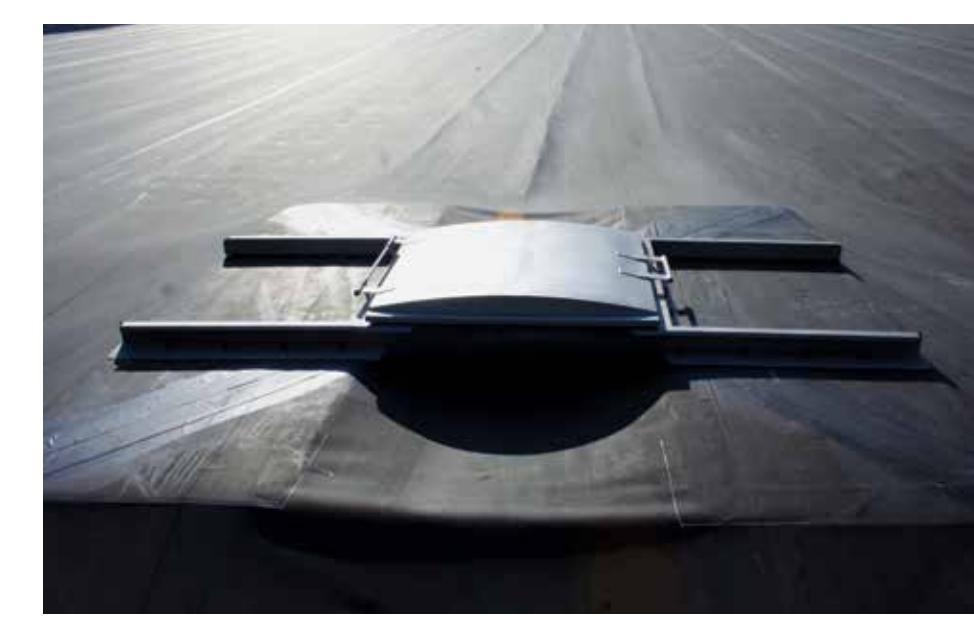
FIGURE 4 Partially installed entry hatch

The cover includes many complex elements and requires significant care during the installation and construction quality assurance (CQA) phases. For example, there are 14 hatches designed into the cover (**Figure 4**). These enable divers to access the reservoir for inspections. The hatches are built with floats using 316 stainless steel for long-term durability. Those hatches and floats were built off-site by a metals company, and assembled by Raven at its Colton, Calif., fabrication plant (**Figure 5**).

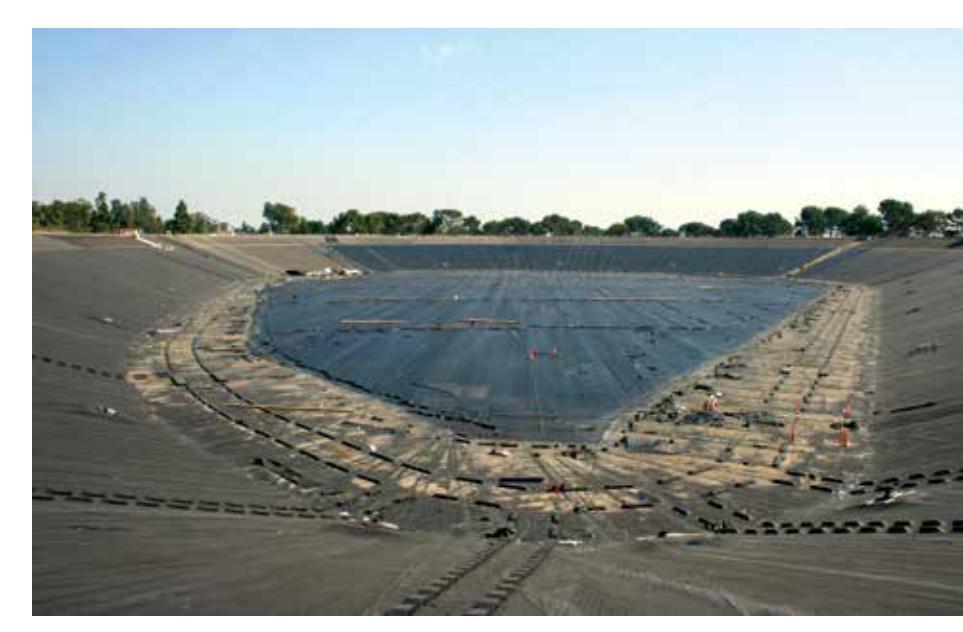
FIGURE 5 Cover installation at 90% with perimeter rain collection trough (RCT) and radial RCT
