# **Jacket Repair Procedure** For 600 Volt and MV Cables Using 3M 2234

## Jacket Repair Procedure For 600 Volt and MV Cables Using 3M 130C

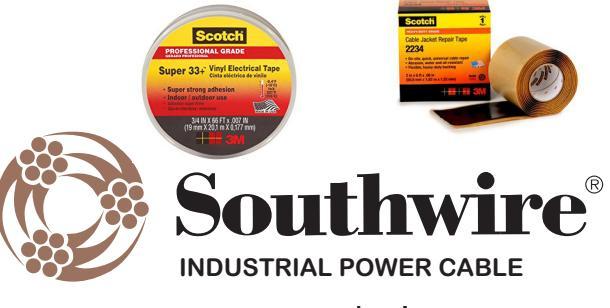
- 1. Clean outer jacket with cable cleaner, wipe dry.
- 2. Abrade cable jacket 4" on each side of removed jacket.
- 3. Apply half lapped layers of 3M 130C splicing tape in the area where the jacket was removed building up to the original jacket thickness.
- 4. Starting 2" past the 3M 130C tape on cable, apply one half lapped layer of 3M 2234 tape extending 2" past the opposite end.
- 5. Starting 1" past the 3M 2234 tape on cable, apply two half lapped layers of 3M 33+ Vinyl Electrical tape extending 1" past the 3M 2234 on the opposite end to hold down until fully

- 1. Clean outer jacket with cable cleaner, wipe dry.
- 2. Remove any protruding sharp edges from damaged area.
- 3. Abrade cable jacket 3" on each side of damage.
- 4. Apply one half lapped layer of 3M 2234 over the damaged area and at least 2" past each side of damage.
- 5. Starting 1" past the 3M 2234 tape on the cable, apply two half lapped layers of 3M 33+ Vinyl. Electrical tape extending 1" past the 3M 2234 on the opposite end to hold down until fully bonded.
