Toyota U151E/F, U250E

Zip Kit®
U151E-U250E-ZIP

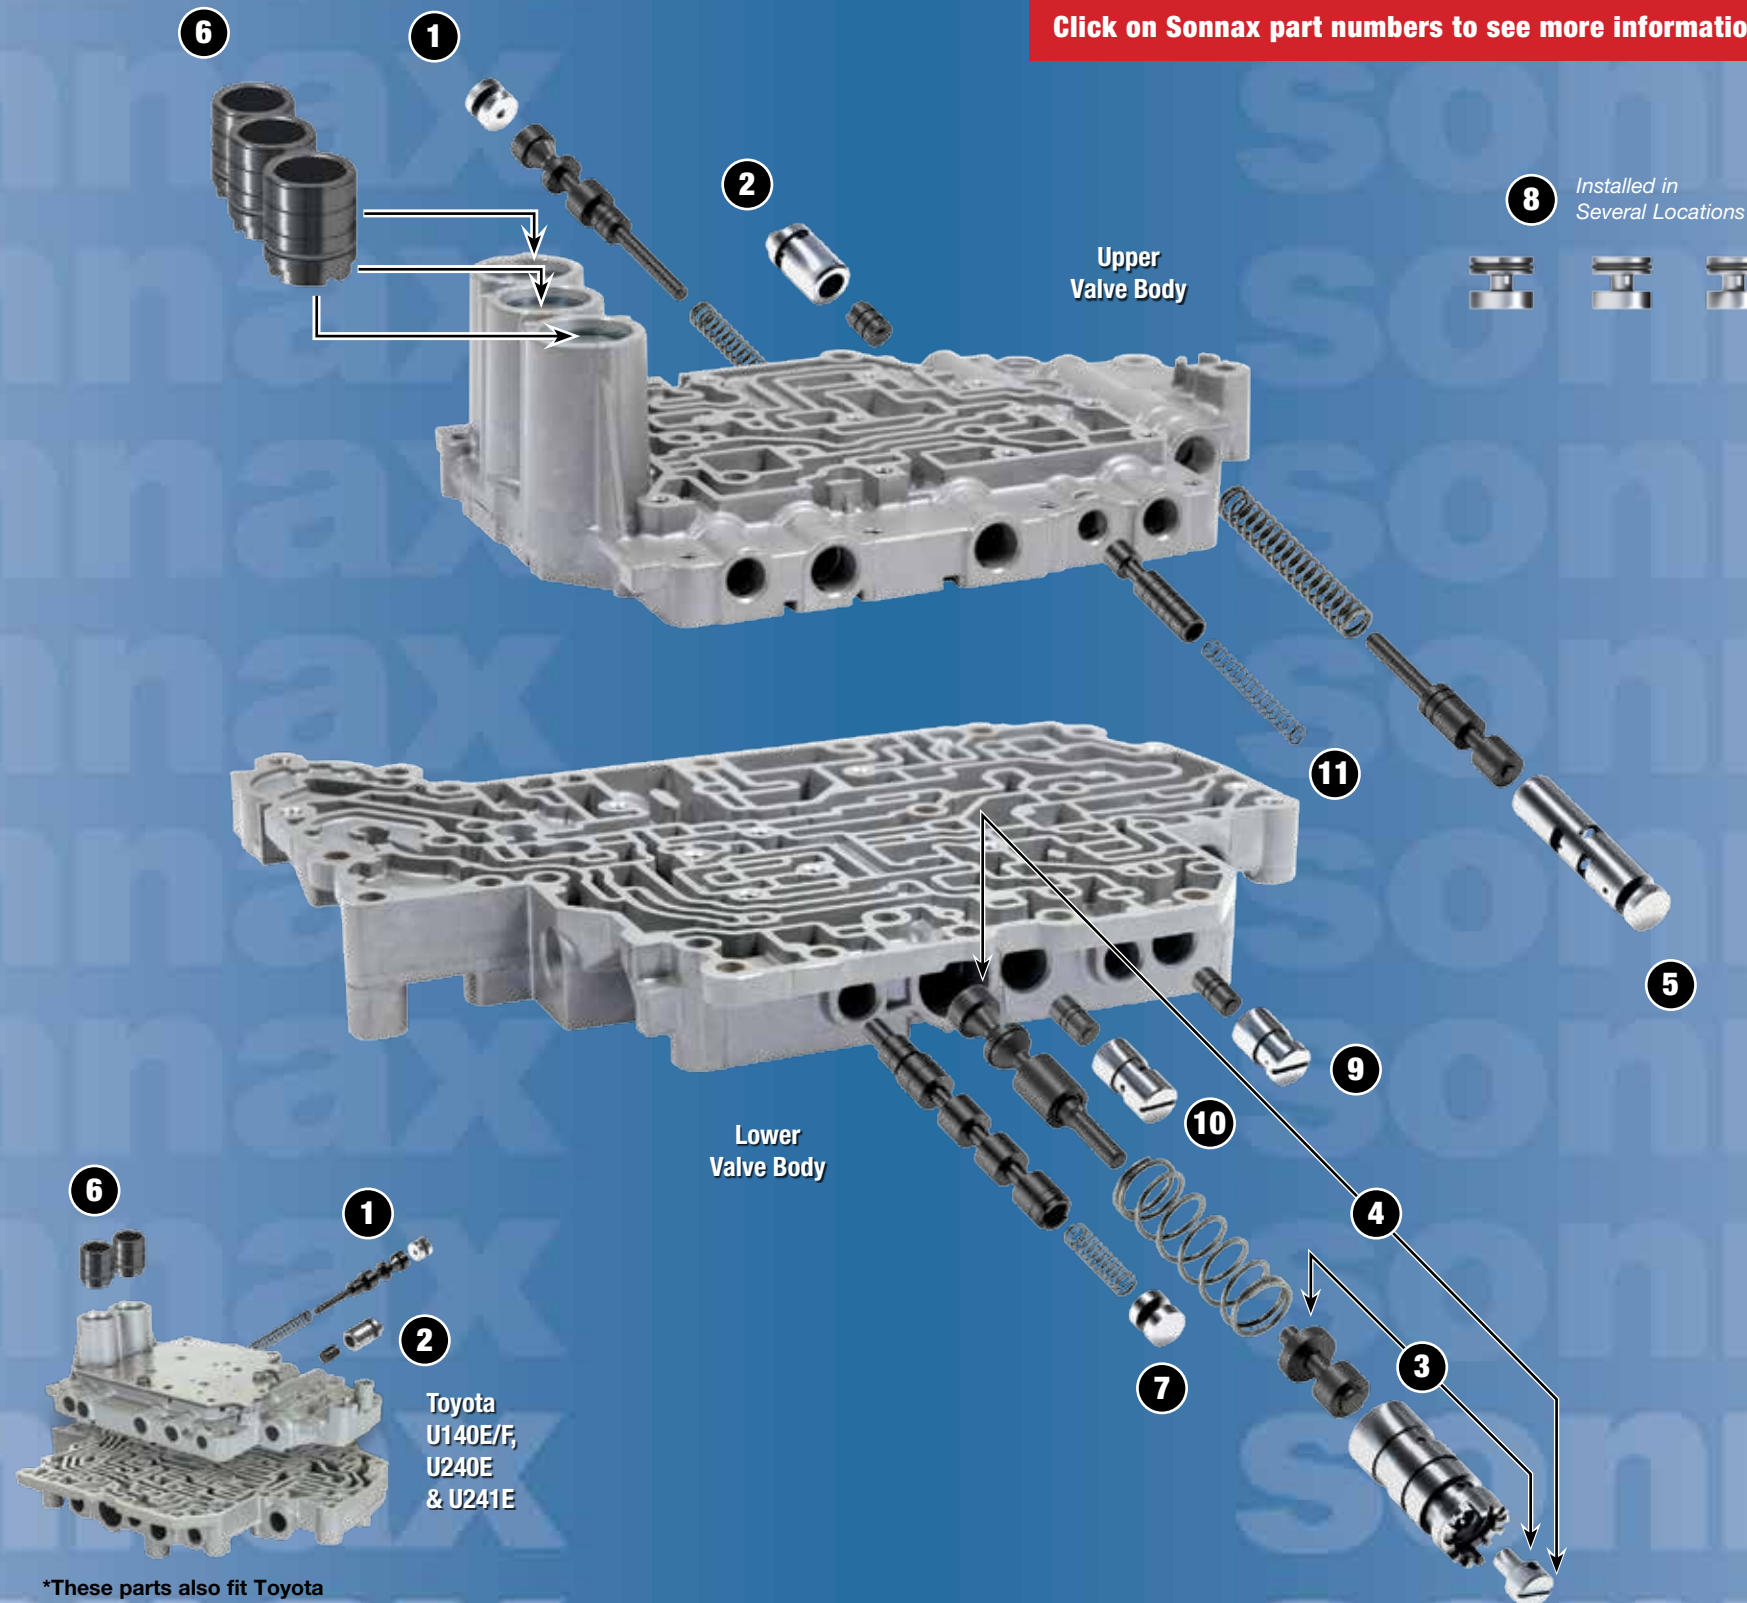
1 57917E-16K* Oversized Secondary Pressure Regulator Valve Kit

Helps cure:

- Harsh lockup
- Converter apply/release complaints

2 57917E-03K* Lockup Control Plunger Valve & Sleeve Kit

- TCC apply/release problems
- Converter codes

3 27741-01K Boost Valve Kit

- Insufficient line rise in drive ranges
- Soft shifts

4 27741-08K Oversized Pressure Regulator & Boost Valve Kit

- Low/High line pressure
- Soft and/or harsh shifts

5 27741-13K Oversized Solenoid Modulator Valve Kit

- Harsh/Flare upshifts
- TCC slip
- RPM cycling

6 57917E-19K* Accumulator Piston Kit

- Delayed engagements
- Slips/Flares in forward gears
- Burnt clutches

7 27741-18K Oversized Clutch Apply Control Valve Kit

- Shift flares/bind-ups
- Burned forward/C1 clutch
- Direct/C0 clutch
- 2nd/B1 brake

8 57917E-20K* O-Ringed End Plug Kit

- Inconsistent shift quality
- Slips, flares, bumps, bangs and/or codes
- Clutch failures

9 27741-06K B2 Apply Control Plunger Kit

- Burned B2 brake/clutch
- Delayed reverse

10 27741-04K B1 Apply Control Plunger Kit

- Burned B1 brake/clutch
- 2-3 or 4-3 bind-up

11 27741-16K Oversized B3 Orifice Control Valve Kit

- Burned UD/B3 brake
- Shift complaints
