RWANDA

Cyobe Community

10 Days 2014

WATER

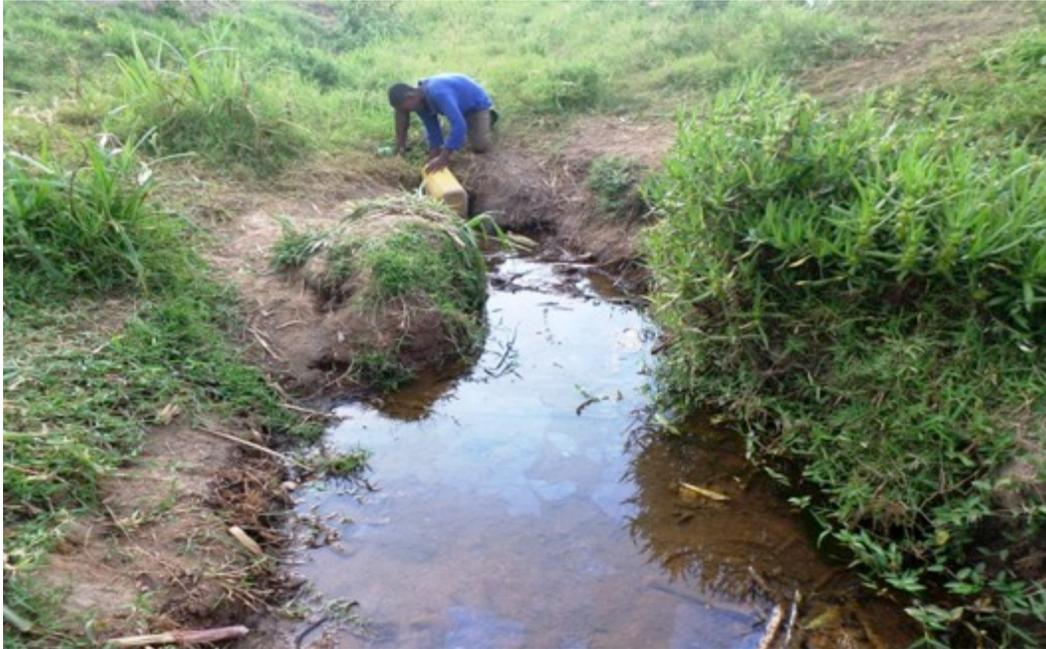
This previous water source was far and dirty and did not provide the community with the accessible, safe water they desperately needed.

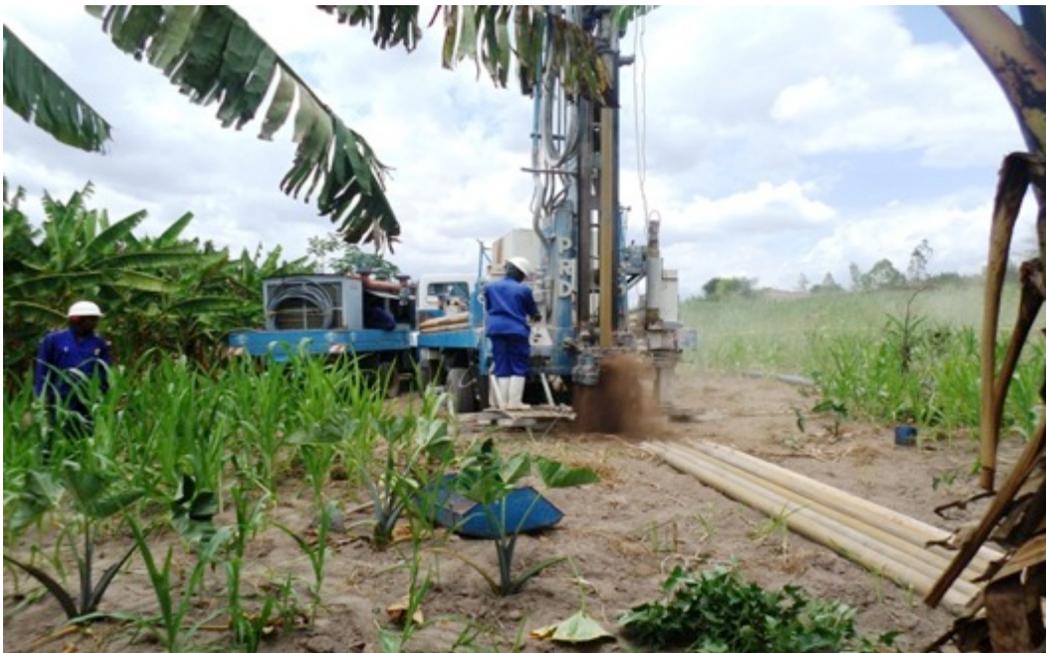
The Living Water field staff waste no time drilling to find safe water for the people of Cyobe using the funds generously given through the “10 Days – 2014” campaign.

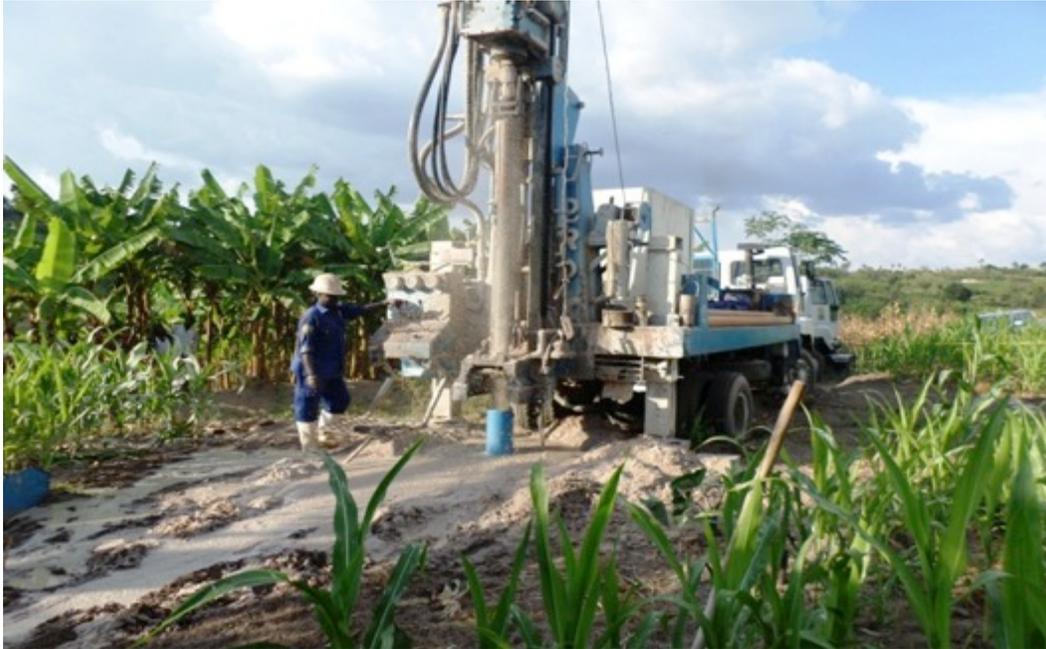
An aquifer was reached at 30 meters deep.

Altitude	1465 m
Total depth drilled	30 m

Static level		1.8 m
Total depth of casing		30 m
External Diameter of casing		125 mm
Casing material		PVC
Screen	Start: 17 m	Stop: 29 m
Pump Type		Afridev
Depth of cylinder		21 m
Gravel Pack		Yes
Gravel Pack Depth		15 m
Well yield		20 Liters/minute
Sanitary seal depth from surface		2 m
Shock Chlorination		Yes

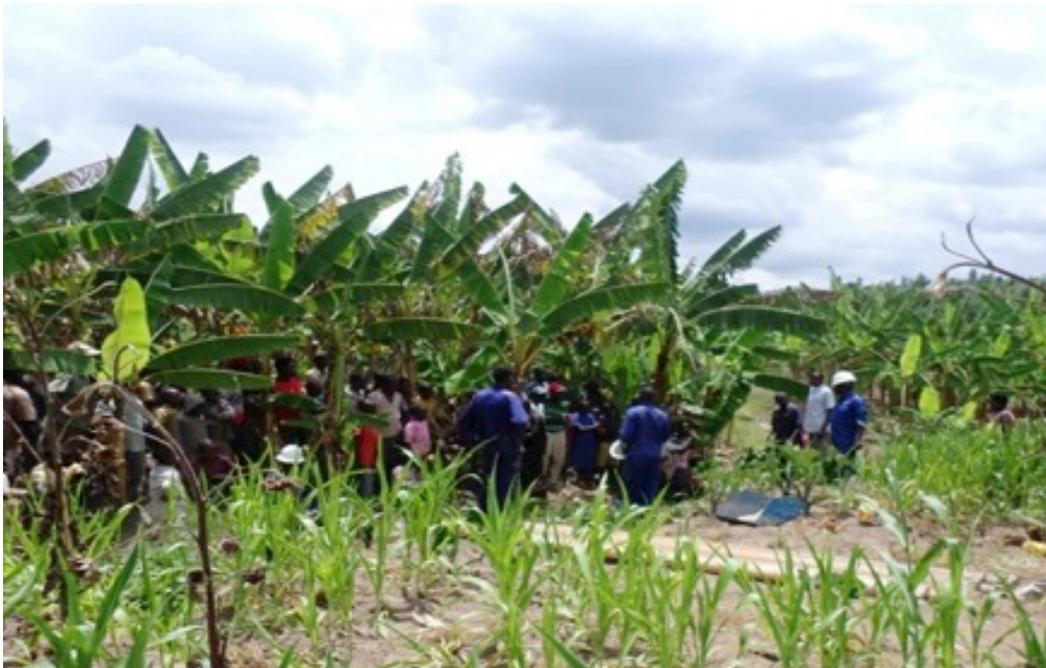
The Living Water team works together with the community to complete the new water point.

Platform is concrete with reinforcing steel		Yes
Dimension of Platform (H*W*L)		2*2*6
Drainage Channel or soak pit installed		Yes
Anything else constructed		Cattle trough

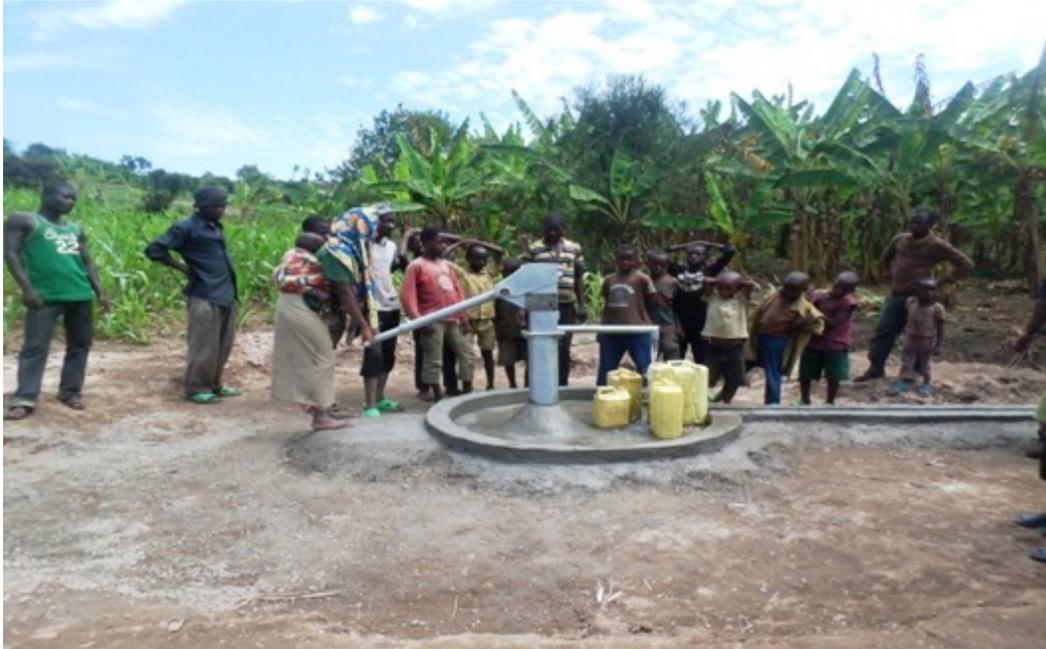
Community members gather to collect safe water from the new well.
