Repair Order Invoice

Unit 2015 BMW RNINET RNINET **Color:** BLACK **Keyboard:**
VIN/Serial No: WB10A1602FZ584171 **Plate:** **Odom/Hrs In:** 1,978 **Out:** 1,982

ANNUAL SERVICE

BMW MOTORRAD USA MULTI-POINT INSPECTION REPORT

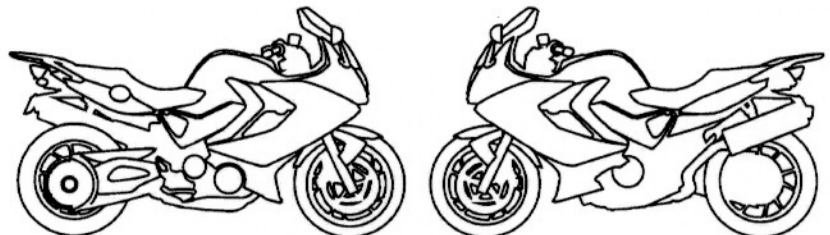
25. Body, paint, trim and windscreen (use diagram below)	<input checked="" type="checkbox"/>	No body damage

Show damage locations at right with codes:

* Stone Damage o Dents Δ Scratches ✓ Body Damage
