NATIONAL REGISTER OF HISTORIC PLACES  
REGISTRATION FORM

historic name: Matanuska Colony Community Center

other name/site number: Palmer Historic District, AHRs Site No. ANC-750

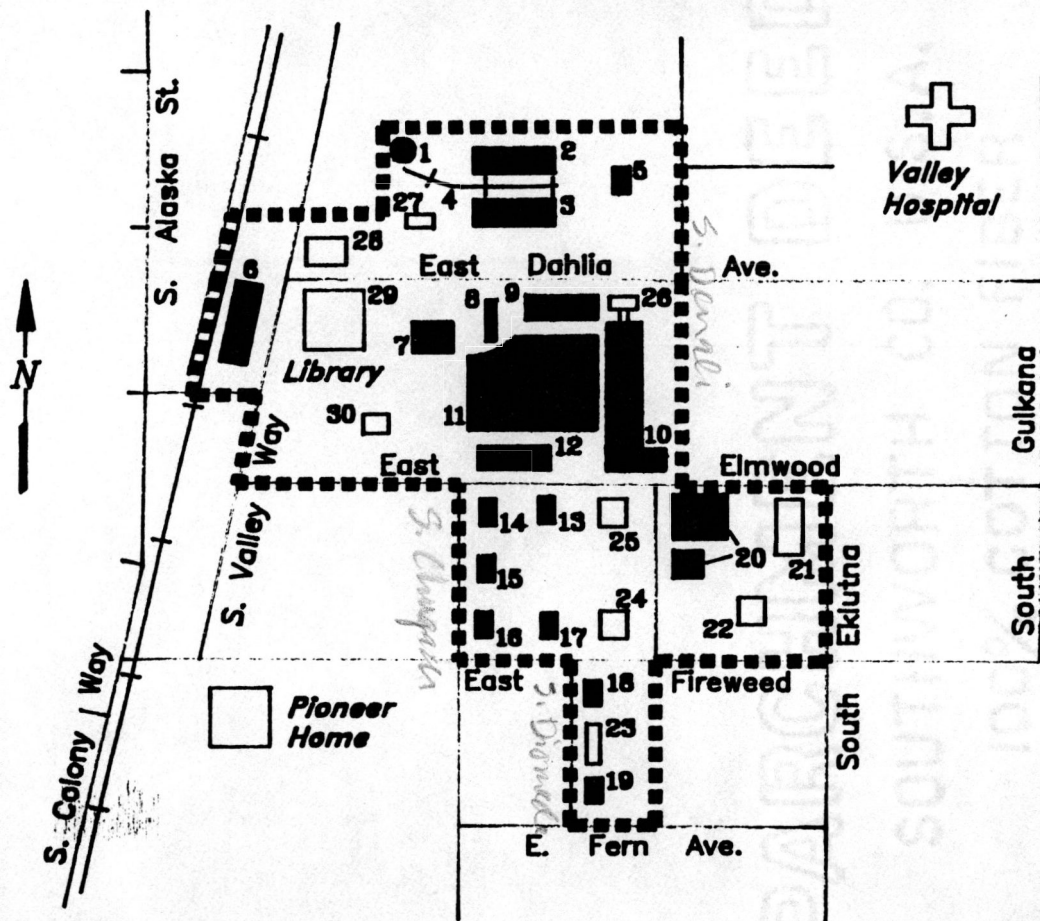
CULTURAL RESOURCES

1. Water Tower
2. Warehouse
3. Cannery/Creamery
4. Alaska Railroad Siding
5. Chicken Hatchery
6. Palmer Depot
7. AERC Administration Office
8. Beauty/Barber/Cobbler Shops
9. Trading Post
10. Central School
11. Matanuska Colony Quadrangle Site
12. Dormitory
13. Superintendent's House
14. Manager's House
15. Accountant's House
16. Staff House #1
17. Staff House #2
18. Staff House #3
19. Staff House #4
20. United Protestant Church & Parsonage
21. St. John Lutheran Church
22. St. Michael's Catholic Church
23. Staff House #5
24. Residence
25. Staff House #6
26. Central School Gymnasium
27. Power House
28. Self-storage Complex
29. Palmer Library
30. Matanuska Colony Memorial
