### NATIONAL REGISTER OF HISTORIC PLACES REGISTRATION FORM

historic name Johnston, Asa, Farmhouse  
other names/site number \_\_\_\_\_

7. Narrative Description

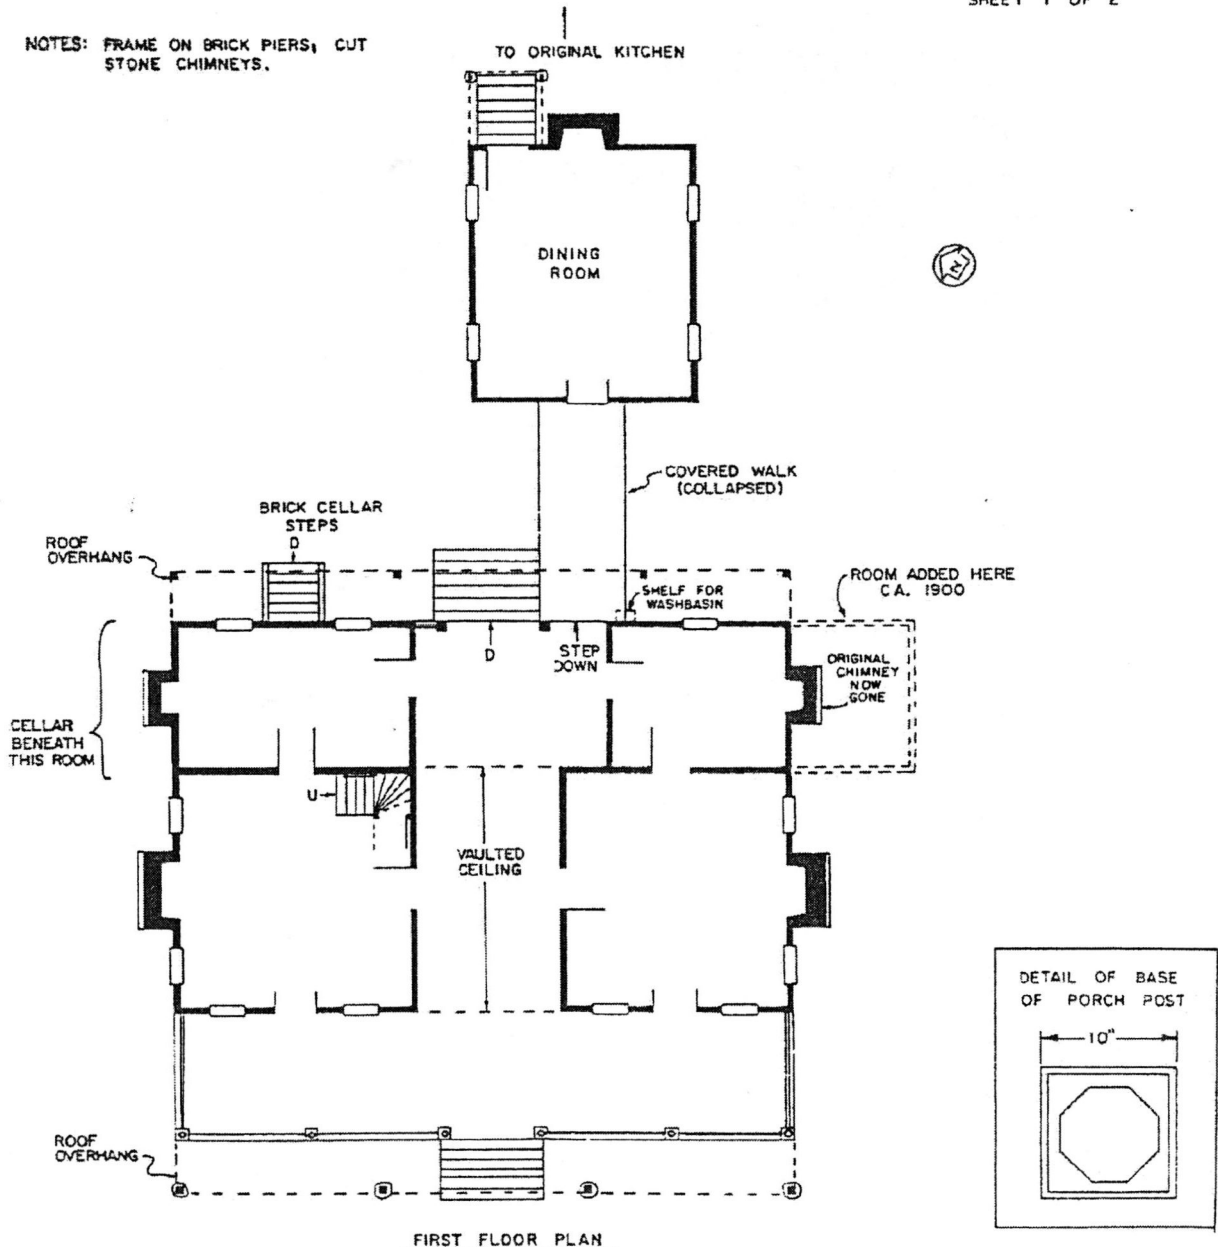
FIRST FLOOR PLAN

NOTES: FRAME ON BRICK PIERS; CUT  
STONE CHIMNEYS.

The floor plan consists of a core of two principal rooms at the first floor separated by the central open dogtrot, with two secondary rooms to the rear. A narrow enclosed stair at the southwest corner of the principal northwest room rises to a finished attic. The attic is divided into two rooms. Interior walls and ceilings are typically paneled with flush tongue and

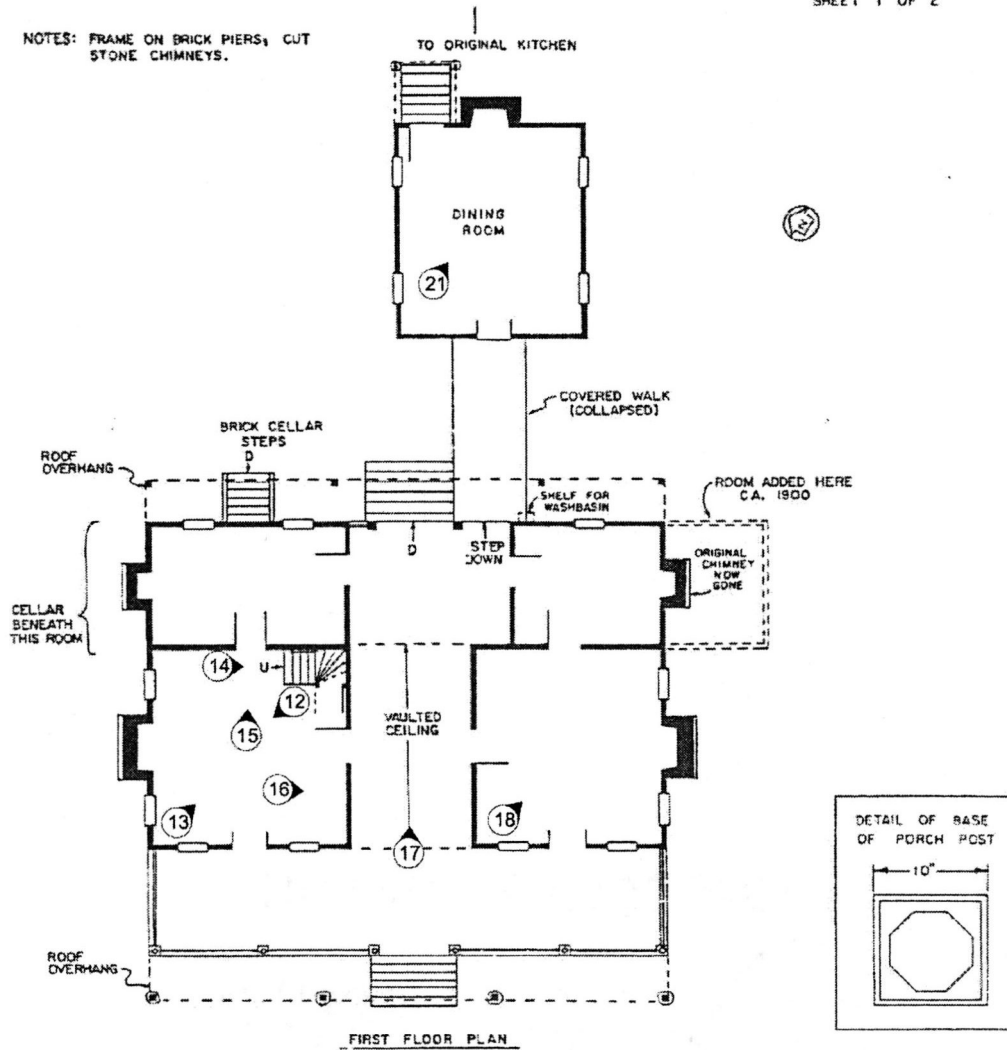
FIRST FLOOR PLAN

Floorplans, Photo Locations Indicated

NOTES: FRAME ON BRICK PIERS; CUT  
STONE CHIMNEYS.

Common to third generation dogtrot houses in Alabama, the Johnston house is of frame construction and has an open central dogtrot flanked by single principal rooms with secondary rooms to the rear. The third generation dogtrot house Alabama represents the final stage in the evolution of the simple folk dogtrot form. The spraddle roof variation consists of a broken or double-pitched gable with the break typically occurring at the intersection of a central core and flanking front and rear shed extensions or porches. According to information contained in the 1992-1993 historic sites survey of Conecuh County, the Johnston House is the most intact and elaborately detailed example of a spraddle roof dogtrot house in the county.

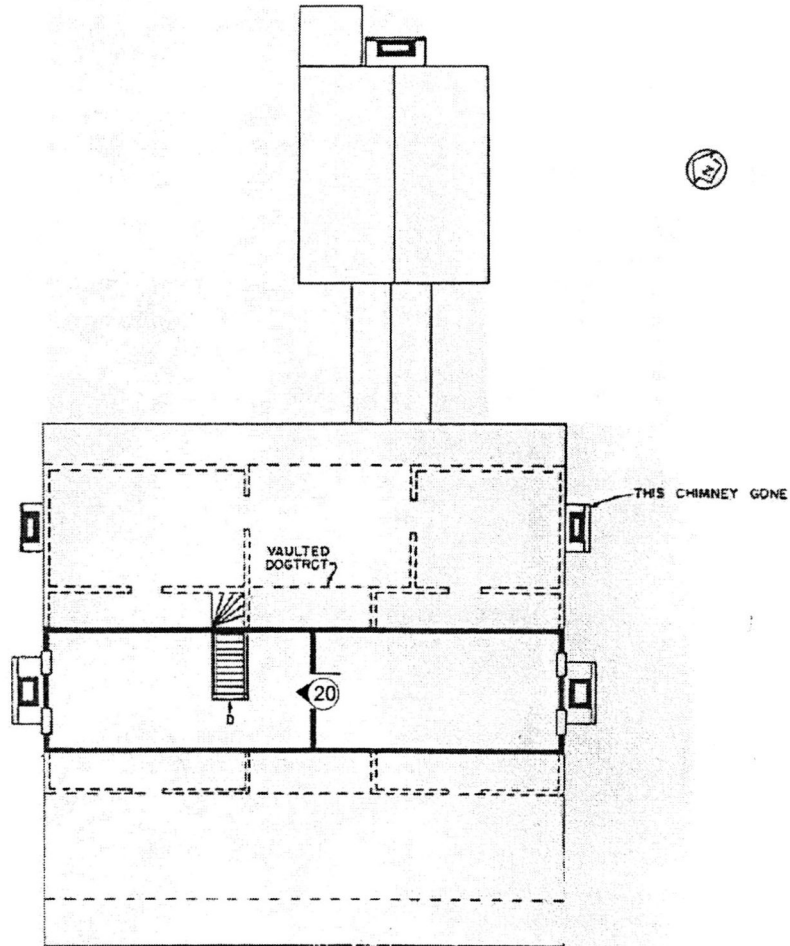
SECOND FLOOR PLAN

Floorplans, Photo Locations Indicated

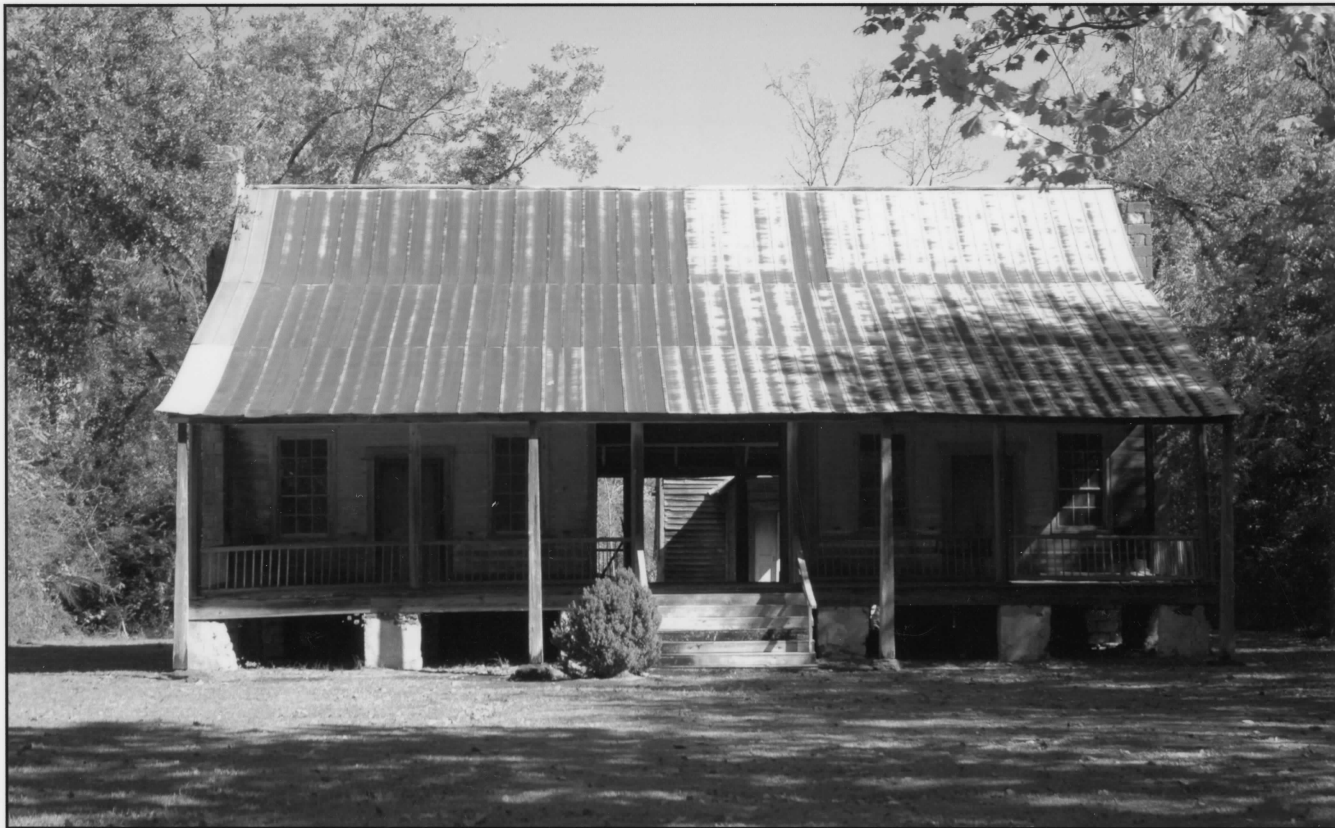
6. Farmhouse, west facade, camera facing east
7. Photo #01

The principal west elevation is visually divided into seven bays with the center bay an open dogtrot. The three western bays include a central entrance with double leaf doors flanked by single nine-over-six double hung sash windows. The three eastern bays are similar. Windows and doors have molded wood surrounds. Flush board siding is terminated by simple corner boards and is fastened by regularly spaced cut nails. The dogtrot opening is framed by simple boxed pilasters that support a boxed cornice with a decorative shaped fascia board. A Carolina porch, with its deck recessed beneath the extended roofline of the house, extends the full width of the house. Four tapered octagonal posts support the overhanging roof at its eave line. Six similar posts extend along the front edge of the deck of the porch and are connected by simple picket railings.

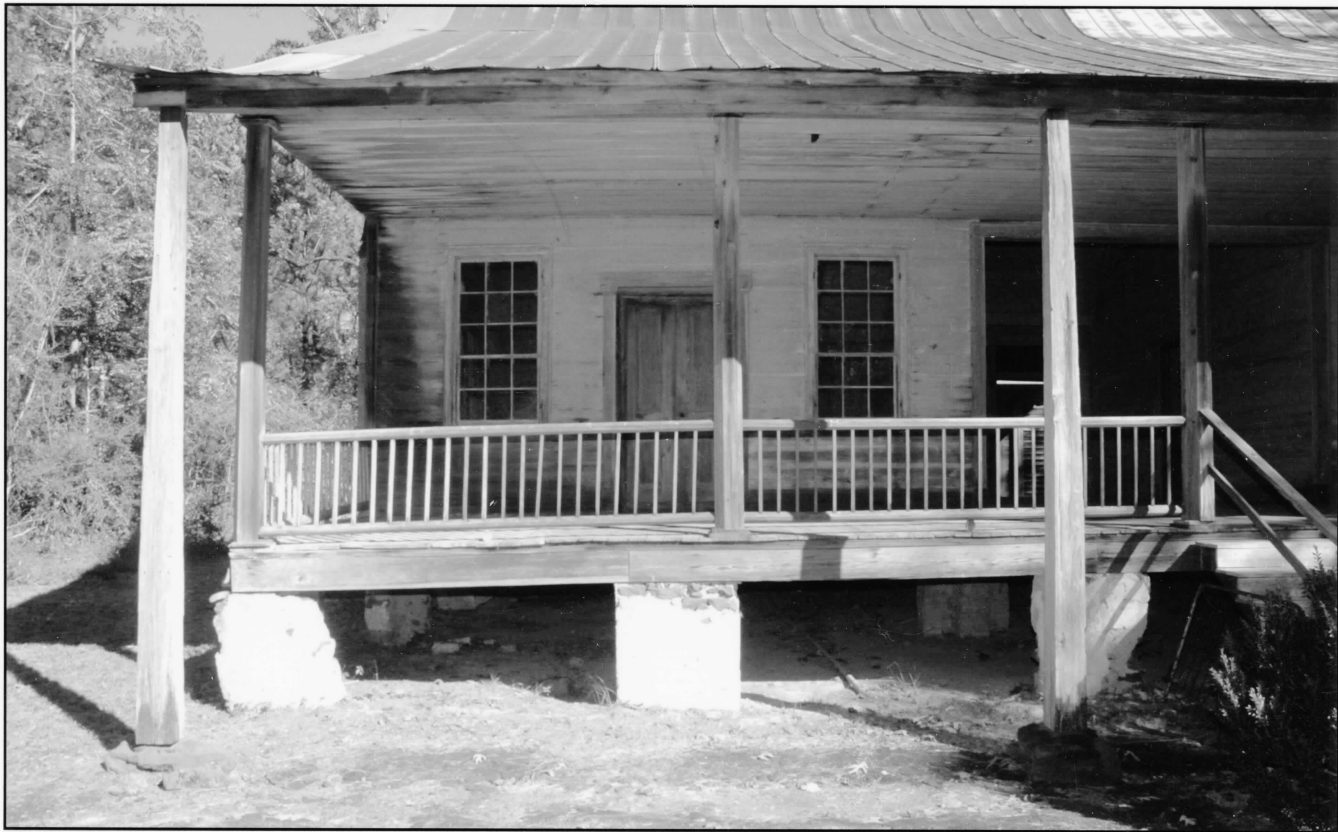
6. Farmhouse, detail of west facade, camera facing east
7. Photo #02

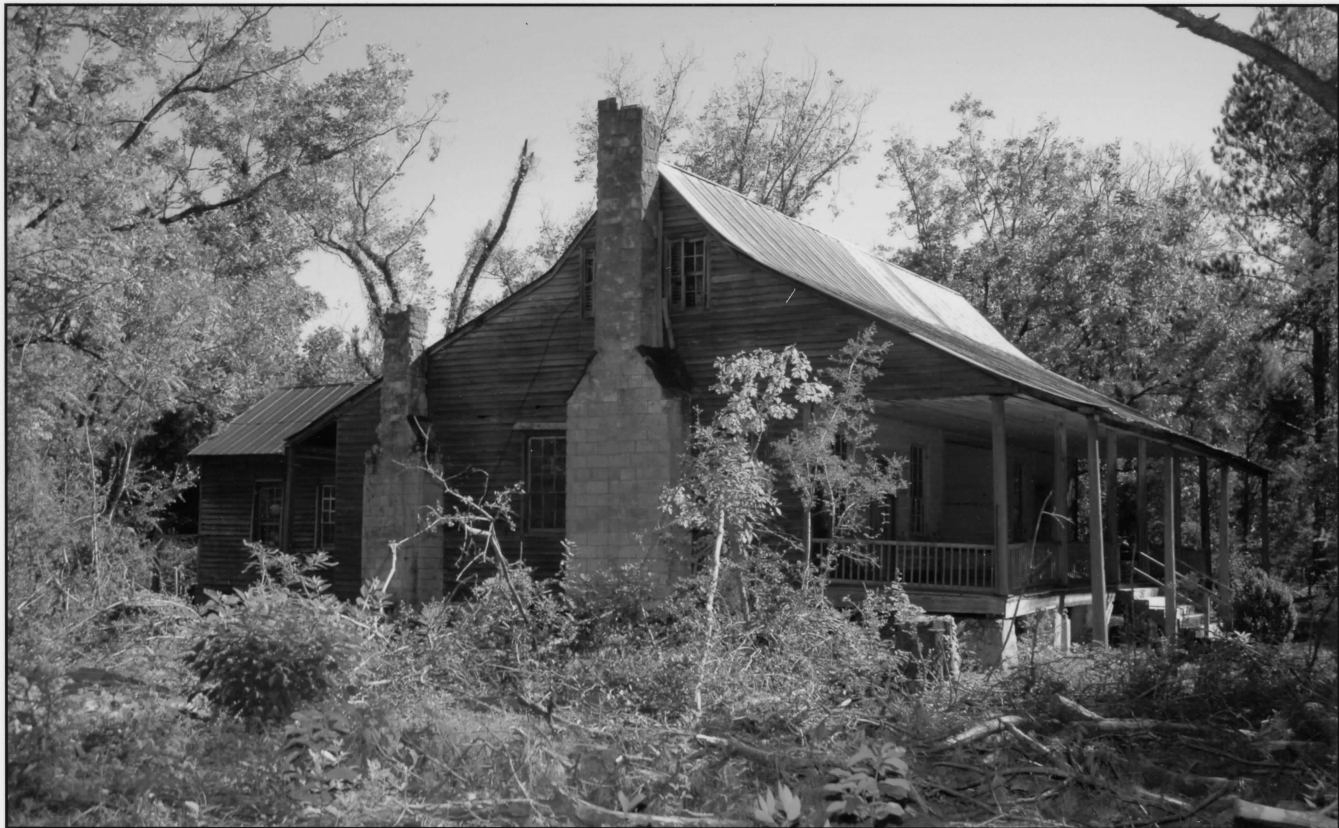
6. Farmhouse, west facade (right) & north elevation (left), camera facing southeast
  7. Photo #03
- Image: AL\_ConecuhCo\_JohnstonFarmhouse\_03.tif
- Print: Epson Ultrachrome Ink on Premium Glossy Photo Paper

The north elevation is clad with wood weatherboard siding and has plain corner boards. A simple plain frieze board extends along the roofline. A large stone chimney rises between the two western bays with a smaller chimney to the east. Wooden nine-over-six double hung sash windows flank the west chimney. Each window has a molded surround and slightly projecting sill. The south elevation is similar with the exception that a modern window corresponds to the east chimney. Structural evidence indicates that a chimney historically existed at this location prior to the construction of a small addition (circa 1900). The addition was removed circa 1995, the siding patched, and the present window installed. The roofline extends slightly beyond the rear (east) elevation and is supported by four octagonal tapered wood posts that are similar to those at the façade. The central dogtrot widens slightly to the south and is flanked to the north by two nine-over-six windows and to the south by a single nine-over-six window. A modern covered walk extends from the south end of the widened rear section of the dogtrot to the center of the dining room building to the east. An exterior stair at the rear of the house leads to a brick basement room under the northeast corner of the house.

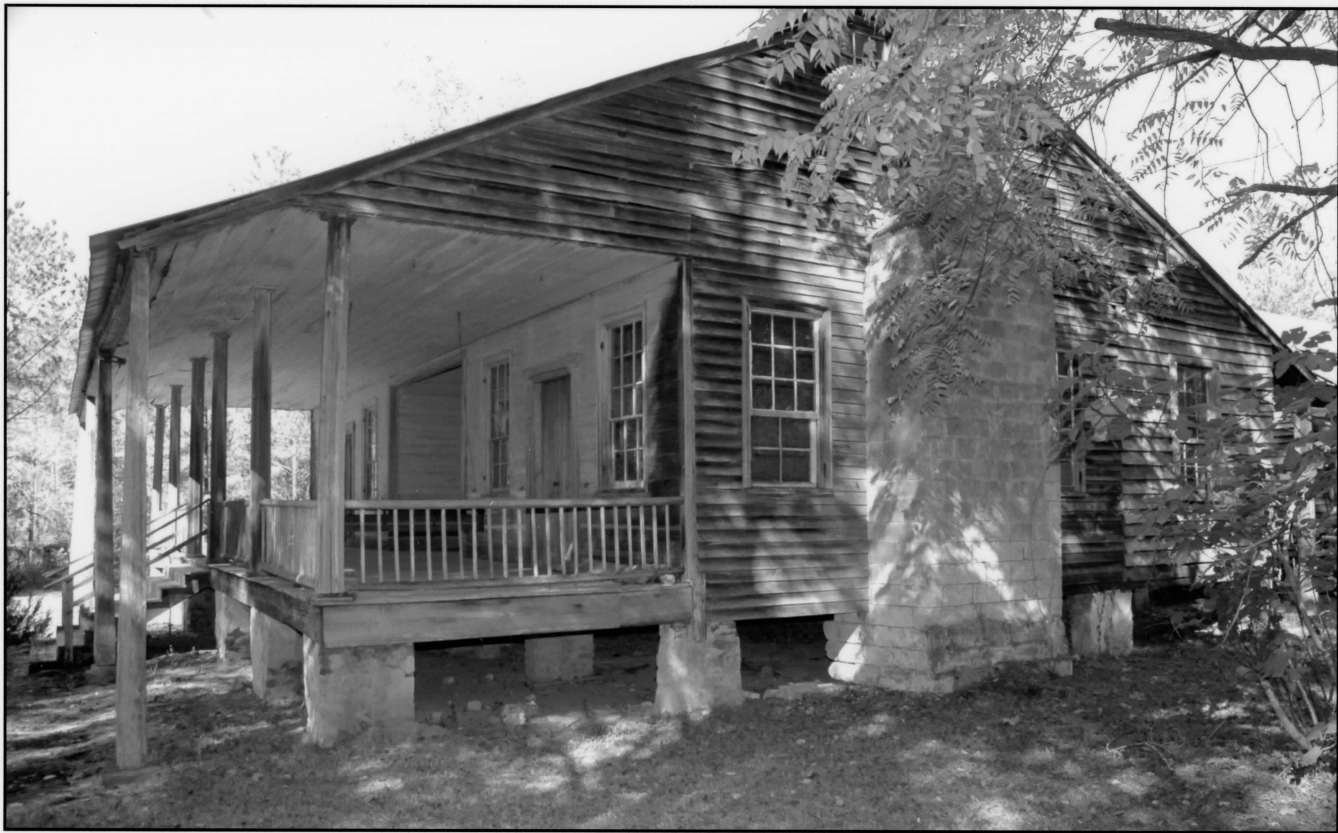
6. Farmhouse, west facade (left) & south elevation (right), camera facing northeast
  7. Photo #04
- Image: AL\_ConecuhCo\_JohnstonFarmhouse\_04.tif

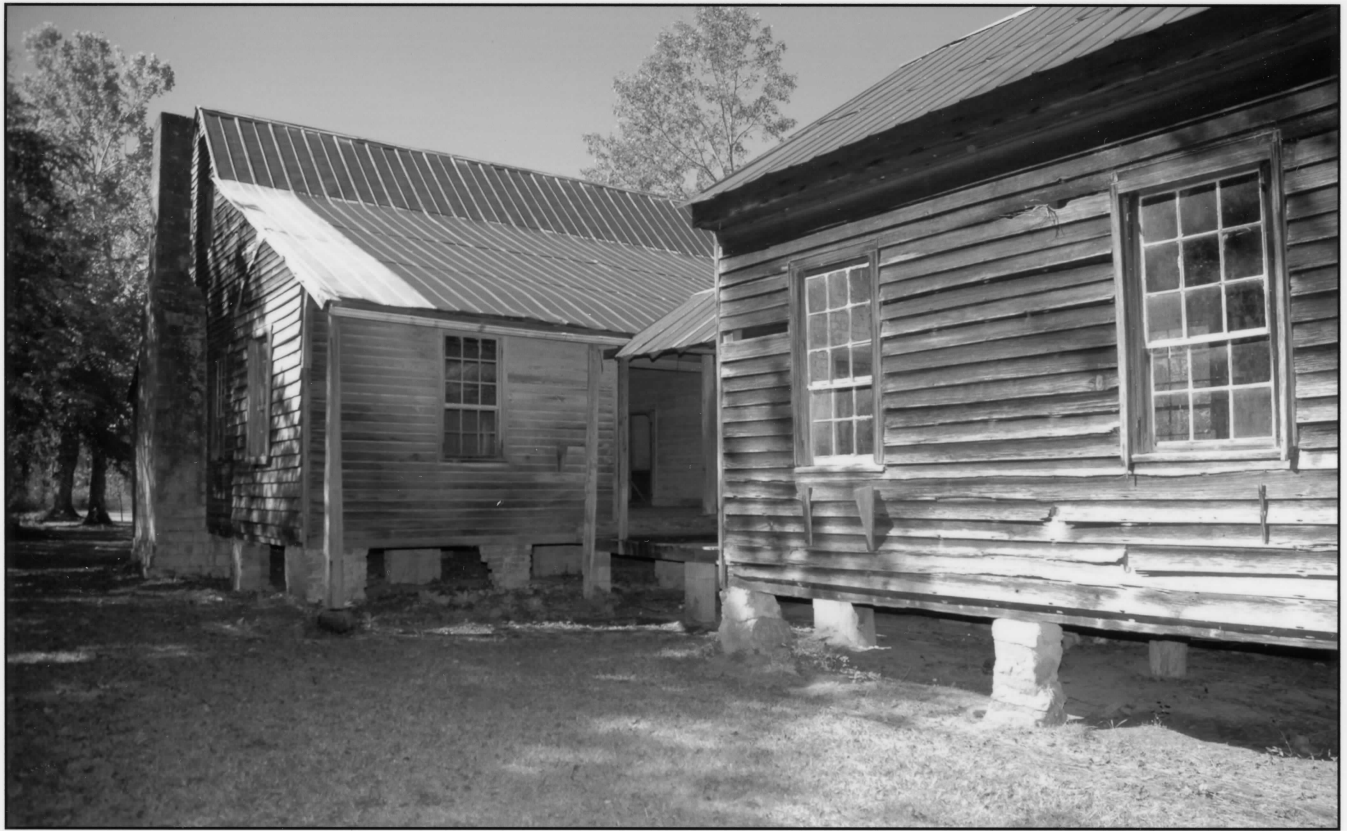
6. Farmhouse and kitchen, south (left) and east (right) elevations, camera facing northwest
  7. Photo #05
- Image: AL\_ConecuhCo\_JohnstonFarmhouse\_05.tif

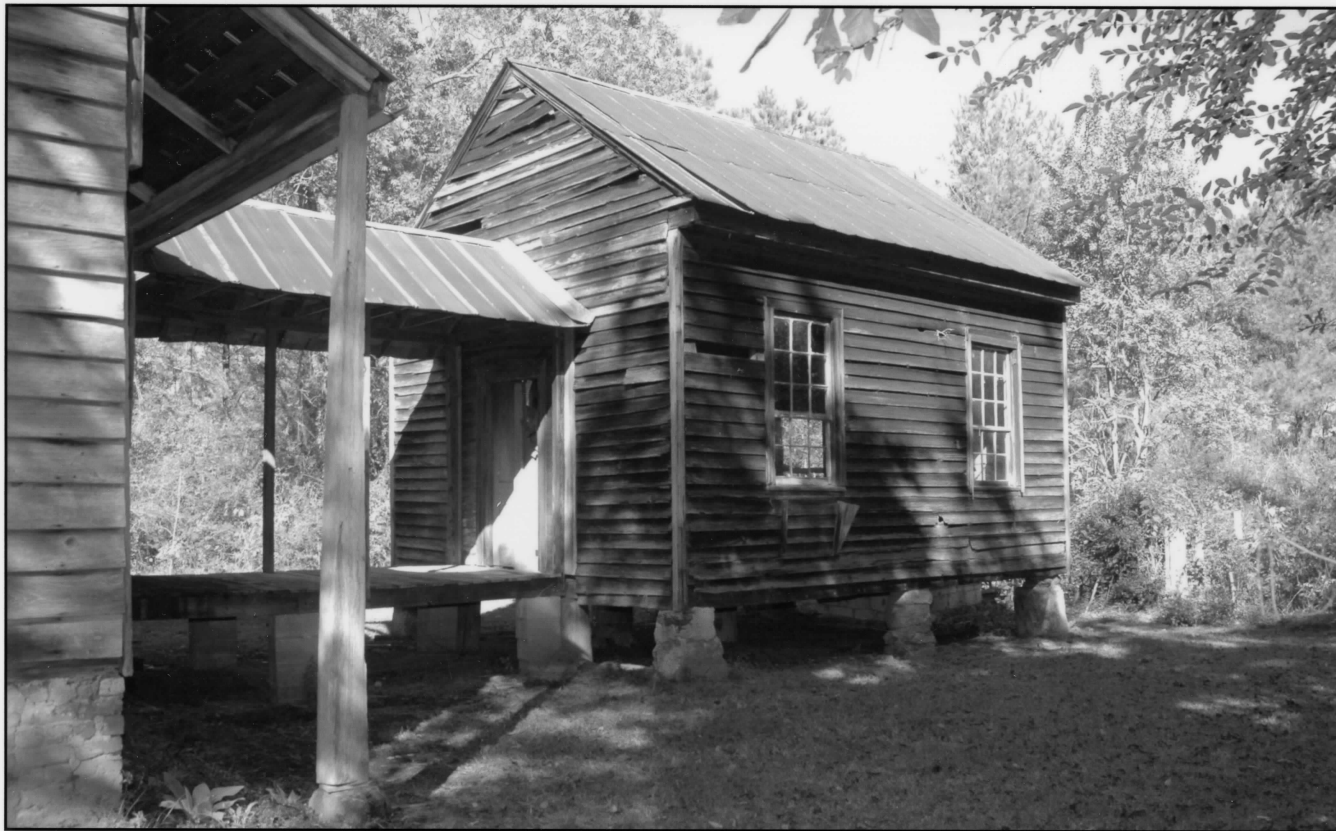
6. Kitchen, west (left) and south (right) elevations, camera facing northeast
  7. Photo #06
- Image: AL\_ConecuhCo\_JohnstonFarmhouse\_06.tif

The dining room is a rectangular one-story frame building oriented perpendicular to the rear of the main house with a front-facing gable V-crimped metal roof. The building is one bay wide and two bays deep. It is attached to the dogtrot of the main house by a simple modern (rebuilt) covered walkway that accesses a centrally placed entrance with double leaf doors at the west elevation of the dining room. The north and south elevations each have two regularly spaced nine-over-six double hung sash windows. An exterior stone chimney with a now collapsed brick cap is centered at the east elevation and is flanked to the north by a single entrance with a simple shed stoop. All elevations are clad with wood weatherboard siding and the building is supported on brick piers.

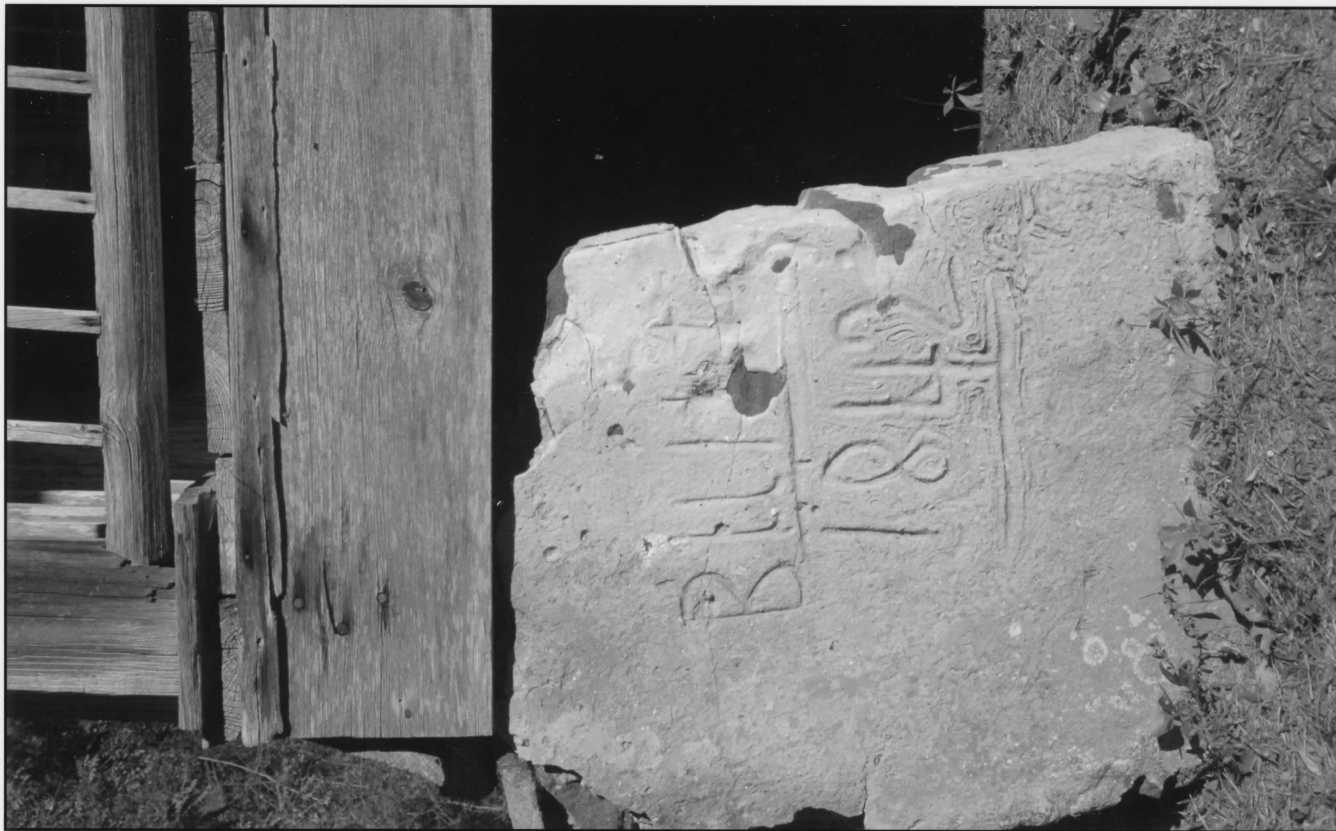
6. Farmhouse, west elevation, detail of foundation pier, camera facing west
  7. Photo #08
- Image: AL\_ConecuhCo\_JohnstonFarmhouse\_08.tif

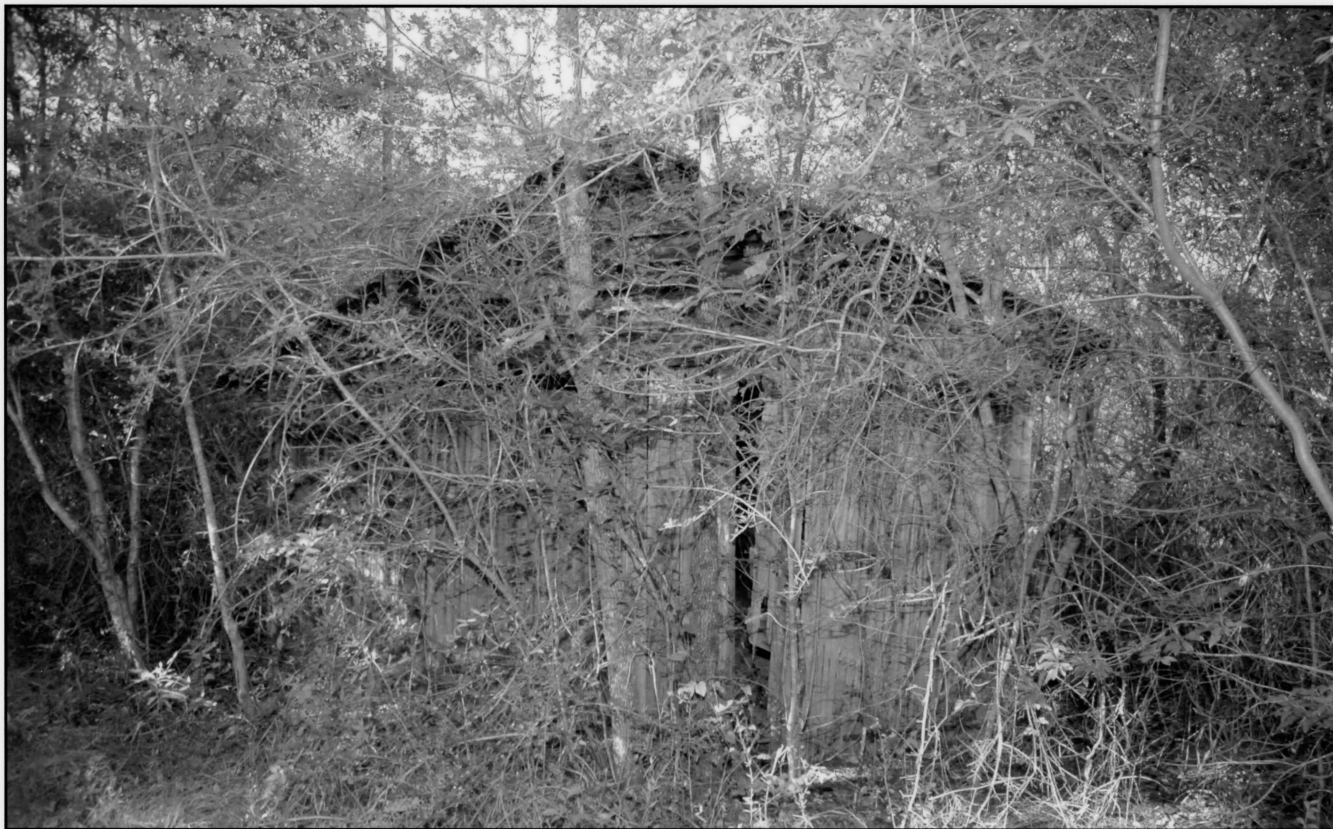
6. Site, garage, south elevation, camera facing north
7. Photo #10

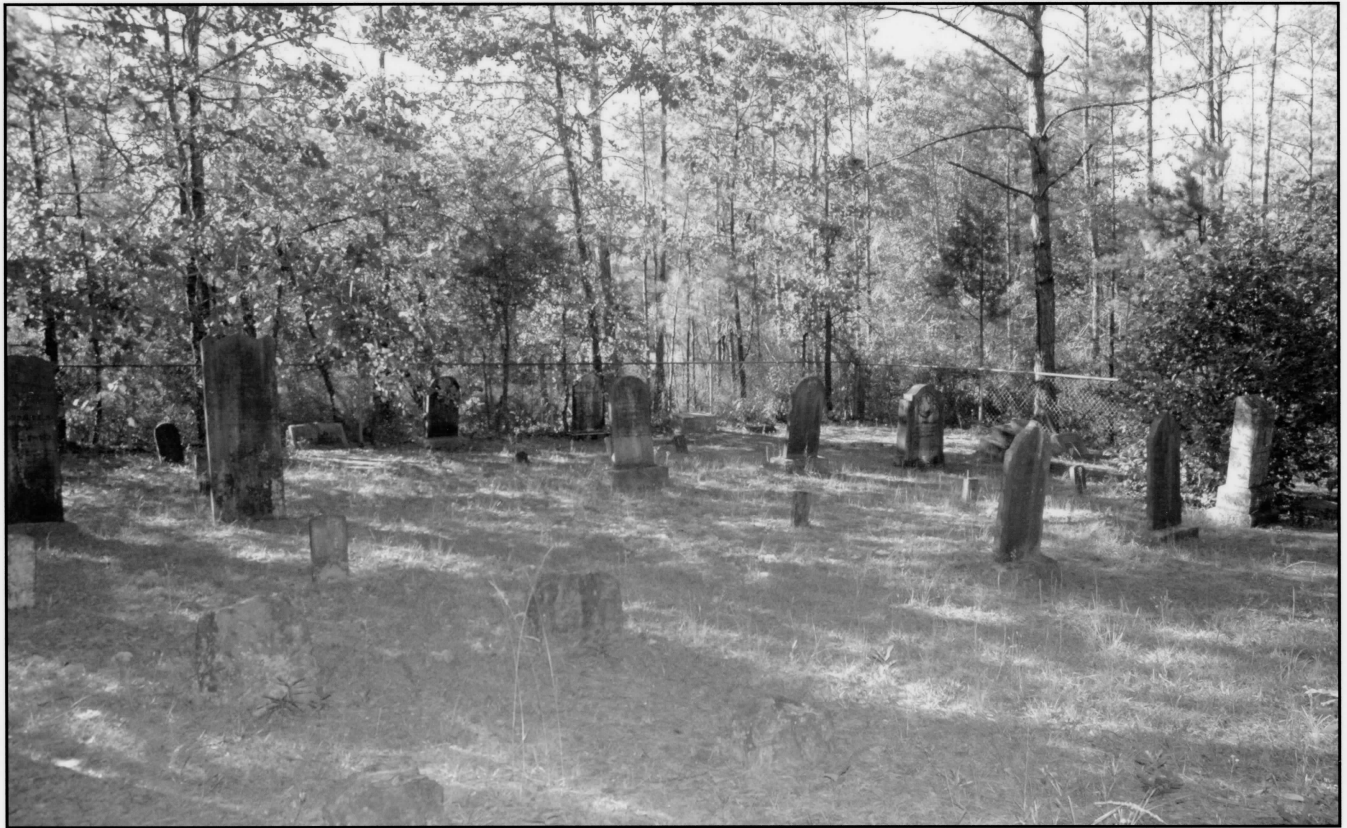
6. Site, cemetery, camera facing north

The cemetery is a flat rectangular plot surrounded by a chain-link fence that is generally well maintained. Twenty stone grave markers remain and at least four unmarked graves are visible. Markers typically include limestone headstones and some footstones. Recorded burials include: Thomas H. Barrow (1842-1880), Ada Garvin (1892-1974), Evelyn Garvin (1858-1927), Henderson Garvin (1888-1964), Allen Johnston (1866-1937), Almira Johnston (1844-1863), Asa Johnston (1798-1890), Asa Johnston, Jr. (1829-1889), Eliza Johnston (1800-1854), Mattie Johnston (1877-1901), Morgan Johnston (1871-1873), Nancy G. Johnston (1897-1902), Nellie M. Johnston (1874-1939), Pearl Johnston (d. 1957), Robert H. Johnston (1849-1897), Sallie A. Johnston (1848-1918) Susan Johnston (b. 1837), McCall (1859-1928), Autry McCall (1858-1950), and James E. McCall (1862-1886).

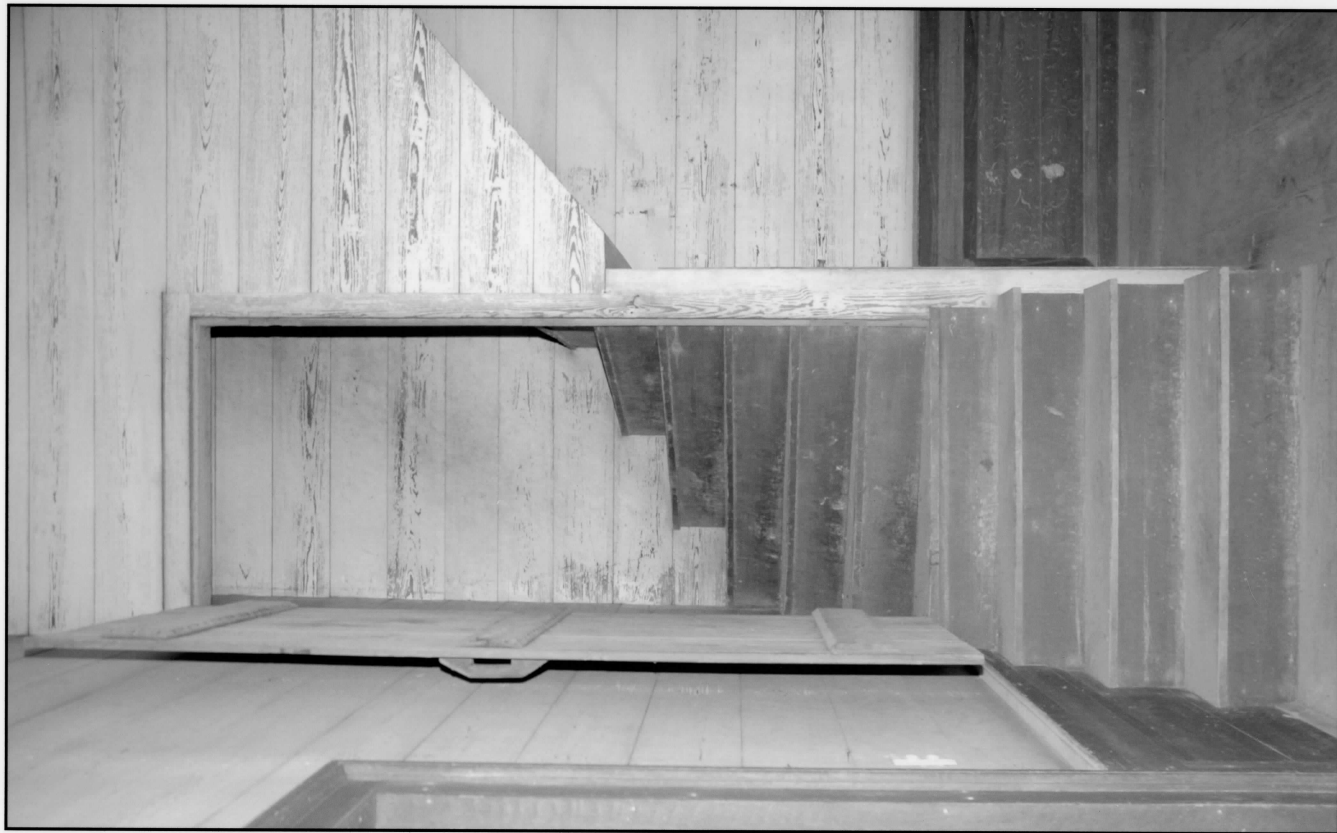
6. Farmhouse, interior, northwest parlor, detail of staircase, camera facing south
7. Photo #14

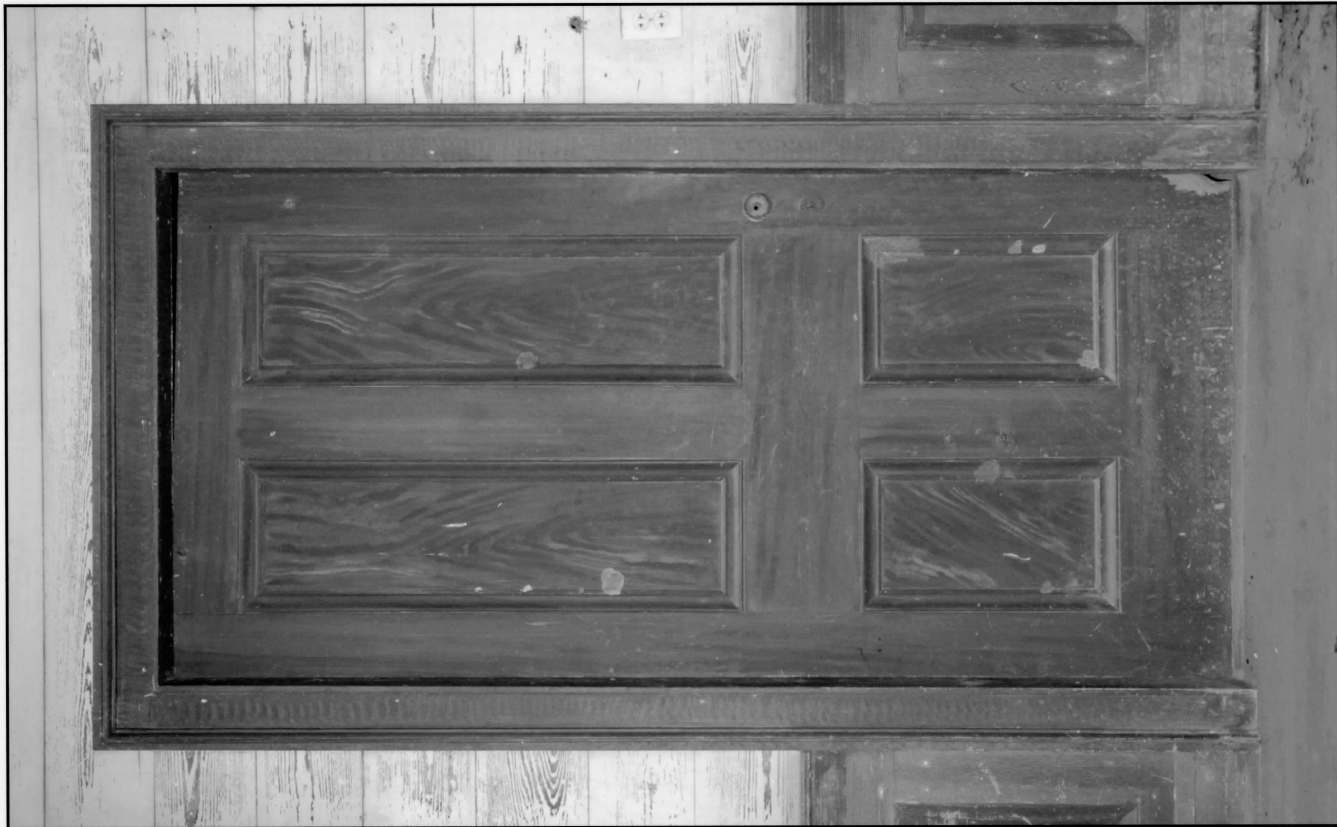
6. Farmhouse, interior, northwest parlor, detail of door, camera facing east

groove board planks. Door and window openings are framed by molded surrounds and doors are typically of a four-panel design. The principal rooms retain molded wood wainscoting and baseboards. Woodwork in the two principal rooms retain historic faux painted finishes. Fireplaces in both rooms of the core have wooden mantelpieces of simple vernacular style consistent with the Greek Revival period. Flooring is typically wood planking of a consistent width. The rear rooms have similar ceiling, wall, and floor finishes but do not have wainscoting or decorative grained finishes. No modern kitchen or bathroom facilities have been added to the house. The dogtrot retains a distinctive vaulted wood ceiling that is the only documented example of its type extant in Alabama.

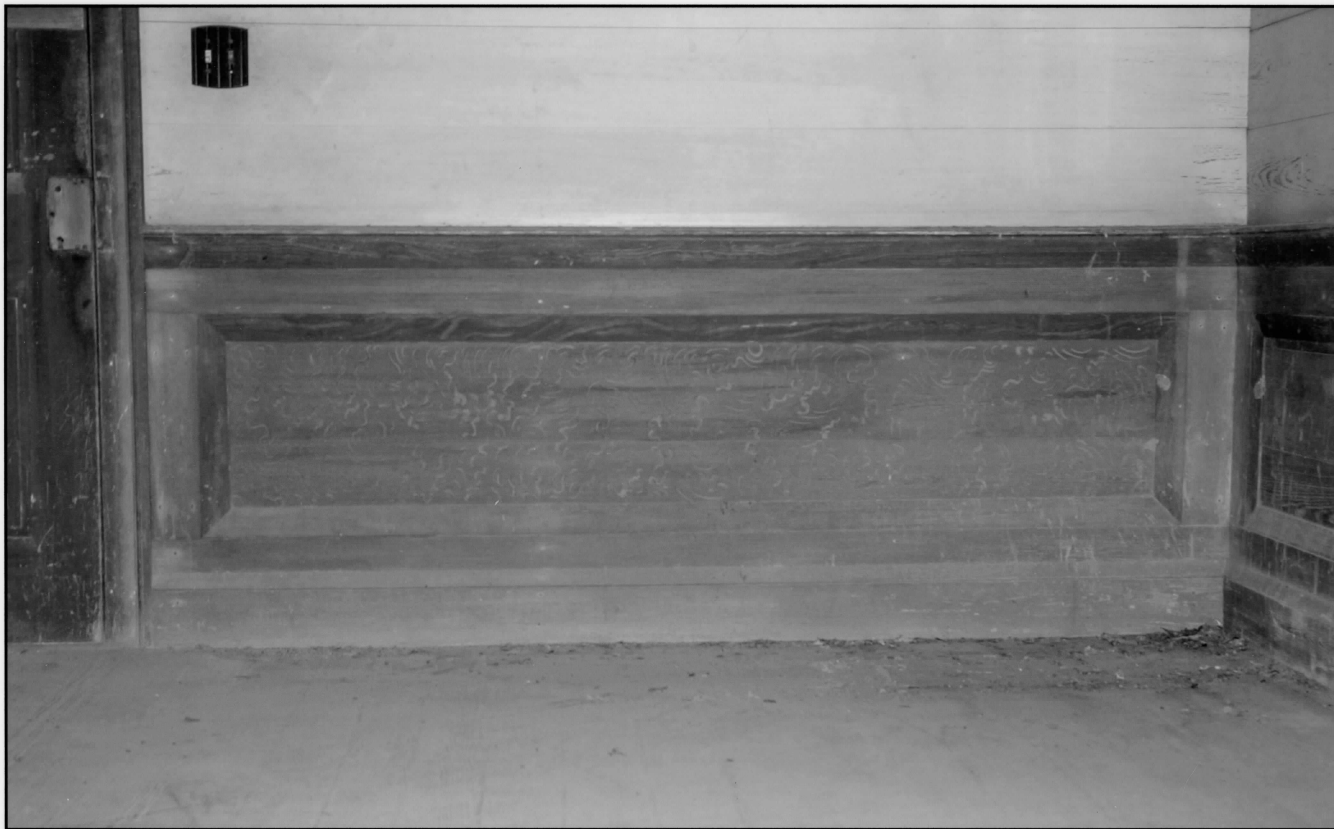
6. Farmhouse, interior, northwest parlor, detail of wainscoting, camera facing south
  7. Photo #16
- Image: AL\_ConecuhCo\_JohnstonFarmhouse\_16.tif

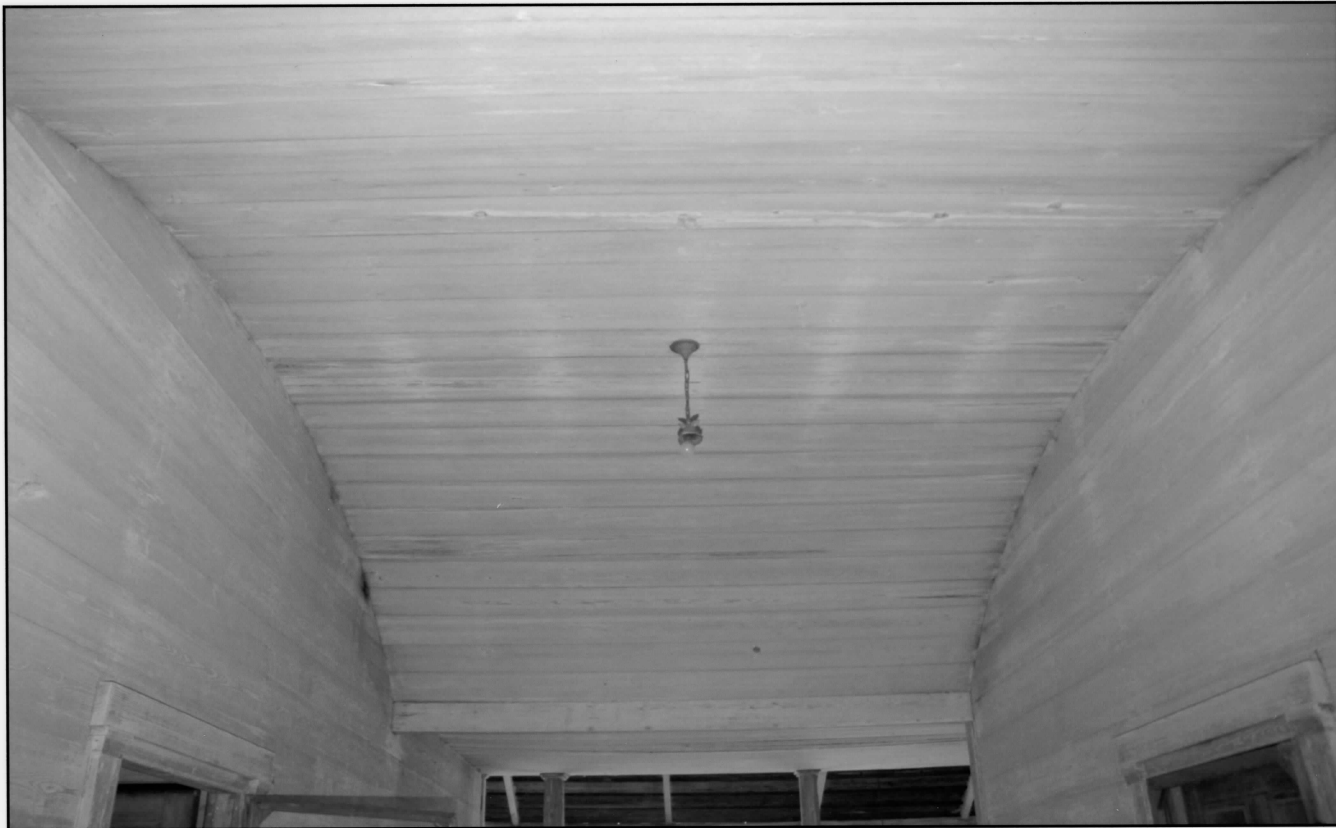
6. Farmhouse, dogtrot, detail of ceiling, camera facing east
7. Photo #17

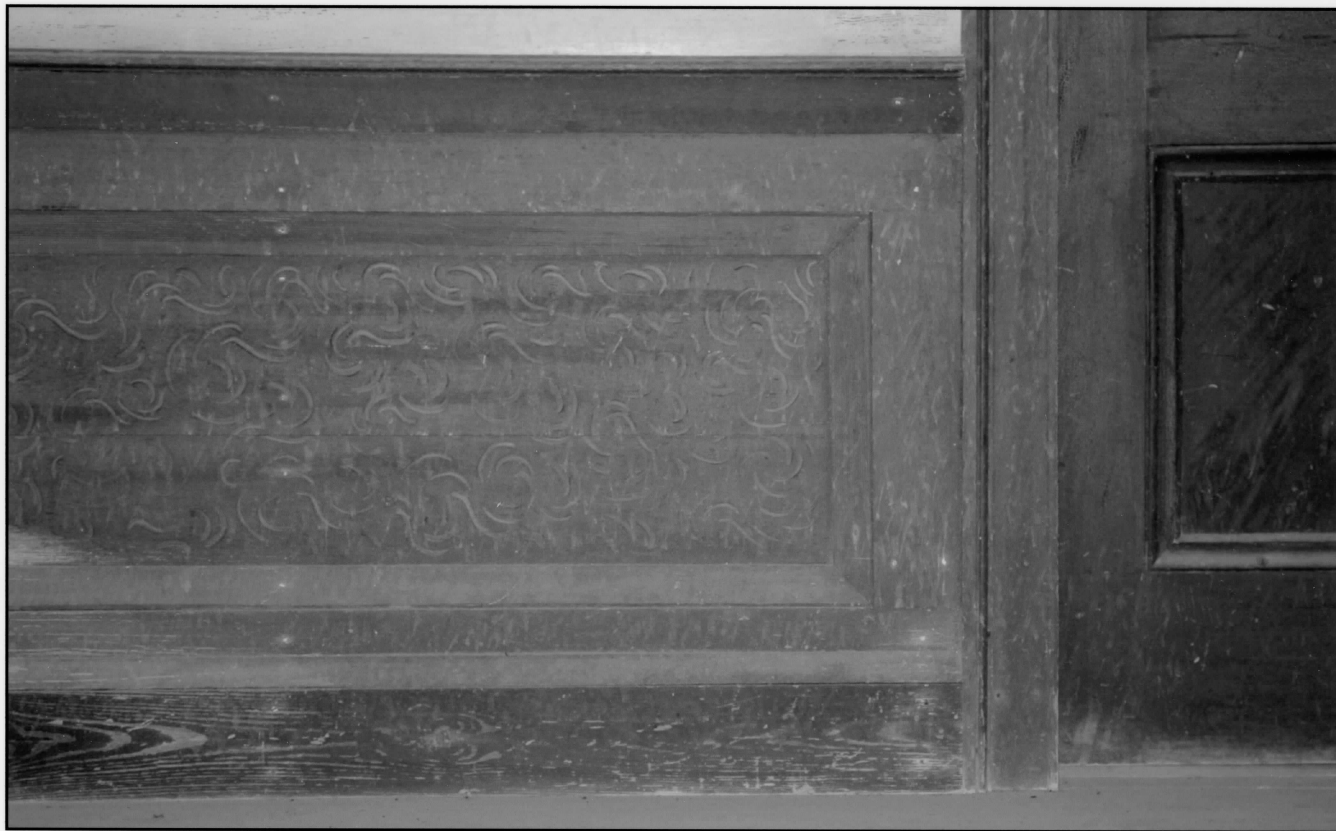
6. Farmhouse, interior, southwest parlor, detail of wainscoting, camera facing east
7. Photo #19

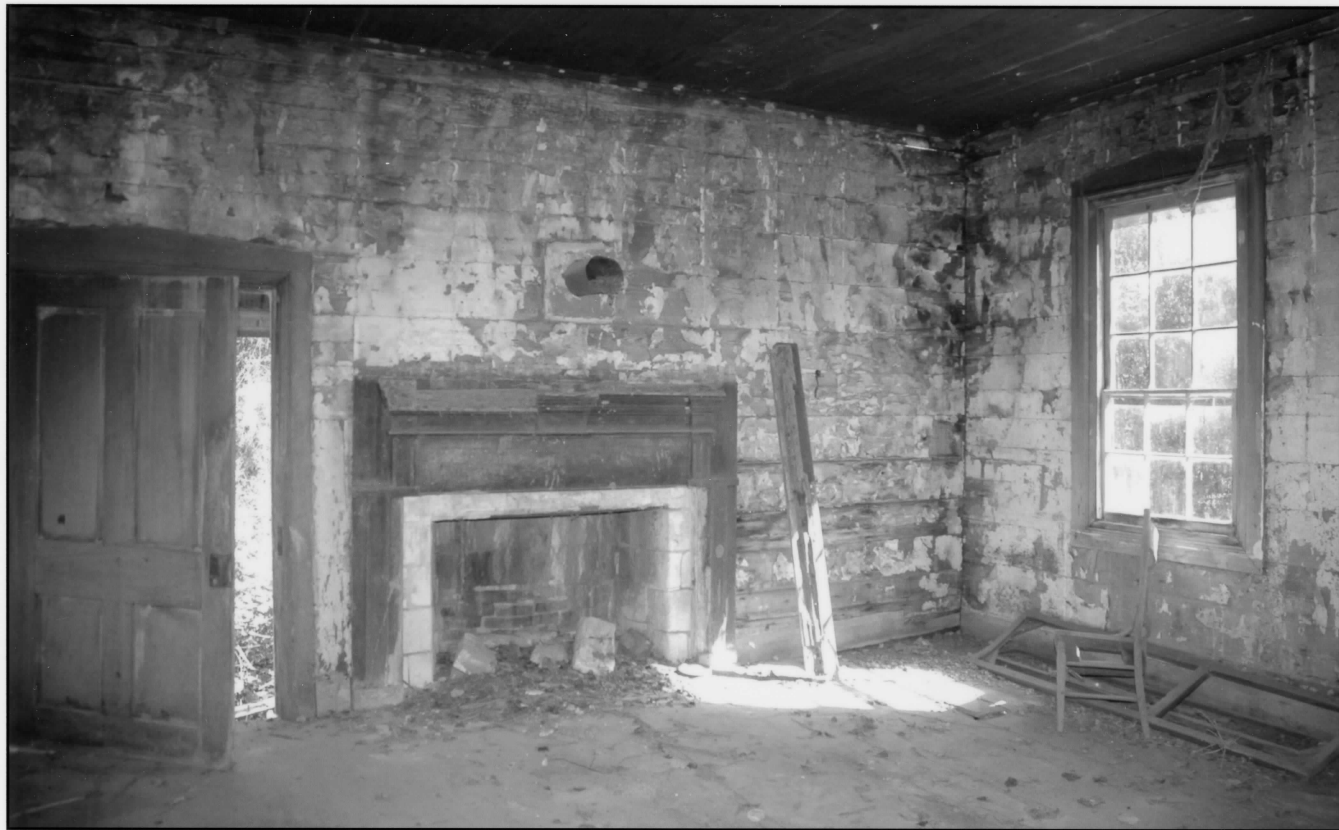
6. Kitchen, interior, camera facing southeast

The interior plan consists of a single open room with a small closet at its southwest corner. A fireplace is centered at the east wall and has a wide hearth with a vernacular Greek Revival style mantelpiece. The ceiling and walls are clad with wood planks and the wood plank floor is exposed.
