National Register of Historic Places  
Registration Form

1. Name of Property Valley National Bank Building

street & number: 27 S. Stone Avenue \_\_\_\_\_ not for publication  
city/town: Tucson \_\_\_\_\_ vicinity  
state: Arizona code: AZ county: Pima code: 019 zip code: 85701

### NARRATIVE DESCRIPTION

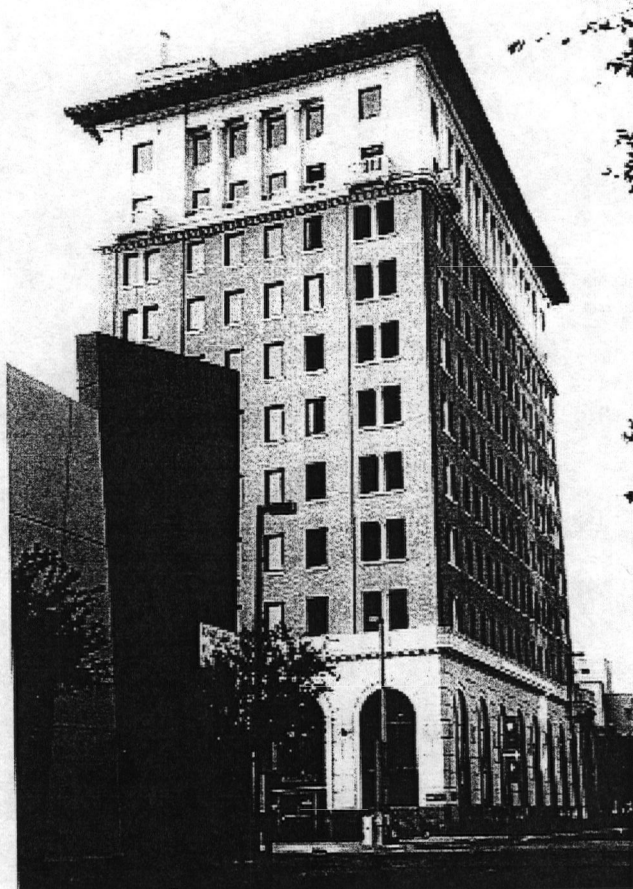
PHOTO #1: Three-quarter view of north and west facades from N. Stone Avenue; Congress Street entrance obscured from view; looking SE.

The north and west side of the exterior of the building are faced with brick and terra cotta of a light cream shade. The base up to the sill line is brown marble while the top two stories are faced with cream colored terra cotta, made to resemble large pieces of cut stone with rusticated joints. The terra-cotta top tier of the building is capped by a classic cornice with dentils, and then by an Italianate hatched overhang painted brown with red tile roofing running back to the parapet. The individual sections on the roof overhang are painted with a repeating black-on red geometric pattern of Southwest Native American design. The pattern repeats after six sections. The front façade, which faces Congress Street, is broken into three horizontal tiers making a top, middle, and bottom tier. The top tier is noted by a false balcony on brackets that extends across the ninth floor. Below the false balcony is a projecting hatched base. Both the ninth and the tenth floor are interrupted by an arcade of eleven superimposed Ionic columns on the west side and three on the north side that terminate at both the east and west office suites. The effect was probably intended to resemble an open loggia (colonnaded space within the lobby of a building but open to the air on one side). The corner office suites on the ninth floor are marked by their extended balconies. The top nine floors once held steel double-hung windows which were later replaced by single fixed panes in black metal frames.

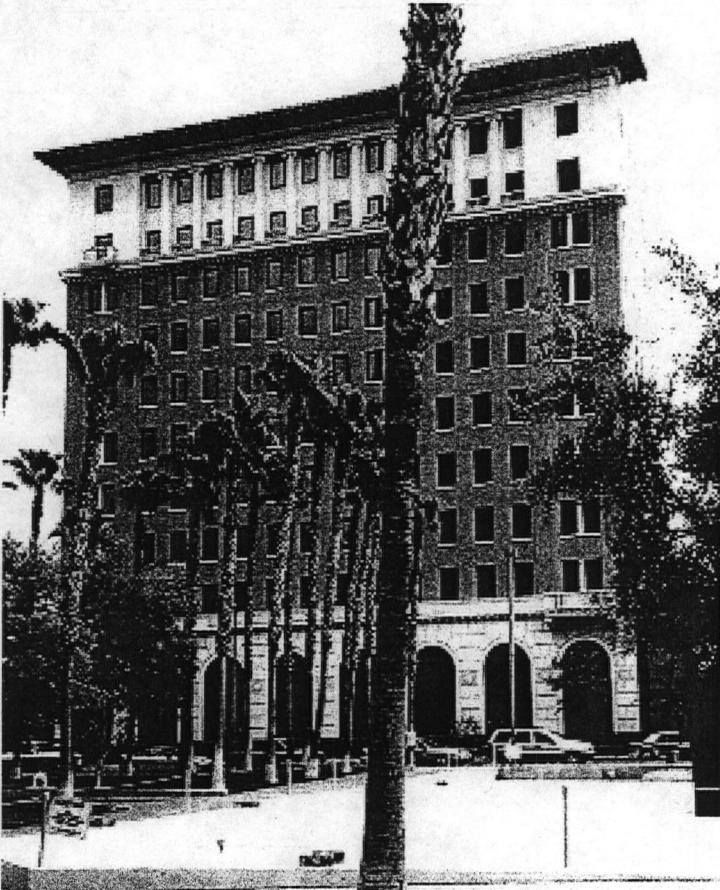
PHOTO #2: West façade from opposite plaza; looking east.

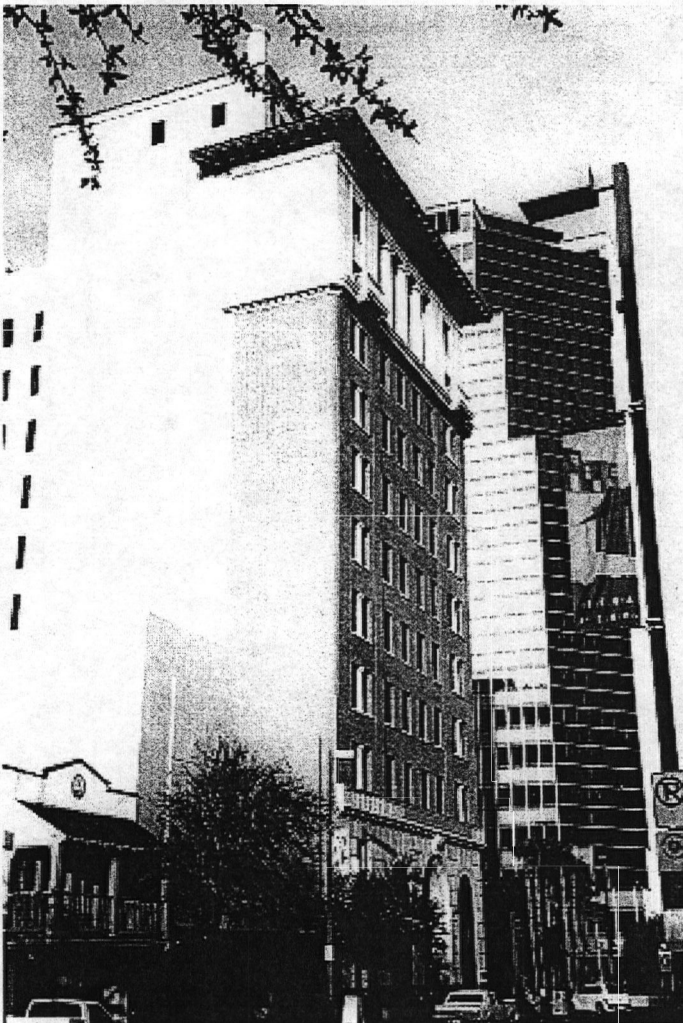
PHOTO #3: Three-quarter view of east and north facades from E. Congress Street showing annex; looking SW.

Abutting the building to the east on Congress Street is a three-story building built in 1912, and now an annex, which underwent some remodeling in 1953 by Marie J. Schiff Construction and a complete remodeling and a new front

façade and entrance in 1960 by F. Knipe, Architect. The front façade of the annex is an eight inch thick wall of reinforced concrete with a painted finish. There are raised concrete panels divided into fifteen sections with a large metal Thunderbird logo at the center and a concrete canopy. Nine foot tall granite veneer from the canopy extends to the ground level. There is terrazzo tile paving in front of the recessed entryway and raised metal signage at eye level. Abutting the west façade on the south is an entry portico designed by the Tucson firm of Cain Nelson Wares & Cook. It is a brick interpretation of the arcaded bottom tier of the main building. A corbel extends across the wall below the flat parapet. Directly south are a series of rectangular brick planters linking a walkway. To the southeast is a parking lot.

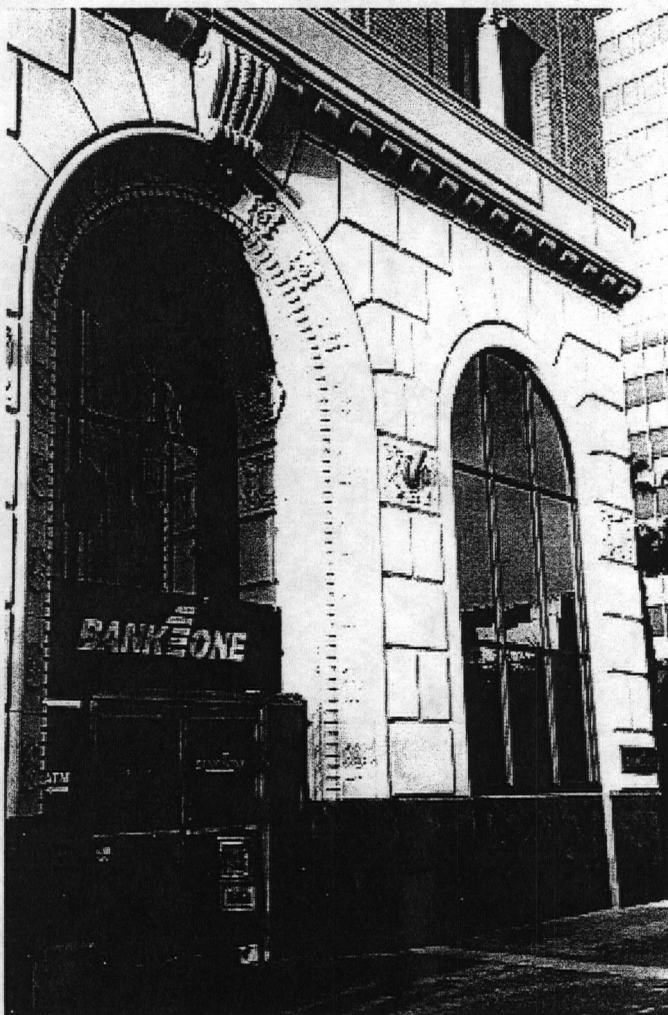
PHOTO #4: Detail of main entrance, Congress Street; looking SW.

The bottom tier of the front façade is marked by high arched windows along the street level; the main entrance to the lobby from Congress Street is through a recessed terra cotta archway, in which is a bronze grille surmounting two large bronze doors topped by a hatchet-shaped keystone. The secondary entrance on the west side of the building has a hatched canopy making a balcony for the mezzanine.

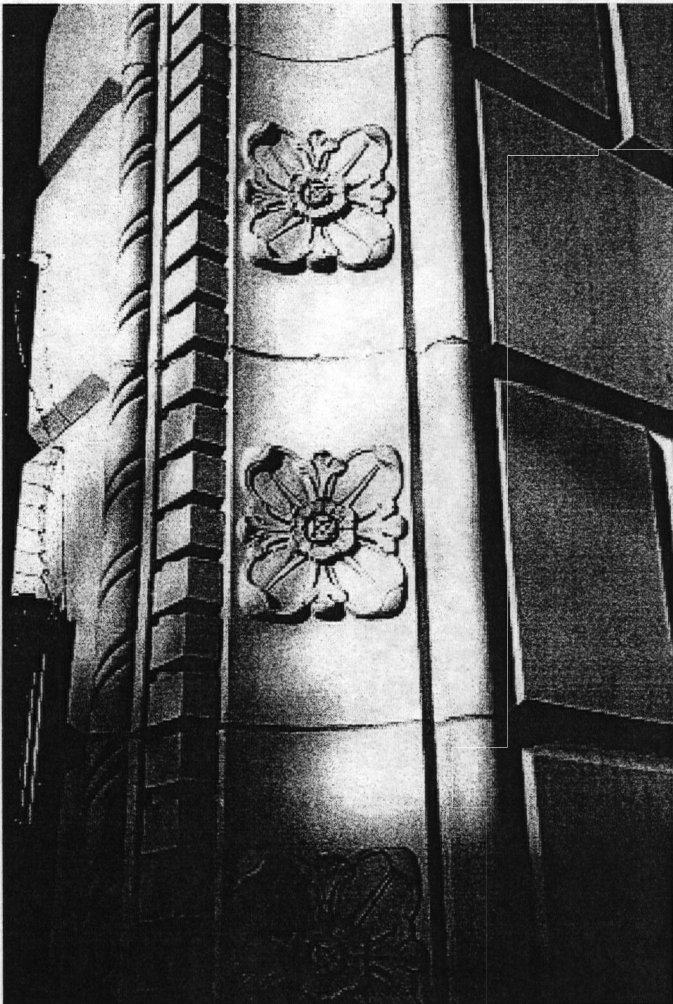
PHOTO #5: Detail of ornamentation, main entrance archway on Congress Street; looking SW.

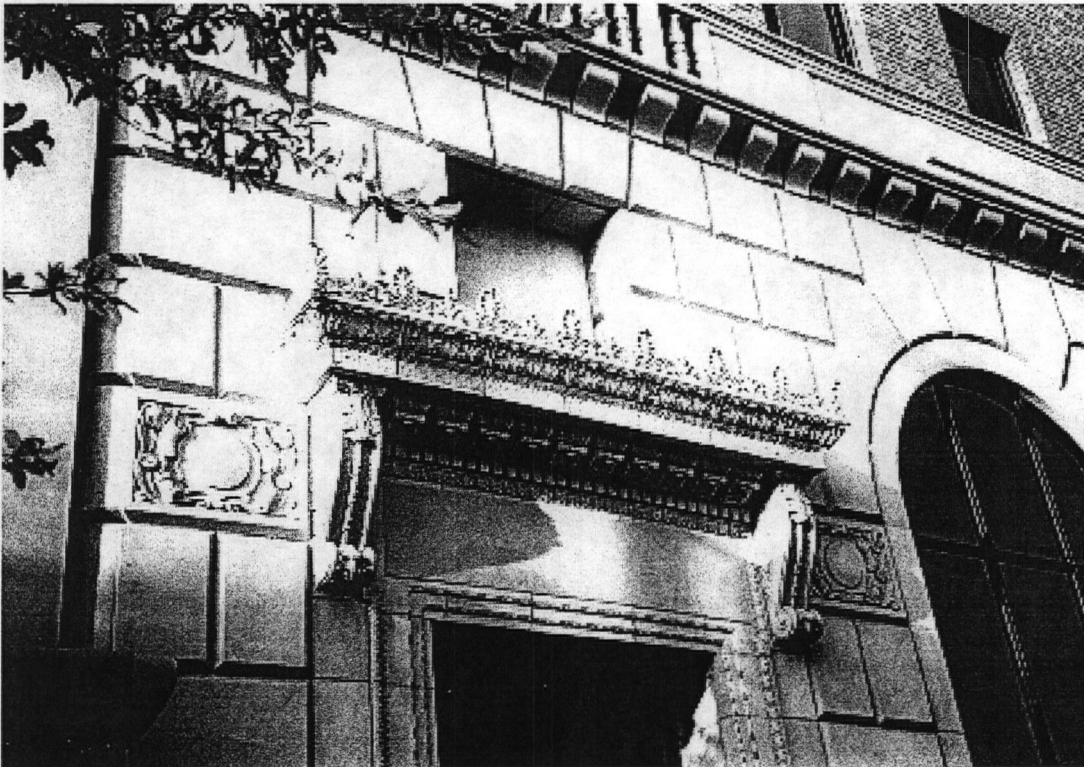
PHOTO #6: Detail of ornamentation at secondary entrance on north facade; looking SW.

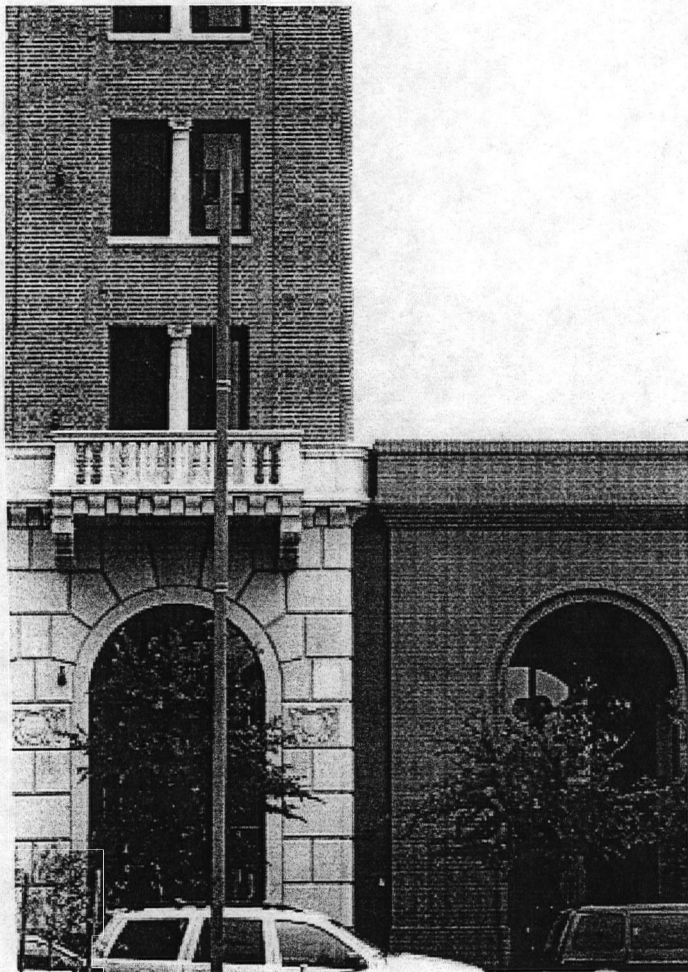
PHOTO #7: West façade at annex showing stylistic treatment between historic and contemporary portions.

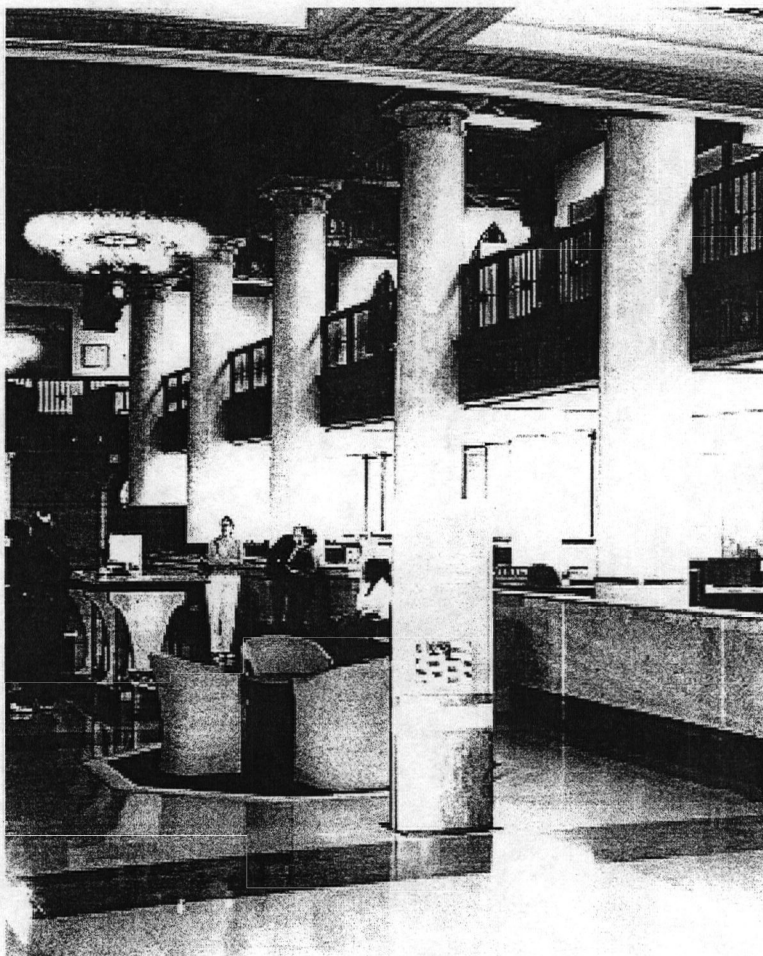
PHOTO #9: Interior view of lobby showing marble columns.

The interior spaces of the building have nine floors dedicated to offices each with mahogany doors and trim. All nine floors originally had sixteen offices to each floor but after some remodeling the number of offices on each floor has changed and varies from floor to floor. Every office has a separate wardrobe and lavatory and each office was originally served with a cooling system and a steam radiator. The bank has always occupied the basement, main floor, and mezzanine floor. On the mezzanine floor, across the Congress Street side, are three rooms, the extreme western one being a tower room which T. N. McCaully used as his office. The walls of this room are in polished Bataan mahogany. The directors' room centers the mezzanine and opens out of the western tower room. Also found on the mezzanine floor is a room that was "especially designed and equipped for the serving of women patrons of the bank, where they may take their financial problems to a woman... in this charming place, which is feminine in all its appointments from the sparkling crystal chandelier to the smartness of its wicker furnishings, and the other touches that all women love," (Hughston, 1929). There are two original chandeliers each one costing one thousand dollars in 1929. Parallel to the tellers are the original tables. The interior of the banking floor was well appointed with fourteen scagliola (faux marble) columns supporting the mezzanine floors and surrounding the public lobby space. These columns are behind the counters that have a facing of rose tavernelle marble and a base of cedar Tennessee marble, blending artistically with the rose-tinted scagliola and pink Tennessee marble floor with a Tennessee marble border. At the end of the banking room is a Venetian mirror with a clock above with its dials illuminated. Two superimposed piers flank either side of this mirror that is fitted into an arch all of which is sheathed in rose tavernelle veneer. Behind this mirror is a grand staircase that leads to the mezzanine and to the basement where the vaults can be found. A solid bronze grill makes up the railing surrounding the mezzanine that is pierced by bronze roundels containing a low relief of the side profile of Columbus, which alludes to the Columbian exposition. Bronze also outlines the tellers' cages.

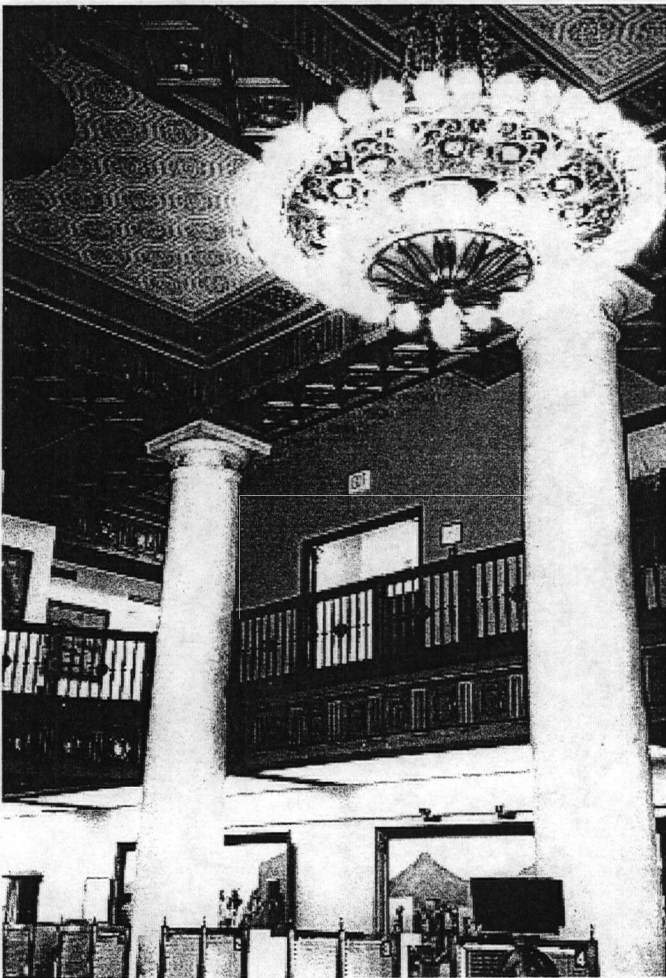
PHOTO #11: Interior view of lobby ceiling.

The walls of the bank were originally painted a gray-green color. The ceiling throughout the bank level is coffered and the ceiling beams are carved with a floral motif, which might be interpreted as symbolic of America's abundance; a popular nineteenth century notion that America was the "new Eden" and reaping the benefits of the natural resources was the right and responsibility of its citizens. This belief would seem appropriate for a bank in a frontier town in which profits were made through the exploitation of local natural resources such as silver, copper, and cotton. This floral motif runs throughout the rest of the bank level and exterior as well where it is carved into the intrados (concave underside of the entrance arch). Throughout the bank level is a geometric neoclassical motif found in the ceiling murals and dentil work along the ceiling beams. The colors that make up the patterns on the ceiling and decorative work are red, rose, blue, green and solid gold leaf in bronze tones. In the lobby there are two elevators serving all floors and there is a stairway adjacent to the elevator shaft running from the roof down to the floor. The lobby is lined with rose tavernelle and the elevator doors are bronze.

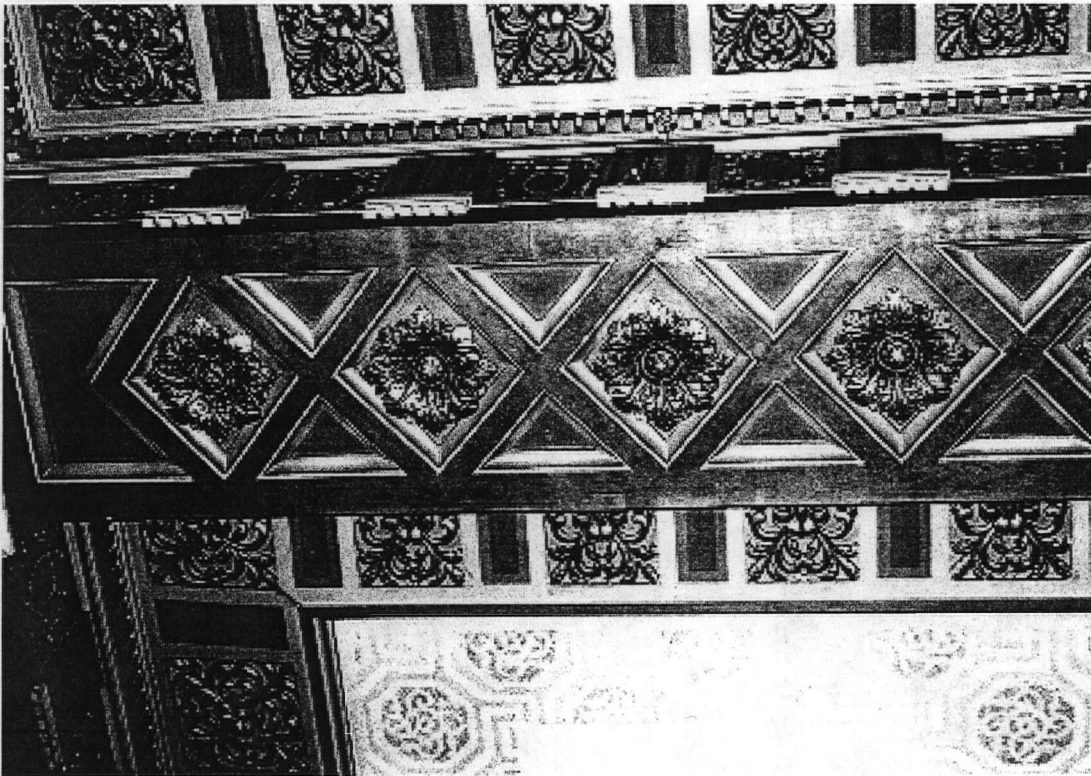
PHOTO #12: Detail view of decorative lobby ceiling.

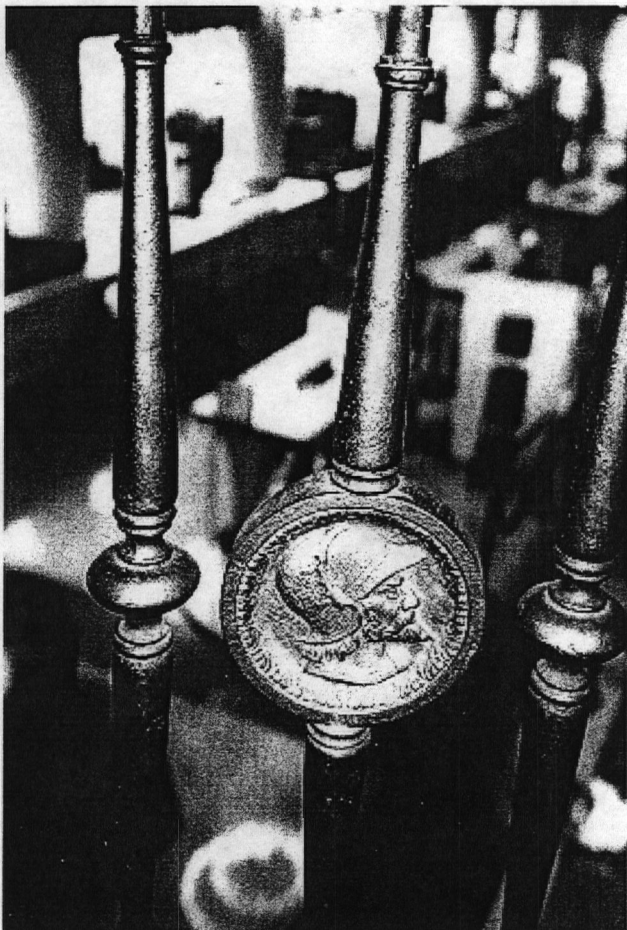
PHOTO #14: Detail view of mezzanine hand railing with medallion of Christopher Columbus.

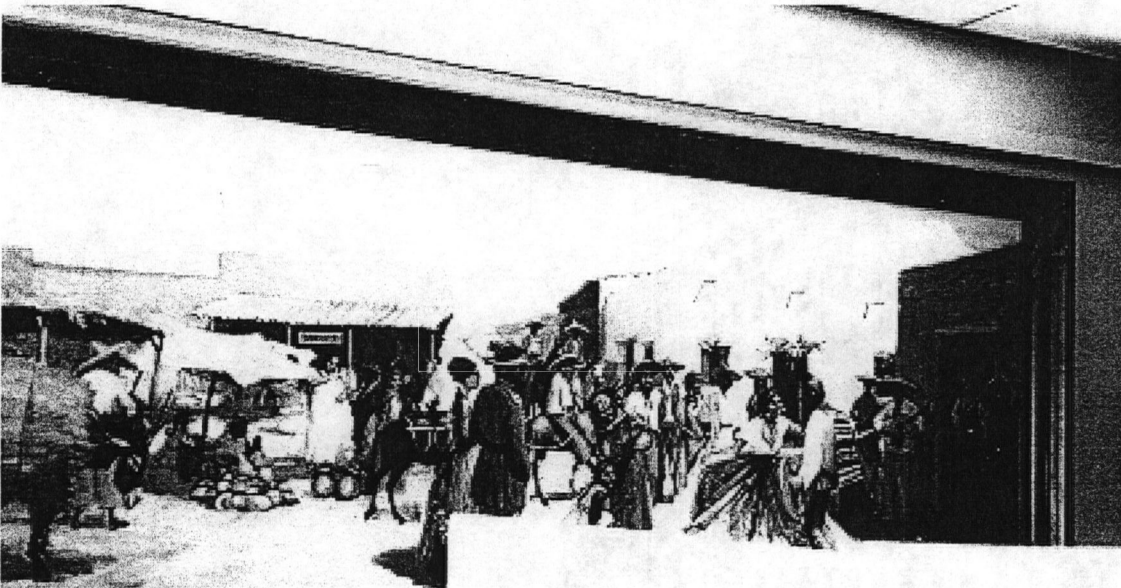
PHOTO #15: Detail view of a typical mural in lobby mezzanine.

The various sections of the lobby ceiling are adorned with miniature murals alluding to visions of "manifest destiny," a

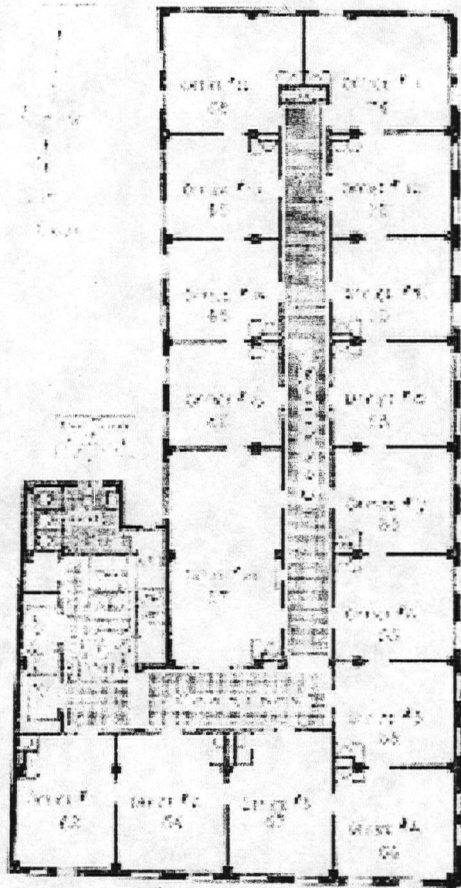
HISTORIC PHOTO #2: Valey National Bank floor plan for office floors 3-8 (plan courtesy of Bank One)
