National Register of Historic Places Registration Form

ormos and narrative items on continuation sheets (ivi o) orm 10-500a). Ose a types	writer, word processor, or computer, to complete all items.
1. Name of Property	
historic name PLUMMER, LOUIS, AUDITORIUM	
other names/site number None

2. Location	
street & number 201 E. Chapman Avenue	N⊬Anot for publication
city or townFullerton_	N/A vicinity
state <u>California</u> code <u>CA</u> county <u>Orange</u>	code <u>059</u> zip code <u>92632</u>

Plummer , Louis, Auditorium Orange County, California

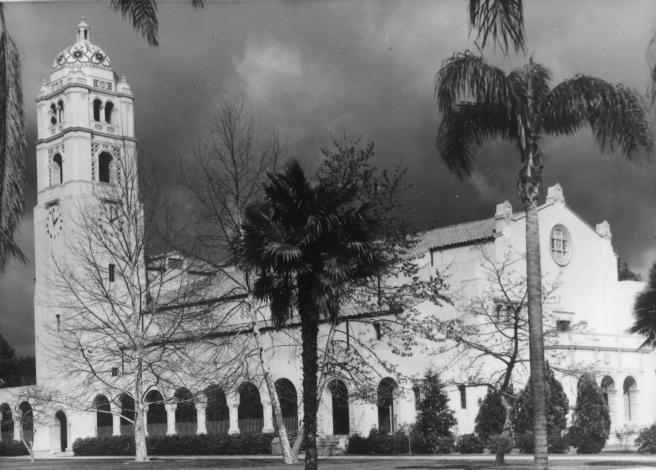
1. Historic photograph, taken in 1931: taken from southwest

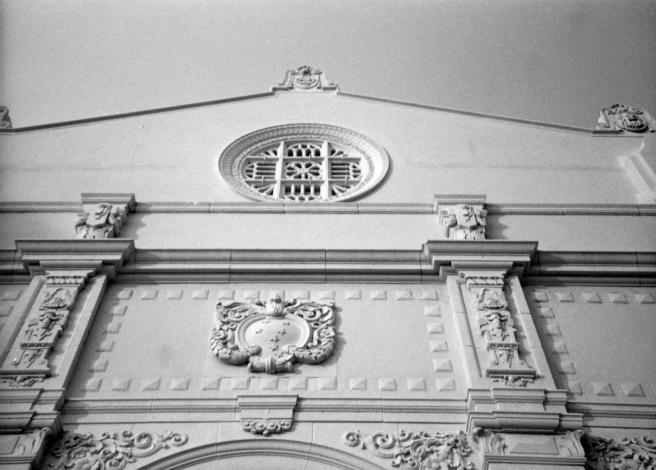
- 2. Front Facade: Taken from steps at south end of building, showing details of parapet and front portico.
- 3. Front Facade: Taken from southwest, on front steps; shows details of doorways

Symmetrical in form, the front facade is centered with an elaborate rose window. Moderne pilasters accent the corners, below the corner pediments. The words "Louis E. Plummer Auditorium" are centered above the wide doorway which leads to the balcony above the projecting portico. A trio of blind windows, elaborately surrounded with squares in a classical motif and crowned with a wide decorative cornice, flank each side of the center section. A second pair of Moderne pilasters forms the edges of the outside walls. A concrete decoration, is a good example of conservative classicism. Three tiers of pilasters and cornices reach from the top of the balcony to the base of the portico, with the four pilasters separating and flanking the three arches. A large cartouche crowns the central arch. Rusticated stones accent the inside face of each arch, and outline the three rectangular panels above the openings. The pilasters are topped with unique capitals featuring acanthus leaves and shields. Wide concrete steps, flanked by concrete piers, lead to the portico. A tall and elaborate wrought iron lamp adorns each pier. Two wrought iron railings separate each of the three sections of stairway.

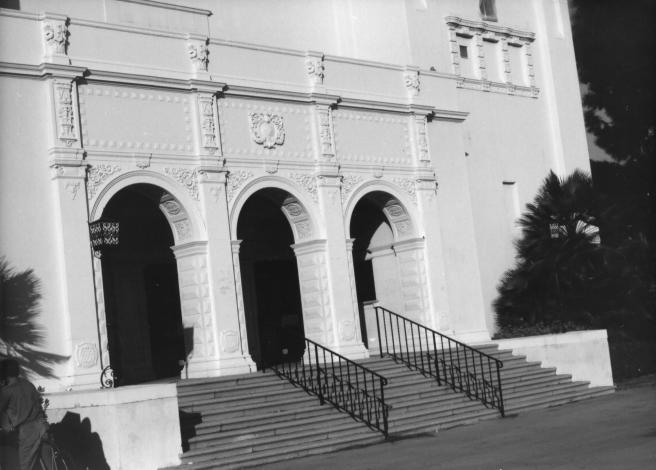
- 4. Front Facade: Taken from southwest, showing front portico.
- 5. West Facade: Taken from south. The front facade is on the right, the arcade that runs along the west facade is directly in front of the camera. The tower is on the west facade.

The three identical arches lead to the rectangular interior of the portico. A wrought iron lamp hangs from each of the three vaults of the portico ceiling. Ticket windows with elaborate surrounds and cornices are located on the east and west sides of the interior. Three sets of doors leading to the lobby are contemporary metal and glass, one of the few alterations to the exterior of this fine building.

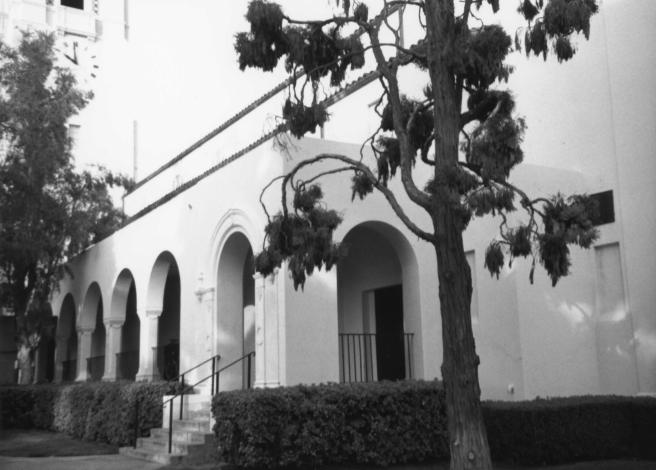
- 6. West Facade: Taken from the southwest. View of the arcade that runs along the west side.
- 7. Interior: Taken from west. Decorative balconet located on the diagonal between the west sidewall and the stage area. Note saying in center, below ledge.

The single-storied arcade, which runs along the west facade, is topped with a flat roof, and extends from a point ten feet from the front facade to the north side of the tower, extending 13 feet beyond the tower. Fifteen arches, separated by pillars with ususual capitals featuring chevrons, form a neat row along the west side. The first, or southernmost, arch is accented by molding and urn-like decorative elements. It serves as the south entrance to the arcade. Seven steps, flanked by concrete piers, lead to the opening. The floor of the arcade is clad in large red clay tiles.

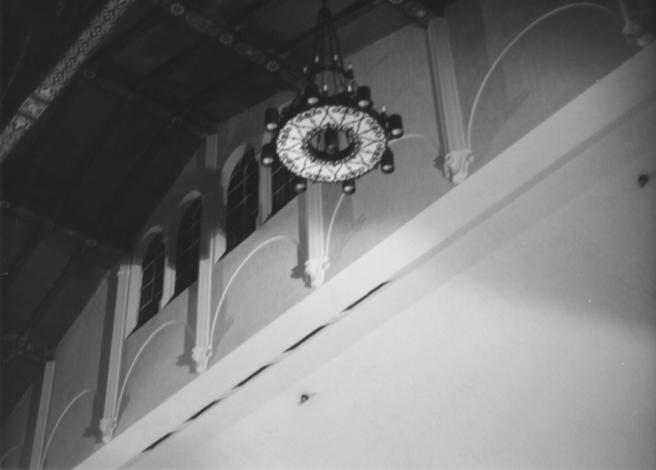
- 8. Interior: South wall, taken from northwest. This is the "back" of the balcony area of the auditorium.
- 9. Interior: A view of the ceiling, taken from the southwest. Original hand painting is still on beams.

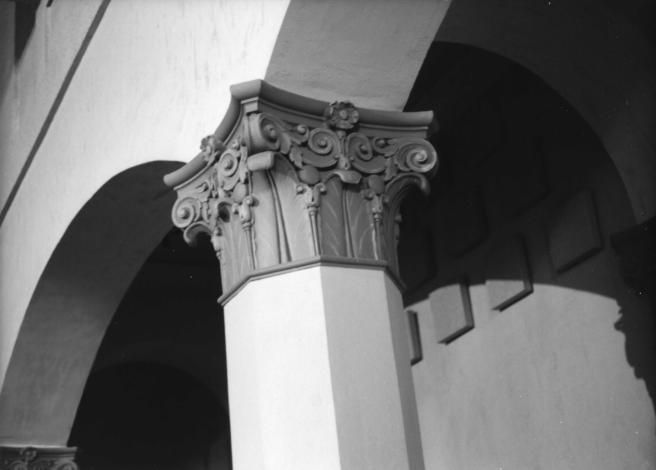
- 10. Interior: Taken from southeast. This detail of the columns which run down the east and west facades, adds a classical note.
- 11. Interior: Taken from east: A detail of the cast concrete capitals placed along each side wall.

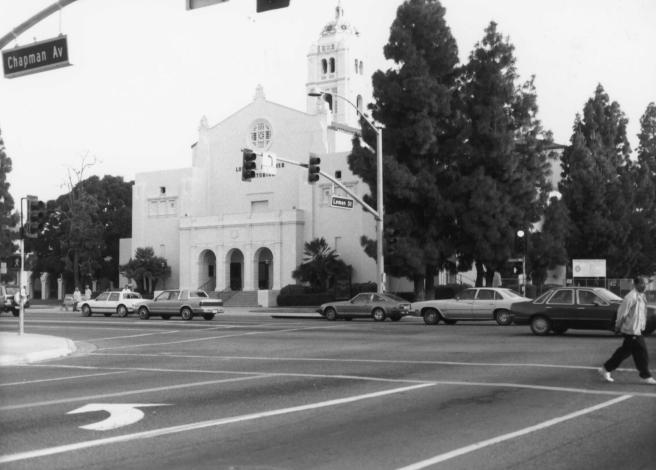
- 12. Front Facade: Taken from southeast. Photo shows buildings prominent position on a major corner, Chapman Ave and Lemon St.
- 13. East Facade: Taken from southeast. The east facade is blank except for the doors at the north end and the entrance on the south end. Note the blind arches with tile cladding above the shed-style roof.

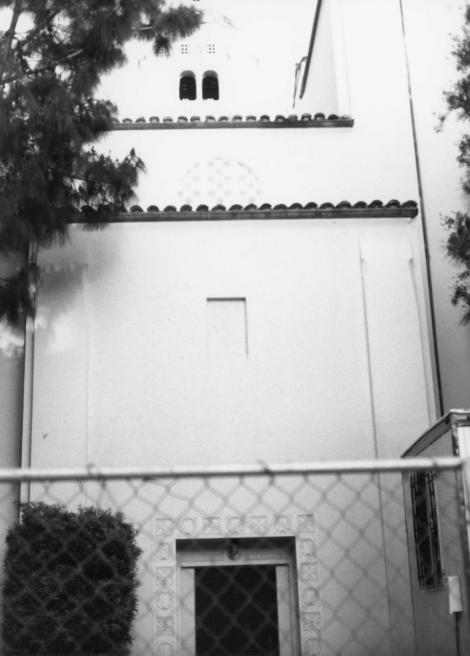
- 14. East Facade: Taken from east. The tower can be seen above this photo of the east facade. This shows a closer view of the tile-clad blind arch on the second level and the classically-trimmed door on the first floor. The door leads to the rear stage area.

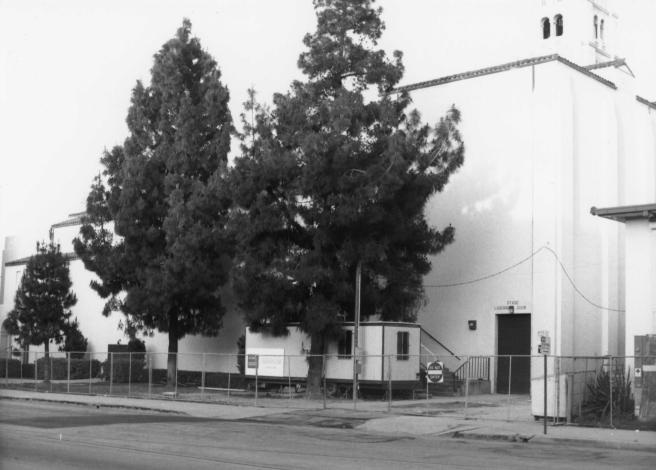
- 15. East and North Facades: Taken from the northeast. The back of the building is not visible from this street because of the close proximity of the music building.

The rear of the building is visible from very few angles, due to the proximity of the music arts building to the north and east and the arcade on the west. A small patio between the two buildings has been enclosed for storage and restrooms. (Please see enclosed floor plan). The addition is clad in plain stucco, has no architectural elements, and is topped with a flat roof.
