National Register of Historic Places Registration Form

historic name First Baptist Church

street & number 809 San Pedro Street [N/A] not for publication

First Baptist Church
Las Animas County, CO

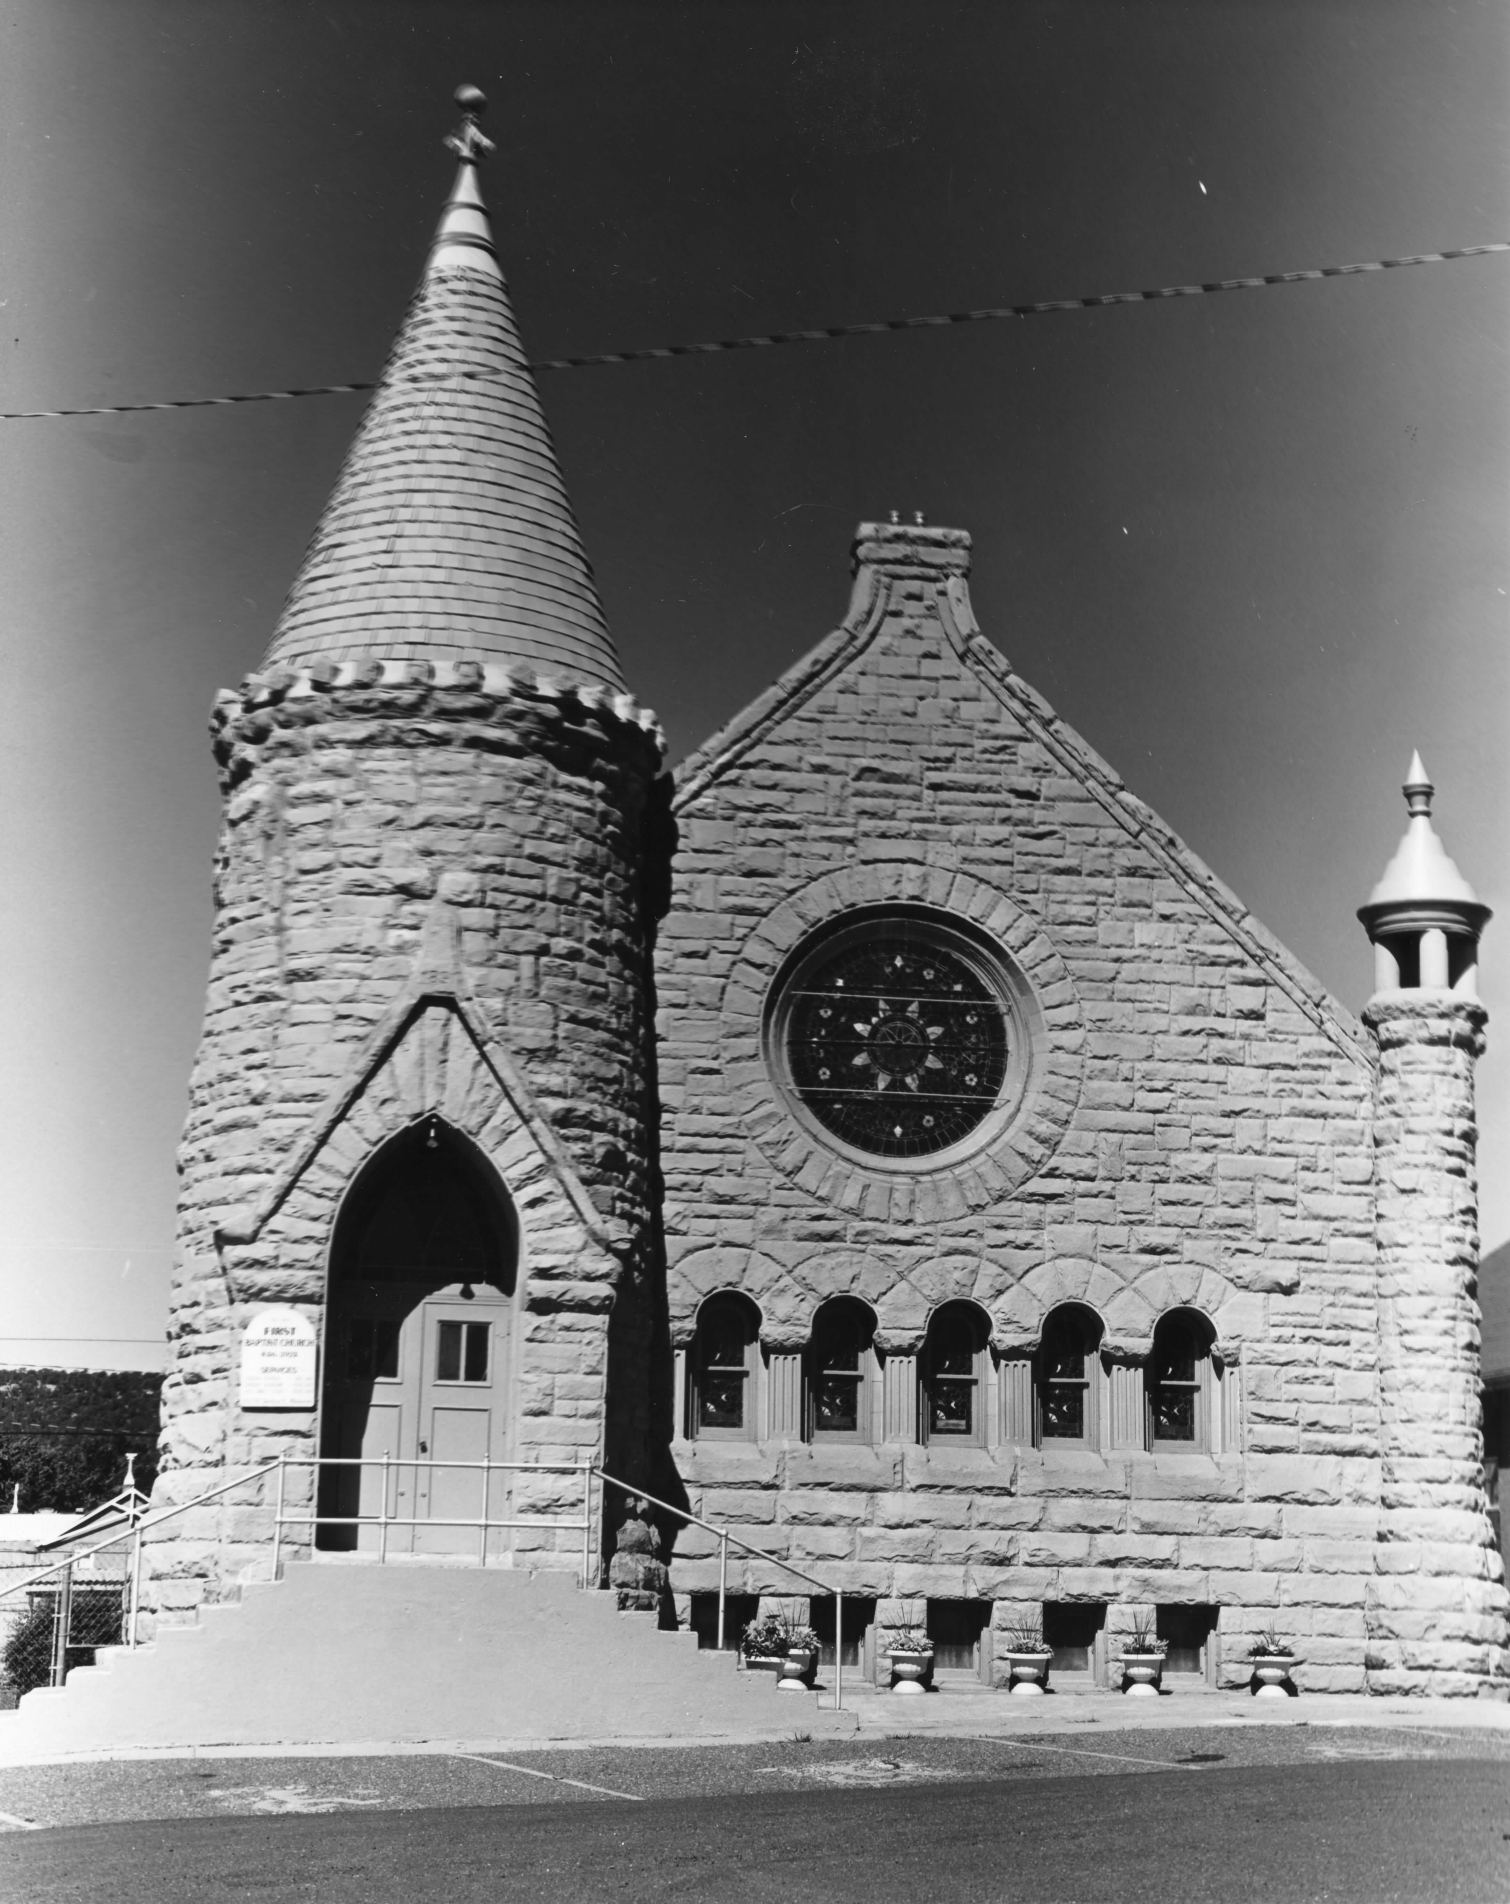
#1

| <u>Photo #</u> | <u>Description</u> |
|---|--|
| 1 | east face of church; camera facing west |

The church faces east onto San Pedro Street where the large round bastion anchors the southeast corner and contains the narthex and the main entrance. A large concrete double stairway with a metal pipe railing ends in a platform in front of a slightly projecting, pointed arched entry. The arched opening is trimmed with voussoirs and a raked molding forming shoulders that is capped with a stone in which "1891" is chiseled. Barely visible is the word "Baptist" spelled out, one letter per stone, in the voussoirs. Recessed within the opening is a pointed arch, stained glass transom above a double leaf entrance. Each of the wood paneled doors contains two vertical lights. Masking the northeast corner is a slender tower topped by an open stage. The asymmetrical gabled façade has a centrally positioned, large rose window. Beneath the rose window are five, round-arched, double hung sash windows separated by short heavy fluted pilasters with basket capitals. Below these windows are four courses of

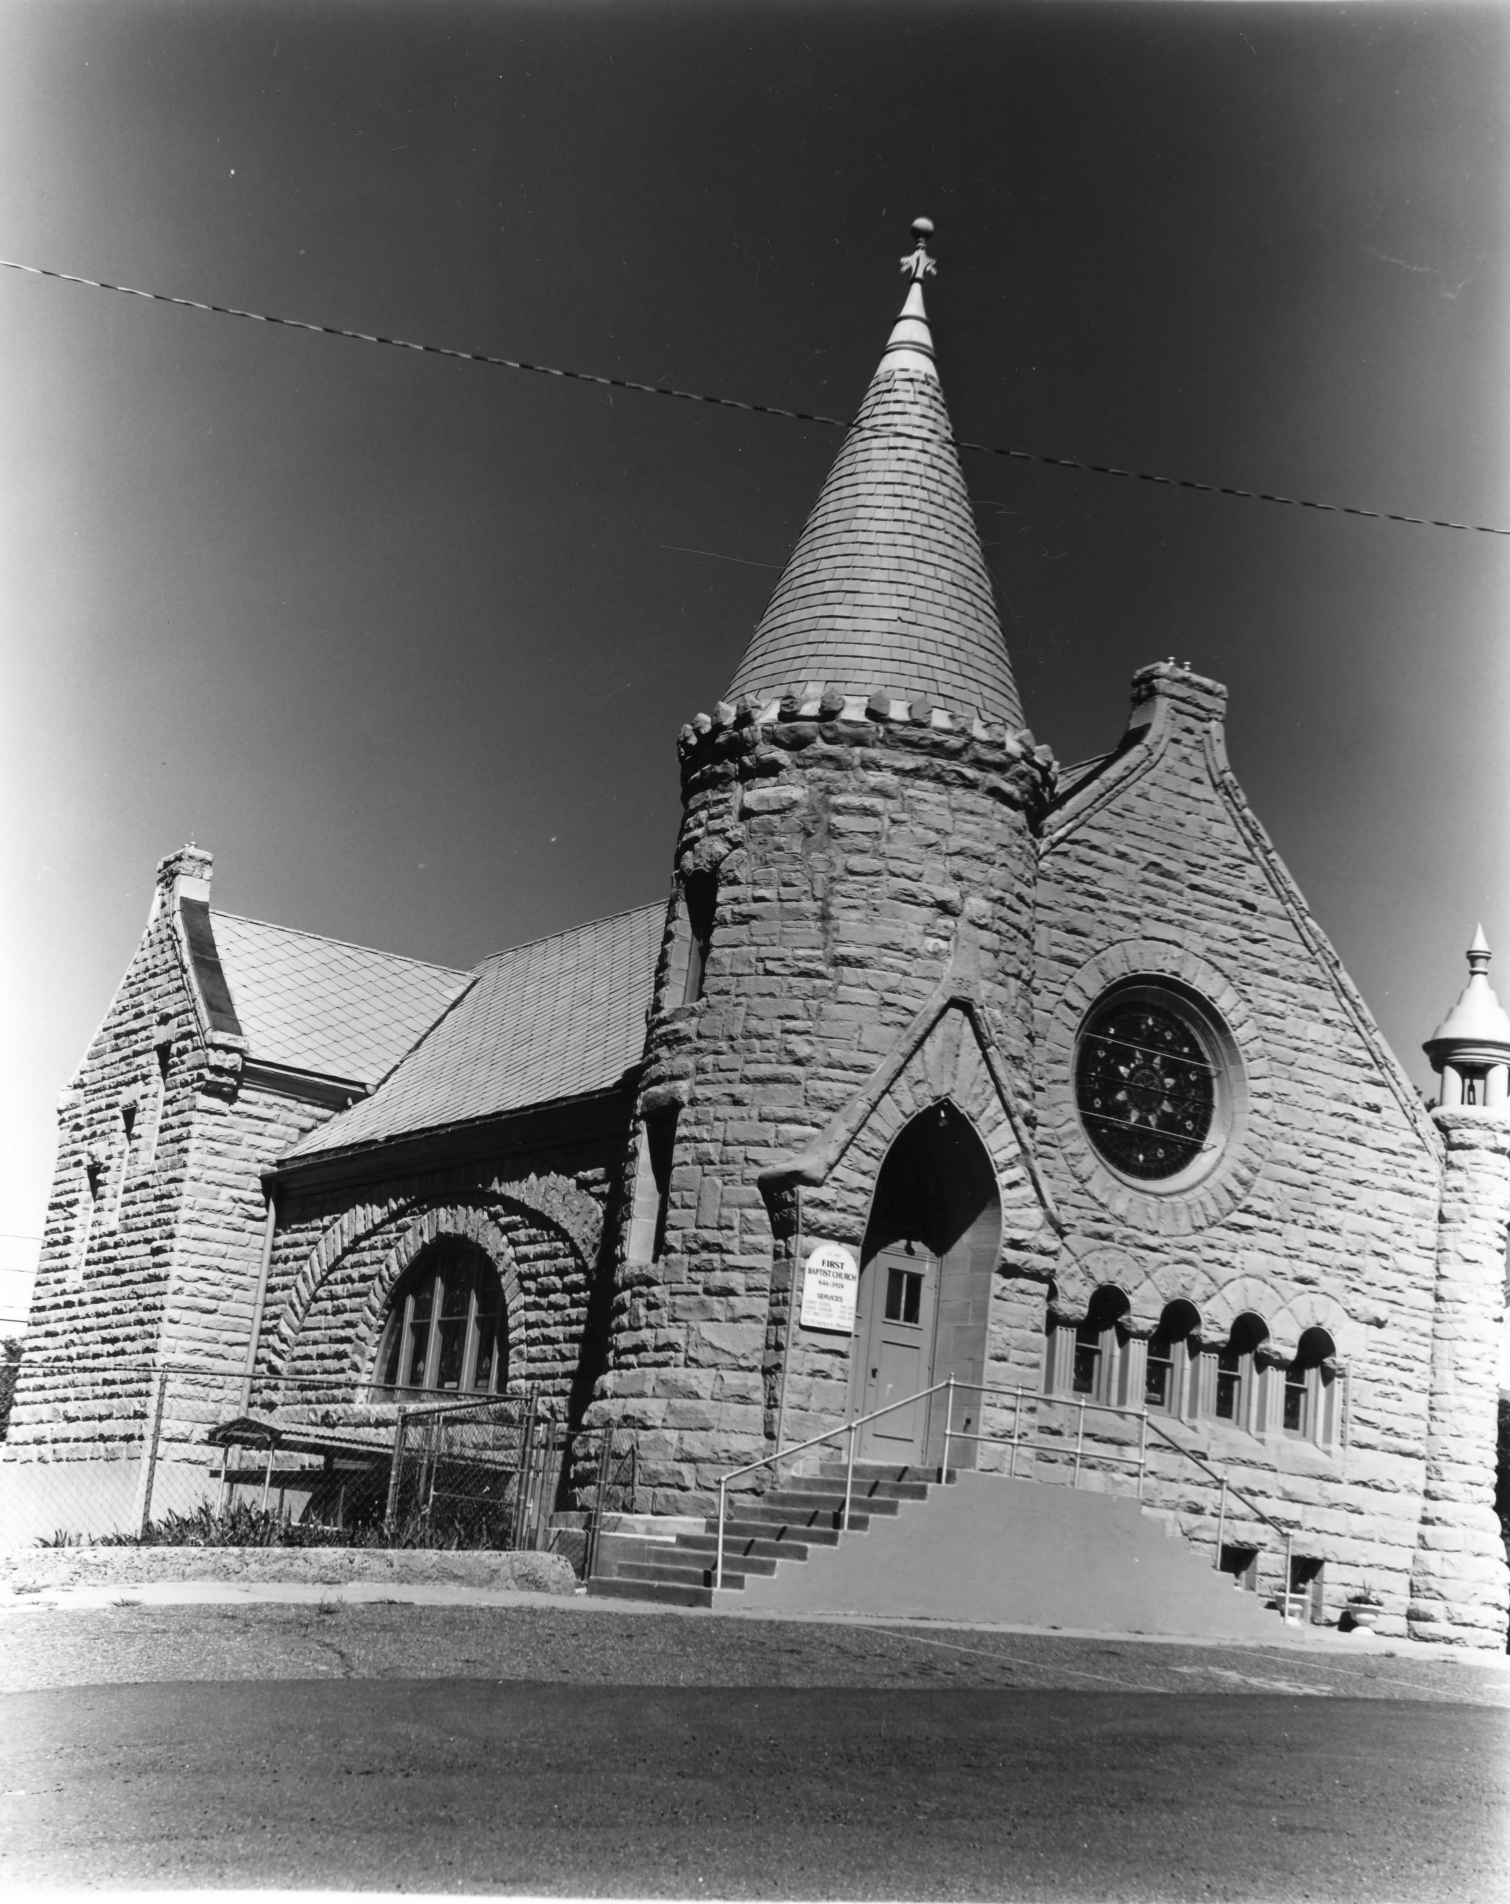
| <u>Photo #</u> | <u>Description</u> |
|---|--|
| 2 | front and south side; camera facing northwest |

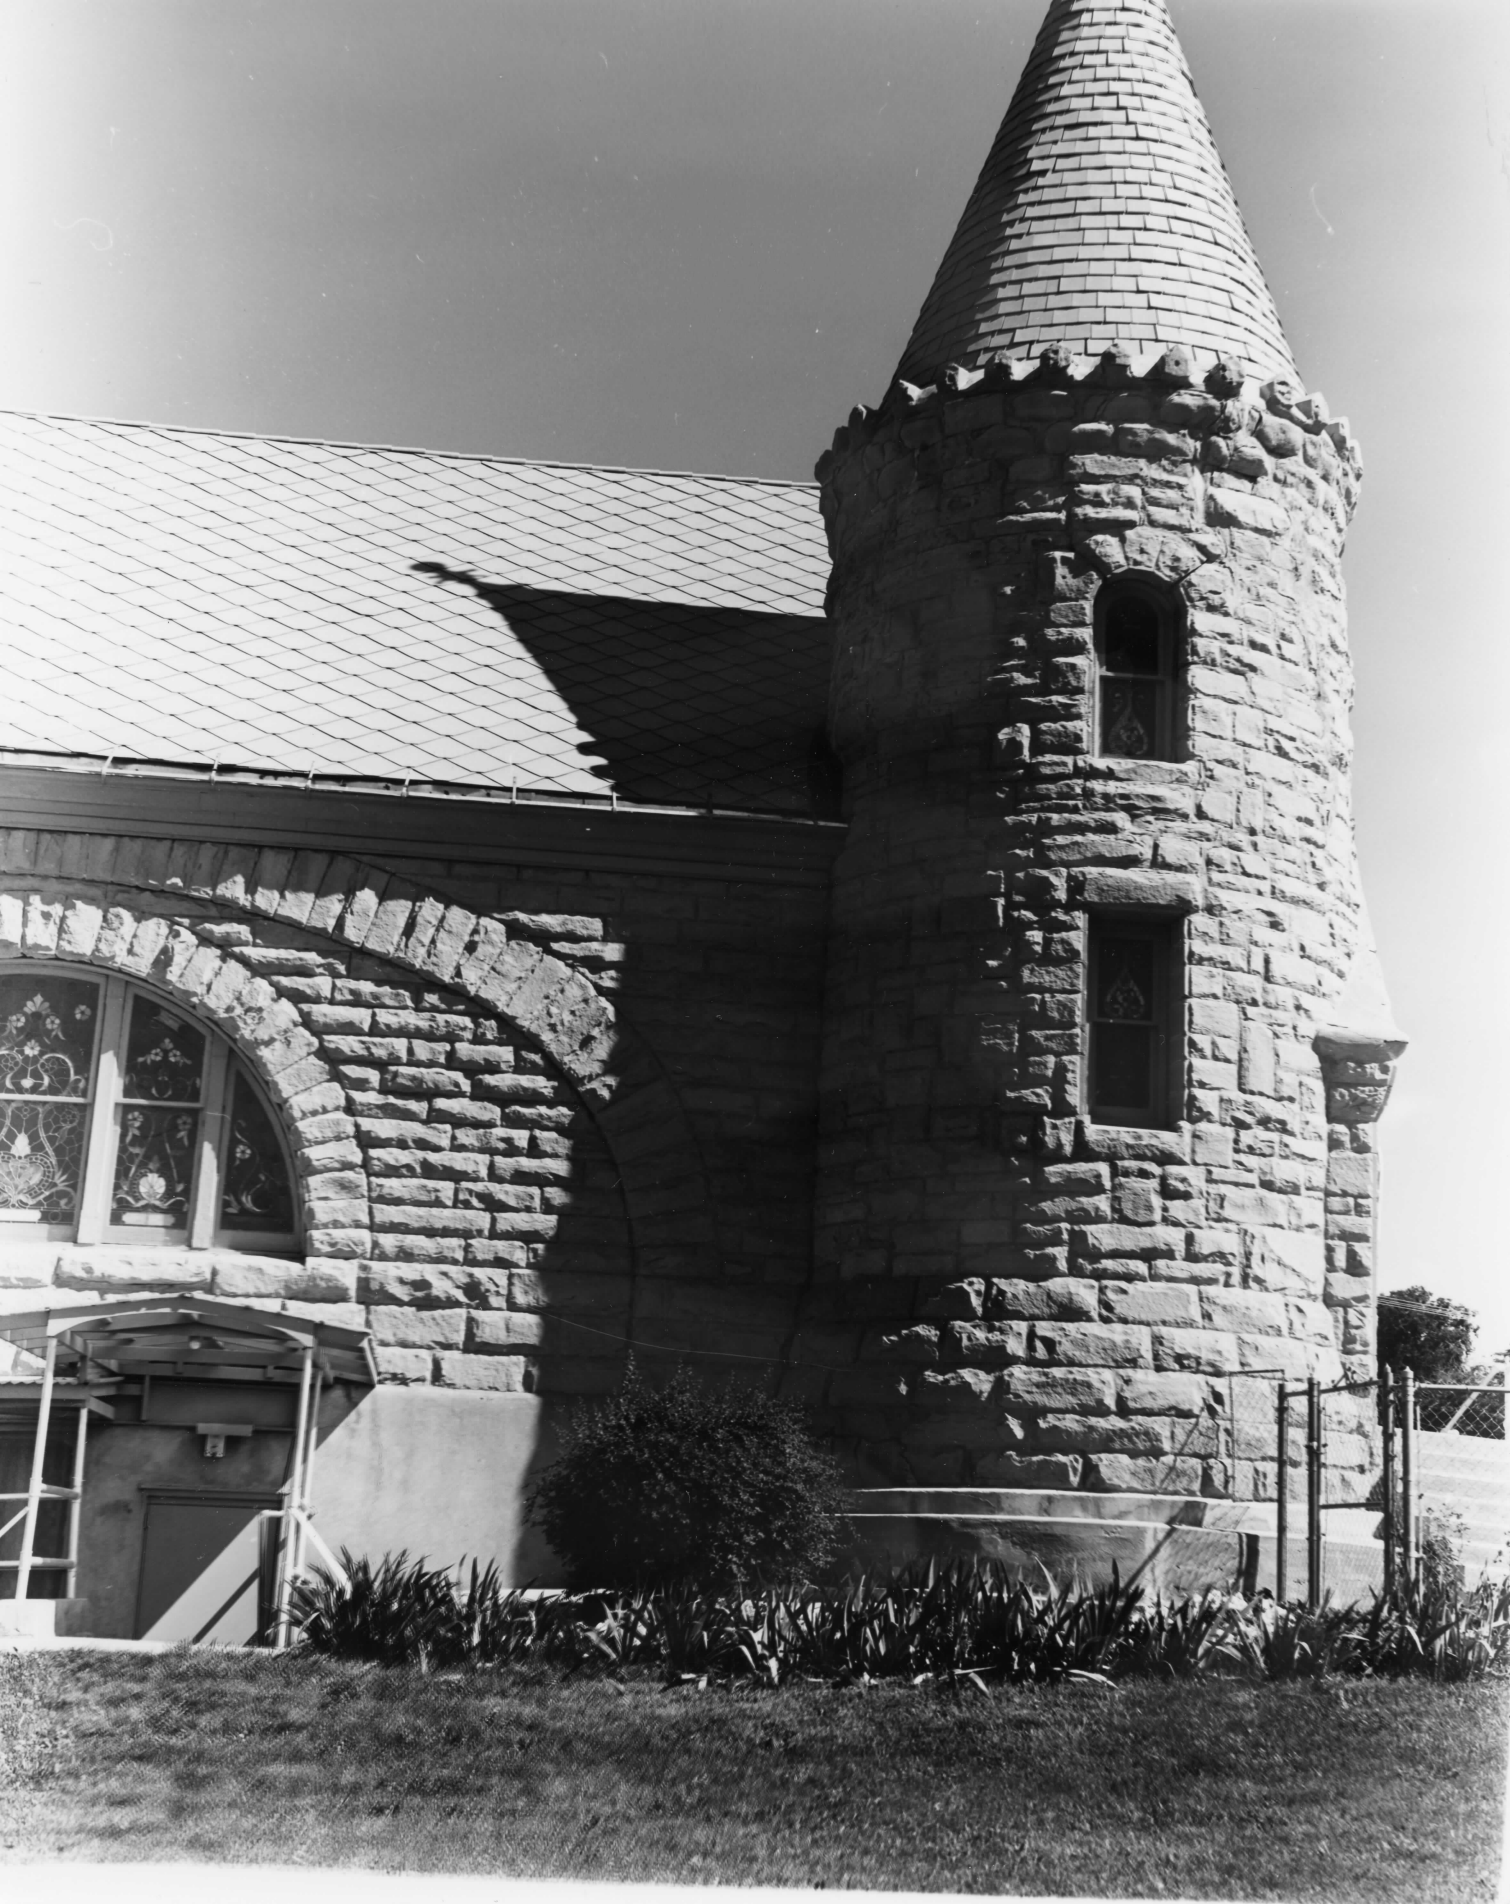
#3

| <u>Photo #</u> | <u>Description</u> |
|---|--|
| 3 | east end of south side with tower/narthex; camera facing north |

Facing Colorado Avenue, the south side is composed of three parts: the narthex/tower, the gabled face of the transept portion of the church, and the expanse of wall between them. The projecting bastion is punctuated by two windows-- a round-arched window with voussoirs above a flat-headed window with a lintel. The connecting wall contains a large basket-handled shaped blind arch, which spans the entire length of the wall and reinforces the visual strength of the building. Centered within the blind arch is a semi-circular window opening with four broad wood mullions separating five stained glass windows. Beneath the arch of stained glass windows is a corrugated metal roof that shelters a below-grade entrance to the basement. The framework of corrugated material and metal poles extends out to cover a series of concrete steps that lead to a solid door. Beside the door is a coupled window. The transept's gabled end is punctuated by three windows stepping up to the parapet gable.

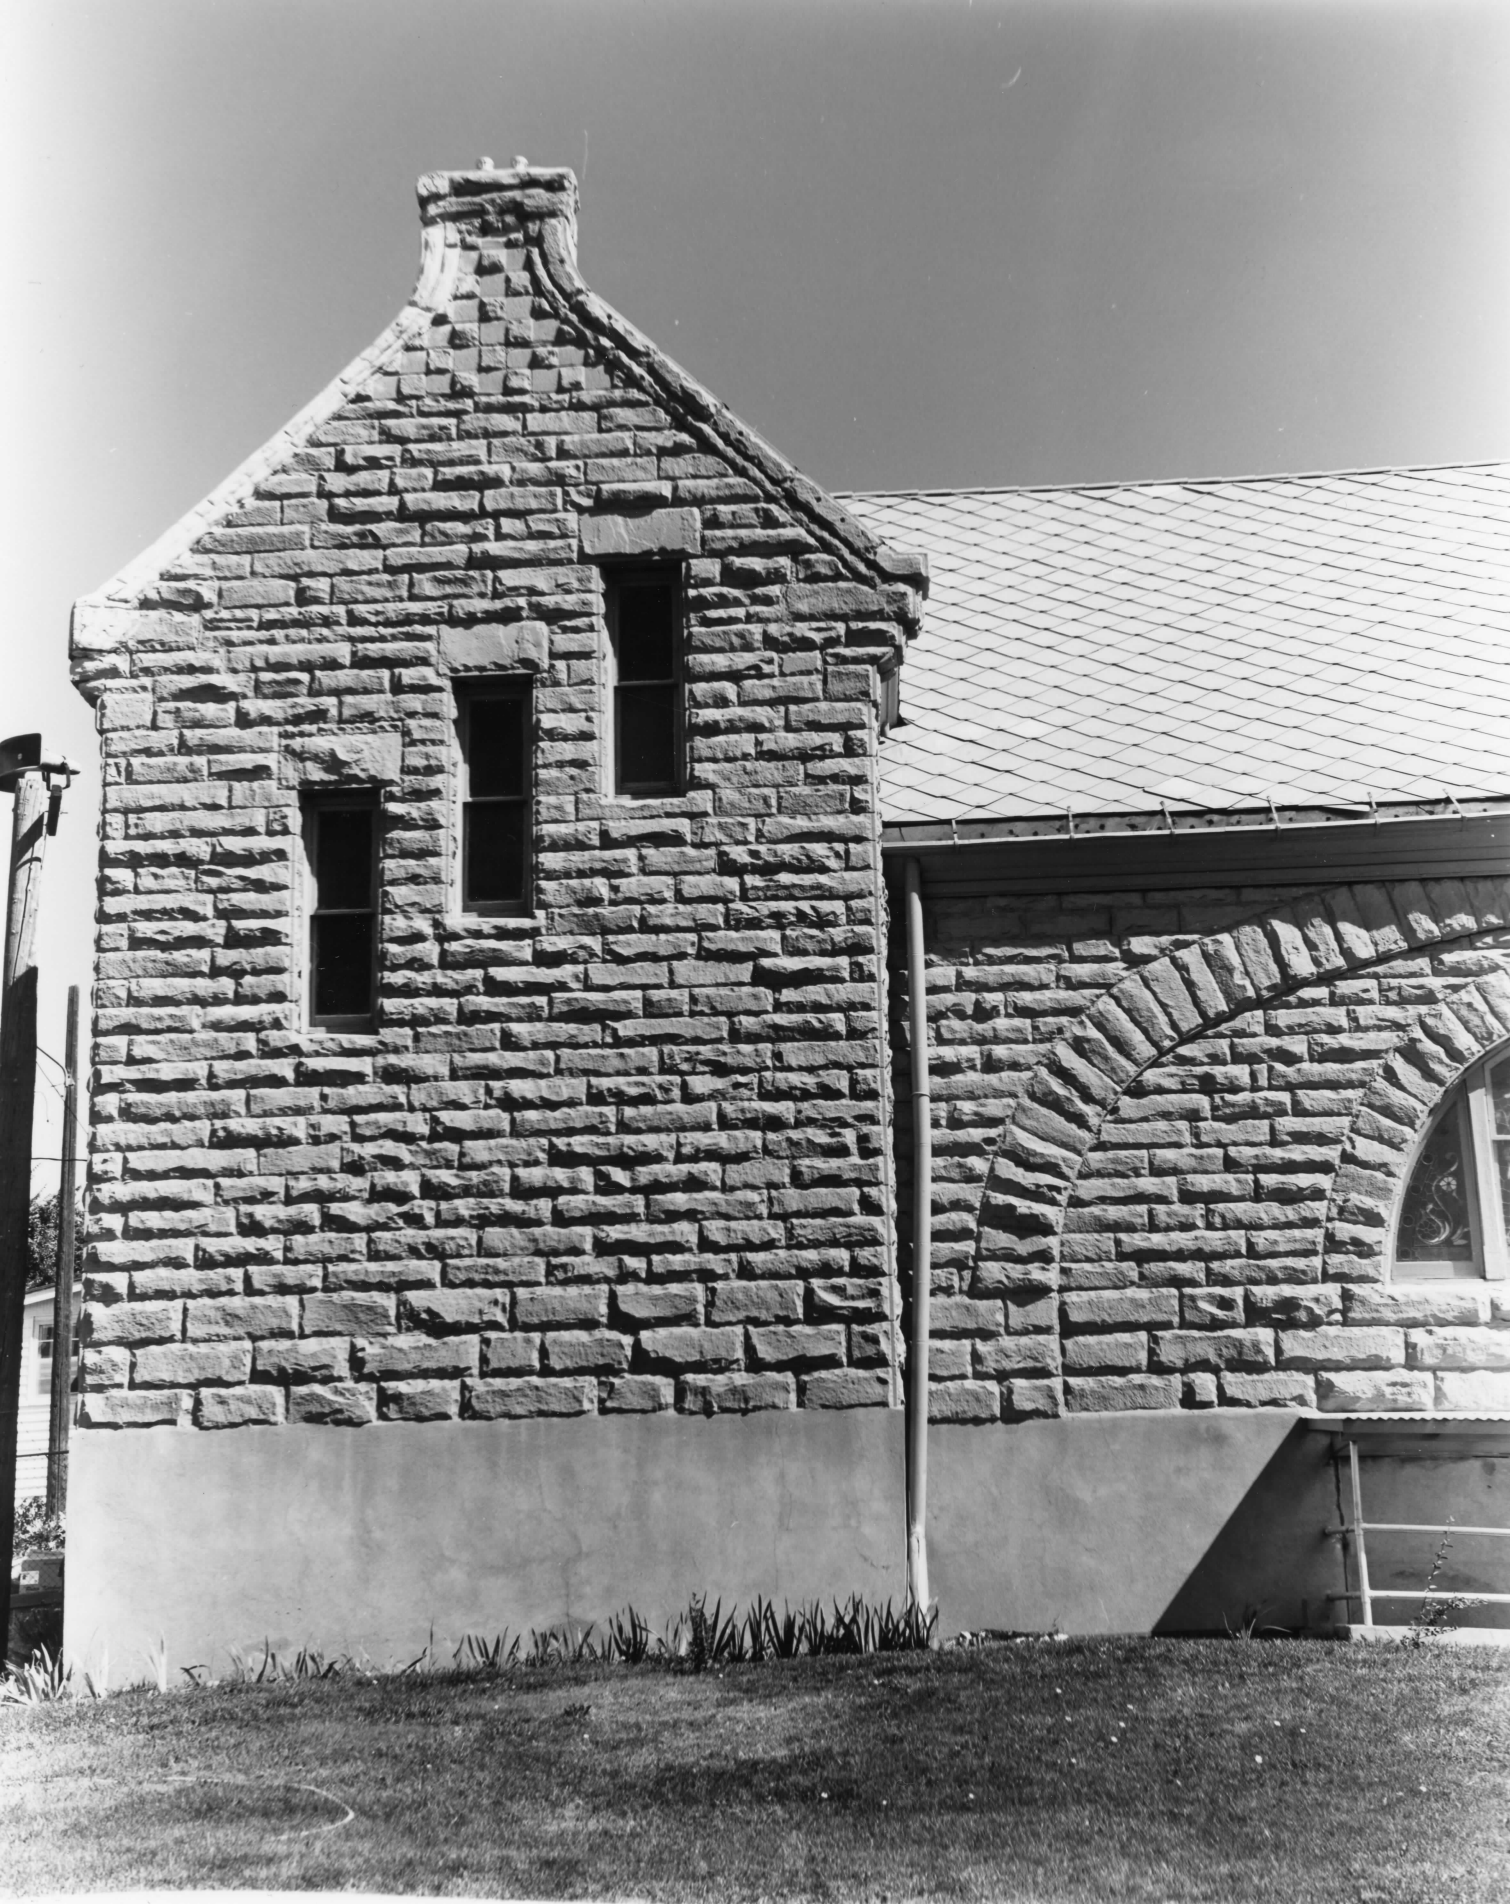
#4

| <u>Photo #</u> | <u>Description</u> |
|---|--|
| 4 | west end of south side; camera facing north |

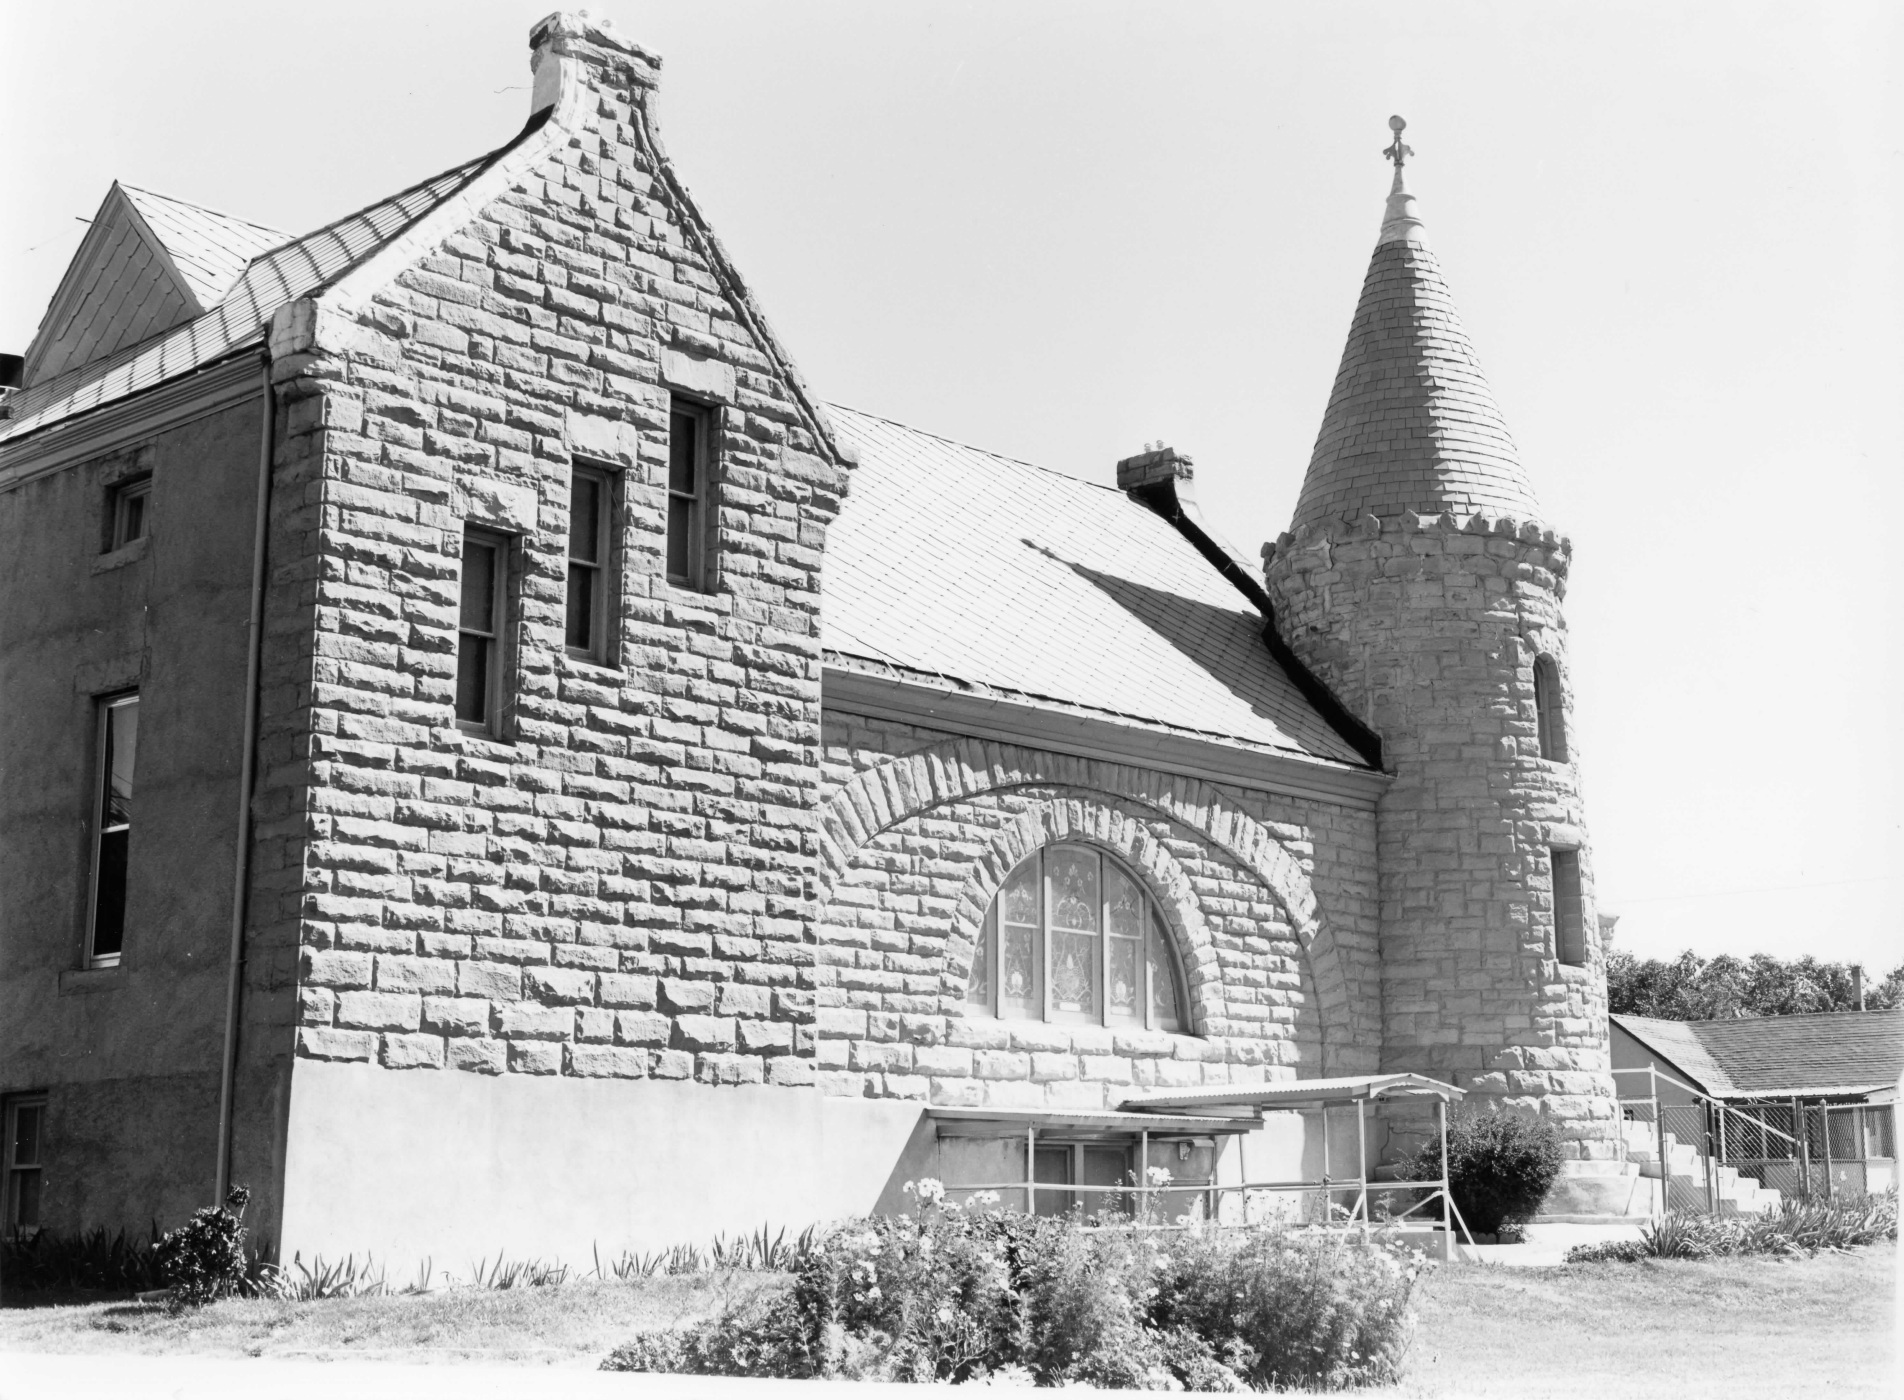
First Baptist Church
Las Animas County, CO
#5

| <u>Photo #</u> | <u>Description</u> |
|---|--|
| 5 | southwest corner; camera facing northeast |

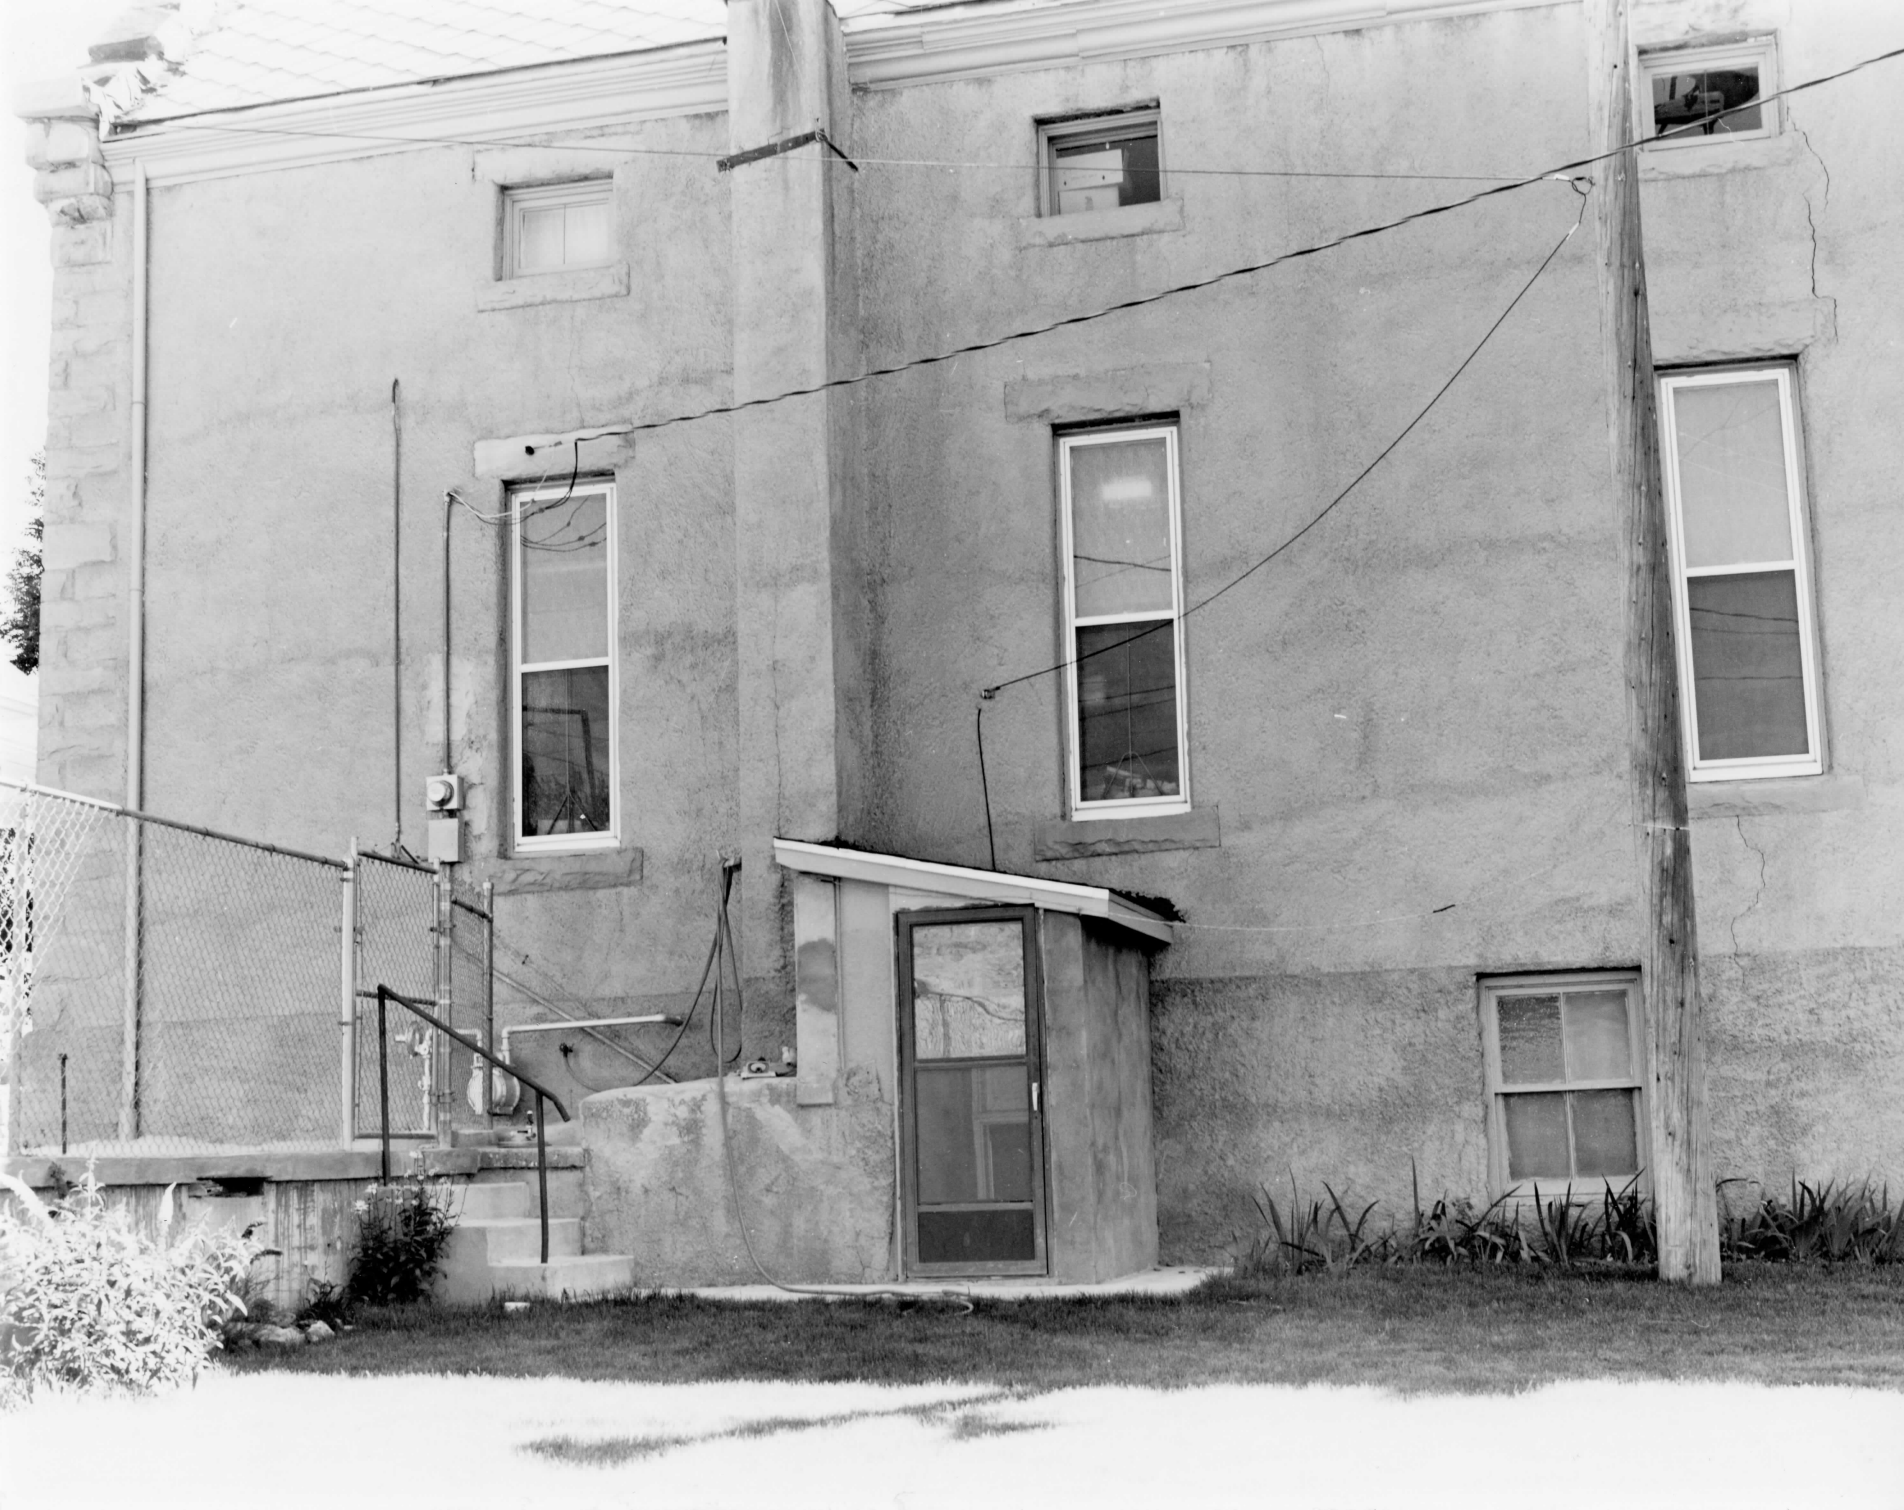
| <u>Photo #</u> | <u>Description</u> |
|---|--|
| 6 | west end (rear) of church; camera facing northeast |

The rear (west side) of the church is covered with stucco. Blocks of stone form lintels and sills for the six original windows that punctuate this two-story portion of the building. There are three, tall, double hung sash windows on the main level with three small, single sash windows directly above. An offset square chimney projects out from the wall and a small shed roof addition is connected to it. This addition covers the door that accesses the kitchen in the basement. To the right of this entrance is a double hung 2-over-2 light basement window. To the left of the entrance are three concrete steps that lead to a raised concrete pad.

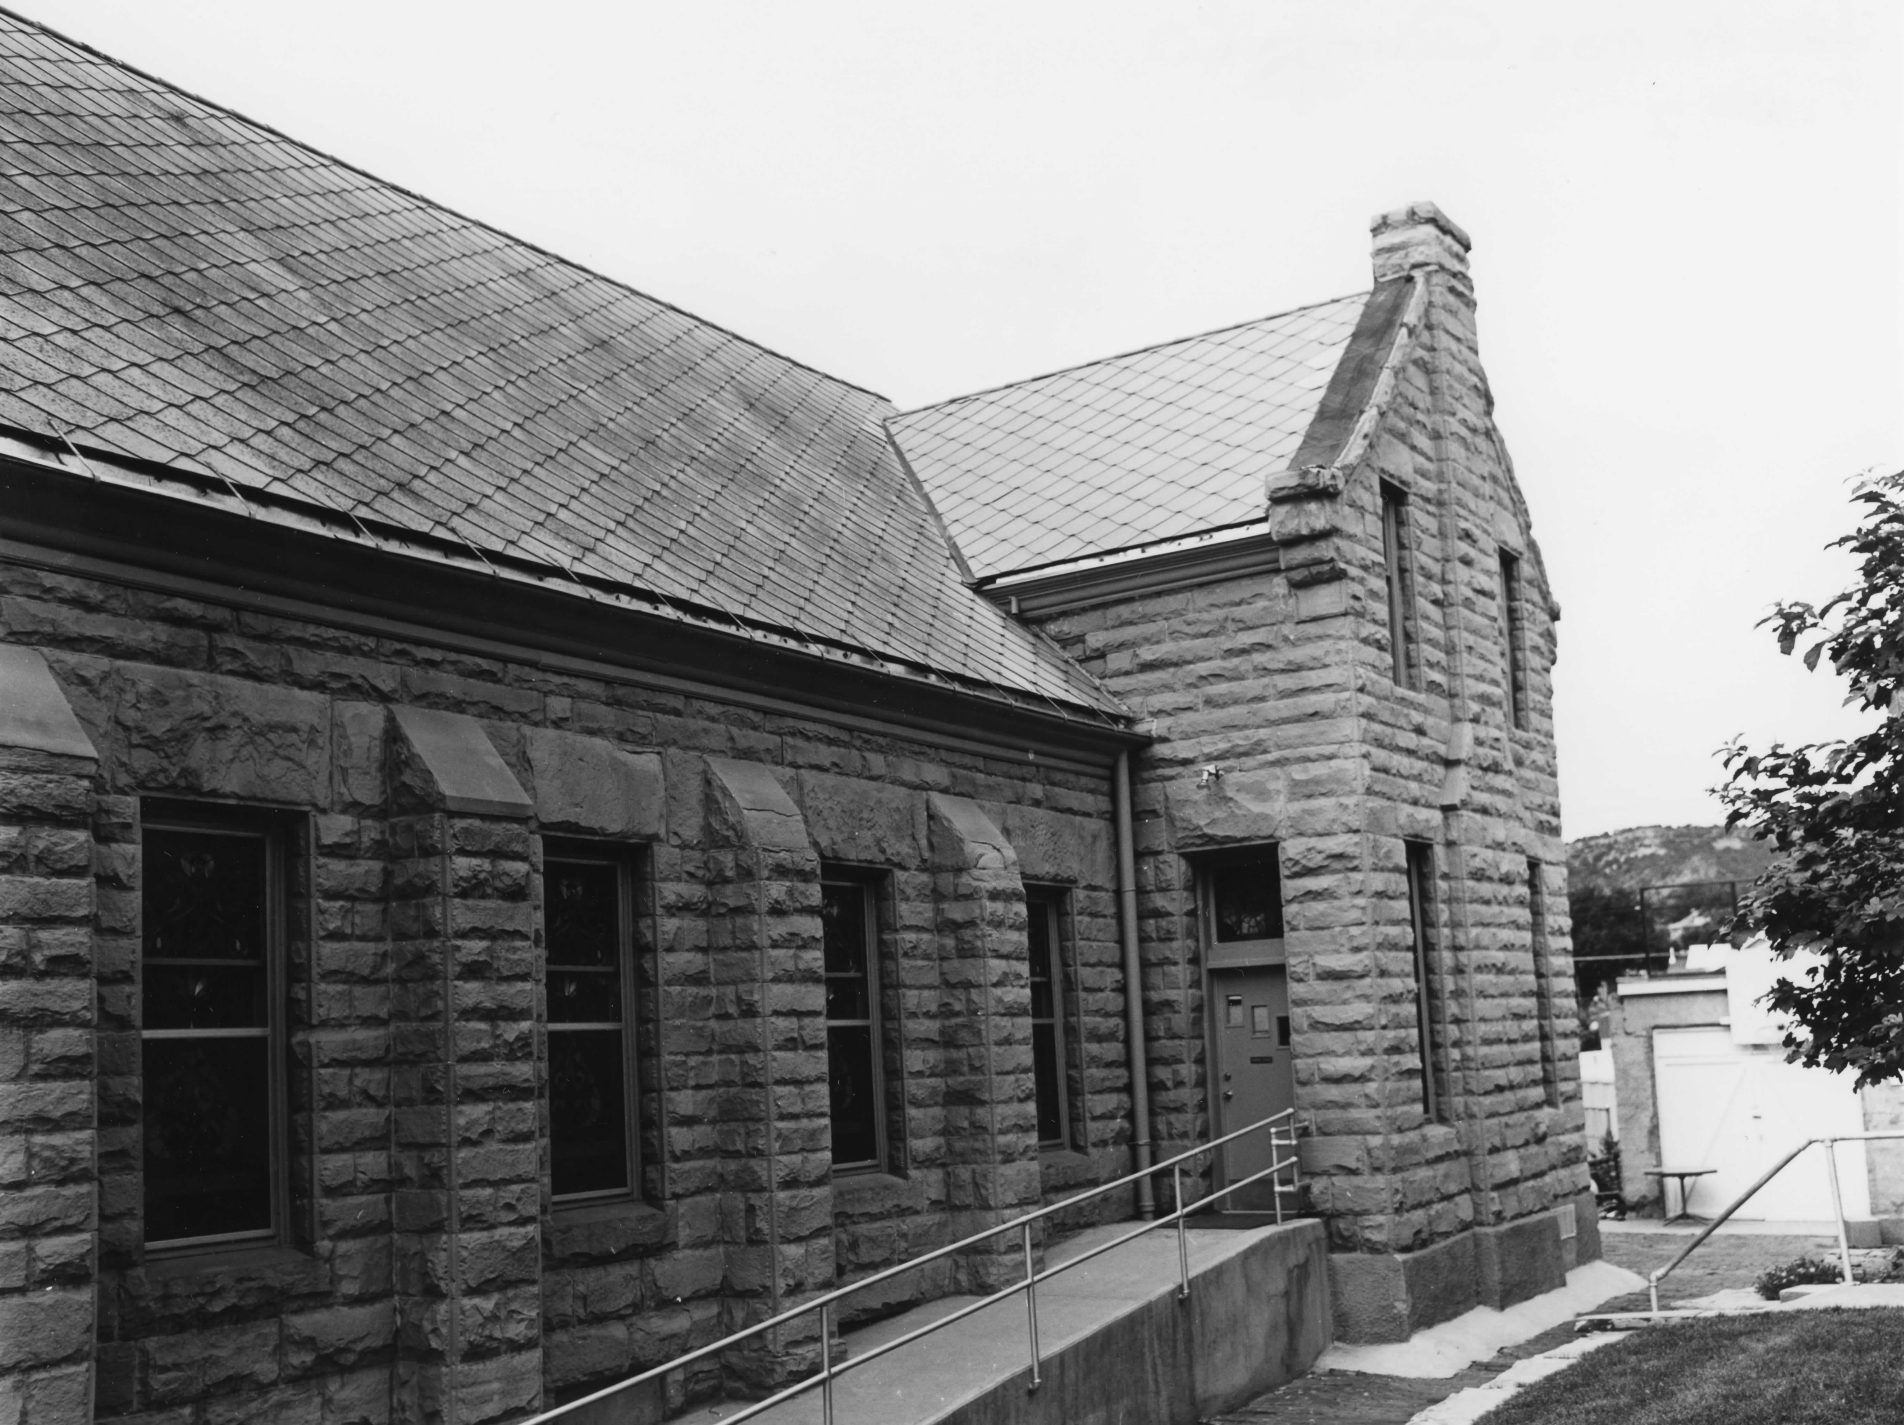
| <u>Photo #</u> | <u>Description</u> |
|---|--|
| 7 | north side; camera facing southwest |

The north side is divided into five bays by the employment of four buttresses. Five, tall, flat-headed, double hung sash windows filled with stained glass are aligned with five small basement windows. Three of the basement windows are obstructed by a concrete ramp with metal pipe railing that parallels much of the building on its way to an entrance into the north transept. The door contains three small stepped windows and has a large stained glass transom. The cross section is a two-story space that contains the sanctuary and office, with classrooms on the second floor. Bisecting the transverse gabled end is a slight chimney-like projection. There are four windows flanking this projection--two on the main floor with two directly aligned on the upper level.
