National Register of Historic Places Registration Form

historic name First Baptist Church

street & number 809 San Pedro Street [N/A] not for publication

First Baptist Church
Las Animas County, CO

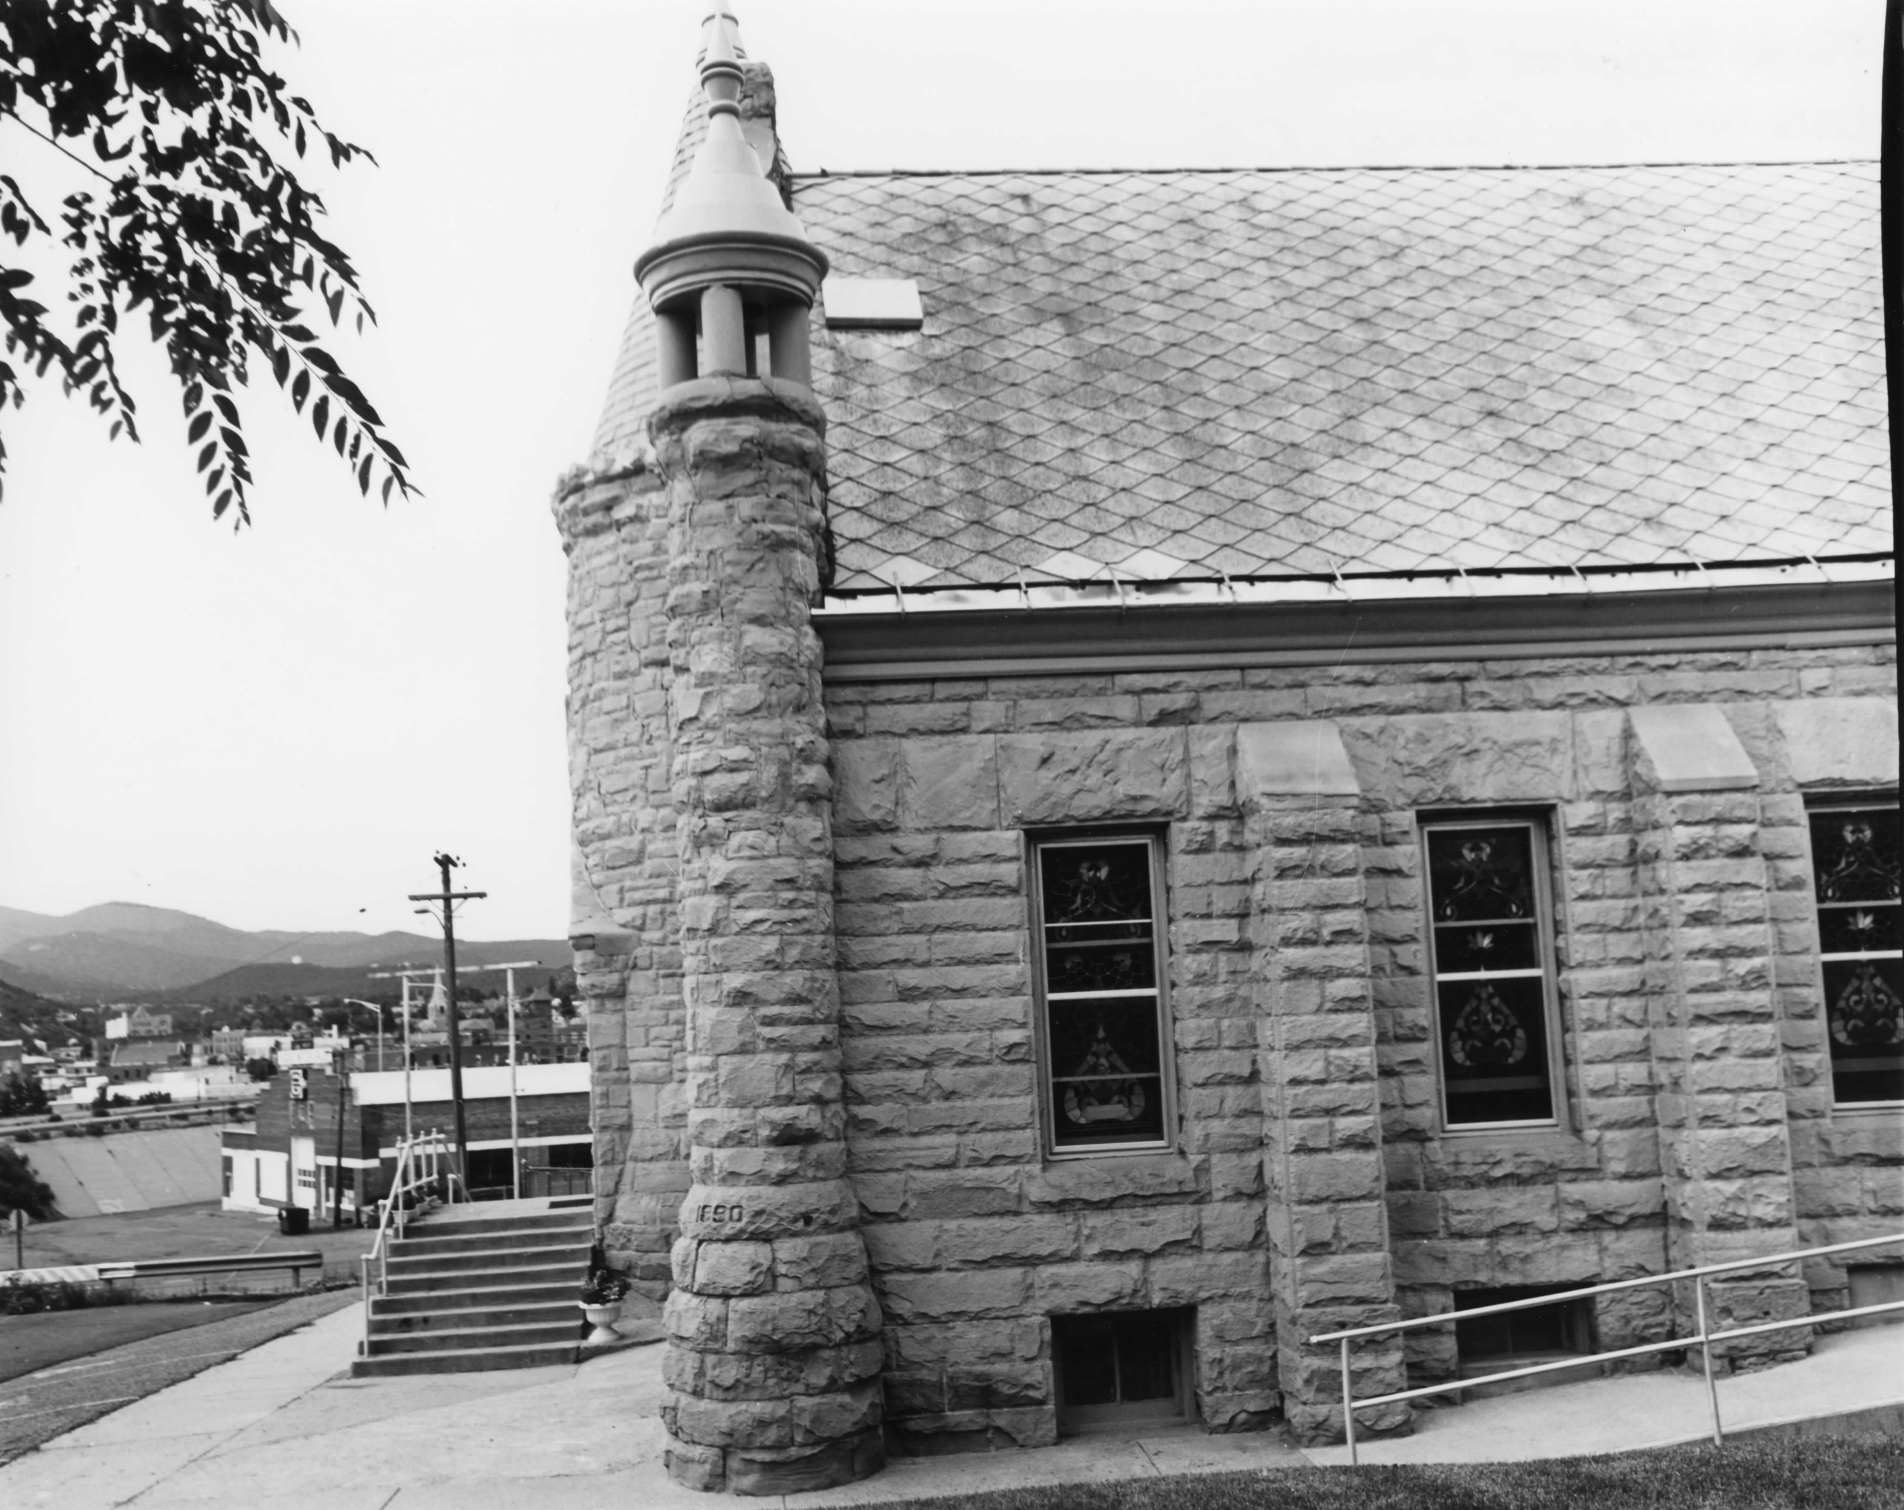
#8

| <u>Photo #</u> | <u>Description</u> |
|---|--|
| 8 | northeast corner with pinnacle; camera facing south |
