United States Department of the Interior National Park Service National Register of Historic Places Registration Form

historic name Bauer Bank Block

other names/site number Bauer Bank Building / 5MT8590

street & number 107 West Grand Avenue [N/A] not for publication

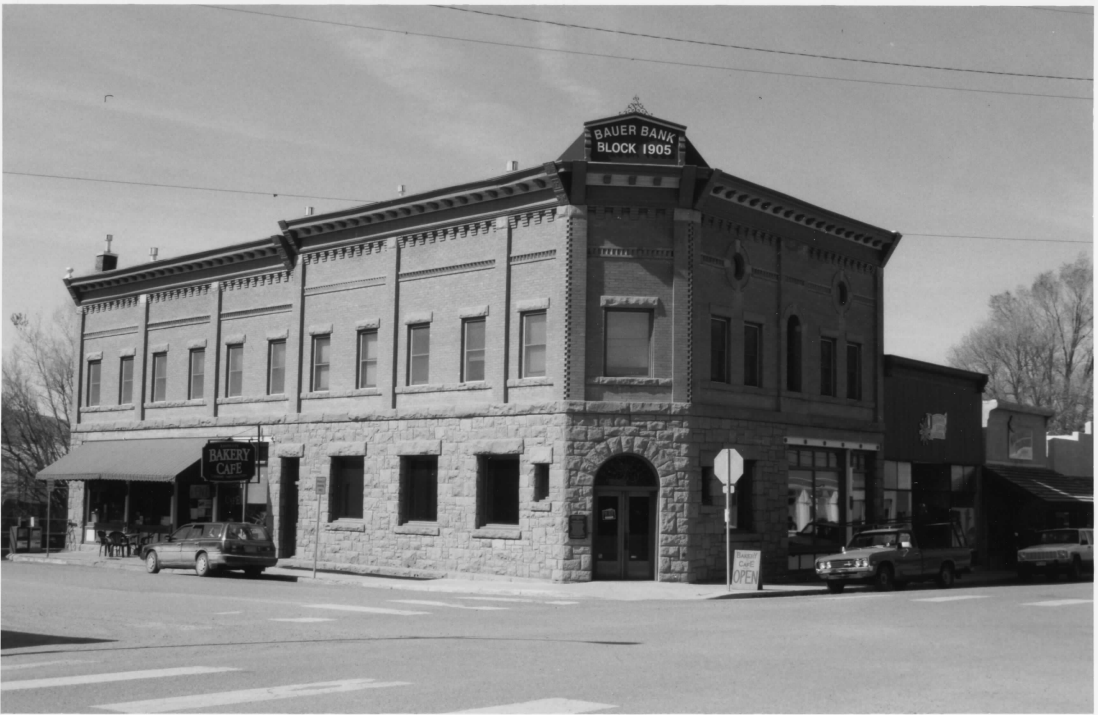
<u>Photograph #</u>	<u>Description</u>
1	Northeast corner of building at the intersection of Main Street and Grand Avenue; looking south-southwest.
2	North side of building; looking south
3	East side of the building and partial view of south side (rear) of the building; looking northwest
4	South (rear) side of the building with pedestrian bridge extending south from the building towards the camera; looking north.
5	North and west sides of the building; looking southeast.

The oblique northeast corner has a round-arched entry with radiating voussoirs, a leaded and beveled glass semi-circular transom above glazed oak framed double doors with brass hardware. The town's United State Geological Survey (USGS) benchmark is located in the wall next to the entry. A brass plaque commemorating the building's restoration in 1998 is located to the left of the door. The upper story is framed by the interlocking brickwork of the pilasters converging at the juncture of the corner and the sides. The second floor has one large fixed sash window. A name block with "Bauer Bank Block 1905" crowns the cornice and is topped by a wrought iron finial.
