First Congregational Church
630 Ohio Street
D. 1902-03

National Register of Historic Places
Inventory—Nomination Form

Name Downtown Terre Haute Multiple Resource Area
State Indiana

First Congregational Church (Downtown Terre
Haute MRA)
Vigo County
INDIANA

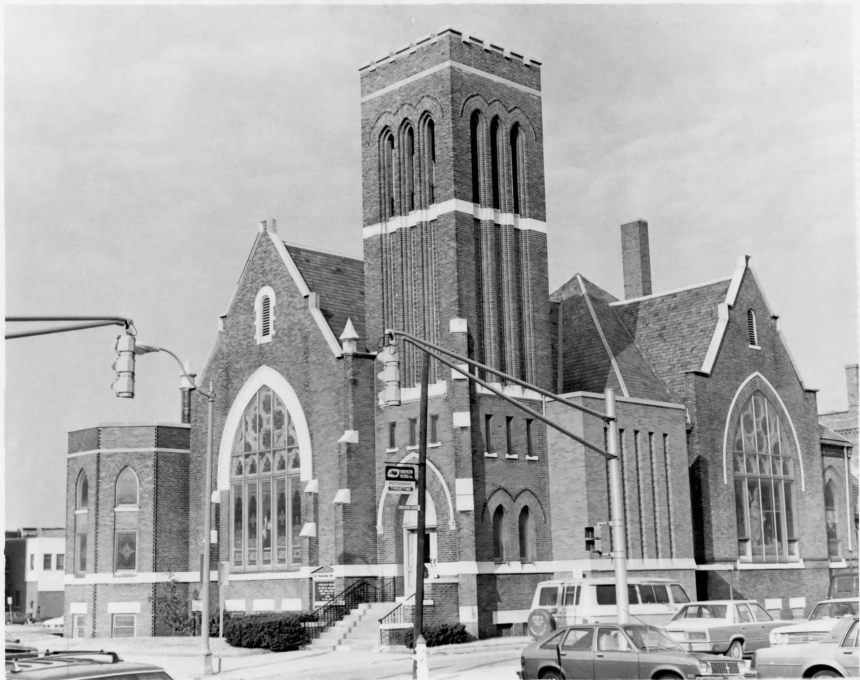
1. Historic Resources of Downtown
Terre Haute
2. Terre Haute, Indiana
3. Department of Redevelopment
4. February, 1981
5. Department of Redevelopment
6. Building # 68
7. Photo # 7 of 52

The First Congregational Church is a large neo-Gothic church building located at the northwest corner of Ohio Street and Spectator Court, near downtown Terre Haute. Built in 1902-1903, it is constructed of buff-colored brick with limestone trim and opalescent glass windows. Some alterations and additions were made to the church in 1962, but these were sympathetically executed and do not detract from the building's overall plan.

In plan, the church originally resembled a cross, with the nave running north/south and the transept running east/west. The slate-covered roof was of a high-pitched gable design, except at the crossing where it became pyramidal. The gable ends of both the nave and the transept features monumental pointed arch window openings with stone hood molds, and the windows, themselves, featured wooden tracery with pointed arch and quatrefoil motifs. Limestone trim was also used in the building's window hood molds and sills, water table, weatherings, and gable coping. These elements survive intact.

On the southeast corner of the nave is the church's square bell tower, which also contains the main entrance. This tower features a single buttress at its southeast corner, and on its upper levels features an arcade of three, tall, slender, pointed arch windows on each facade. These windows are bisected by a stone belt course which runs around the perimeter of the tower; limestone is also used to form a more delicate string course above these windows and to form a base for the tower's crenellated parapet. The original spire which rose from this tower has been removed.

In a 1962 remodeling, an addition was made to the southwest side of the nave. Constructed of similar buff brick, this addition features pointed arched windows, a stone water table, and a polygonal south facade. Another small addition was attached to the east side. Designed by local architect and church member, Juliet Peddle, the scale and design of these additions is such that they remain sympathetic to the original structure.

meeting halls, the building is particularly notable for its square tower, limestone capped buttresses, its lancet windows, and its stone water table and coping.
