National Register of Historic Places  
Registration Form

historic name Norway Historic District  
other names/site number \_\_\_\_\_

street & number Parts of Main, Cottage, Deering, Whitman Streets N/A not for publication  
city, town Norway, N/A vicinity  
state Maine code ME county Oxford code 017 zip code 04268

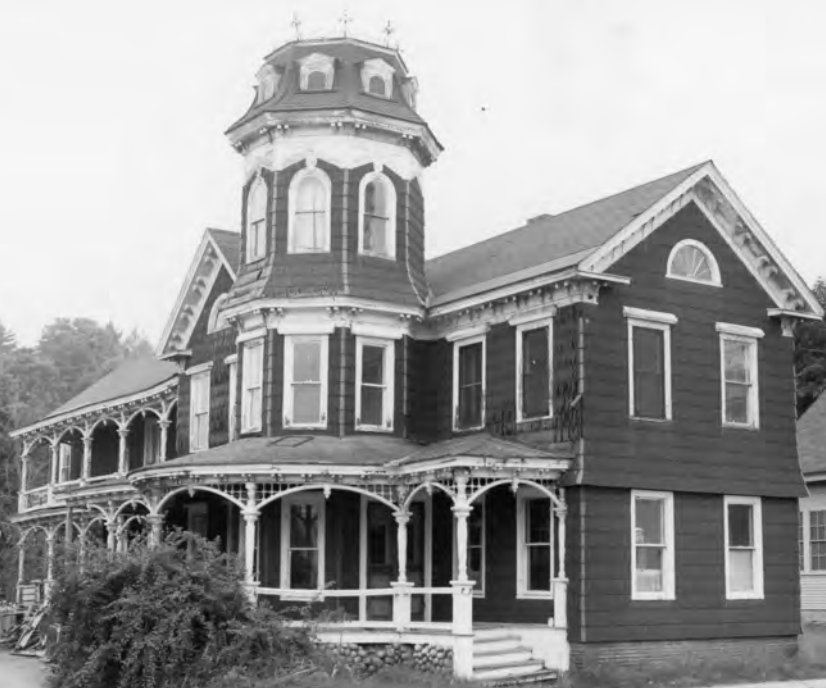
PHOTO 5

EVANS - CUMMINGS HOUSE, NORWAY  
HISTORIC DISTRICT

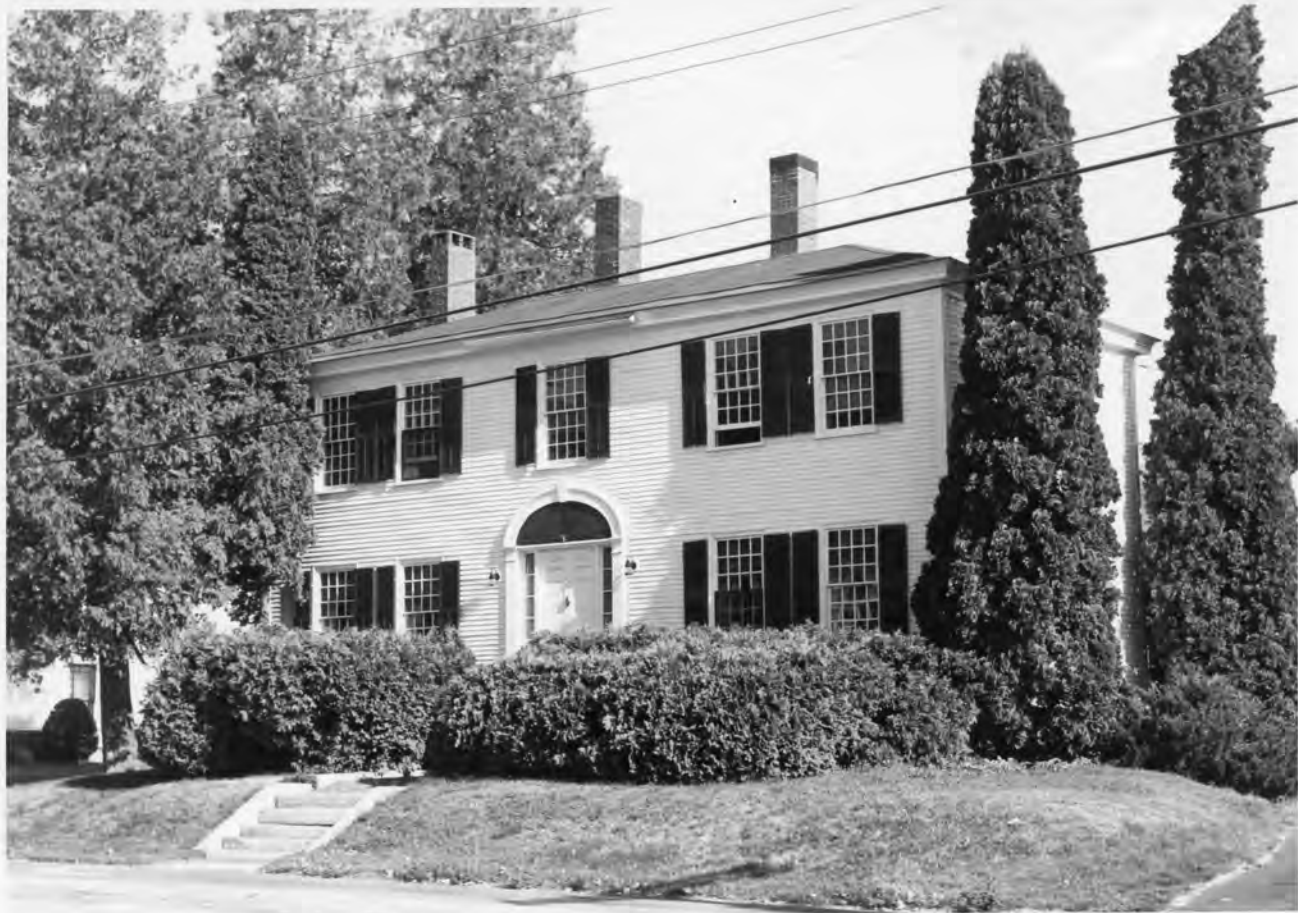
PHOTO 6

INCREASE ROBINSON HOUSE  
NORWAY HISTORIC DISTRICT

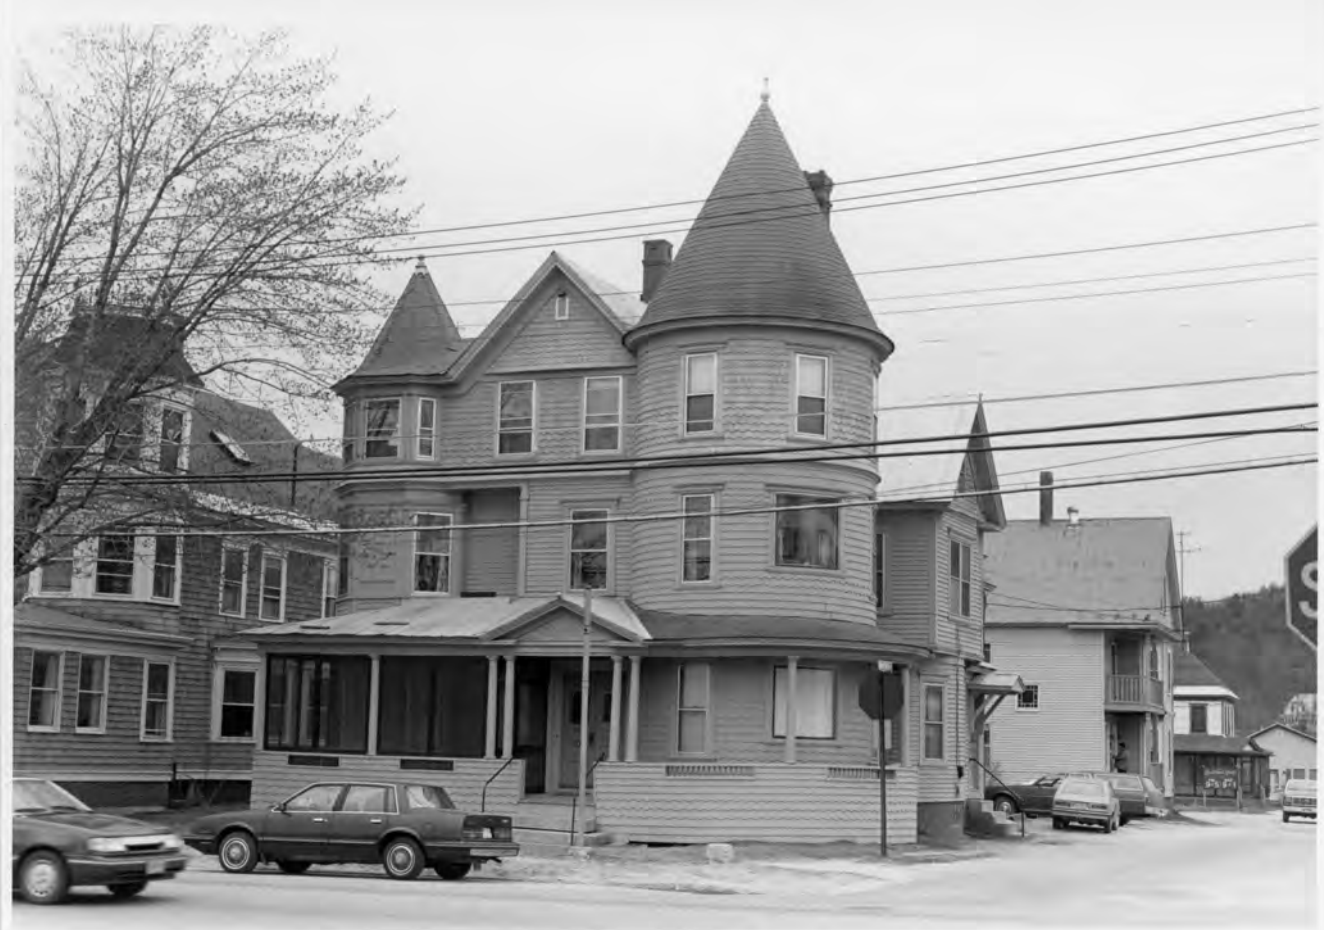
PHOTO 17

DR. FRANK BARKER House,  
NORWAY HISTORIC DISTRICT

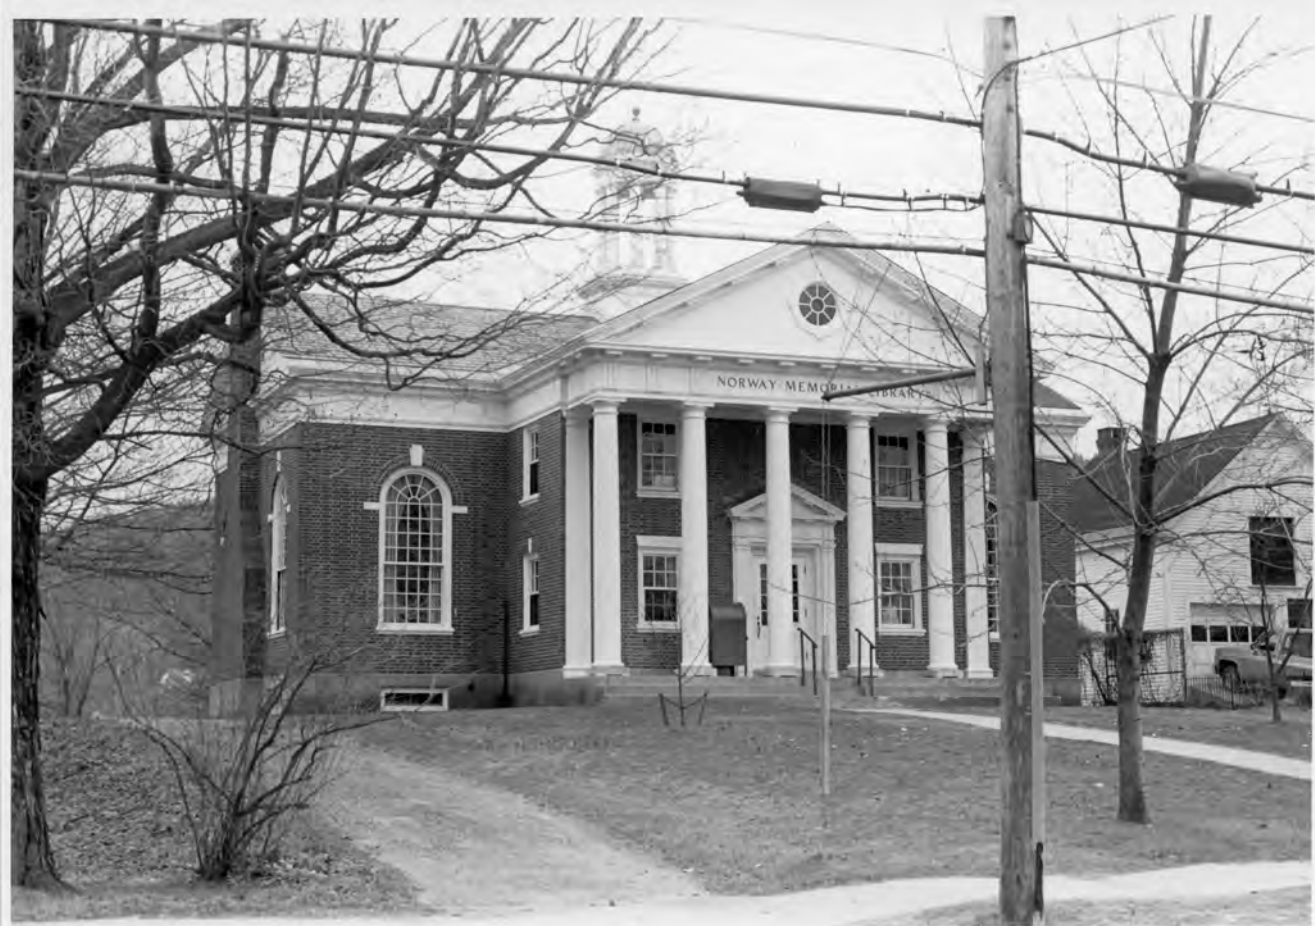
PHOTO 8

NORWAY MEMORIAL LIBRARY,  
NORWAY HISTORIC DISTRICT

Prior to the United States' entry into World War II, a pair of large brick buildings were constructed within the limits of the historic district. Interest in providing a public library for the residents of Norway culminated in 1885 with the founding of the Norway Library Association. In 1938 local commitment to the library was underscored by the construction of the Norway Memorial Library (22), a handsome Georgian Revival building designed by William B. Coffin of Boston. Finally, the federal government built the present post office (29) in 1940. The design of both of these buildings maintains in material, scale and design the cohesiveness that characterizes the district. They are also the most significant Depression era resources in Norway, and their construction in the latter years of the period is a distinctive reminder of improving local economic conditions after nearly a decade in which no major additions were made to the historic district.

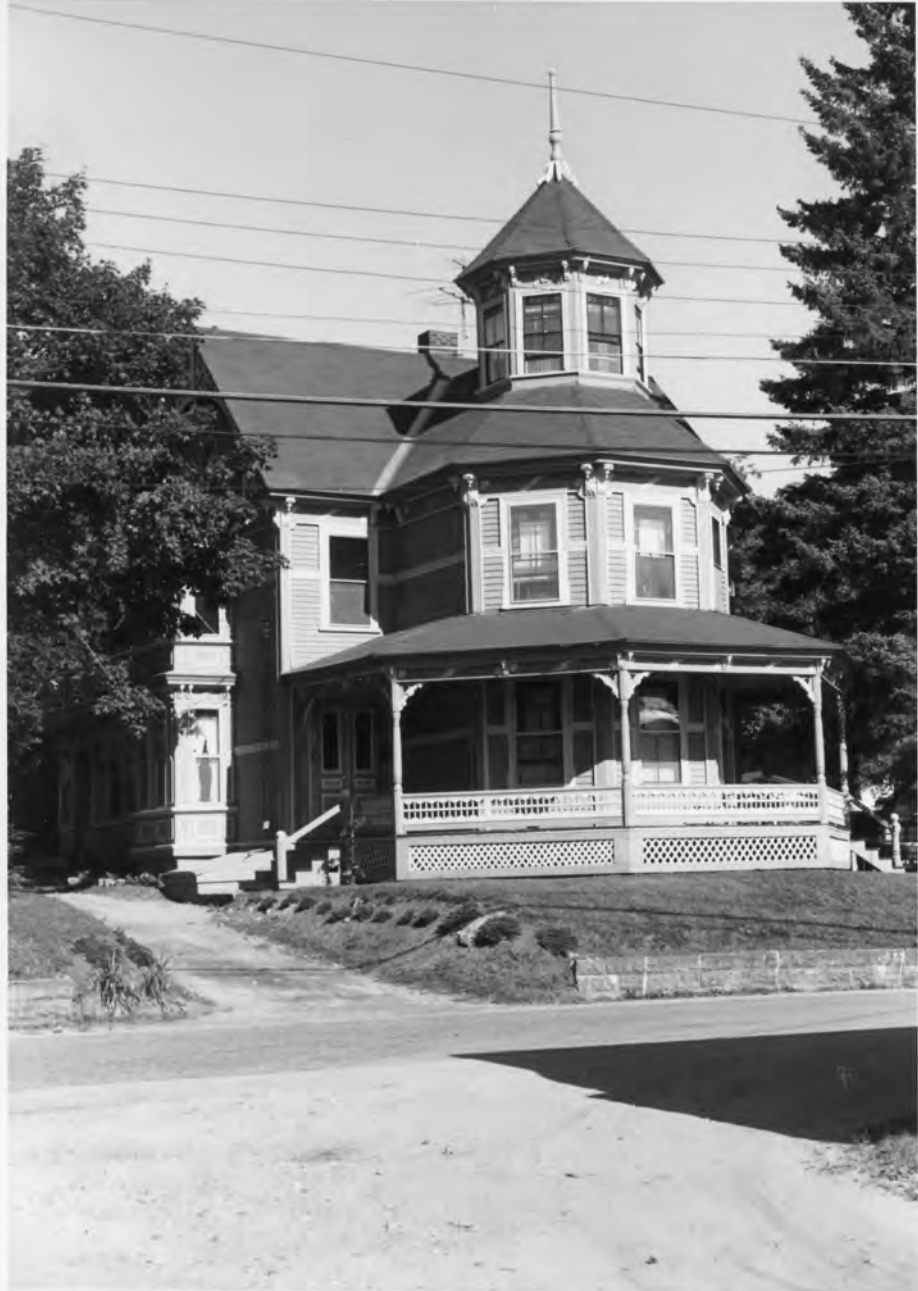
8/87  
MHPC  
VIEW FROM EAST  
PHOTO 10

STEPHEN + EDWIN CUMMINGS HOUSE,  
NORWAY HISTORIC DISTRICT,  
NORWAY, MAINE  
ROGER G. REED

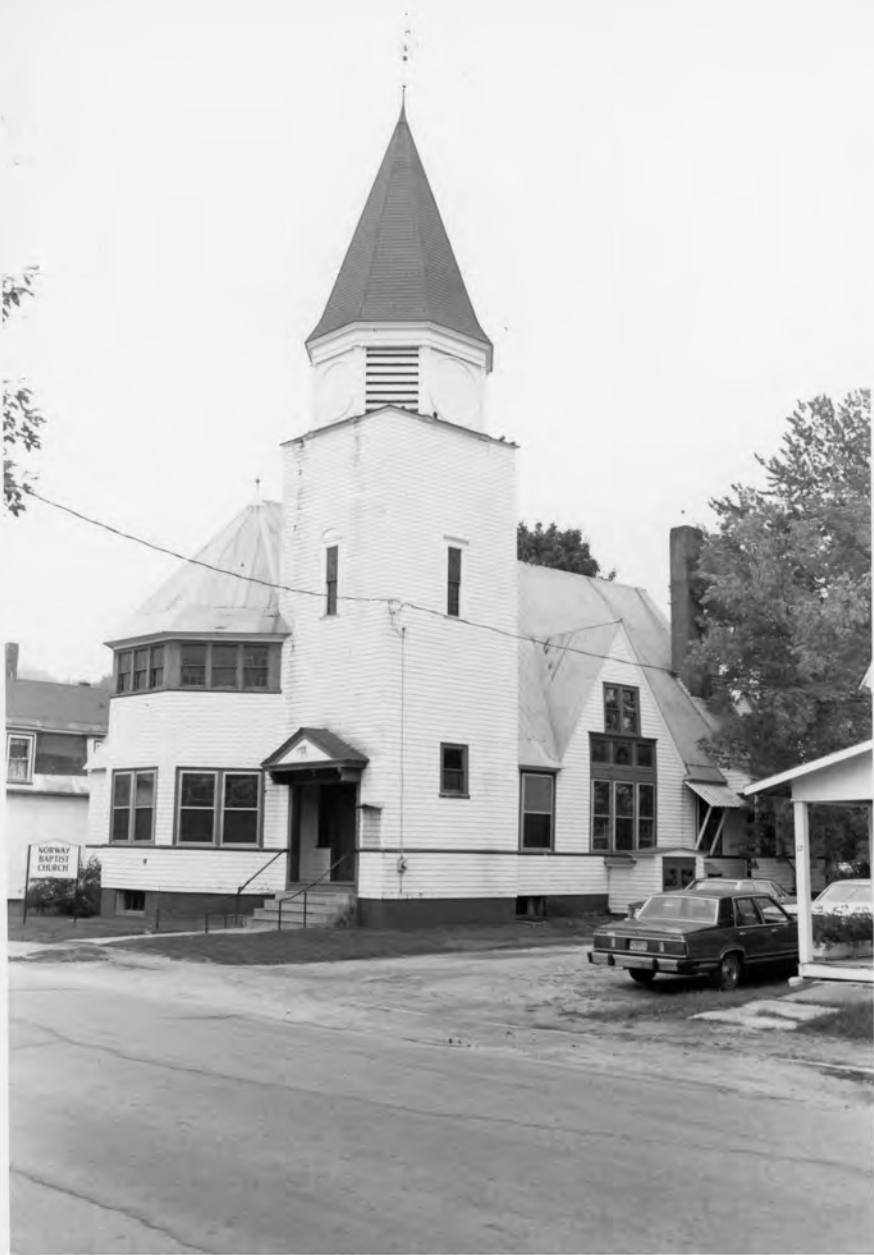
PHOTO 11

BAPTIST Church, NORWAY

| <u>Site No.</u> | <u>Address</u> | <u>Description</u> |
|---|---|--|
| 62 | 10 Cottage St. | Baptist Church - C<br>1889<br>Stevens & Cobb of Portland, Architects<br>This one-and-a-half-story church is a wood-frame structure with shingle siding, a gable roof and a corner tower. The rectangular building has a polygonal two-story bay roof. the windows, most of which have double-hung sash, have either stained glass or multi-pane over single pane lights. Exterior decorative detail is minimal, the pedimented portico over the entrance being a notable exception.<br>This church is architecturally important as one of a series Stevens and Cobb designed for Baptist Societies in Maine during 1888-89. These architects, who had a national reputation, developed a basic scheme which was used in variations for the Baptist Churches in Gardiner (1888), Westbrook (1888), Yarmouth (1889), Skowhegan (1889), and Sanford (1889). The Norway Baptist Church, built at a cost of \$4,000, was the most inexpensive version. In plan, the characteristic features are |

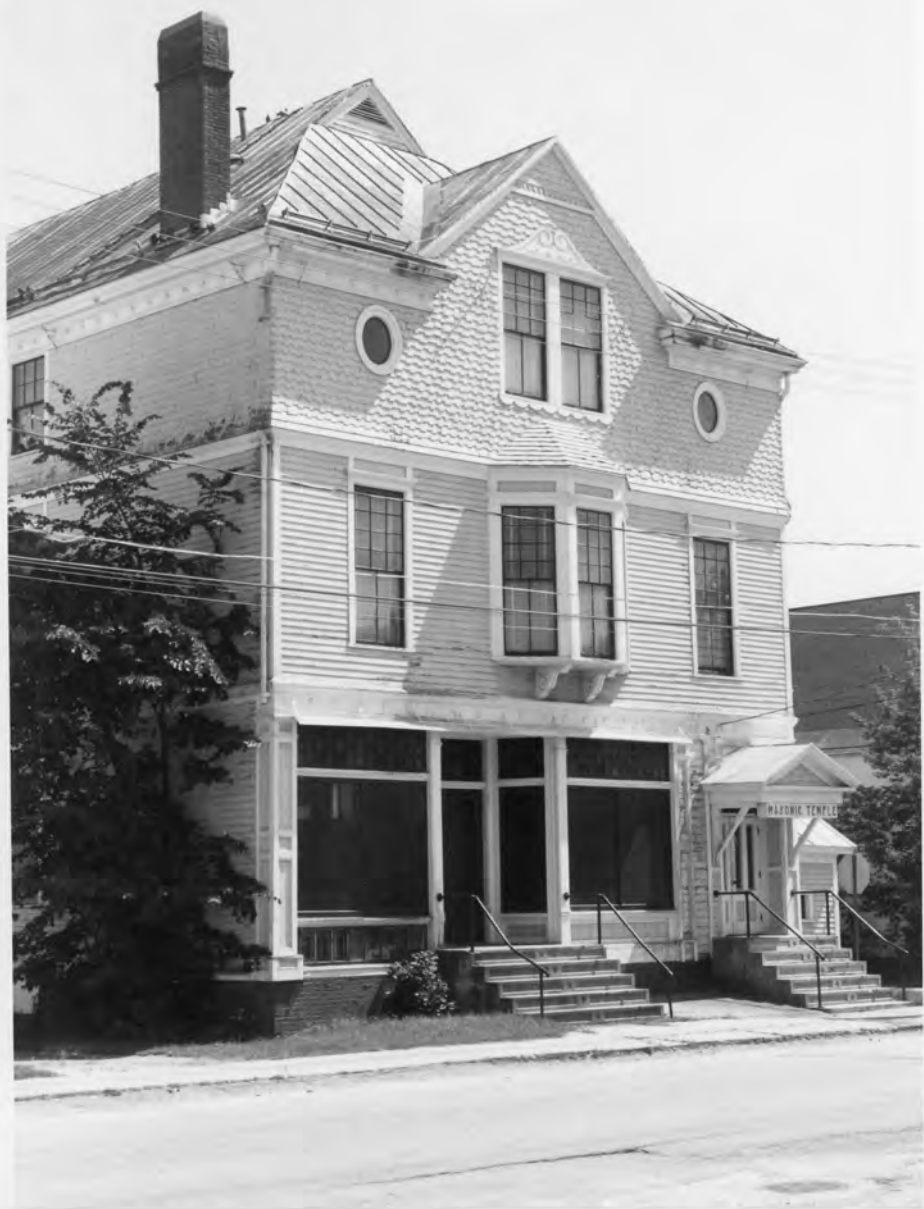
MASONIC TEMPLE, NORWAY

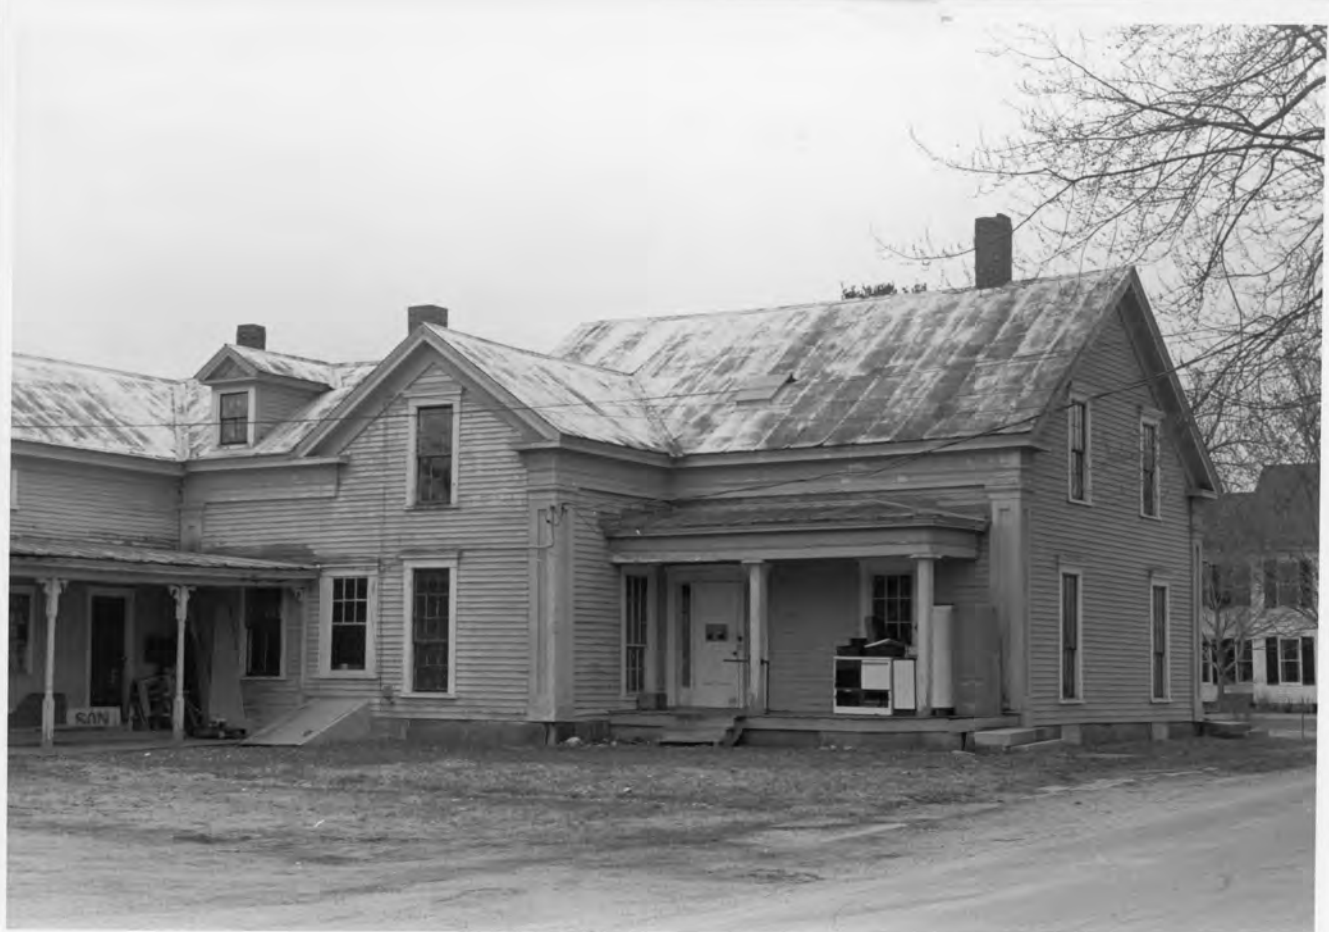
PHOTO 13

CLEMENT-NOYES HOUSE  
NORWAY HISTORIC DISTRICT

| <u>Site No.</u> | <u>Address</u> | <u>Description</u> |
|---|---|--|
| 51 | 13-15 Deering St. | <p>Clement-Noyes House - C<br/>c. 1837</p> <p>Constructed as a double-house, this one-and-a-half-story residence is of timber frame construction with clapboard siding. The Greek Revival style structure has cornice returns and pilasters supporting a full entablature. Each window has a cornice and the two principal entries have a cornice with sidelights. The windows are either nine-over-six or six-over-six double-hung sash. Original hipped roof porches flank the rectangular main section, but square posts have replaced columns or piers. Extending from the south side is a one-and-a-half-story wing with a porch supported on turned posts with brackets.</p> <p>Clement Noyes was a local carpenter who built this house about 1837. With entries on either side of the main section, the house was evidently constructed for two families. Sometime during the middle of the century two perpendicular wings were</p> |
