## **National Register of Historic Places Registration Form**

#### Stuntz Bay Boathouse Historic District

#### Saint Louis County MN County and State

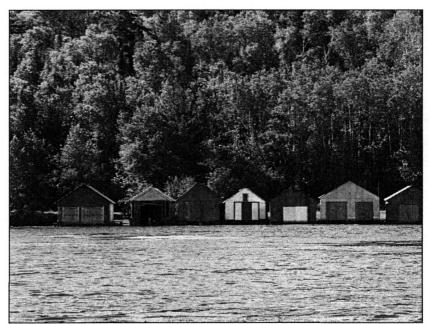
Boathouse Nos. 105-111. View to south.

Most of the boathouses rest on wood skids made from round logs or sawn timbers. The skids are placed perpendicular to the shoreline and project out over the water. Each skid is supported on one end by the ground (occasionally reinforced by rocks or additional timbers) and at the opposite end by stacked-wood cribs set in the water. The interiors of the cribs are filled with rock for stability. In rare cases, there are wood or steel pilings instead of crib footings.

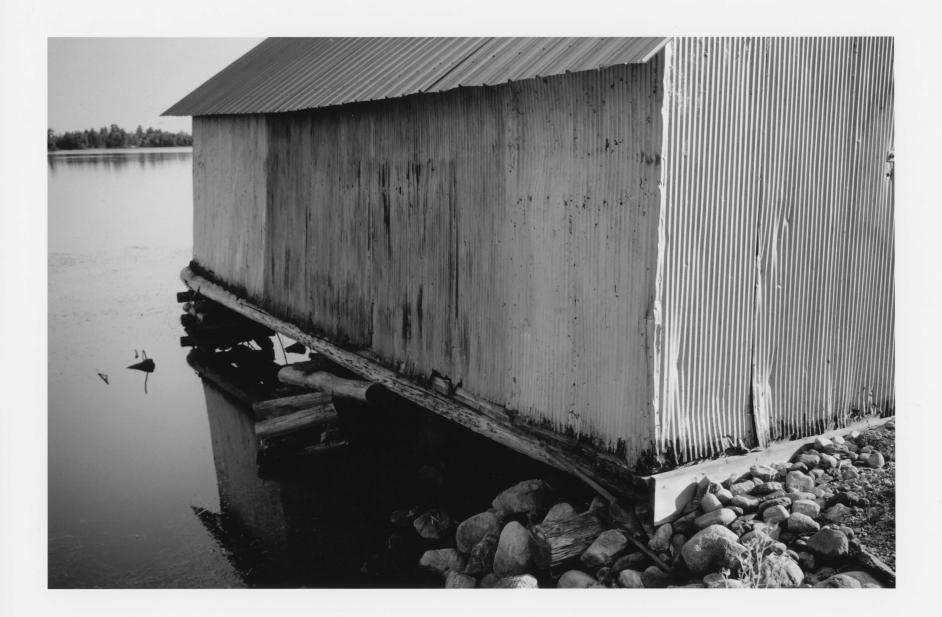
# 13. Stuntz Bay Boathouse Historic District
Tower vicinity, Saint Louis County, MN
See Index to Photographs for caption.

Boathouse NO. 140 Showing crib footings & LOG SKID ON West facade
LOOKING NE

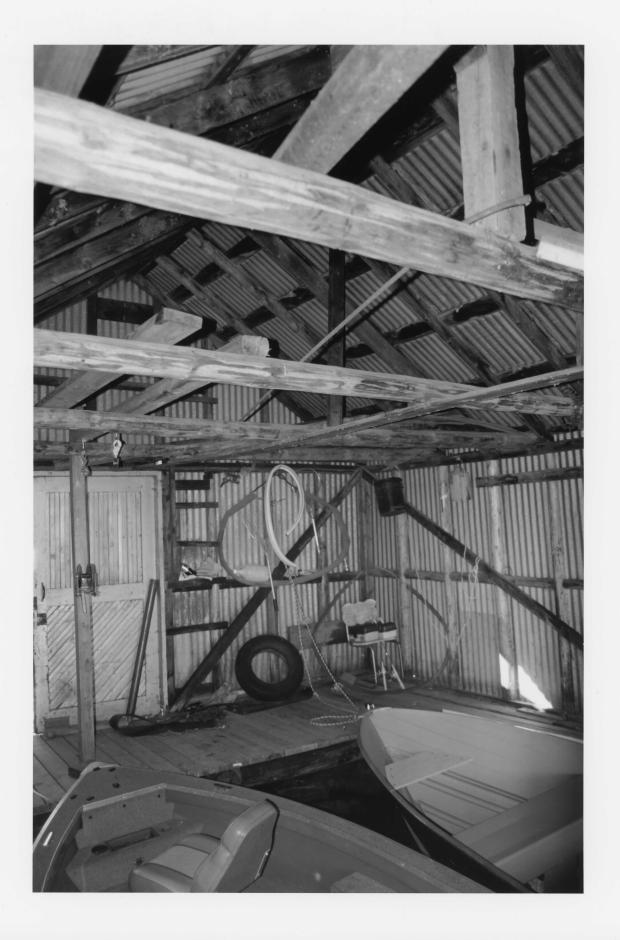
# 14. Stuntz Bay Boathouse Historic District Tower vicinity, Saint Louis County, MN See Index to Photographs for Caption.

Boothouse NO. 131, Interior

The interiors of the boathouses are typically utilitarian and unadorned, with exposed framing and siding. Cantilevered catwalks with wood plank flooring line three sides of the interior, allowing easy access to the boat. In some cases, the catwalk is angled on the shore end following the profile of the bow of the boat, which provides additional floor area within the building.

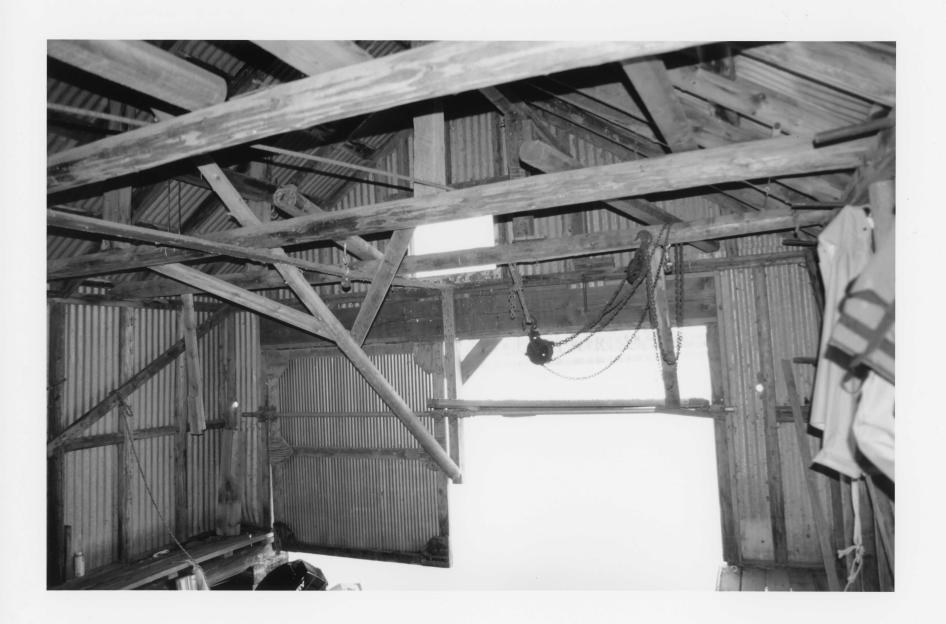
# 15. Stuntz Bay Bouthouse Historie District Tower vicinity, Saint Louis County, MN See Index to Photographs for caption:

Boat house No. 131, Interior

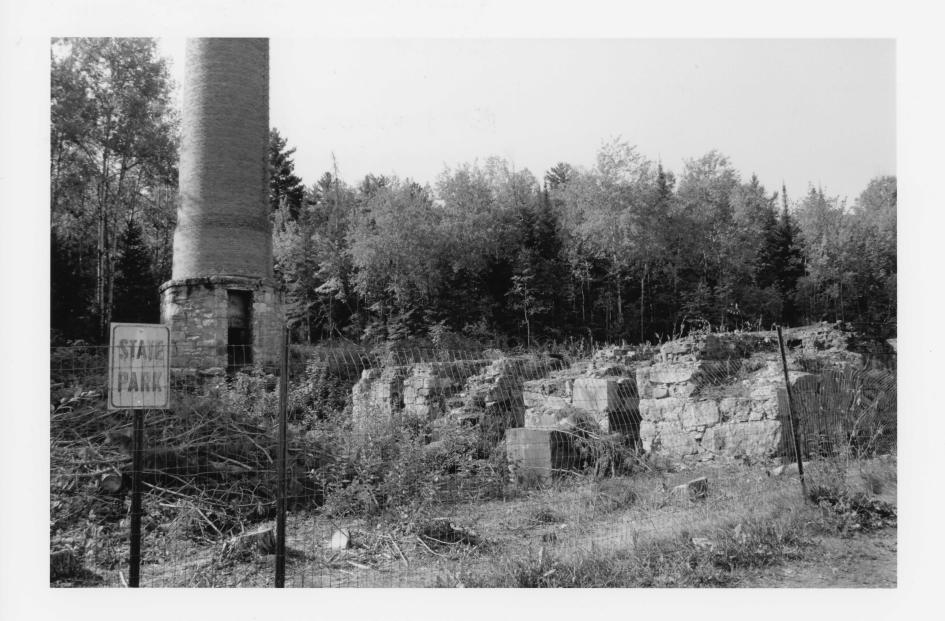
# 16. Stuntz Bay Boathouse Historic District Tower vicinity, Saint Louis County, MN See Index to Photographs for caption.

> Compressor Plant Ruins ? Smokestack Looking SW

The smokestack has an octagonal base of rubble stone about ten feet in height. A cylindrical, red brick chimney approximately twelve feet in diameter stands on top of the base. Several feet above the base is a band of eight courses of dark brown brick that corbel inward. The chimney narrows slightly as it extends upward an additional sixty to seventy feet. Near the top of the chimney is a band of corbelling that forms a rounded ring. The smokestack appears to be in fair condition, although the brick shows signs of spalling.

The foundation ruins of the compressor plant are mostly stone topped with a few courses of crumbled brick. The ruins are somewhat overgrown with grass and weeds, but the rectilinear plan and approximate dimensions of the building are still evident.
