NATIONAL REGISTER OF HISTORIC PLACES NOMINATION, GLACIER NATIONAL PARK

STRUCTURE NAME: Upper Kintla Lake Patrol Cabin STRUCTURE NUMBER: 613

Upper Kintla Lake Patrol Cabin (addendum), Flathead County, MT.

Section number 7 Page 2 Upper Kintla Lake Patrol Cabin (addendum), Flathead
County, MT.

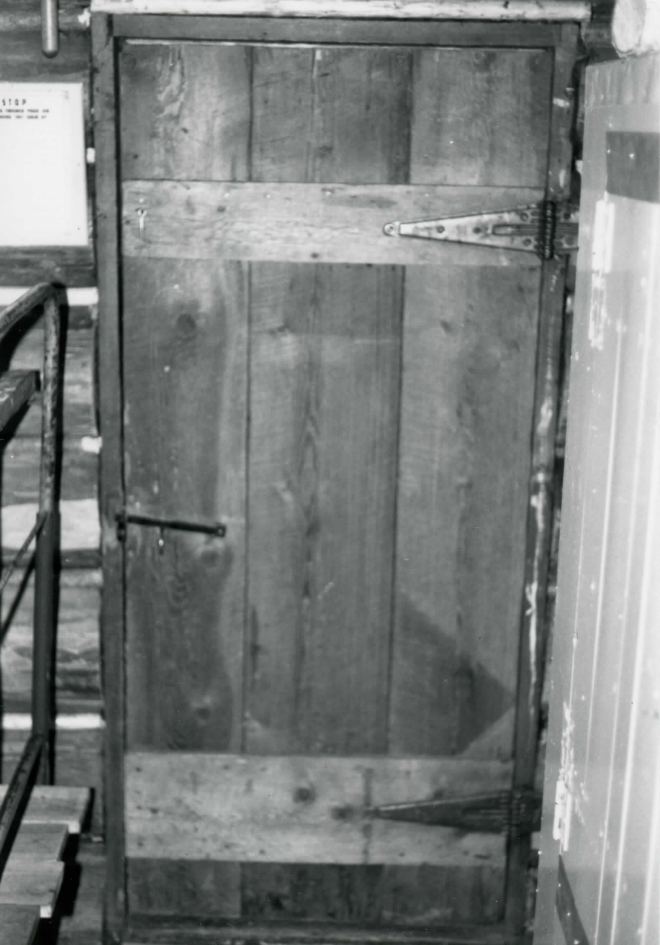
Figure 1

A heavy door, constructed of three 8"-12" planks secured with horizontal braces, provides access to this simple one-room cabin where 7" planks, painted grey, cover the floor. The trap door to the concrete-lined cellar

Interior

Door

PHOTO NUMBER	STRUCTURE NAME AND NUMBER	LOCATION/DIRECTION OF VIEW
1	Upper Kintla Lake Patrol Cabin (#613)	Interior-door detail
2	Upper Kintla Lake Patrol Cabin (#613)	Interior-unusual bedding-storage cupboard

A heavy door, constructed of three 8"-12" planks secured with horizontal braces, provides access to this simple one-room cabin where 7" planks, painted grey, cover the floor. The trap door to the concrete-lined cellar

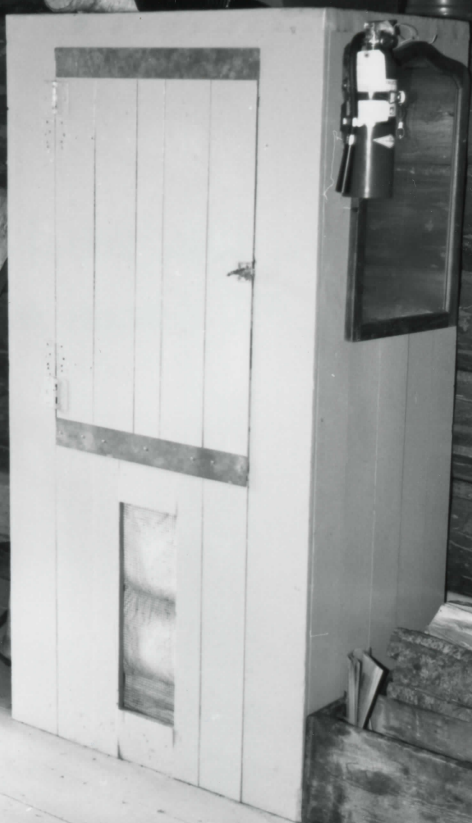
Figure 2

is located just off-center, near the wood box. The ceiling is open to the roof exposing the log purlins and roof planks. Full logs, chinked with sapling, form the interior walls. Furnishing include a standard wall-mounted cupboard with hinged table top/door and a tall standing cupboard constructed of shiplap planks and holding folded up mattresses (a variation on the standard rodent-proof bedding boxes). A set of metal bunkbeds is located just to the right of the door and a folding bed rests against the east wall near floor space shared with the hinged table top. Coleman lanterns hang from the ceiling and a woodstove provides both heat and a cooking surface.

Interior

Cabinet

is located just off-center, near the wood box. The ceiling is open to the roof exposing the log purlins and roof planks. Full logs, chinked with sapling, form the interior walls. Furnishing include a standard wall-mounted cupboard with hinged table top/door and a tall standing cupboard constructed of shiplap planks and holding folded up mattresses (a variation on the standard rodent-proof bedding boxes). A set of metal bunkbeds is located just to the right of the door and a folding bed rests against the east wall near floor space shared with the hinged table top. Coleman lanterns hang from the ceiling and a woodstove provides both heat and a cooking surface.
