National Register of Historic Places Registration Form

historic name Farm Credit Building

street & number 206 South 19th Street

city or town Omaha

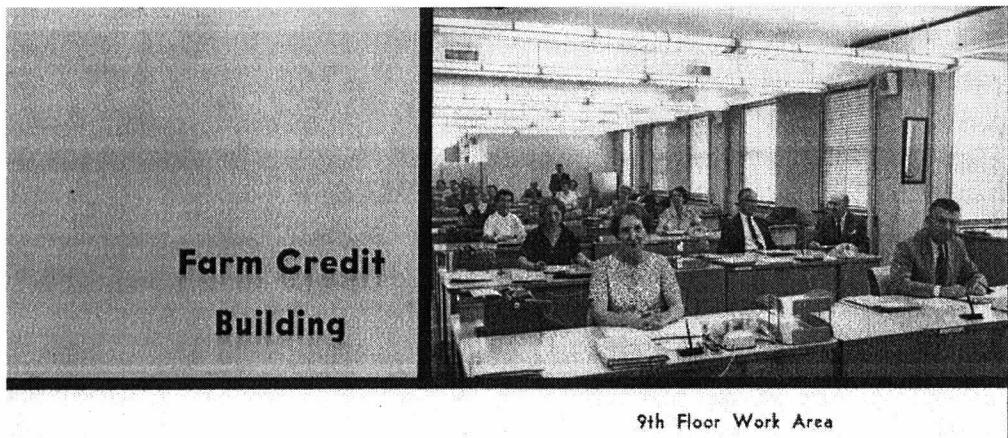
Figure 13:
1960 Booklet – page 2
From Farm Credit Services of America Archives

CONSTRUCTION The Farm Credit Building is a "U" shaped building consisting of an east wing and a west wing connected by a corridor on the north. Each wing has its own bank of elevators. The east wing, constructed in 1924, is twelve stories and basement in height. The west wing, built in 1934, is nine stories and basement in height.

SERVICES **Air Conditioning**—Air conditioning was installed in this building in 1939. It was one of the first office buildings in Omaha to be completely air conditioned. Two 225-ton compressors are required to air condition this building.

Elevators—Contracts have been let to replace the present elevators with new fully automatically-operated elevators. The savings which will result from the elimination of elevator attendants' costs will pay for this change. The new elevators will provide better service and enhance the appearance of the building.
