National Register of Historic Places
Registration Form

historic name East Andover Village Center Historic District
other names/site number _____

East Andover Village Center Historic District

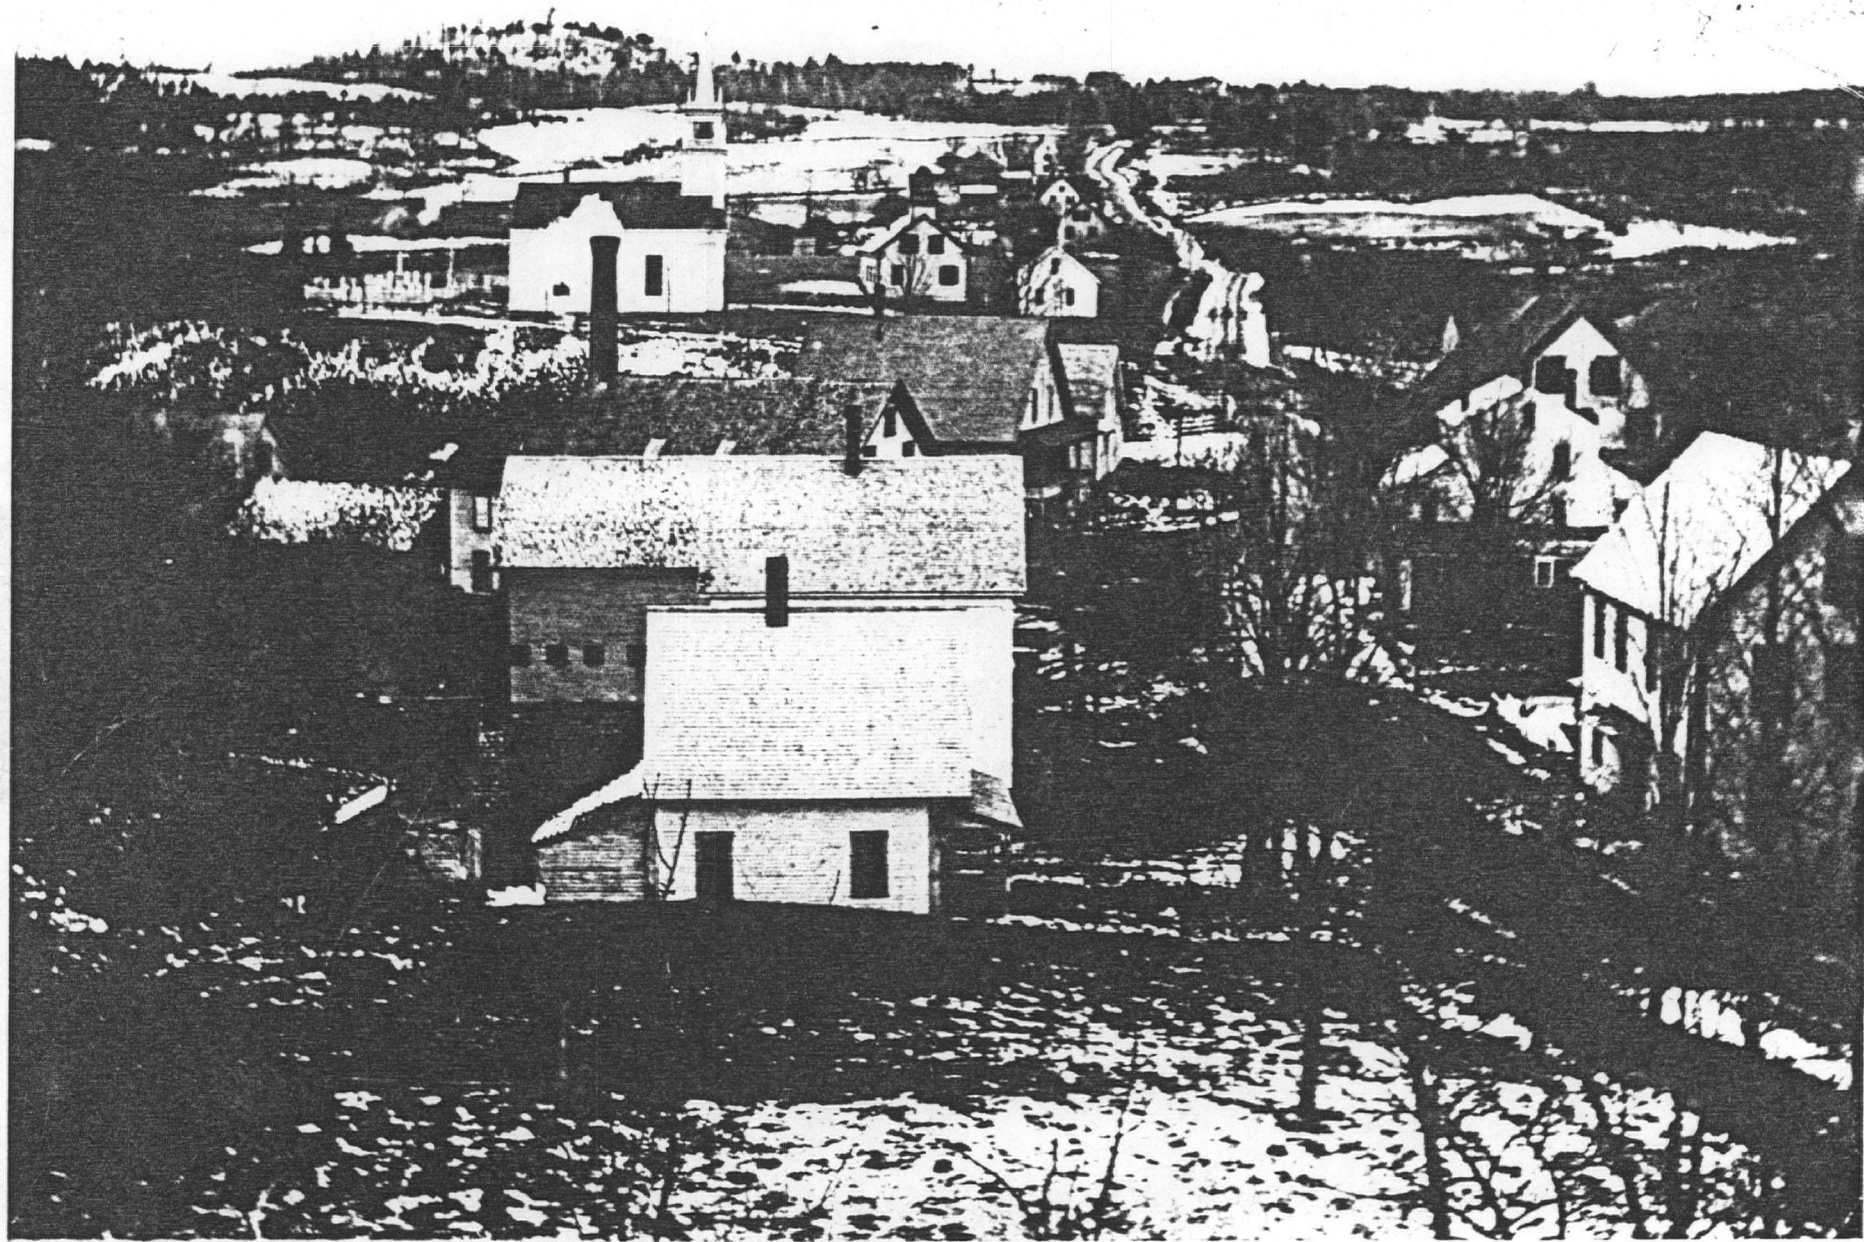
This photograph was taken before the construction of the present schoolhouse and shows the old schoolhouse to the right of the Grange Hall. Apparently taken between 1893 and 1903.

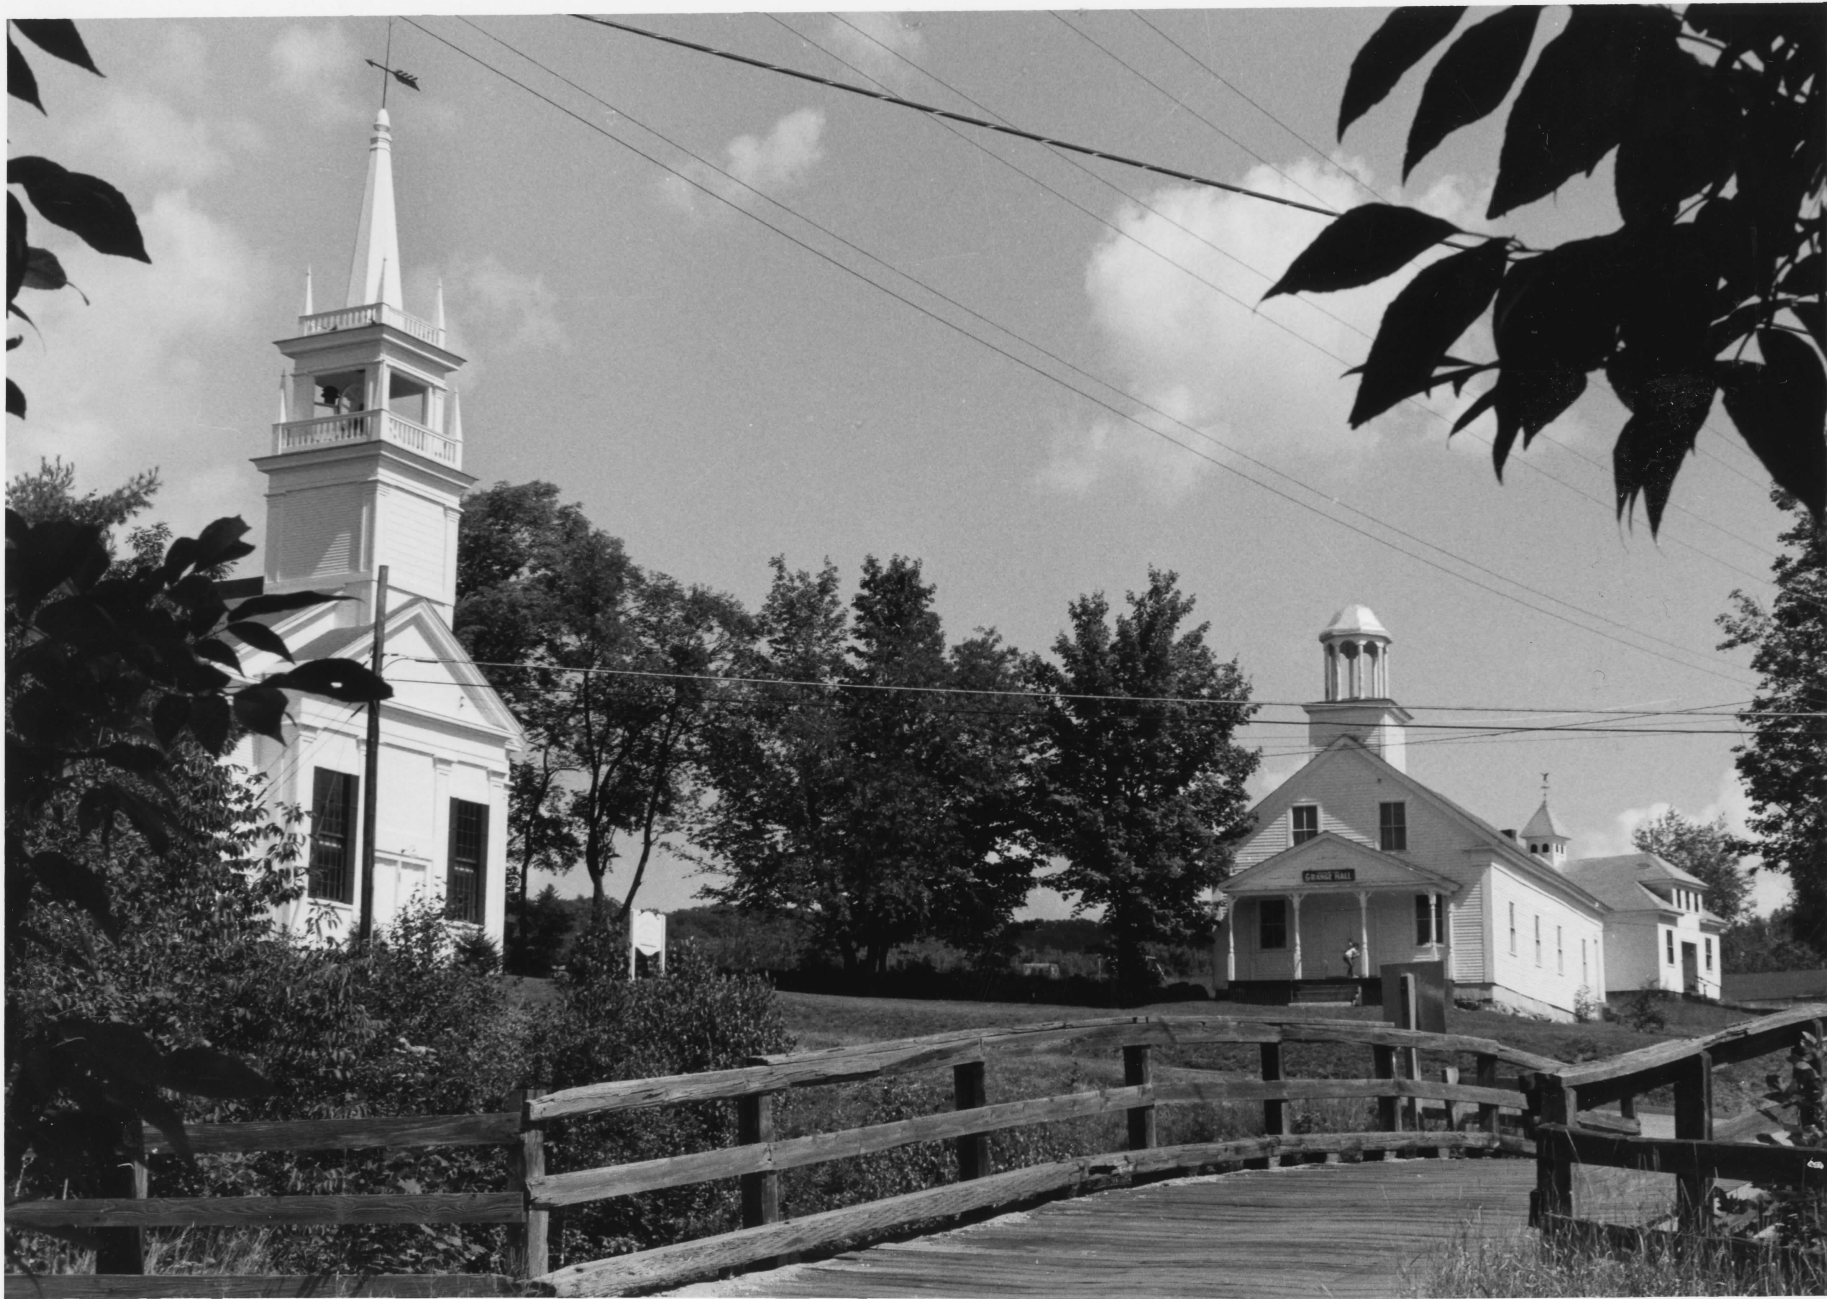
7 - PHOTO #1

6 - L. to R. - ANDOVER CONGREGATIONAL CHURCH (#2)
HIGHLAND LAKE GRANGE HALL (#3) and EAST ANDOVER
SCHOOLHOUSE (#4) CAMERA FACING NORTHEAST

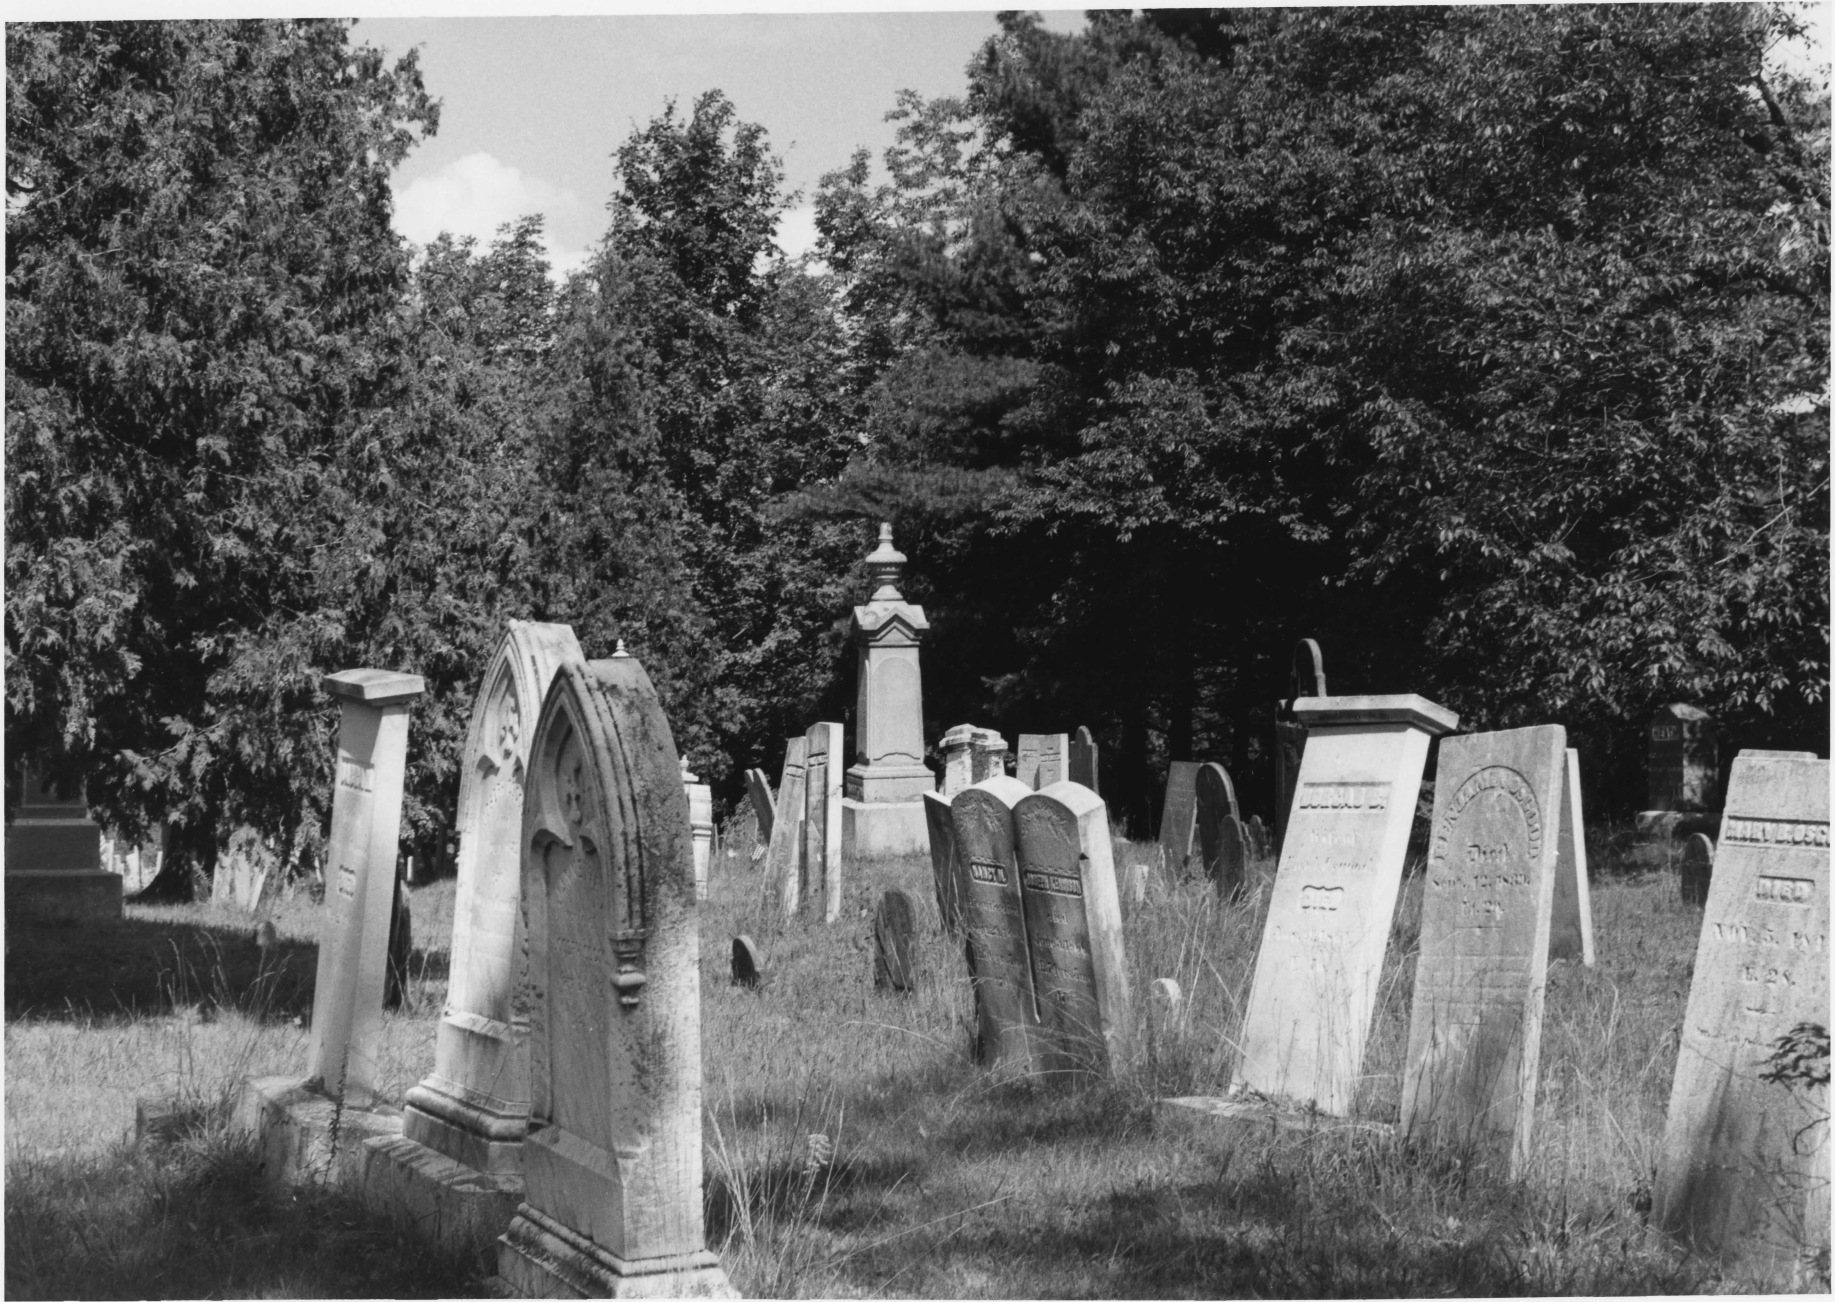
7 - PHOTO # 2

6 - INTERIOR OF OLD NORTH CHURCH CEMETERY
(#1) CAMERA LOOKING NORTH EAST

The Old North Church Cemetery is a small cemetery, less than half an acre in size. The cemetery, which runs along Route 11, is basically four sided in shape, with a small projection at the southeast corner, and a front (westerly) boundary that curves to follow Route 11. The Route 11 frontage is now marked by a three foot high, battered retaining wall built of granite blocks laid in mortar. The land is generally level at the south end of the cemetery, but slopes downhill to the north and northeast from about the center of the cemetery. The grave markers are mostly placed in north-south rows, with the monuments facing westerly towards the highway. The monuments are primarily 19th century in date. Most of the grave markers are marble and slate slabs, which vary greatly in their ornament. The most elaborate early slab is that of Jacob B. Moore, who died in 1813. The

cemetery also contains some more ornate late 19th century monuments, including some richly carved monuments, five tall shafts topped by carved urns, one large and one small obelisk, and a tall column standing on a plinth and topped by a carved urn. Four family plots are surrounded by low granite retaining walls, and two family plots are set apart by granite fence posts, although the chains that connected the posts are often missing. The cemetery is mostly grassed, save for a narrow strip along the top of the new retaining wall, which is partly covered by wood chips. A number of trees, mostly cedars, are scattered among the monuments. And rows of trees grow along the rear and side boundaries. On the sides and rear (the north, east, and south), the cemetery boundary is marked by a metal pipe fence.

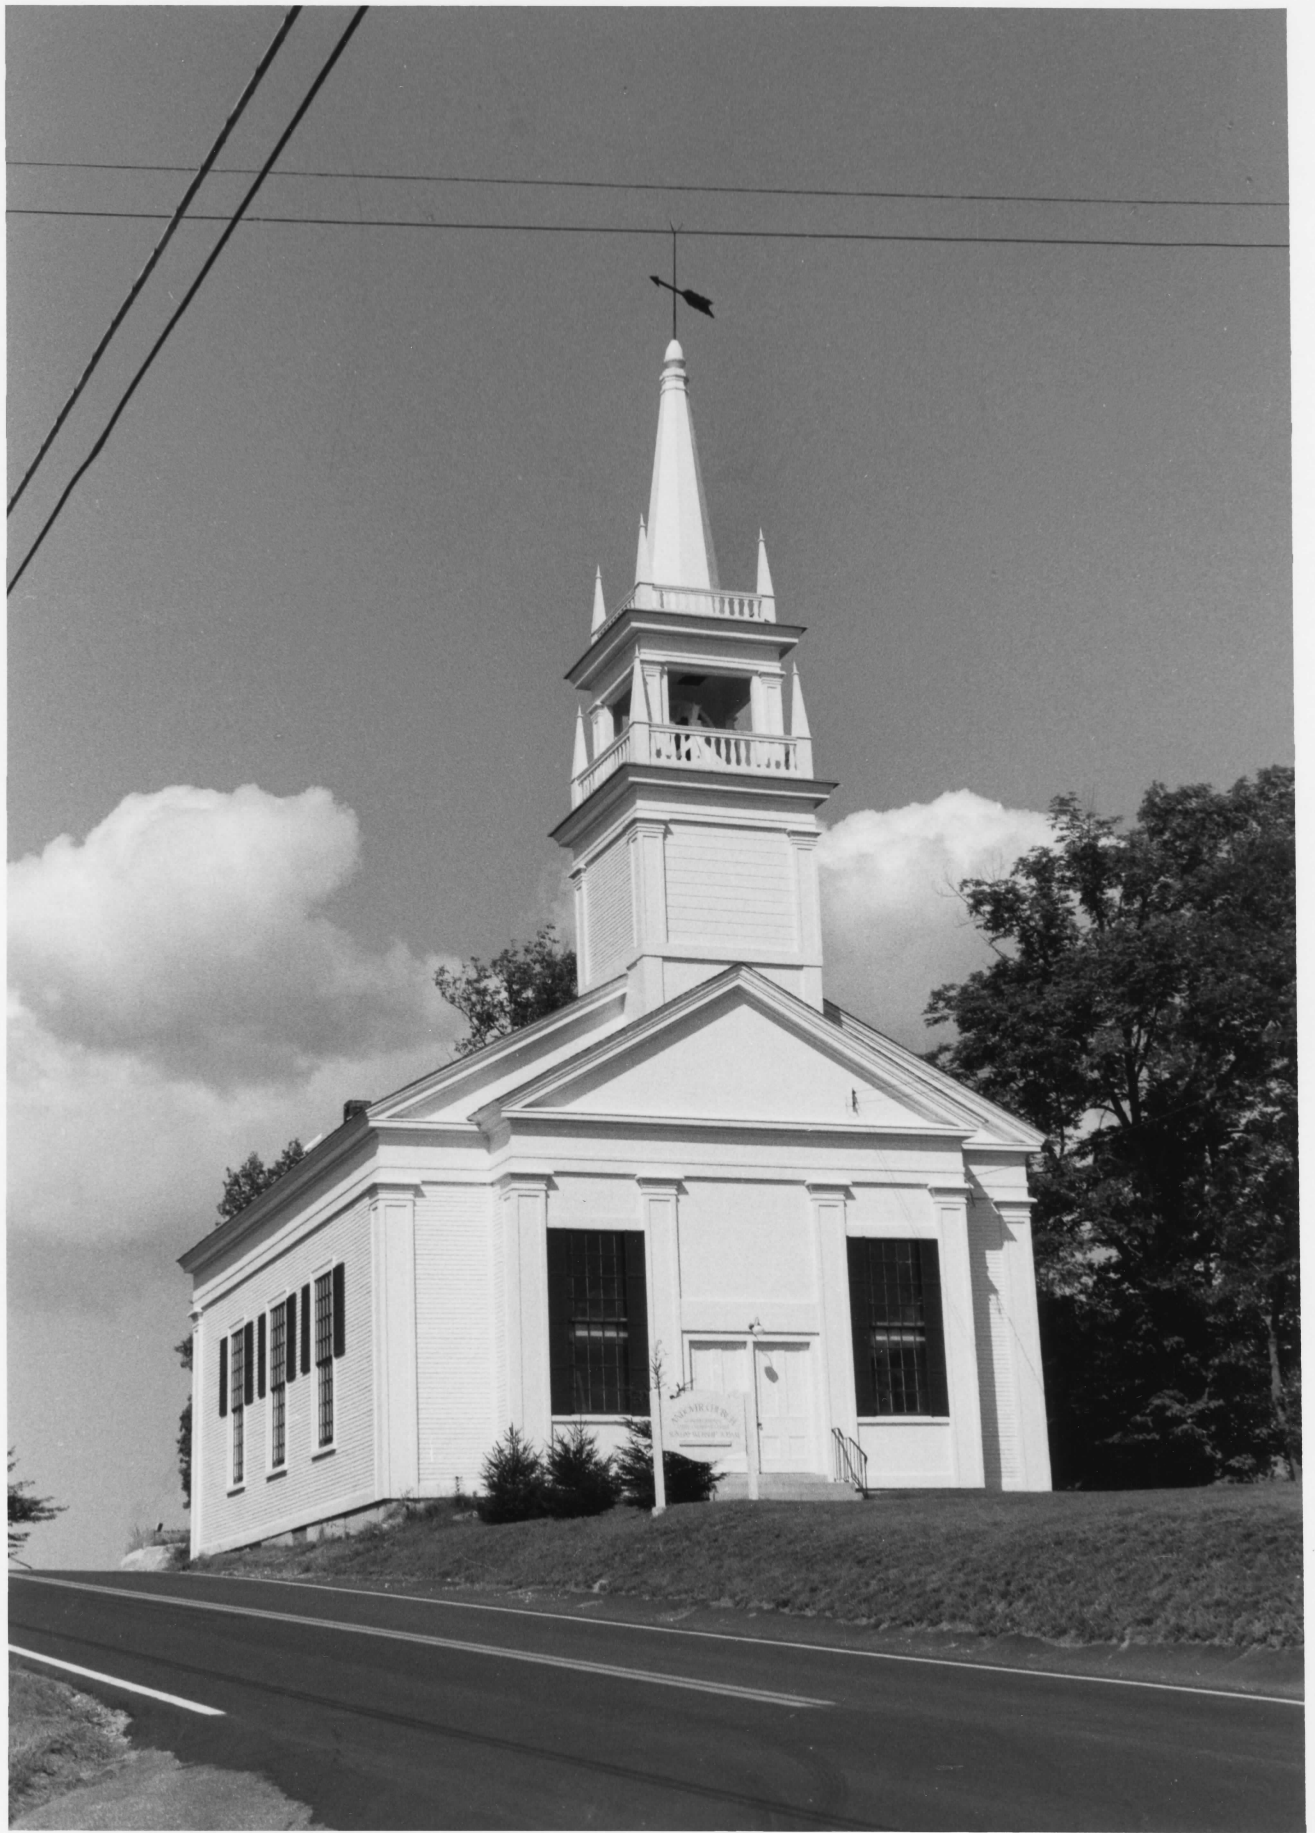
- 1 - ANDOVER CONGREGATIONAL CHURCH
EAST ANDOVER VILLAGE CENTER HISTORIC DISTRICT
- 2 - ANDOVER NEW HAMPSHIRE
- 3 - DAVID RVEU
- 4 - SEPTEMBER 1 1988
- 5 - LAKES REGION PLANNING COMMISSION
MEREDITH N.H.
- 6 - WEST AND SOUTH FACADES ; ANDOVER
CONGREGATIONAL CHURCH (#2)
CAMERA PACING NORTHEAST
- 7 - PHOTO # 3

The Andover Congregational Church is a Greek Revival style wooden church. The tall, large, one and a half story, gable roofed main block has a shallow, gable roofed entry pavilion centered on its main (south) gable end. The pavilion, although two stories high, is shorter and narrower than the main block. Rising from the roofs of both the pavilion and the main block is the two stage church tower, topped by an octagonal spire.

The main block and the pavilion share a number of features, including foundations of smooth granite blocks, and deep sillboards. Both have very wide paneled corner pilasters topped by heavy moulded capitals, but having no bases. (On the rear north gable end of the main block, the pilasters are omitted, the corners being ornamented by narrower cornerboards.) The main block and the pavilion also share a heavy box cornice with mouldings, deep frieze, and architrave that is pedimented on both southern gables. (The architrave and frieze are omitted on the raking cornices of both pediments. And on the rear north gable of the main block, the cornice is omitted entirely, as the gable is trimmed by close verges with short returns of the lateral cornices, the latter without architrave and frieze.) The horizontal cornices of the southern pediments of the main block and the pavilion are set at the same height, so that they are continuous. Finally, both the main block and the pavilion are covered by asphalt shingled gable roofs.

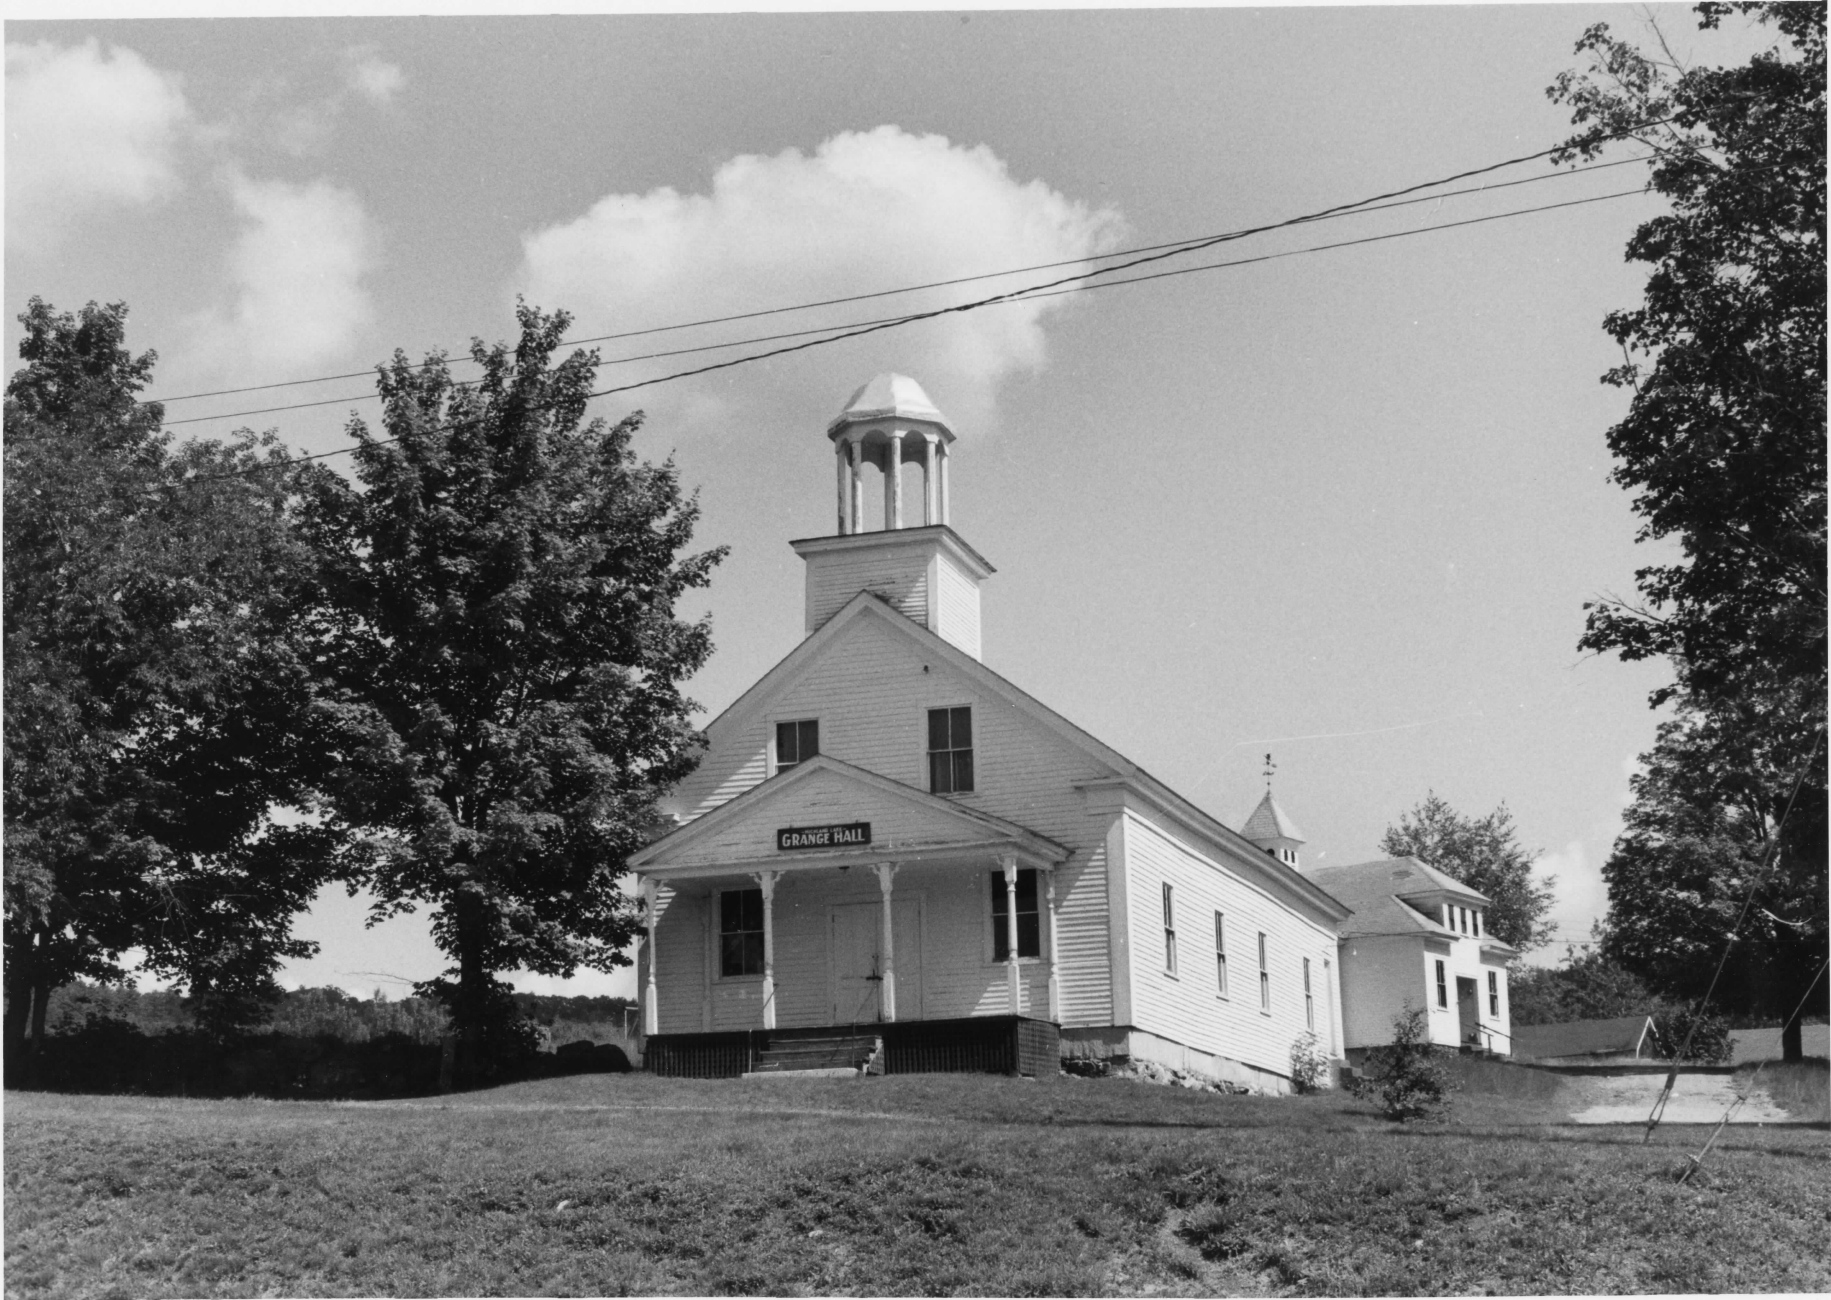
7 - PHOTO #4

6 - WEST AND SOUTH PACAPES, HIGHLAND LAKE GRANGE
HALL (#3) EAST ANDOVER SCHULTHEISE (#4) TO RIGHT
CAMERA LOOKING NORTHEAST

Basically a vernacular wooden building, the Highland Lake Grange Hall does show the influence of the Greek Revival style in its cornice, and of the Federal style in its belfry. The one and a half story, gable roofed main block has a one story, gable roofed entry porch, sheltering the main entry in its west gable end, and a two stage belfry tower astride the roof ridge above the western gable end. The original portion of the long main block has a cut granite block foundation, although the lower fieldstone foundation that supports the granite blocks is exposed on parts of the south and west sides. The eastern twenty feet of the main block have a fieldstone foundation, virtually the only exterior indication of the 1893-94 addition, which in all other respects matched the original building and continued the walls and roof of the old academy. The main block has clapboarded walls and wide cornerboards. The box cornice is ornamented with simple mouldings, frieze, architrave, and returns. (The architrave is omitted on the raking cornices of both gables.) The asphalt shingled gable roof is interrupted by a concrete block chimney, towards the rear on the north slope, as well as by the already noted belfry tower.

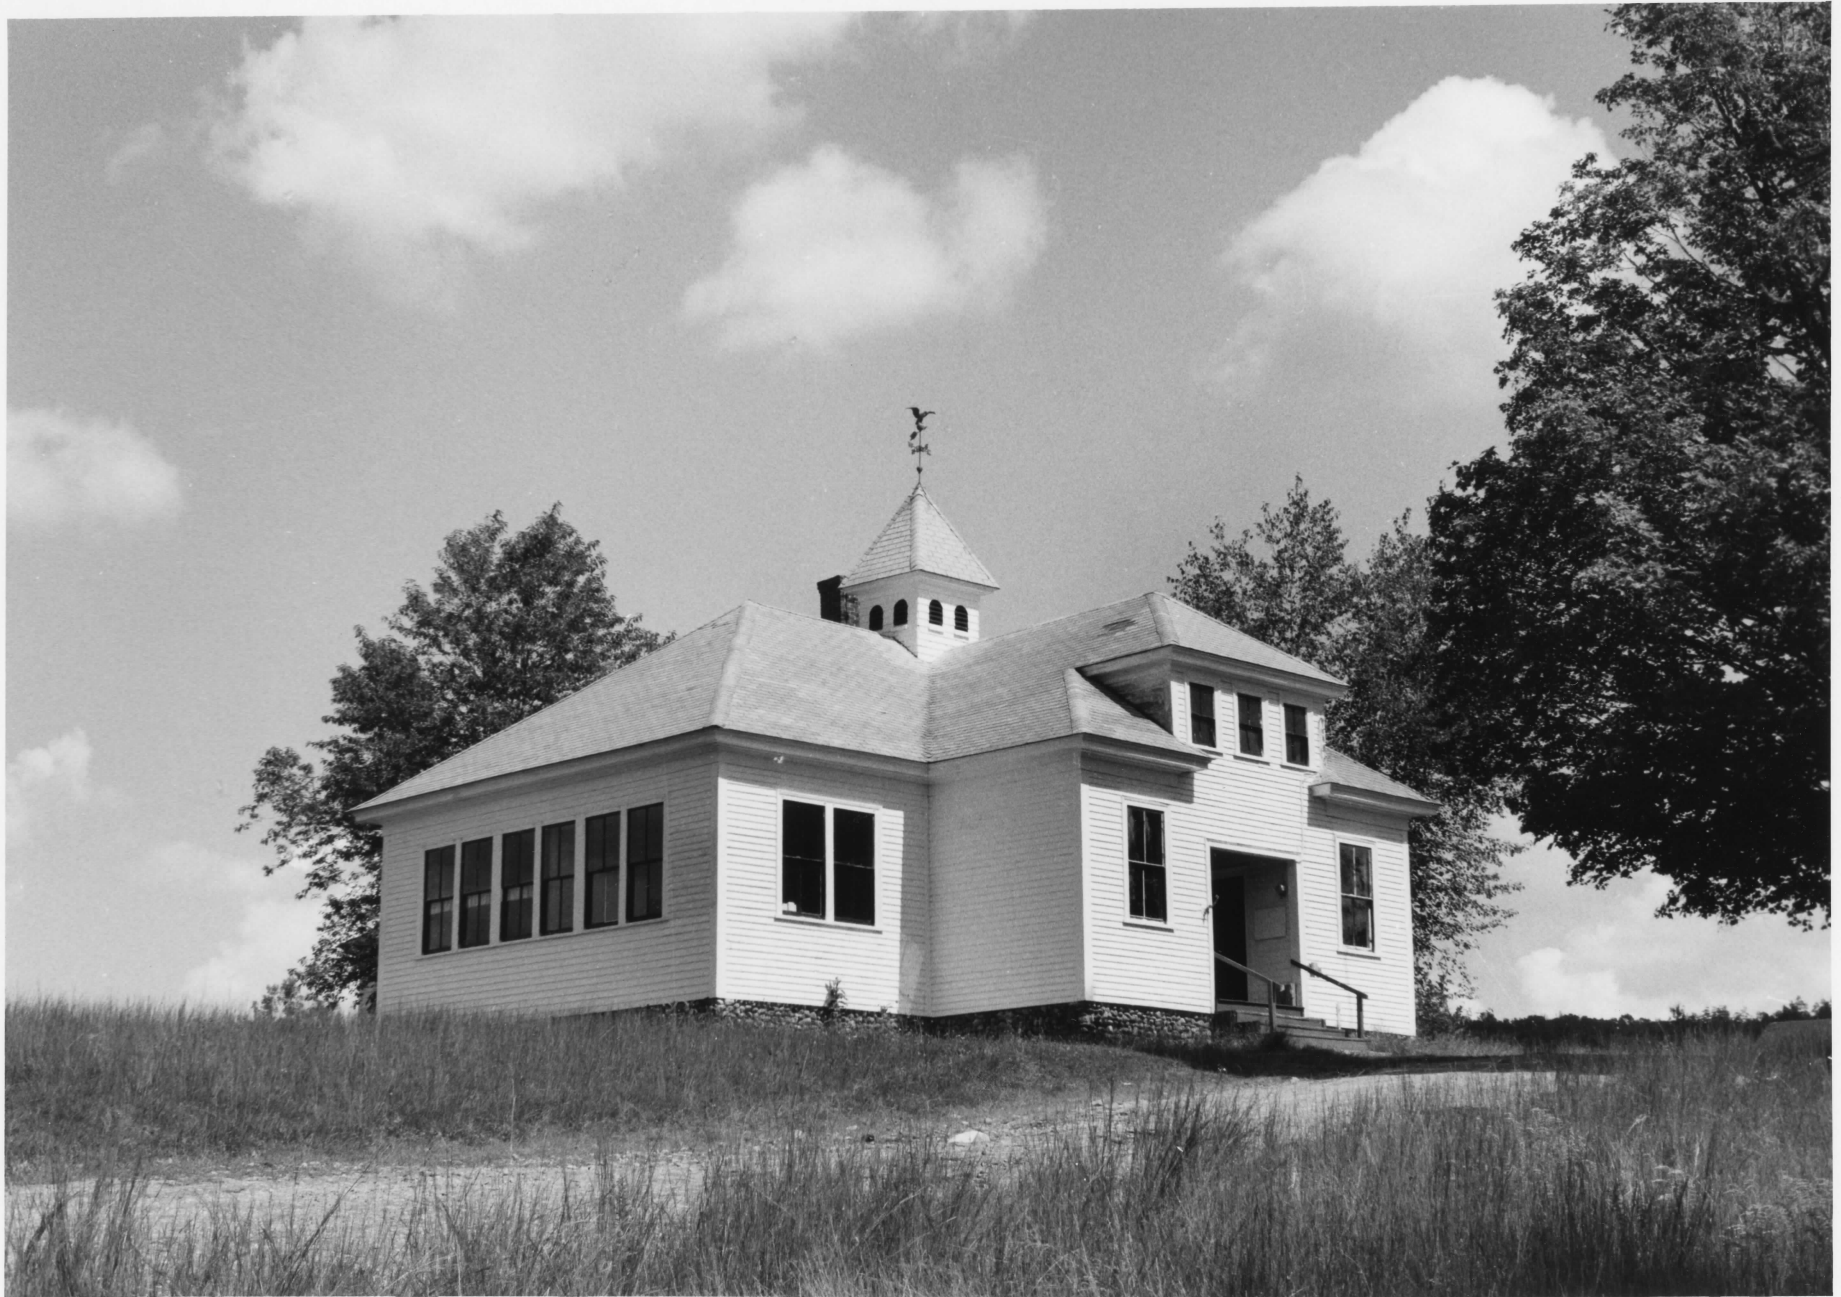
7- PHOTO #5

6- WEST AND SOUTH FACADES, EAST ANDOVER SCHOOLHOUSE (#4)
CAMERA LOOKING NORTHEAST

The main block's windows all have two over two sash and the same moulded frames seen on the pavilion windows. The south (street) facade has a double window to the east of the pavilion, but is windowless to the west of the pavilion. The east and west ends each contain a bank of six windows sharing the same moulded frames. (The west end also has a boarded up basement window.) The rear north facade has three windows to the east of the rear wing, but is windowless to the west of the rear wing. On the north slope of the main block roof is found a tall brick chimney with corbeled cap. But, the main feature of the roof is the central decorative belfry. The short square belfry has wooden shingled walls and a box cornice with mouldings and frieze. In each face are found two small semicircular arched louvers, untrimmed save for plain wooden sills. The steep pyramidal roof is sheathed with asphalt shingles and topped by a metal weathervane, featuring an eagle perched on a globe and an arrow.

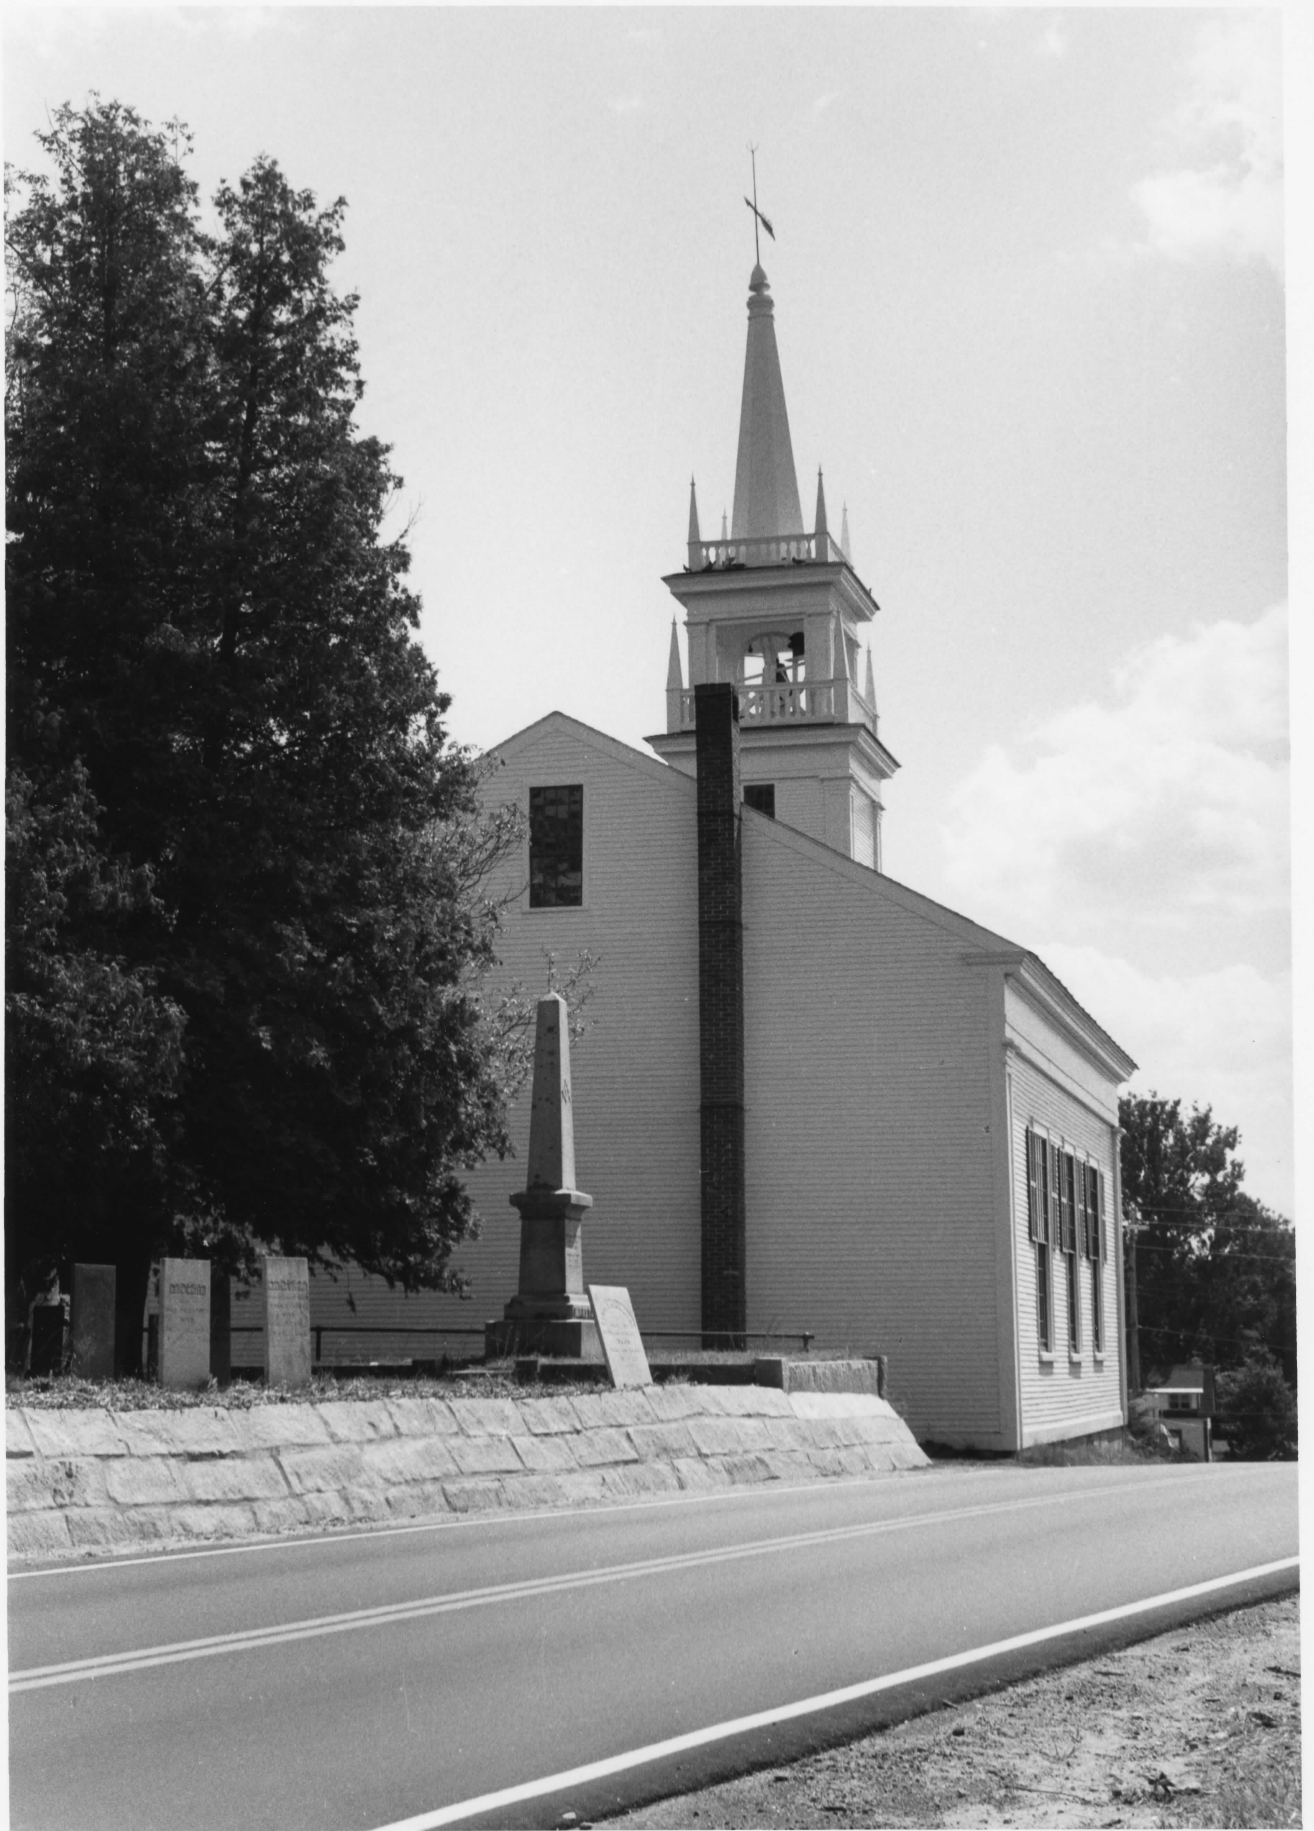
7- PHOTO # 6

6- SOUTH WEST CORNER, OLD NORTH CHURCH
CEMETERY (#1); NORTH AND WEST FACADES
ANDOVER CONGREGATIONAL CHURCH (#2)
CAMERA LOOKING SOUTH

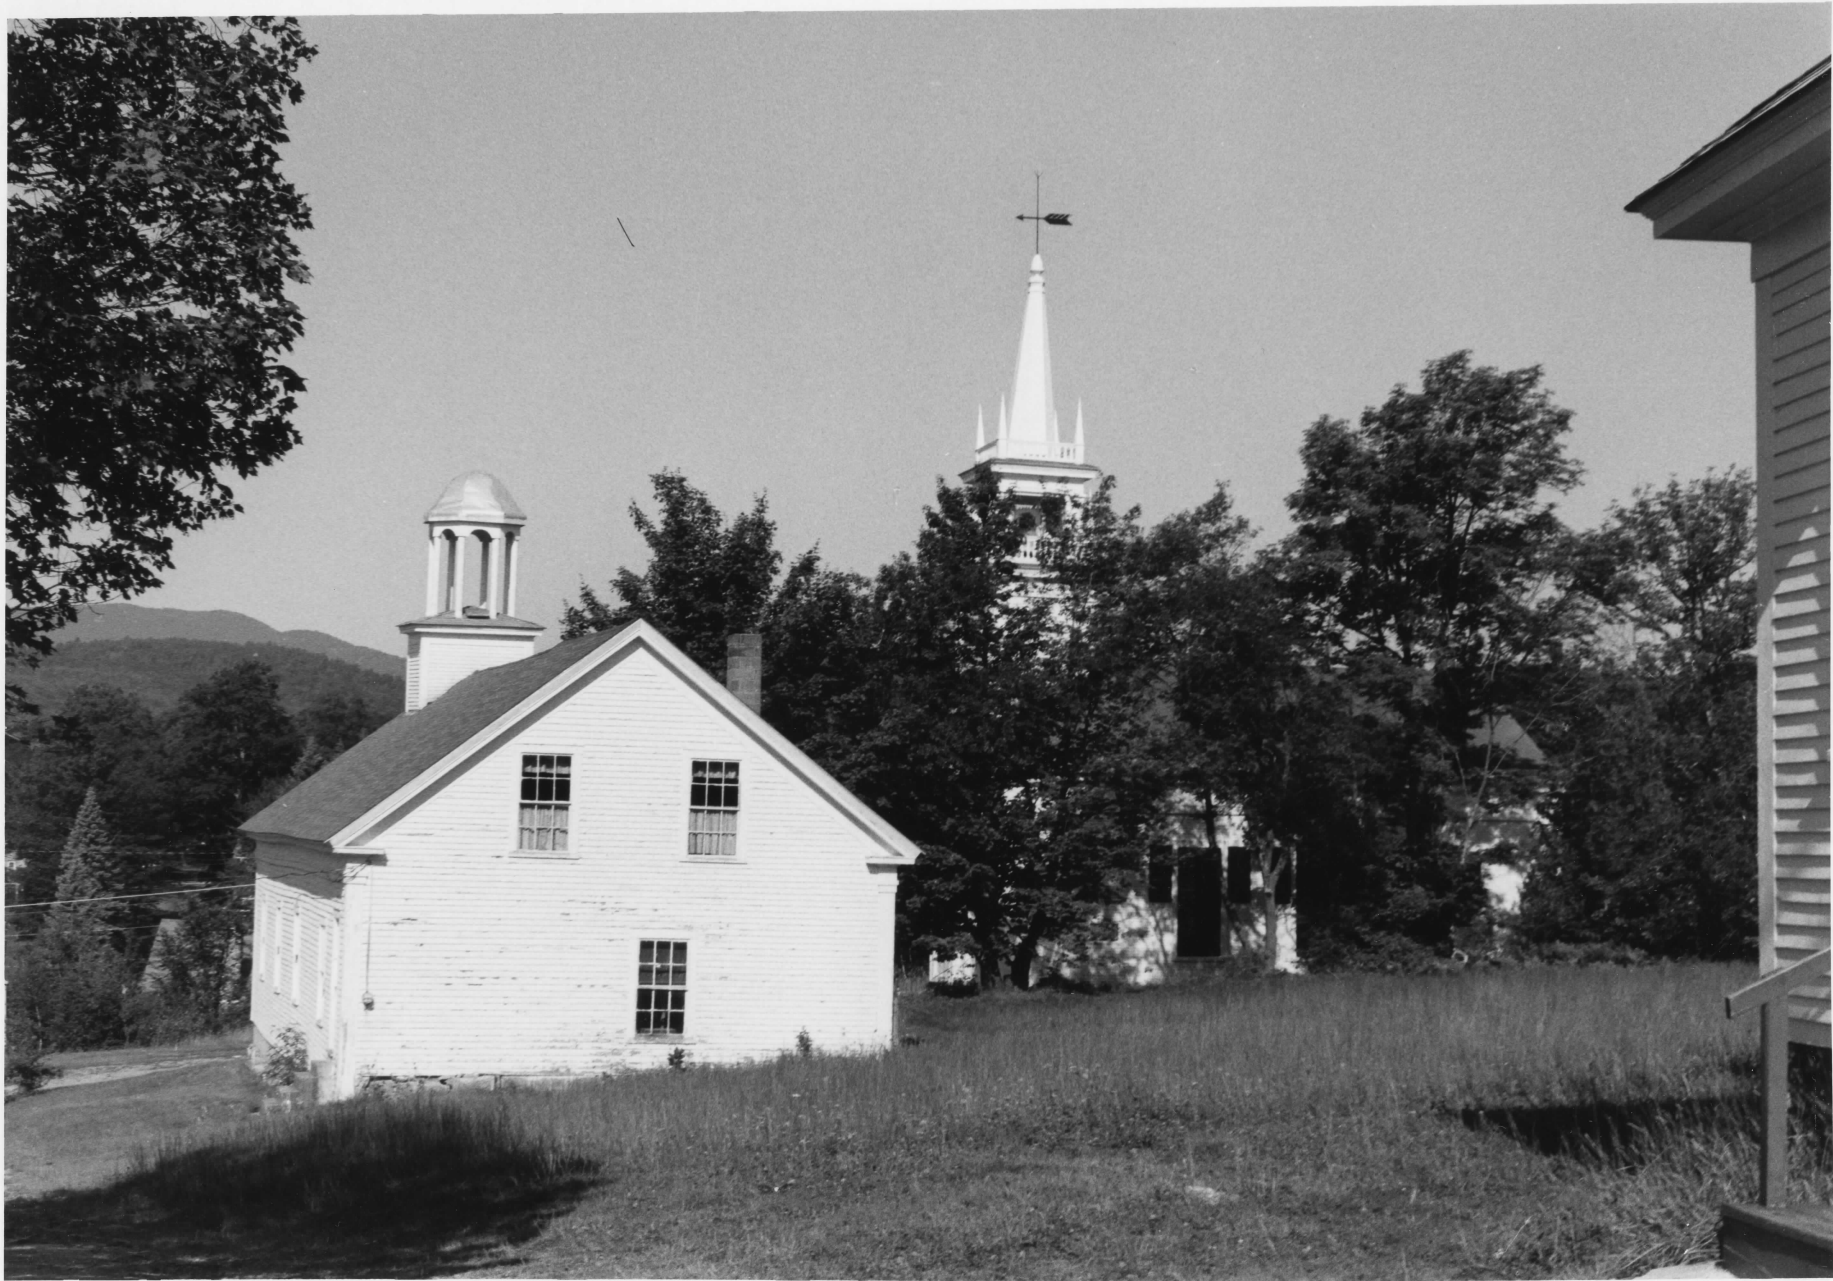
- 1- HIGHLAND LAKE GRANGE HALL, ANDOVER CONGREGATIONAL CHURCH — EAST ANDOVER VILLAGE CENTER HISTORIC DISTRICT
- 2- ANDOVER NEW HAMPSHIRE
- 3- DAVID RUELL
- 4 - SEPTEMBER 1 1988
- 5 - LAKES REGION PLANNING COMMISSION MEREDITH N.H.
- 6- HIGHLAND LAKE GRANGE HALL (#3) TO LEFT ANDOVER CONGREGATIONAL CHURCH (#2) IN BACKGROUND CORNER OF EAST ANDOVER SCHOOLHOUSE (#4) TO RIGHT CAMERA LOOKING WEST
- 7- PHOTO #7
