National Register of Historic Places
Registration Form

historic name East Andover Village Center Historic District
other names/site number _____

East Andover Village Center Historic District

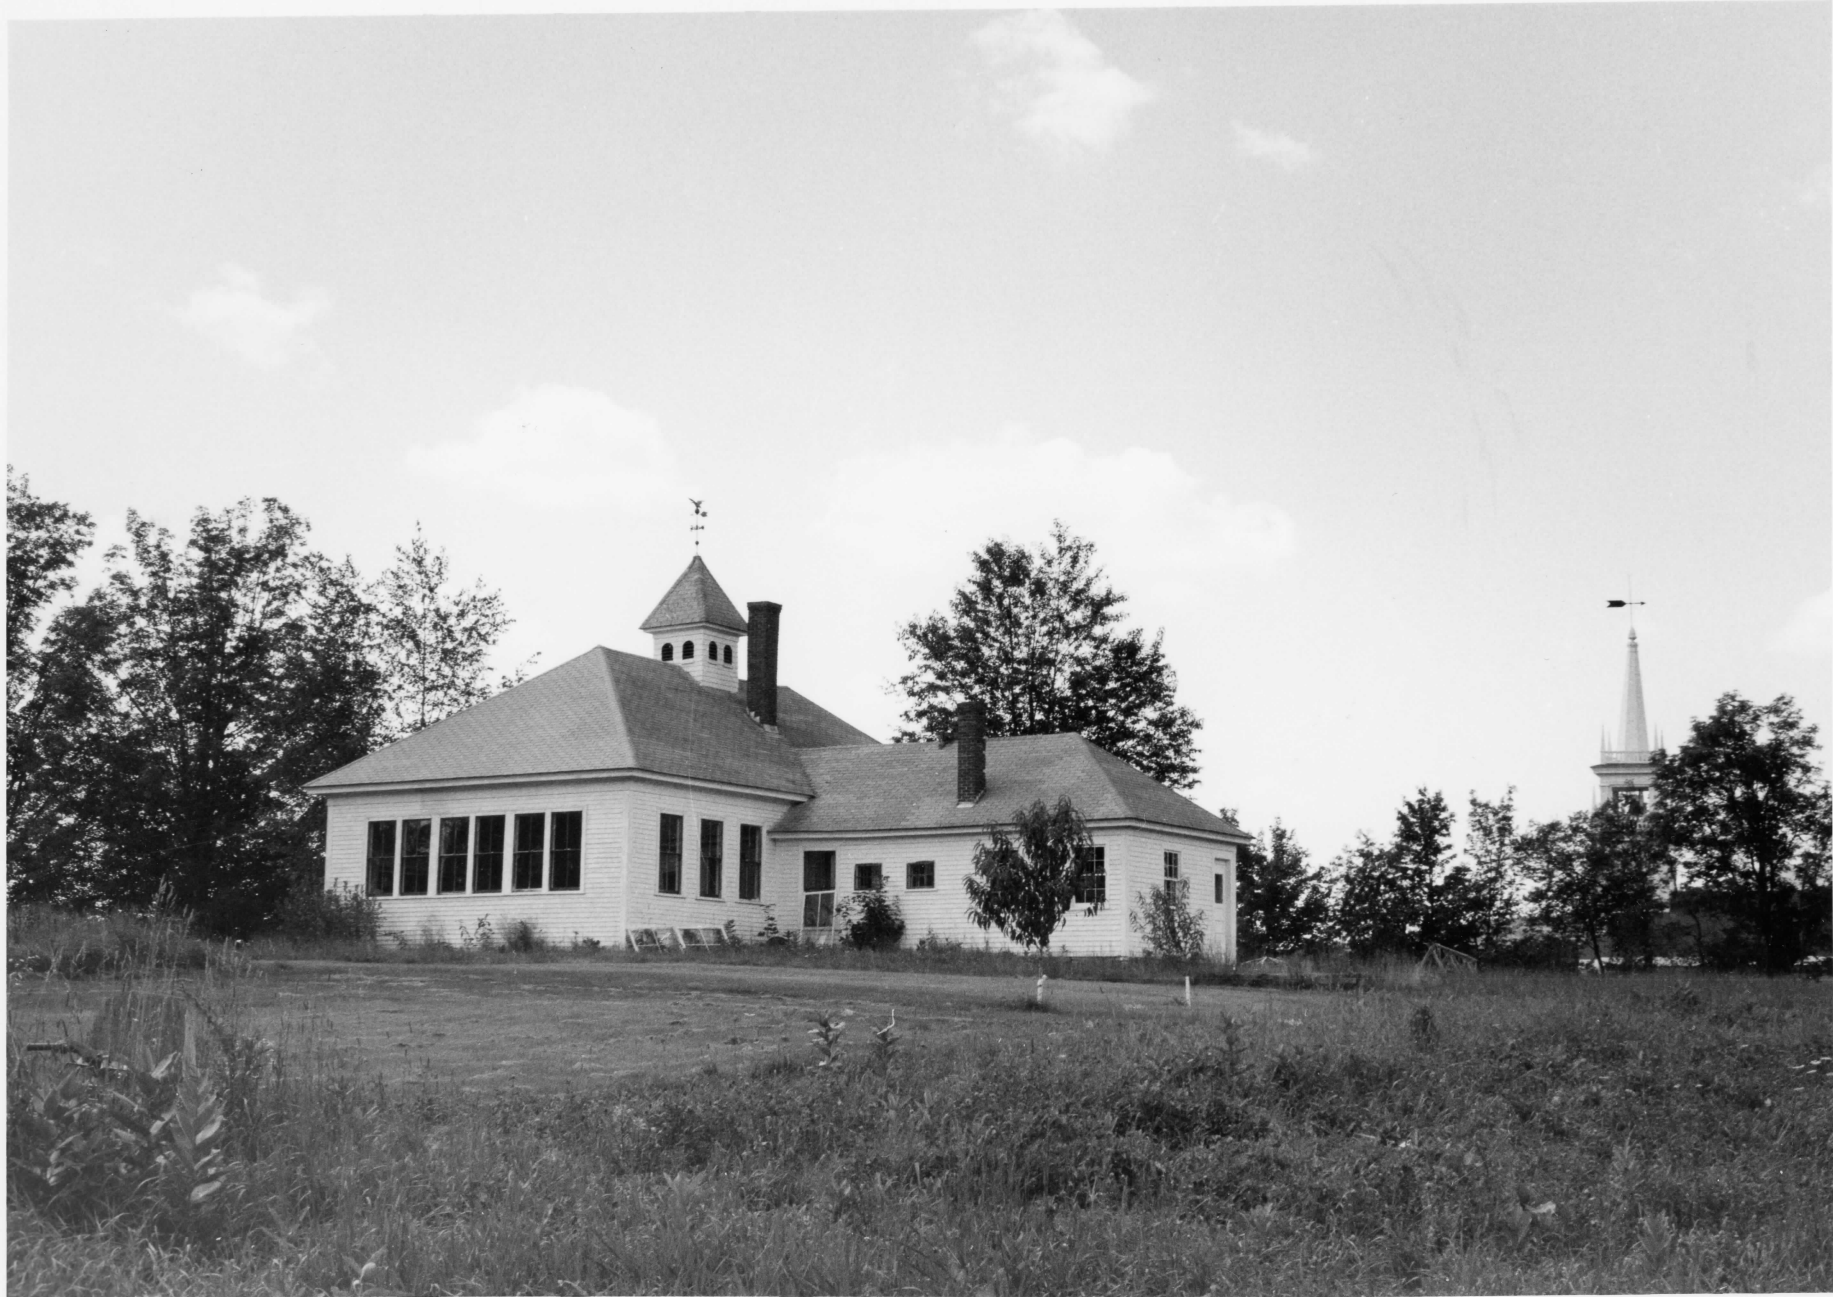
- 1- EAST ANDOVER SCHOOLHOUSE , ANDOVER CONGREGATIONAL CHURCH, EAST ANDOVER VILLAGE CENTER HISTORIC DISTRICT
- 2- ANDOVER NEW HAMPSHIRE
- 3- DAVID RUELL
- 4- SEPTEMBER 1, 1988
- 5- LAKES REGION PLANNING COMMISSION
MEREDITH N.H.
- 6- EAST AND NORTH FACADES, EAST ANDOVER SCHOOLHOUSE (#4)
TOWER AND ROOF, ANDOVER CONGREGATIONAL CHURCH (#2)
CAMERA LOOKING WEST
- 7- PHOTO #8
