NATIONAL REGISTER OF HISTORIC PLACES REGISTRATION FORM

1. NAME OF PROPERTY			
HISTORIC NAME: Eklund Hotel OTHER NAME/SITE NUMBER: Hotel Eklund			
2. LOCATION			
STREET & NUMBER: 15 Main Street CITY OR TOWN: Clayton STATE: New Mexico CODE: NM	COUNTY: Union	NOT FOR PUB VICINITY: N/ CODE: 059	LICATION: N/A /A ZIP CODE: 88415

Eklund Hotel Clayton, Union County, New Mexico

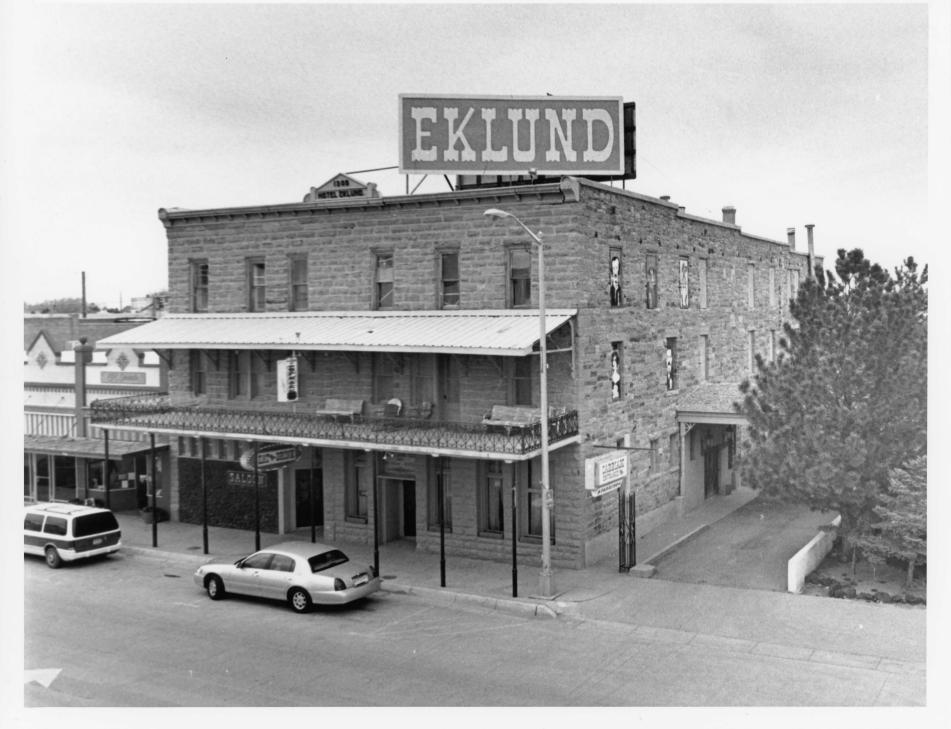
Photo No. 1 of 7 South and east elevations Camera facing northwest

Eklund Hotel
Clayton, Union County, New Mexico
South and east elevations
Camera facing northwest
Photo No.10f 7

The three-story Eklund Hotel has rectangular plan and a flat roof and is constructed of load-bearing stone masonry walls, with the exception of the center wall at the third floor, which is wood frame. The exterior of the building is faced with rough-cut sandstone block arranged in regular courses. The south elevation or front façade is coursed with quarry-faced stone finished with evenly spaced mortar joints (see Photo 1). This elevation displays a symmetrical arrangement of window openings on the second and third floors. These consist of wooden one-over-one, double hung windows framed by sandstone sills and lintels. A second story porch supported by steel posts extends out to the edge of the sidewalk and is sheltered by a shed-roof canopy. The current porch is not historic, but generally conforms to the historic appearance of a second story porch during the 1910s (see Photo 2). The first floor displays an irregular fenestration pattern, with historic wooden windows along the east or dining side of the facade, and lava rock infill and clerestory windows along the west or saloon side of the façade. The building is topped with a metal cornice and centered pediment with the date "1905" and name "Hotel Eklund" raised across its face. Surmounting the building are two large billboard signs arranged at skew displaying in large letters the name "Eklund."

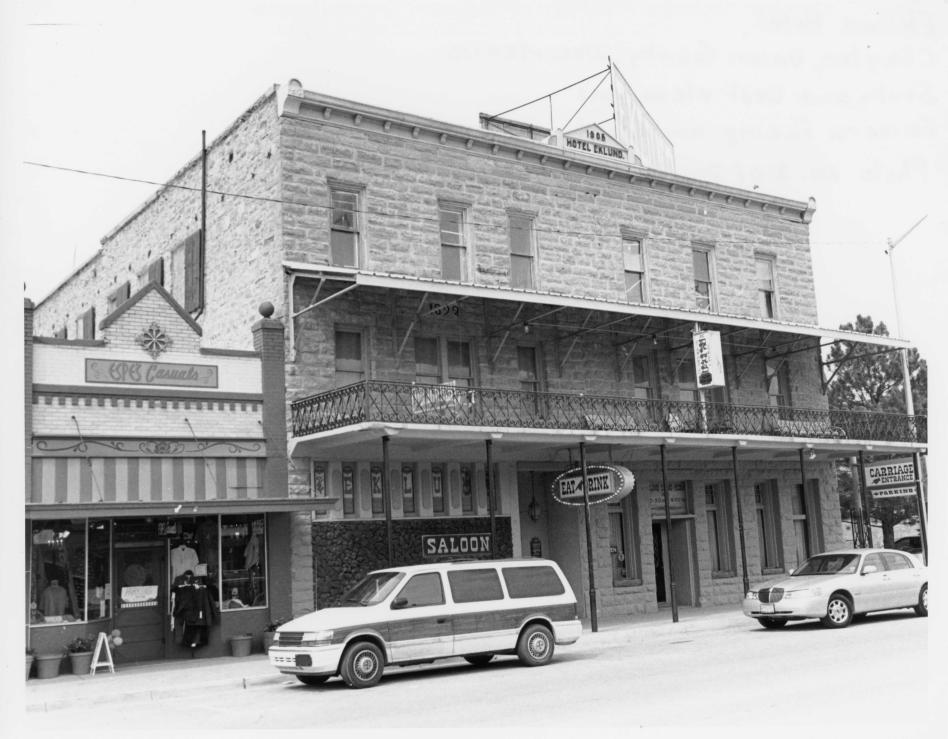
Photo No. 3 of 7 South and west elevations Camera facing northeast

Eklund Hotel
Clayton, Union County, New Mexico
South and West elevations
Camera facing northeast
Photo No. 3 of 7

The west elevation is constructed of rough-cut sandstone laid in a coursed ashlar pattern, with wide, irregular mortar joints between a half and two inches in width. The stone does not have the same finished look of the façade (see Photo 3). Only half of the second story is visible because of the adjoining building, which has concrete parging covering the stone to a height of about 15 inches above the roofline. Along this elevation, the roofline of the hotel has three steps, progressing in height from south to north. The parapet cap, most likely

added in the last 35 years, is concrete. Five six-light and one eight-light casement windows are present at the second story level. These are replacement windows with a combination of original sandstone lintels and replacement concrete sills. The third story windows, currently boarded over, are original with sandstone lintels and sills. The original metal fire shutters are still in place next to the windows. A series of tie rod bolt ends are present just above the third story windows.

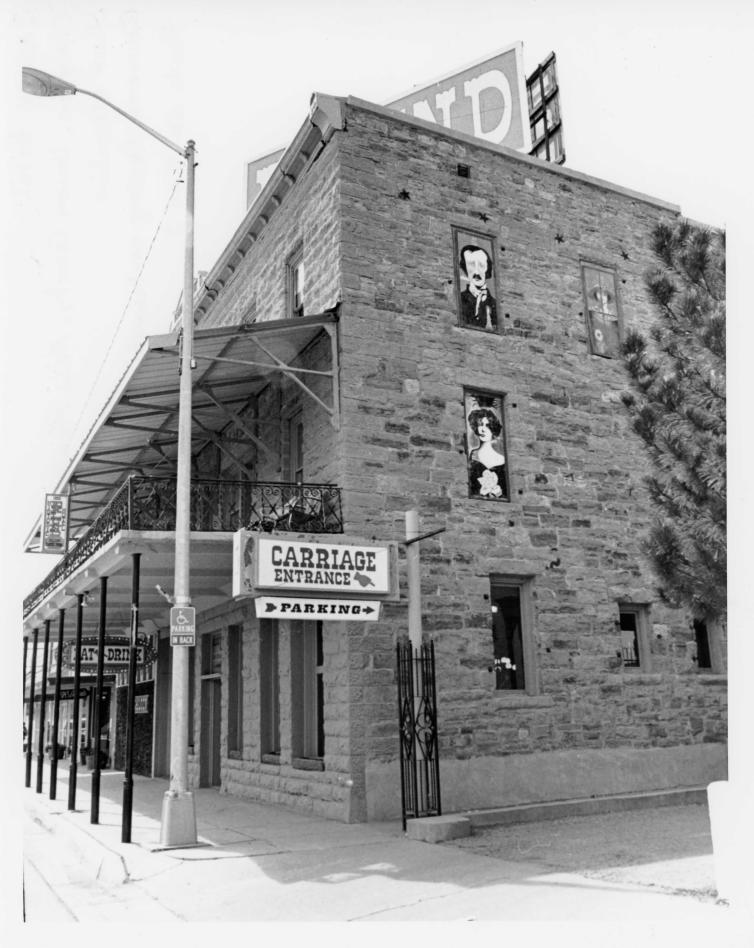
Photo No. 4 of 7
East elevation
Camera facing northwest

Ekland Hotel
Clayton, Union County, New Mexico
East elevation
Camera facing northwest
Photo No. 4 of 7

The east elevation is also constructed of rough-cut sandstone displaying a coursed ashlar pattern with wide mortar joints. The driveway abuts the base of the wall, which is surfaced with concrete to a height of two and one half feet (see Photo 4). The first story currently has nine window openings with sandstone lintels and sills, with most of these containing replacement windows. Spanning a section of the driveway is a c. 1974 porte cochere made of a wood frame and canopy covered with wooden shingles. The doorway at the porte cochere replaced one of the original windows. The second story contains eight one-over-one, double hung windows, while the third story contains nine units of the same configuration. These windows are currently boarded over and all windows display sandstone lintels and sills. The roofline is stepped with four steps with the parapet capped with concrete. Tie rod bolts are present between the first and second stories, the second and third stories, and just above the third story windows. The remnants of the original fire shutter hardware are present at each level.

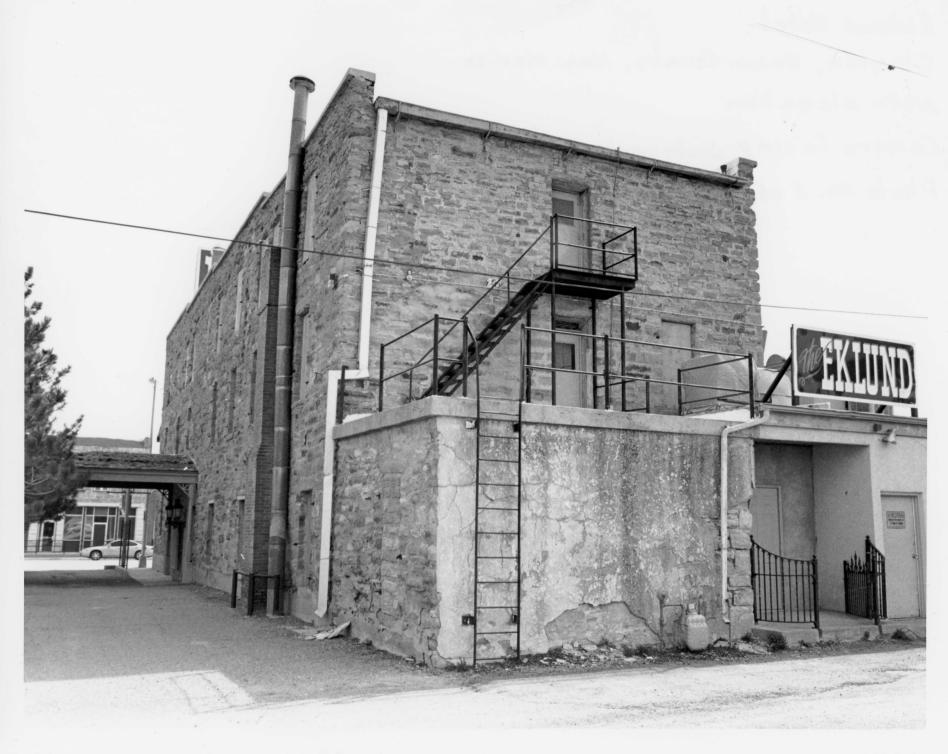
Photo No. 5 of 7 North elevation Camera facing southwest

Eklund Hotel
Clayton, Union County, New Mexico
North elevation
Camera facing Southwest
Photo No. 5 of 7

The original walls of the north elevation are rough-cut, coursed sandstone with wide mortar joints. The 1892 section has two original one-over-one, double hung windows at the third floor, and two non-original windows at the second floor level (see Photo 5). The 1898 section reveals a doorway on both the second and third floor levels, which give access to the roof of the one-story sandstone room. A metal ladder from the roof of this room leads to the ground. The sandstone room and the 1970's one-story kitchen addition make up the present north wall of the structure. An alley giving access to the hotel is directly behind the building.
