**National Register of Historic Places  
Inventory—Nomination Form**

historic Ojo Caliente Mineral Springs

city, town Ojo Caliente N/A vicinity of

state New Mexico code 35 county Taos code 055

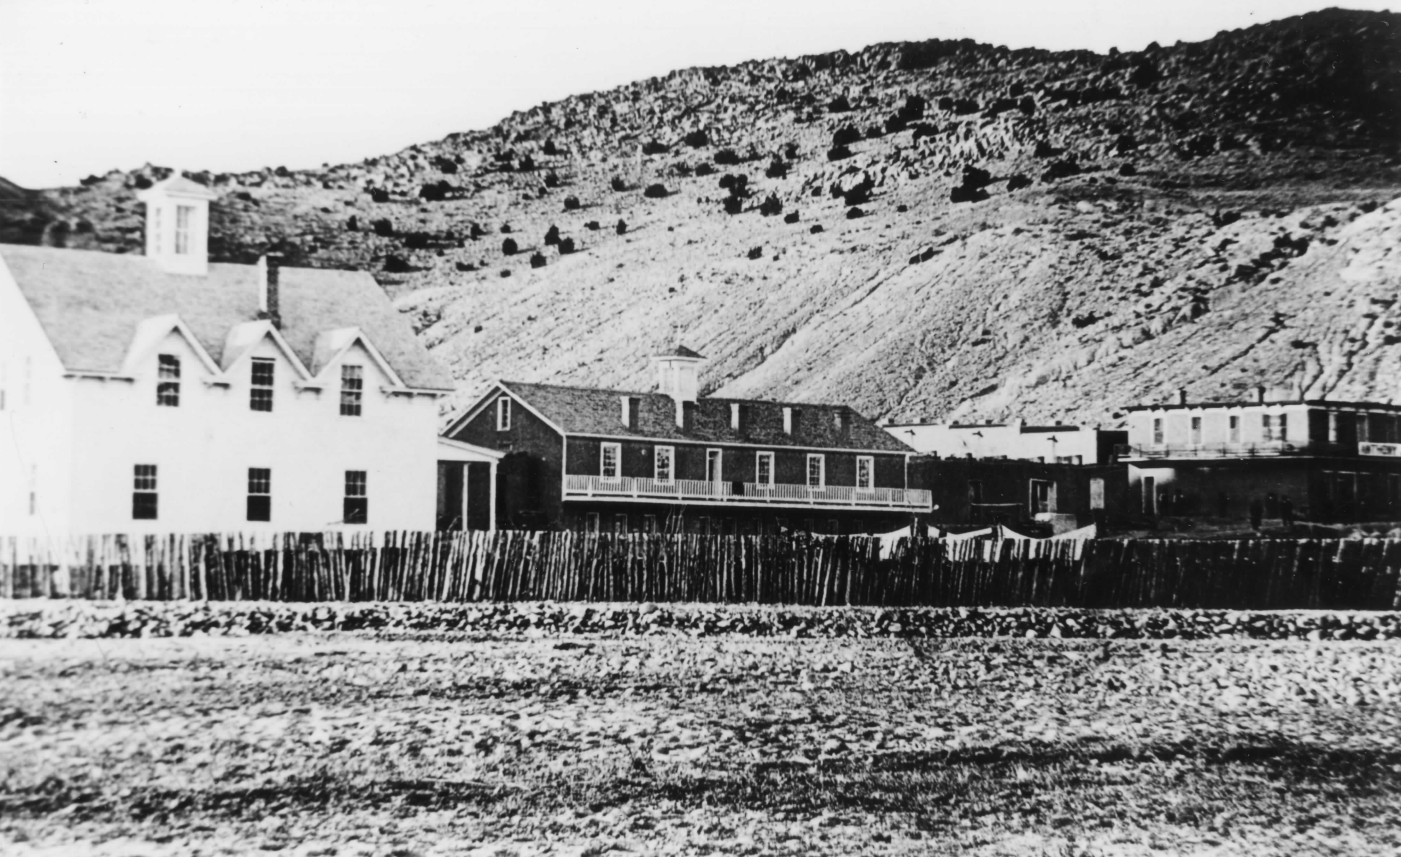
1. OJO CALIENTE MINERAL SPRINGS
2. Ojo Caliente, New Mexico
3. James A. Caufield
4. 2/85
5. Negative on file in Ojo Caliente Mineral Springs records, Ojo Caliente Mineral Springs, Ojo Caliente, New Mexico 87549
6. Historic photograph c. 1900 looking northwest showing appearance of Mineral Springs complex under Antonio Joseph's operation. The first floor of the recreation building (center with second floor balcony) remains today.
7. Photo no. 1

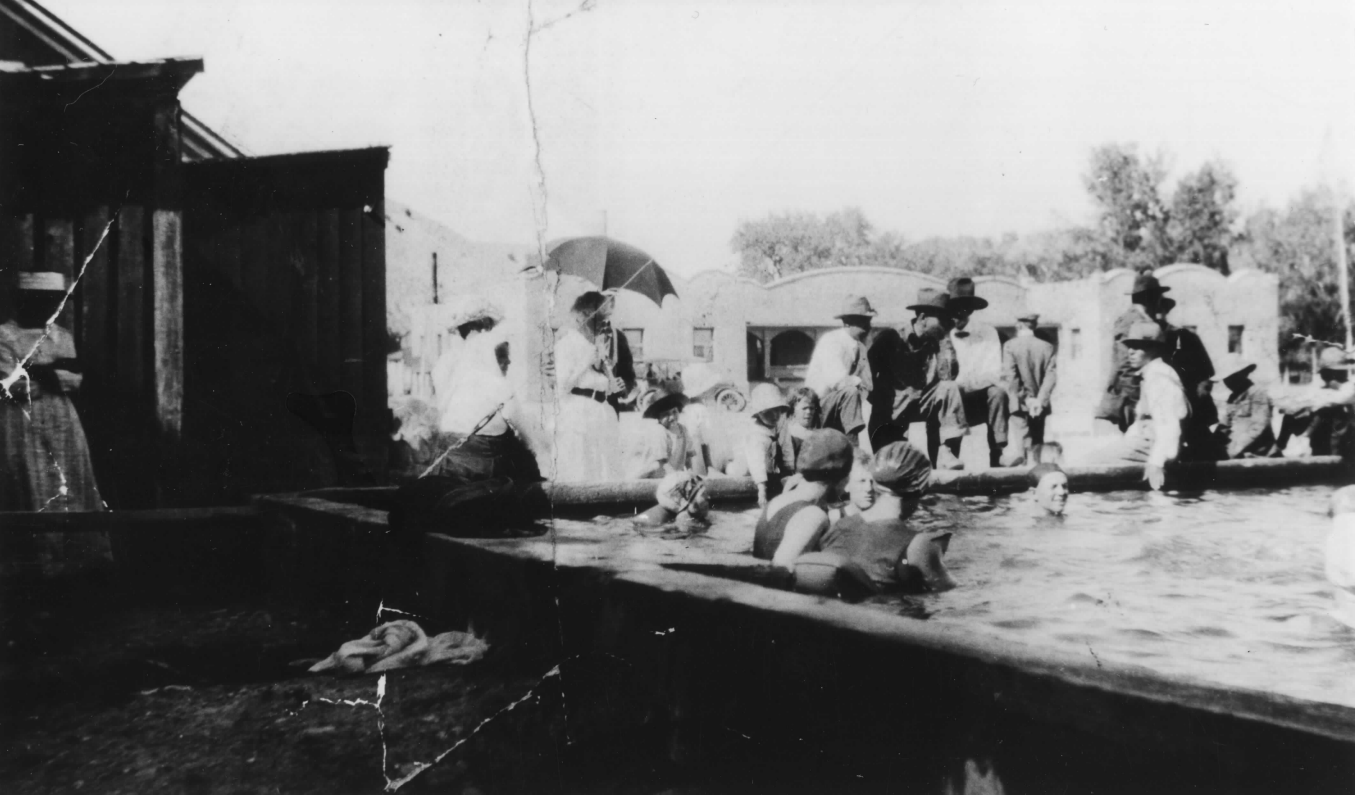
1. OJO CALIENTE MINERAL SPRINGS
2. Ojo Caliente, New Mexico
3. James A. Caufield
4. 2/85
5. Negative on file in Ojo Caliente Mineral Springs records, Ojo Caliente Mineral Springs, Ojo Caliente, New Mexico 87549
6. Historic photograph c. 1918 looking northeast showing outdoor pool (foreground) and 1917 hotel (background). Photograph was taken prior to construction of existing bath house. Gable end of one story recreation building shows on extreme left.
7. Photo no. 2

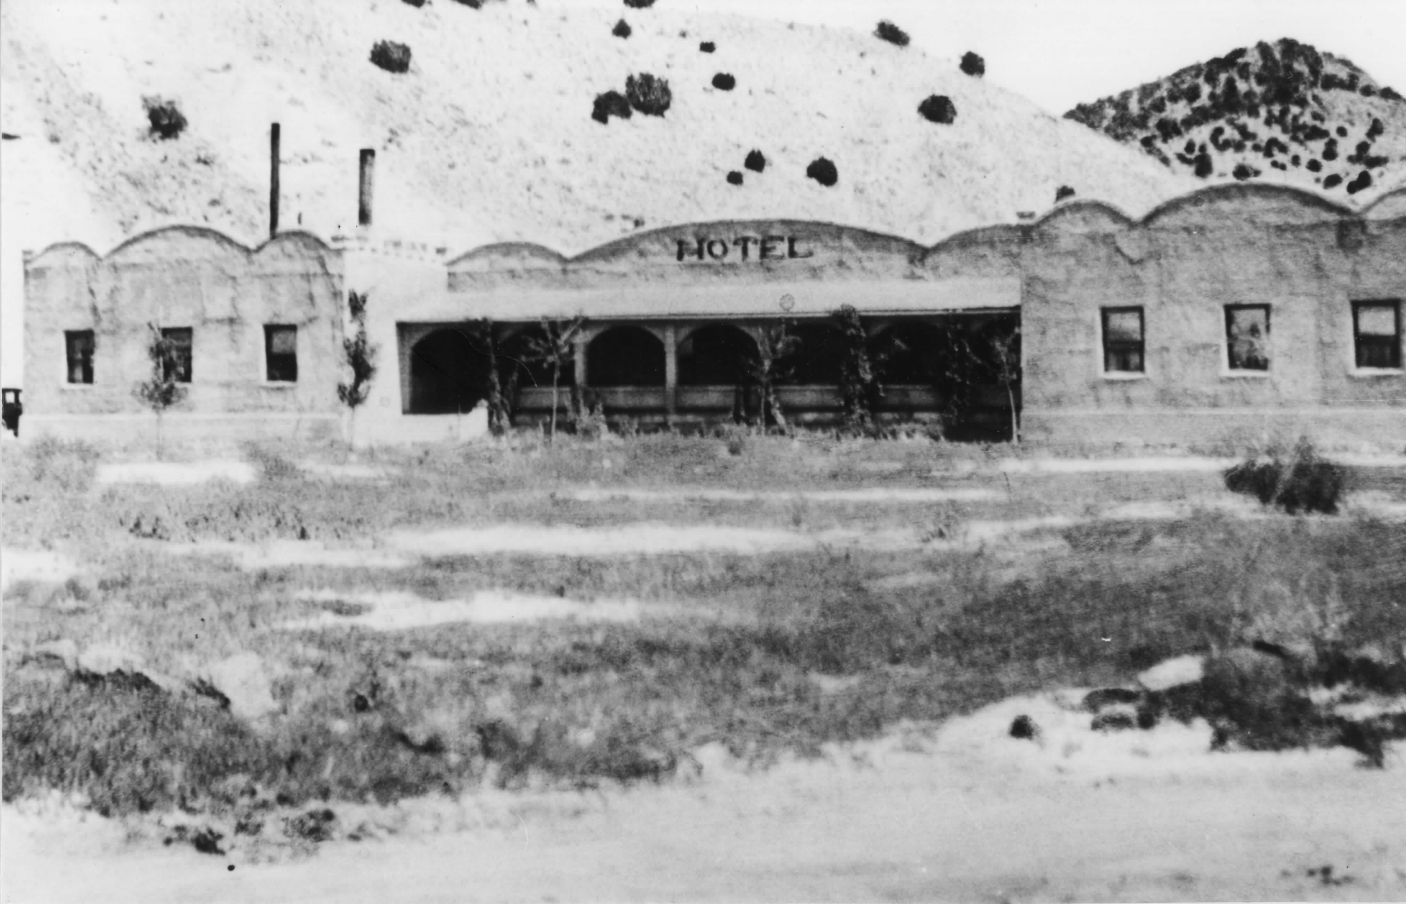
HOTEL

1. OJO CALIENTE MINERAL SPRINGS
2. Ojo Caliente, New Mexico
3. James A. Caufield
4. 2/85
5. Negative on file in Ojo Caliente Mineral Springs records, Ojo Caliente Mineral Springs, Ojo Caliente, New Mexico 87549
6. Historic photograph (date unknown - probably late 1920's) looking northwest showing south elevation of 1917 hotel and quadrangle.
7. Photo no. 3

Hotel: The Spanish mission revival hotel was constructed of adobe in 1917 by Mrs. Antonio Joseph to replace the original frame hotel that burned circa 1912. The hotel is U shaped with the open side facing south. The entire building is finished with rough textured cement stucco. The south elevation of both end wings and the central block have raised shaped parapets with molded caps, and the east and west elevations of the end wings have stepped parapets. The recessed central block of the south elevation has a full length veranda supported by square columns with simple intermediate banding and shallow arches filling between the columns. Solid stucco finished panels with molded handrail provide lower infill between the columns in all but the westernmost bay. The principal entrance to the building is at the extreme west end of the veranda. The roof of the hotel, not visible from the ground, slopes slightly to the north for drainage. The roof of the veranda is asphalt shingles.

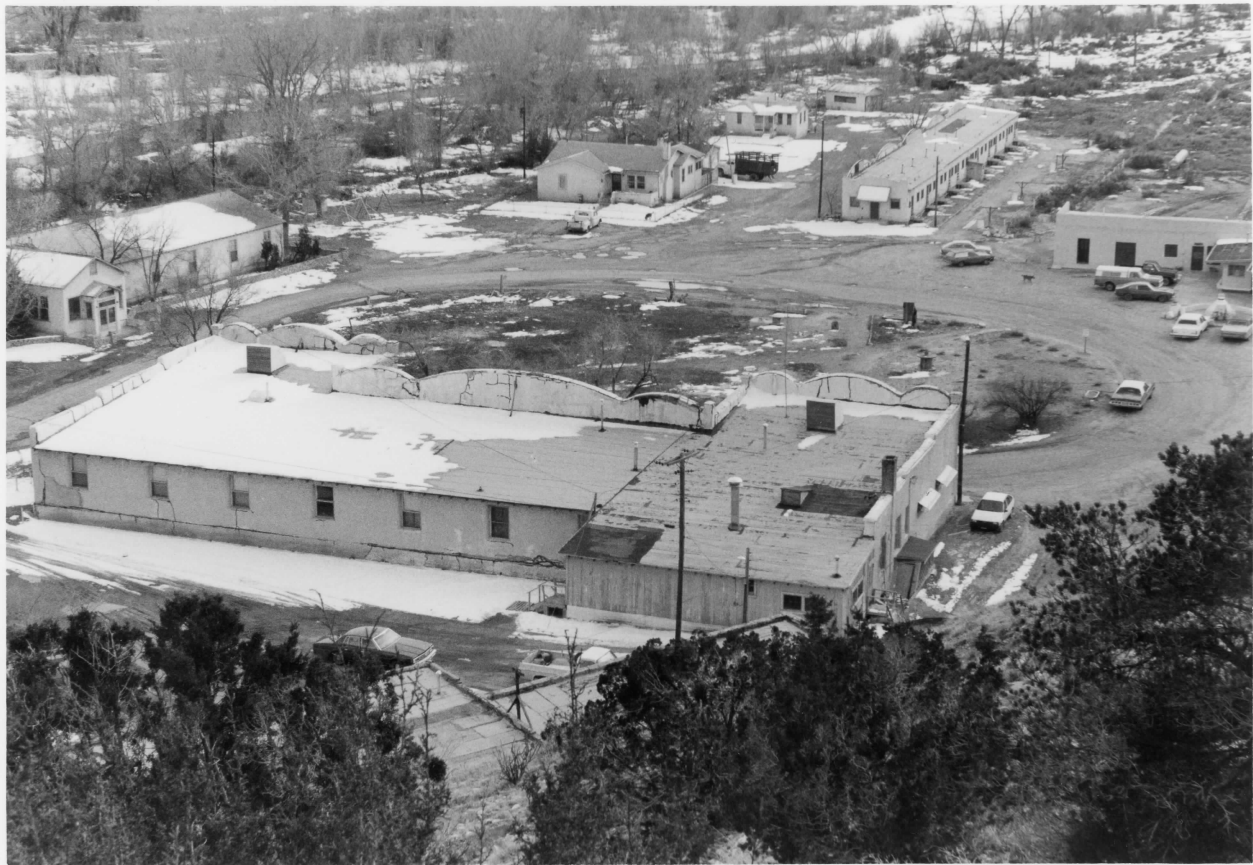
1. OJO CALIENTE MINERAL SPRINGS
2. Ojo Caliente, New Mexico
3. James A. Caufield
4. 2/85
5. Negative on file in Ojo Caliente Mineral Springs records, Ojo Caliente Mineral Springs, Ojo Caliente, New Mexico 87549
6. Partial view of complex looking southeast showing hotel from back (lower center), quadrangle (center) and bath house (upper right).
7. Photo no. 4

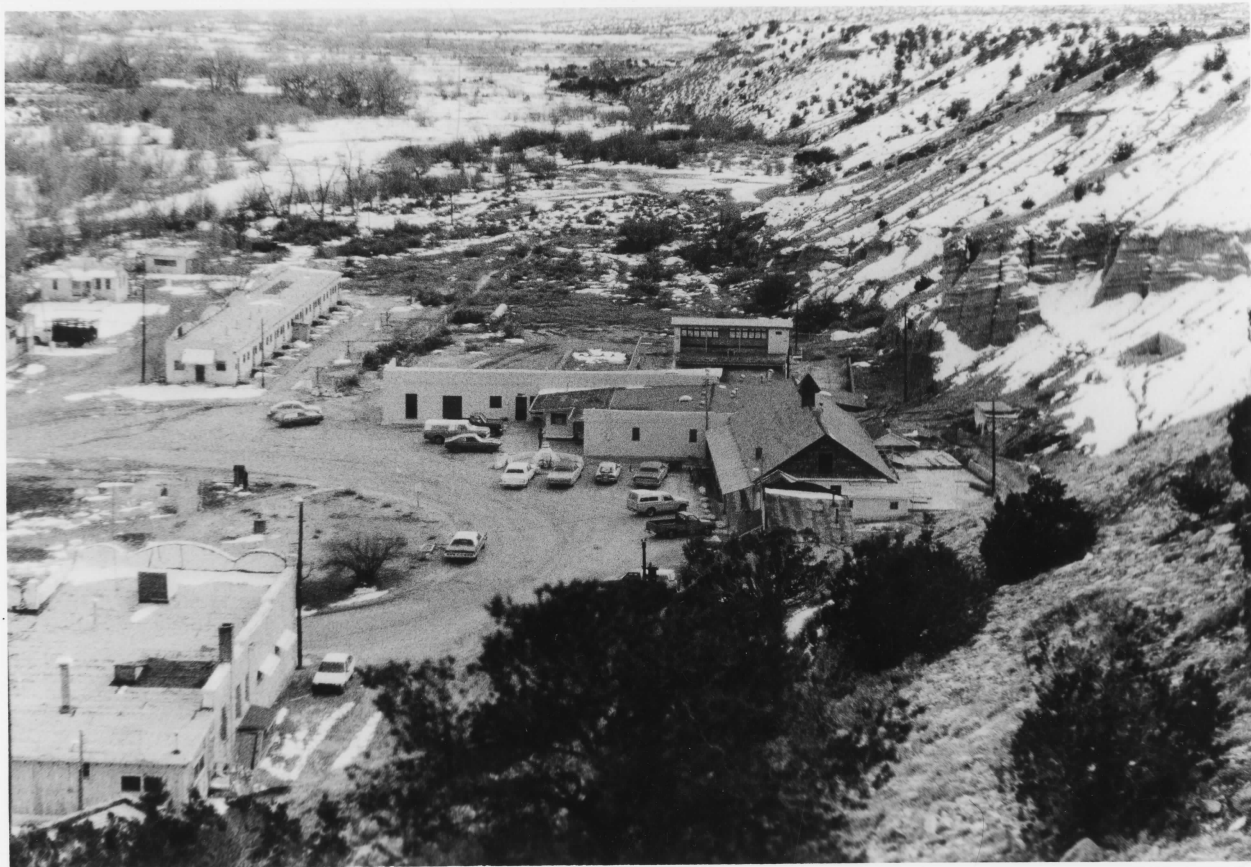
1. OJO CALIENTE MINERAL SPRINGS
2. Ojo Caliente, New Mexico
3. James A. Caufield
4. 2/85
5. Negative on file in Ojo Caliente Mineral Springs records, Ojo Caliente Mineral Springs, Ojo Caliente, New Mexico 87549
6. Partial view of complex looking south showing hotel from back (lower left), quadrangle (center left), bath house (center) and recreation building (center right).
7. Photo no. 5

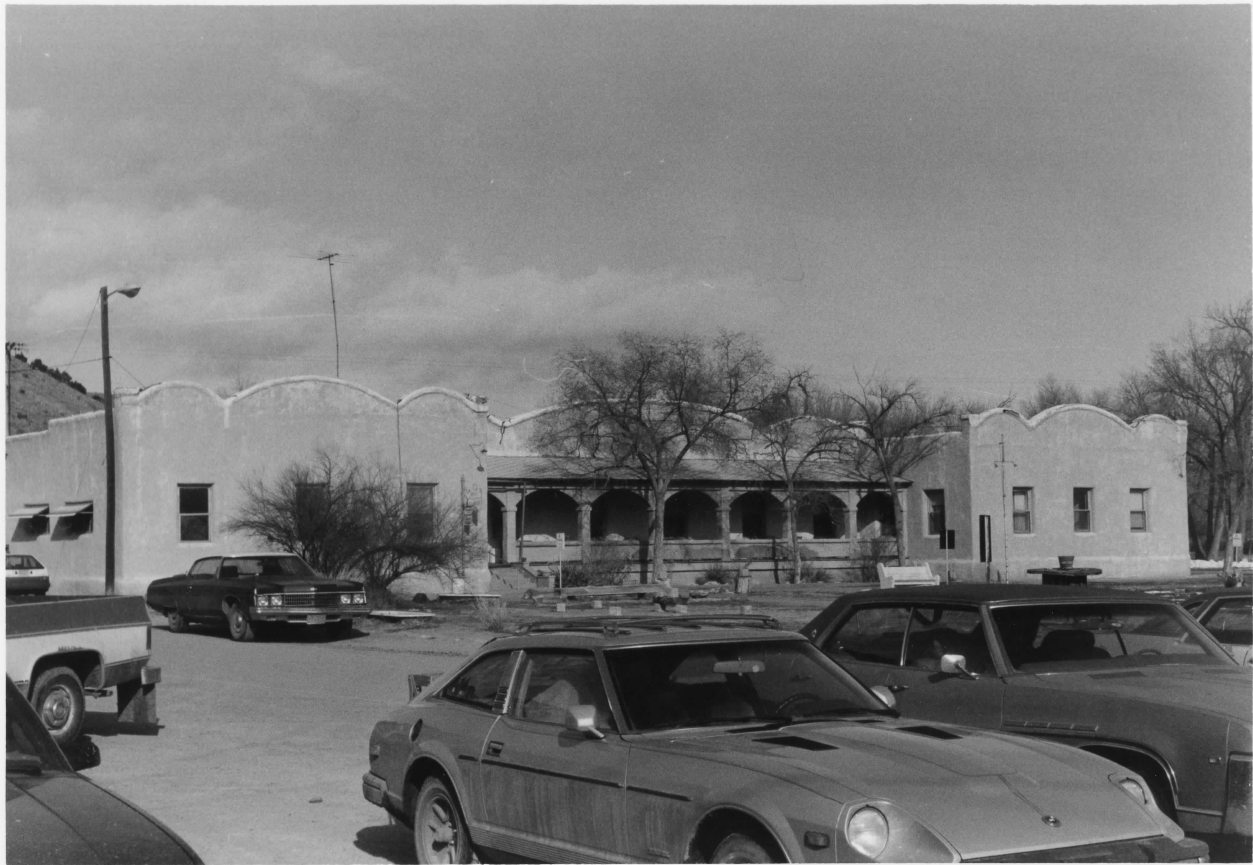
1. OJO CALIENTE MINERAL SPRINGS
2. Ojo caliente, New Mexico
3. James A. Caufield
4. 2/85
5. Negative on file in Ojo Caliente Mineral Springs records, Ojo Caliente Mineral Springs, Ojo Caliente, New Mexico 87549
6. View looking northeast showing south elevation of hotel.
7. Photo no. 6

The windows of the hotel are wood and have predominantly one-over-one sash. The south elevation of each end wing has three equally spaced windows and the central block has five windows and the principal entrance equally spaced. The west elevation of the east wing has two windows, one of which opens onto the veranda. The east elevation of the west wing has one window onto the veranda. The north elevation has six windows. The west elevation has two pairs of 6 paned casement windows, both of which light the hotel dining room.

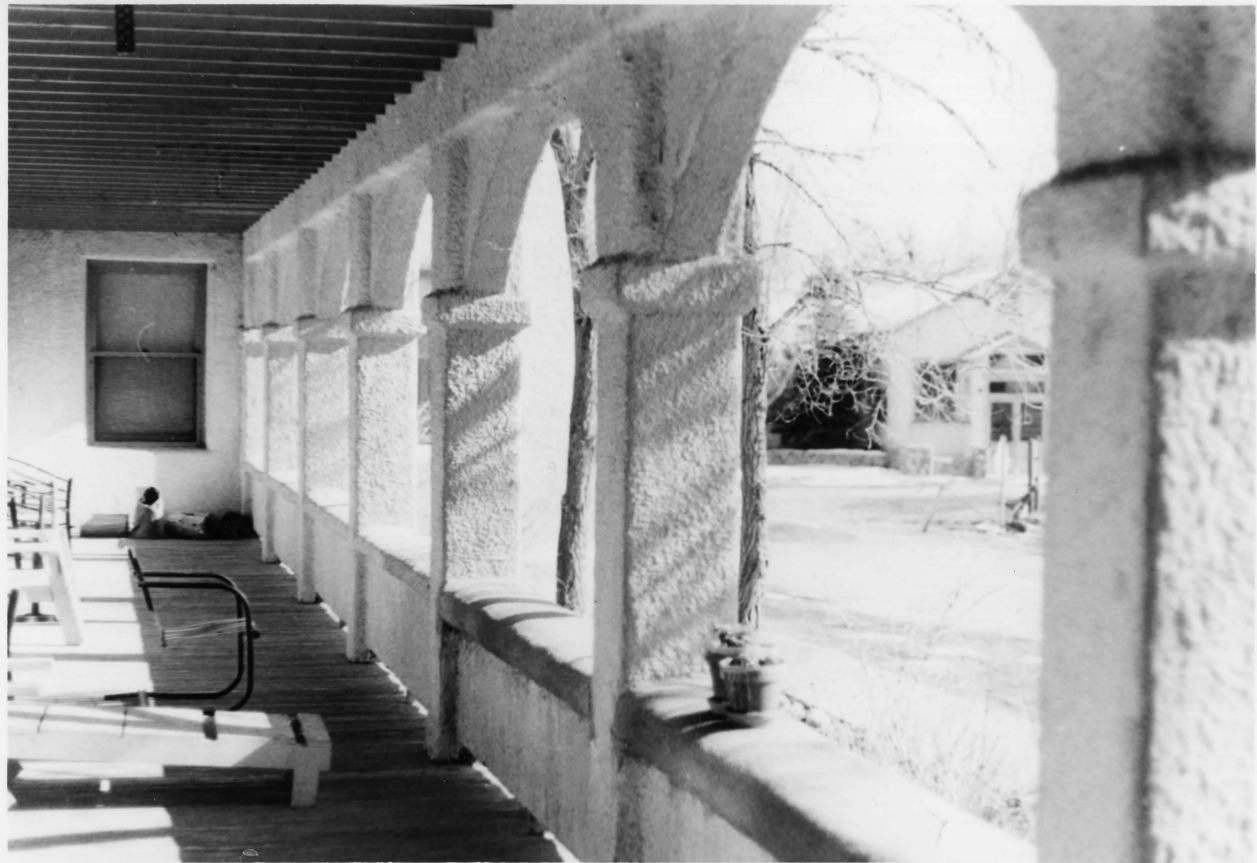
1. OJO CALIENTE MINERAL SPRINGS
2. Ojo Caliente, New Mexico
3. James A. Caufield
4. 2/85
5. Negative on file in Ojo Caliente Mineral Springs records, Ojo Caliente Mineral Springs, Ojo Caliente, New Mexico 87549
6. View looking east showing hotel veranda detail./
7. Photo no. 7

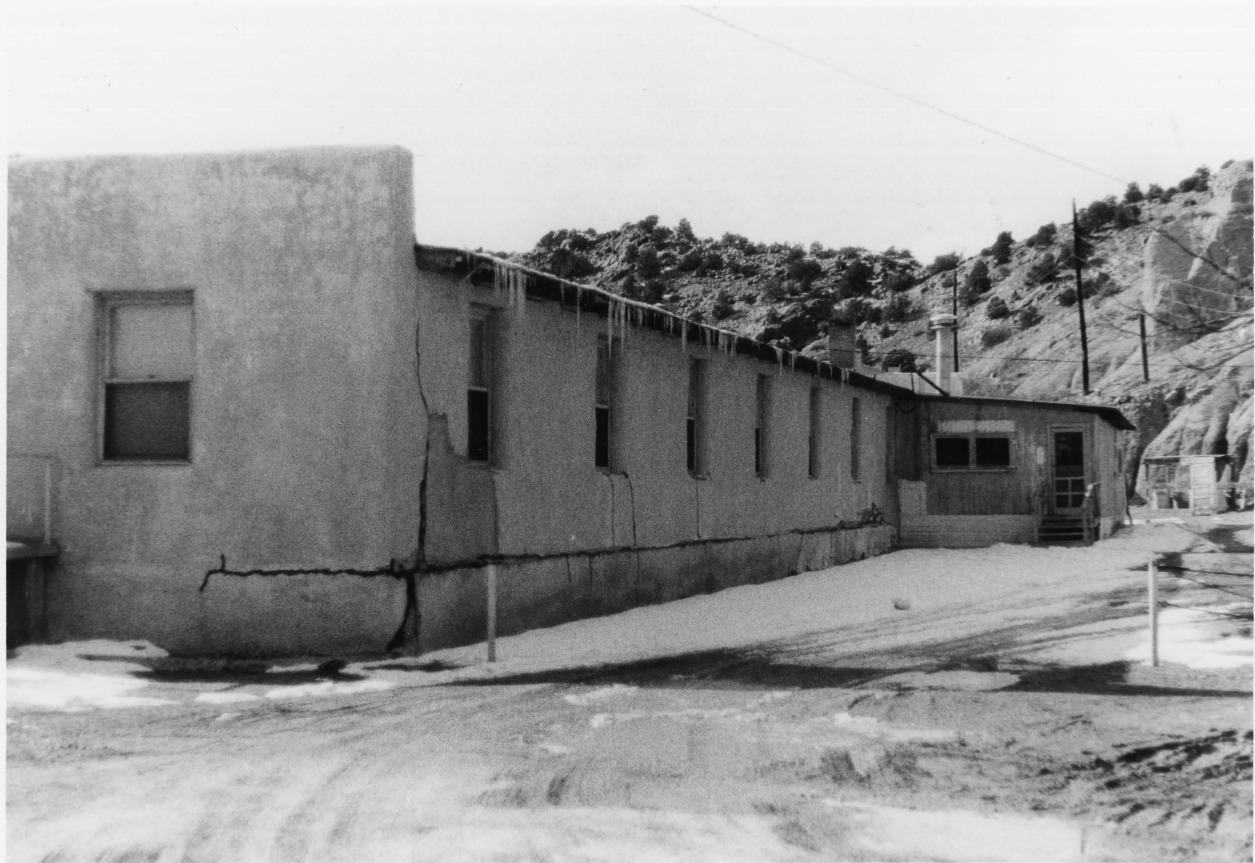
1. OJO CALIENTE MINERAL SPRINGS
2. Ojo Caliente, New Mexico
3. James A. Caufield
4. 2/85
5. Negative on file in Ojo Caliente Mineral Springs records, Ojo Caliente Mineral Springs, Ojo Caliente, New Mexico 87549
6. View looking west showing north (rear) elevation of hotel.
7. Photo no. 8

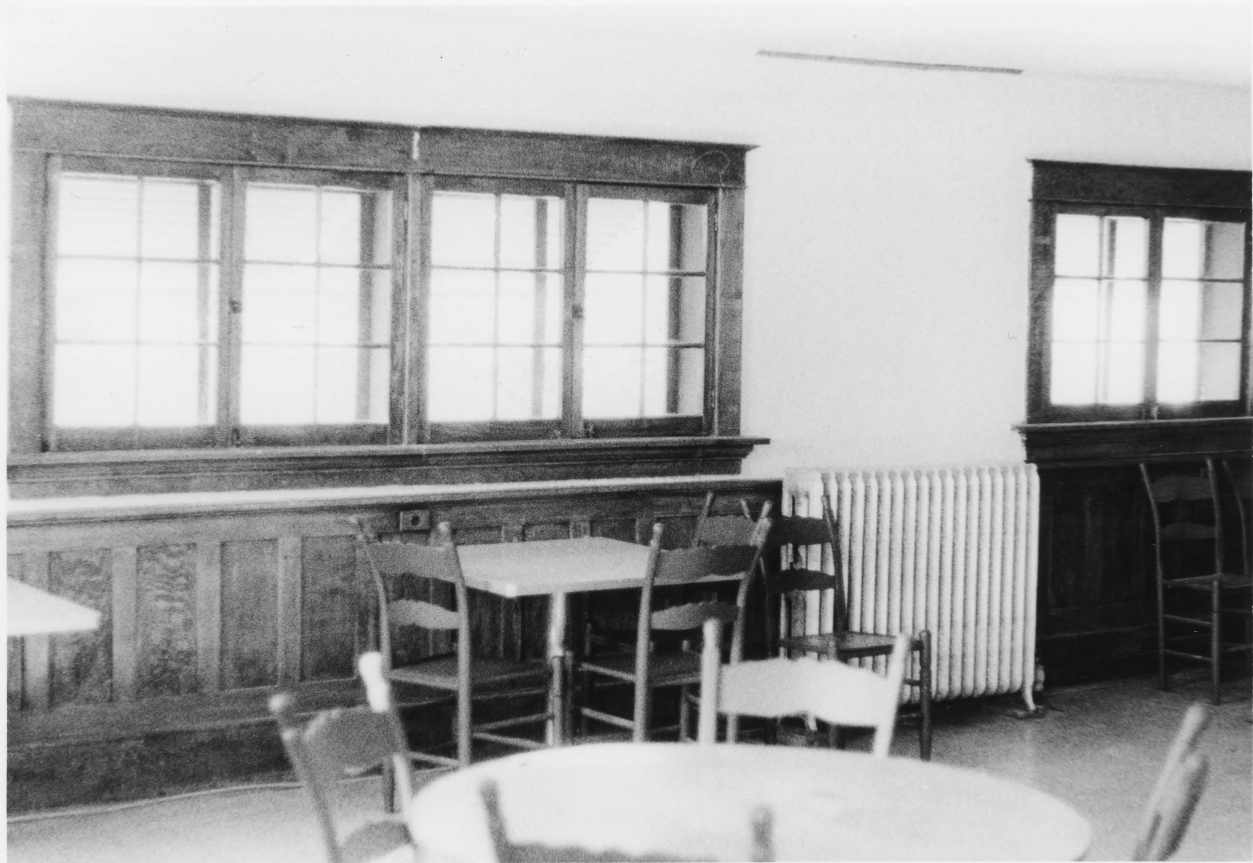
1. OJO CALIENTE MINERAL SPRINGS
2. Ojo Caliente, New Mexico
3. James A. Caufield
4. 2/85
5. Negative on file in Ojo Caliente Mineral Springs records, Ojo Caliente Mineral Springs, Ojo Caliente, New Mexico 87549
6. View of west wall of hotel dining room showing typical mission detailing.
7. Photo no. 9

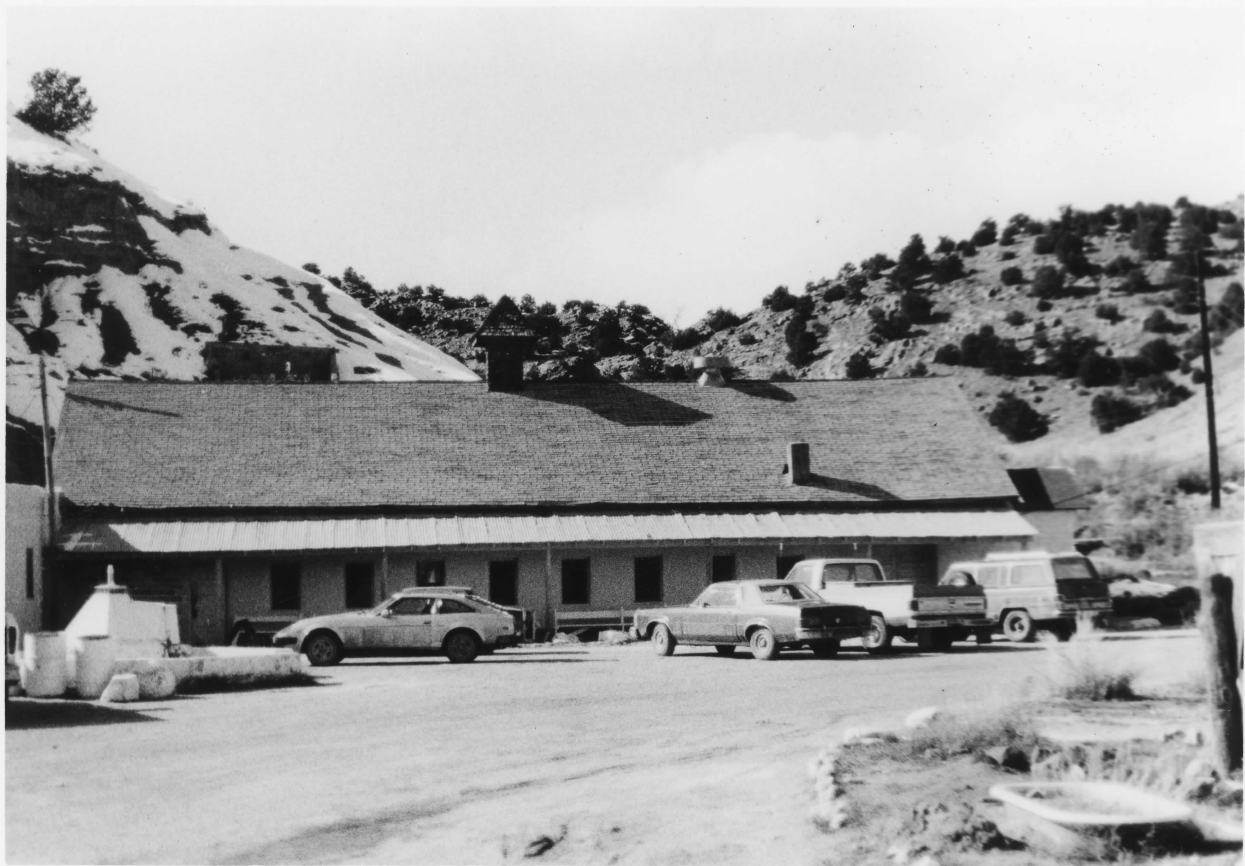
1. OJO CALIENTE MINERAL SPRINGS
2. Ojo Caliente, New Mexico
3. James A. Caufield
4. 2/85
5. Negative on file in Ojo Caliente Mineral Springs records, Ojo Caliente Mineral Springs, Ojo Caliente, New Mexico 87549
6. View looking west showing east elevation of recreation building.
7. Photo no. 10

**Recreation Building:** Constructed circa 1860 of uncoursed stone, the one story modified territorial recreation building exists today as the earliest structure of the resort complex. The front (east) elevation is finished with cement stucco while the back (west) elevation is exposed stone. A shed tin roof portal supported by simple timber posts extends the length of the east elevation. The north end wall of the structure is obscured by a later frame storage addition and the south end wall is obscured by the bath house structure. The pitched roof is covered with asphalt shingles and has a small enclosed hipped roof cupola in the center of the north-south ridge. The gable ends of the roof are sheathed with feather and butt cut wood shingles. A window opening occurs in each gable. The east elevation has twelve equally spaced openings - 11 windows and one door. The windows have wood one-over-one double hung sash. The door is located at the south end of the elevation and is in an enlarged prior window opening. The west elevation has no openings and stands in the flow of the arsenic spring outlet. Perhaps because of this excessive and continuous moisture, the

west wall is noticeably bowing outward, having been braced and stabilized in the late 1950's against the then built concrete arsenic spring holding tank. In spite of the holding tank construction, the continual overflow of the spring still flows against the lower portion of this wall. The earliest bath house facility on the site exists at the south end of the west elevation and is fed by the iron spring. This bath facility is in a small square structure with a gable roof with a north-south ridge attached to the recreation building. A small hipped roof cupola is centered on the ridge. A small gable is centered on the west slope to cover an entrance to the bathing pool inside.

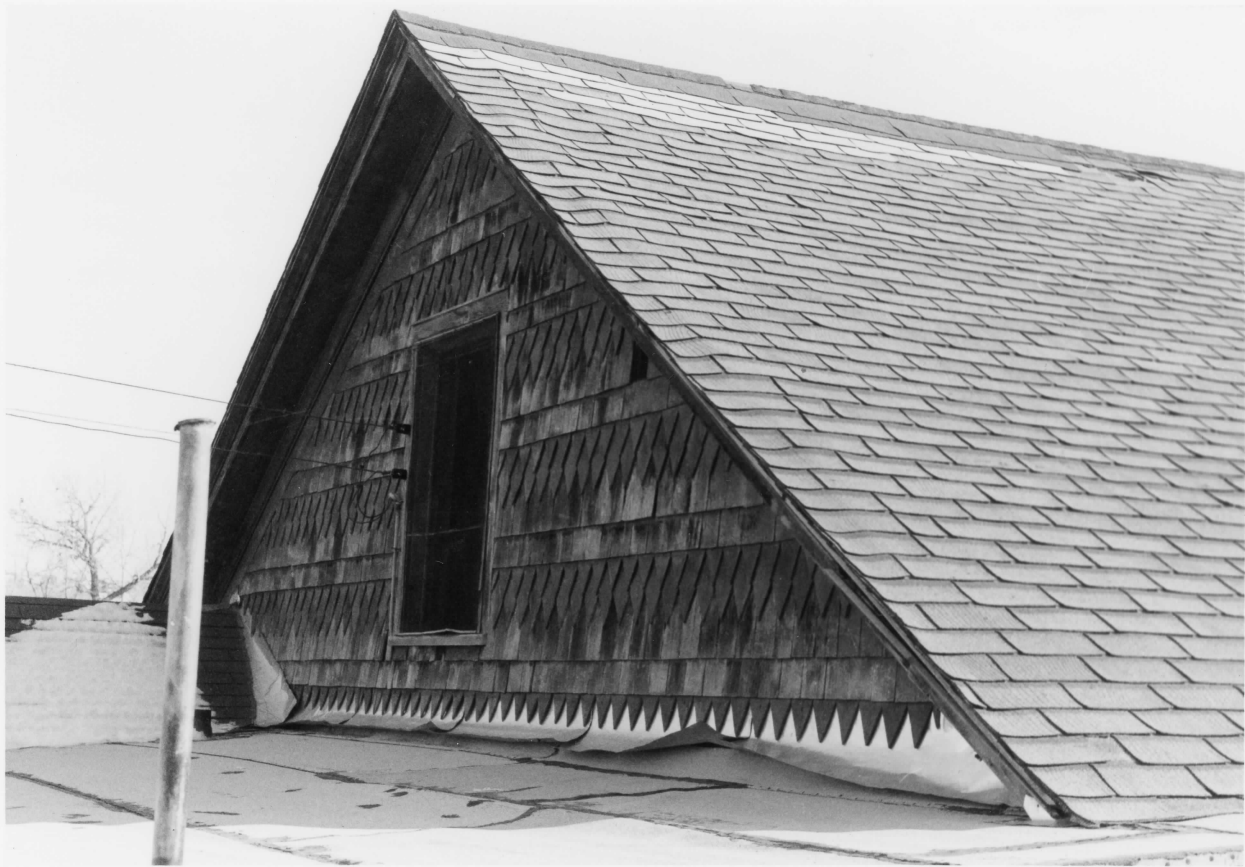
1. OJO CALIENTE MINERAL SPRINGS
2. Ojo Caliente, New Mexico
3. James A. Caufield
4. 2/85
5. Negative on file in Ojo Caliente Mineral Springs records, Ojo Caliente Mineral Springs, Ojo Caliente, New Mexico 87549
6. View looking southeast showing north gable end of recreation building.
7. Photo no. 11

The recreation building was altered in 1924 when the second floor was removed, perhaps in an effort to control the rear wall structural problem. From an examination of the existing roof structure, it is possible that at least the original framing material was reused in construction of the roof on the remaining one story building. The existing cupola is of different size and proportion than the original cupola shown in early photographs.

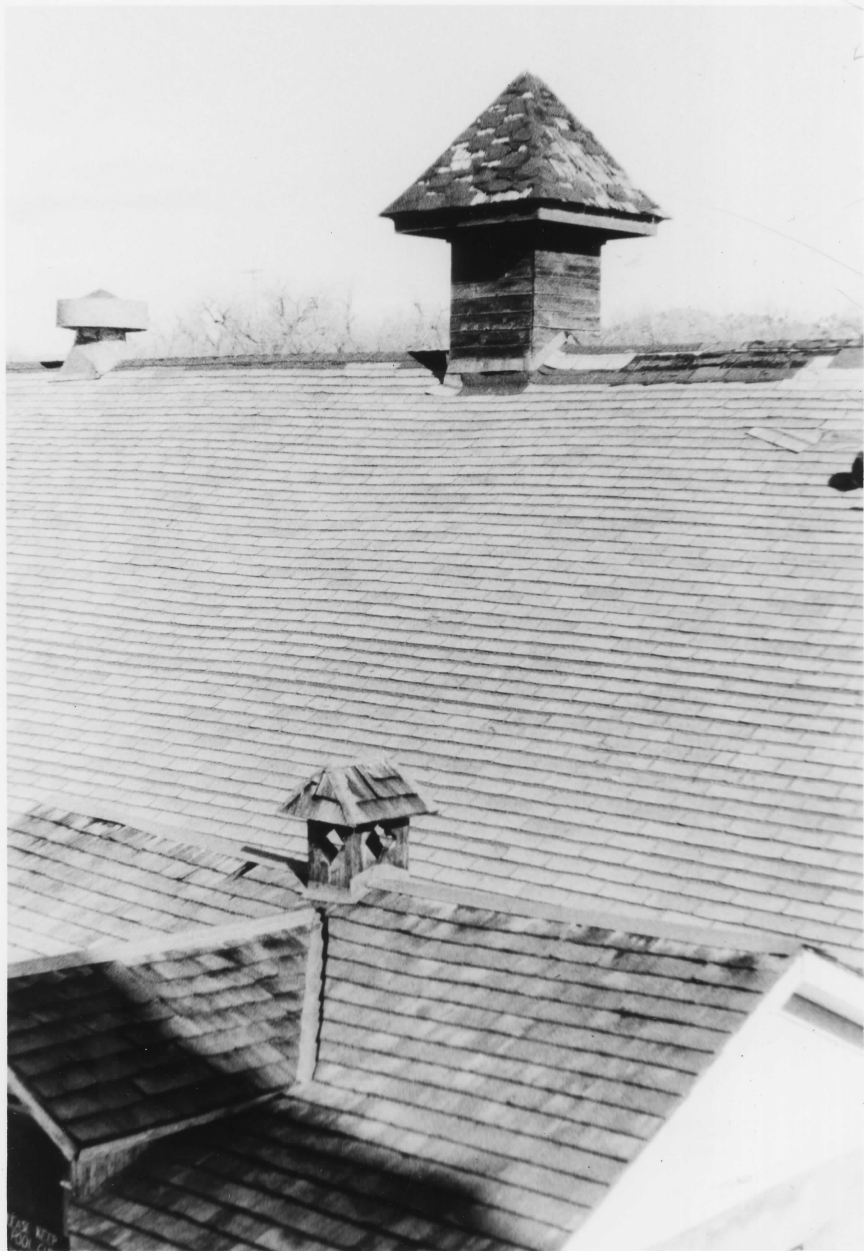
1. OJO CALIENTE MINERAL SPRINGS
2. Ojo Caliente, New Mexico
3. James A. Caufield
4. 2/85
5. Negative on file in Ojo Caliente Mineral Springs records, Ojo Caliente Mineral Springs Ojo Caliente, New Mexico 87549
6. View looking northeast showing rear roof of recreation building and iron spring bath enclosure.
7. Photo no. 12

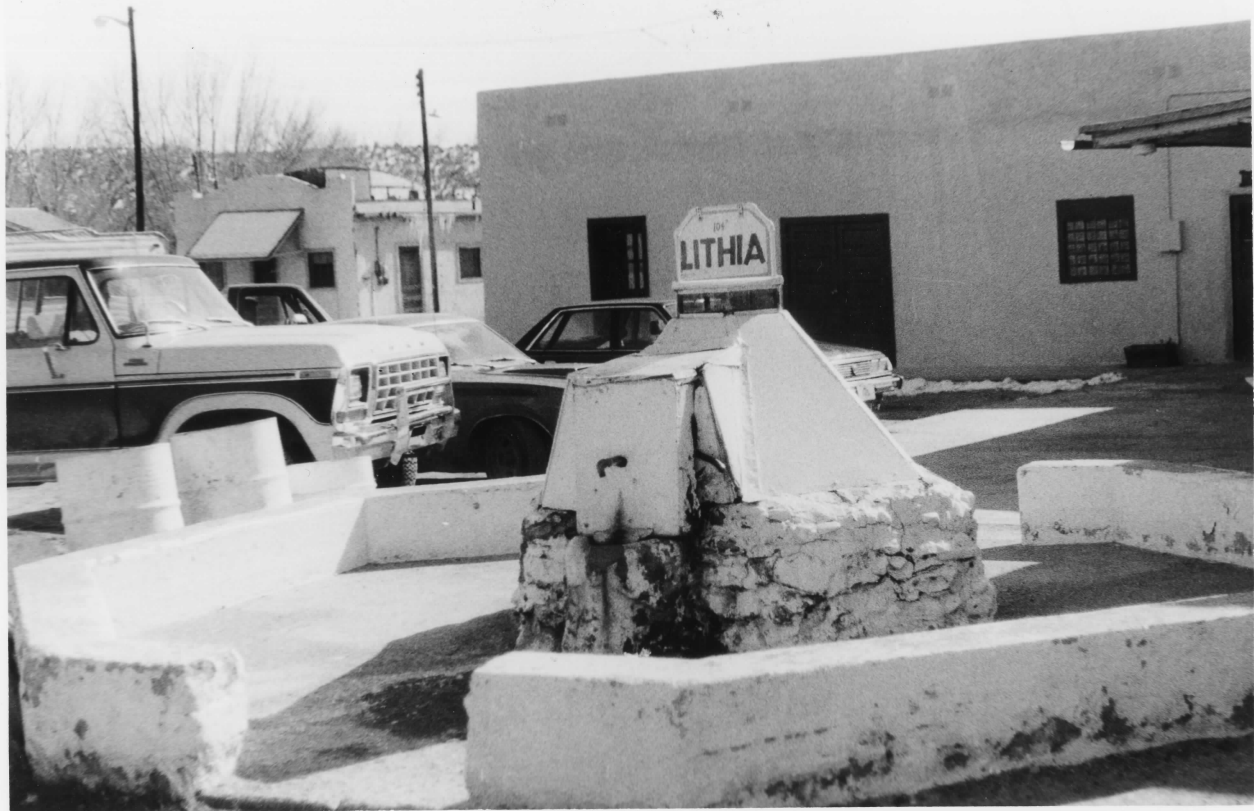
1. OJO CALIENTE MINERAL SPRINGS
2. Ojo Caliente, New Mexico
3. James A. Caufield
4. 2/85
5. Negative on file in Ojo Caliente Mineral Springs records, Ojo Caliente, New Mexico 87549
6. View looking southeast showing lithia spring fountain with bath house in background.
7. Photo no. 13

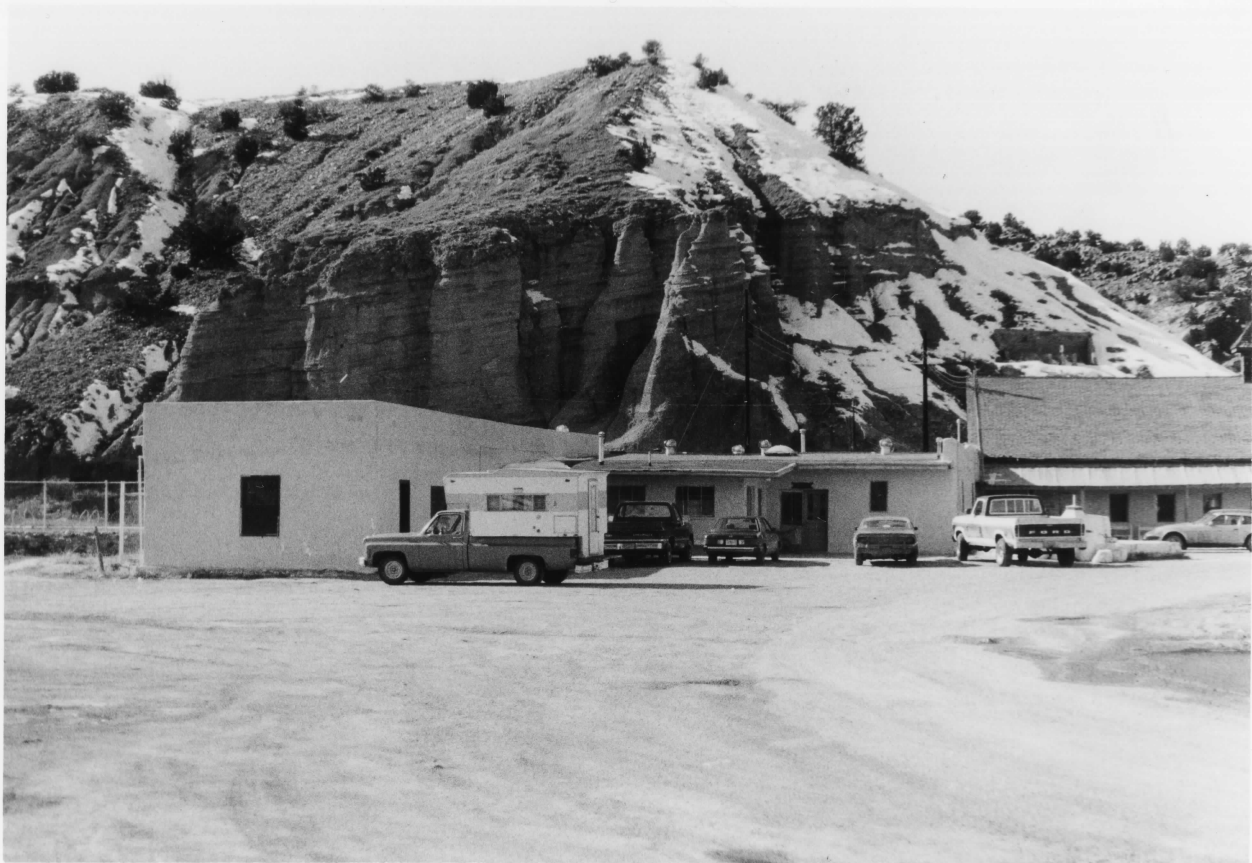
1. OJO CALIENTE MINERAL SPRINGS
2. Ojo Caliente, New Mexico
3. James A. Caufield
4. 2/85
5. Negative on file in Ojo Caliente Mineral Springs records, Ojo Caliente, New Mexico 87549
6. View looking southwest showing north and east elevations of bath house.
7. Photo no. 14

**Bath House:** Constructed in 1929 of concrete and stone, the bath house was built by a new owner of the resort to enclose and utilize the iron and sodium sulphate springs. The bath house initiated what was to become 25 years of expansion for the resort, extending into 1953. This building provided dressing, private bathing and enclosed pool and restroom facilities for visitors to the mineral springs. The bath house was built strictly as a utilitarian structure with no apparent desire to blend with or complement the other buildings on the site, as do the other later major structures. The building detracts from the complex in its massing, detail and austere design. Adjacent to and south (rear) of the bath house is a 1953 outdoor swimming/bathing pool fed by the iron, arsenic and soda springs. The pool and its support facilities are part of the bath house functions. Although the springs, and the existence of an open swimming/bathing pool facility are significant to the history and use of the mineral springs complex, the existing pool structure and surrounding equipment facilities do not contribute either historically or architecturally.

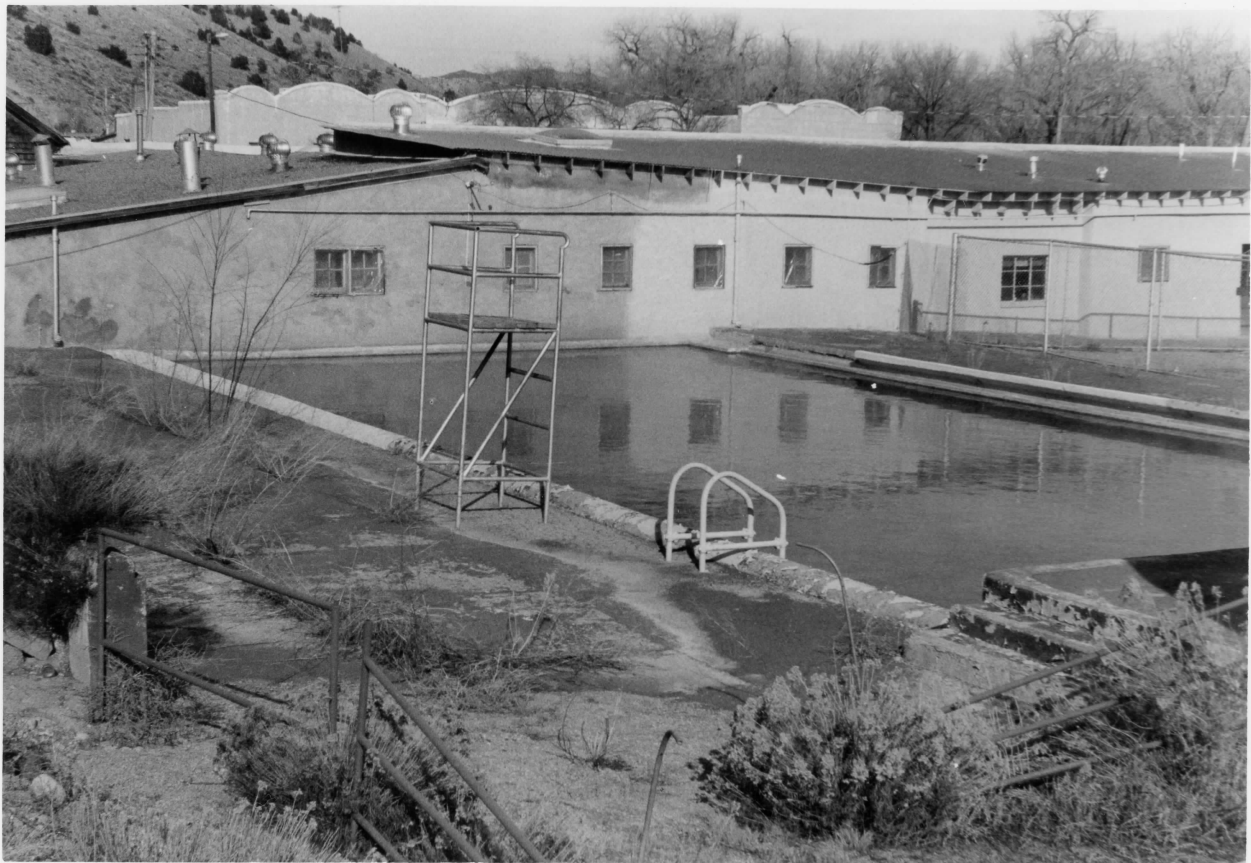
1. OJO CALIENTE MINERAL SPRINGS
2. Ojo Caliente, New Mexico
3. James A. Caufield
4. 2/85
5. Negative on file in Ojo Caliente Mineral Springs records, Ojo Caliente Mineral Springs Ojo Caliente, New Mexico 87549
6. View looking northeast showing south (rear) elevation of bath house and outdoor swimming pool.
7. Photo no. 15
