UNITED STATES DEPARTMENT OF THE INTERIOR  
NATIONAL PARK SERVICE  
NATIONAL REGISTER OF HISTORIC PLACES  
REGISTRATION FORM

historic name Duke Residence  
other names/site number \_\_\_\_\_

street & number 1009 Fifth Avenue | | not for publication  
city, town New York | | vicinity  
state NY code NY county NY code 06 zip code 10550

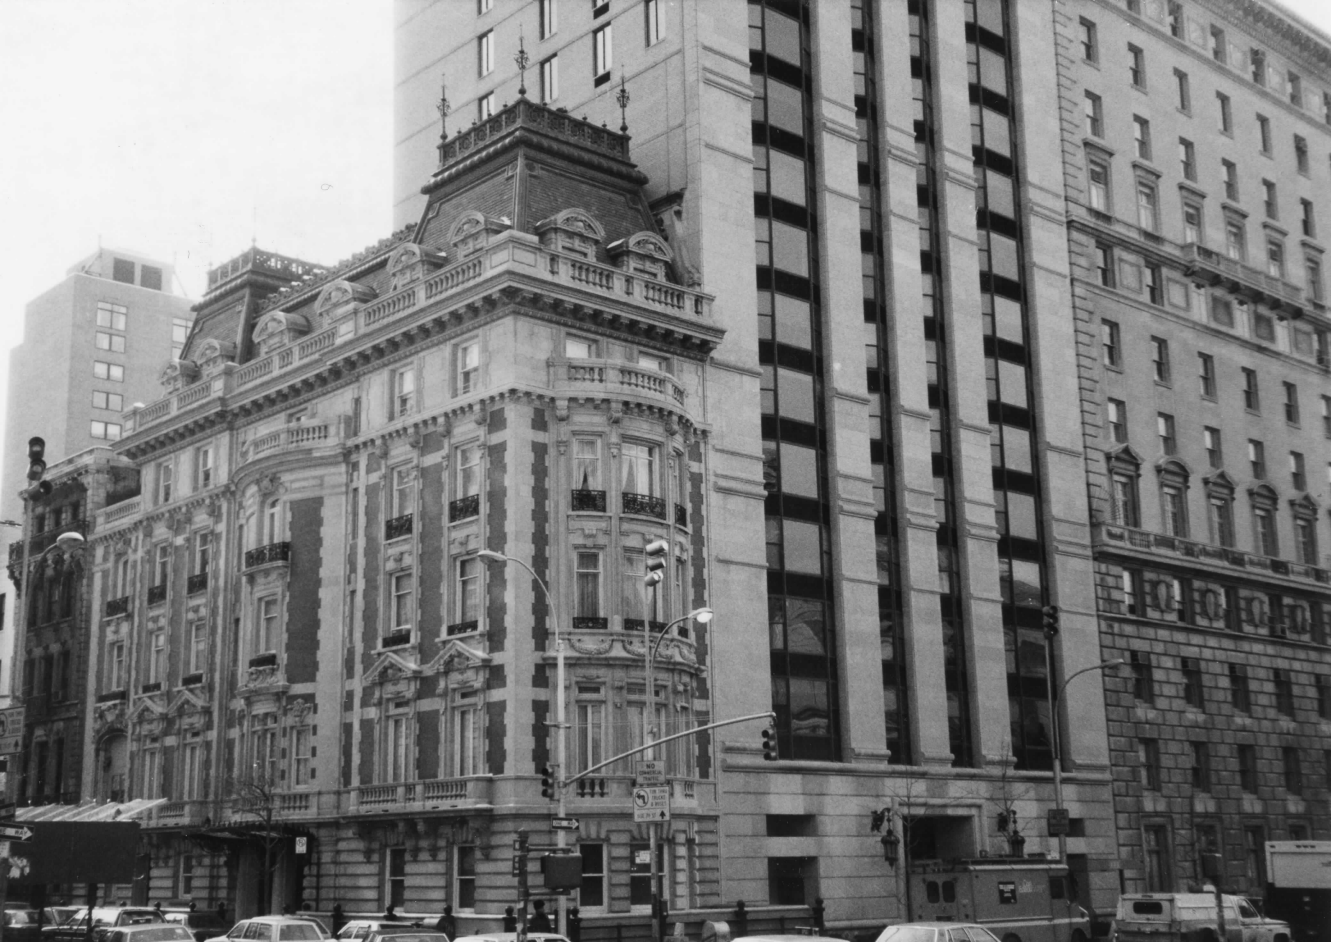
Photo 1

View from northwest

The building is a five-story and mansard roof corner mansion with a narrow three-bay facade facing Fifth Avenue and a six-bay facade along East 82nd Street. A moat-like areaway, surrounded by a cast-iron railing, separates the house from the street. The basement and first floor are executed in rusticated limestone, while the upper stories are of red brick with heavy limestone trim. Limestone quoins outline and clearly define the major components of the design, including the corners of the building and the curving bays that project from the center of each elevation.

The main block of the 82nd Street facade is symmetrically composed with two slightly projecting, two bay wide pavilions flanking a central four-story curved bay that is crowned by a balustrade railing at the fifth floor. The main entrance, at the first floor of the curved bay, has an elegant glass and iron marquee that was probably added shortly after the building was completed. Glass and wrought-iron doors are separated from similarly treated side windows by engaged columns. Above the entrance, in the center of the curved bay, is a three-story limestone window enframingent that is the focal point of this elevation. On the second floor this bay contains a pair of windows capped by a projecting lintel and ornate cartouche. On the second floor is a single rectangular window with an iron balcony. On the third floor is a segmental-arched window with an iron balcony and large projecting cartouche.

The Fifth Avenue facade is dominated by a broad, curved limestone bay that extends from the basement through the fourth floor and is crowned by a balustrade railing. The bay is highlighted by limestone railings at the second floor, carved garlands between the second and third floors, carved brackets at the third floor, and iron window guards at the third and fourth floors. The beltcourse and cornice seen on 82nd Street continue onto Fifth Avenue.

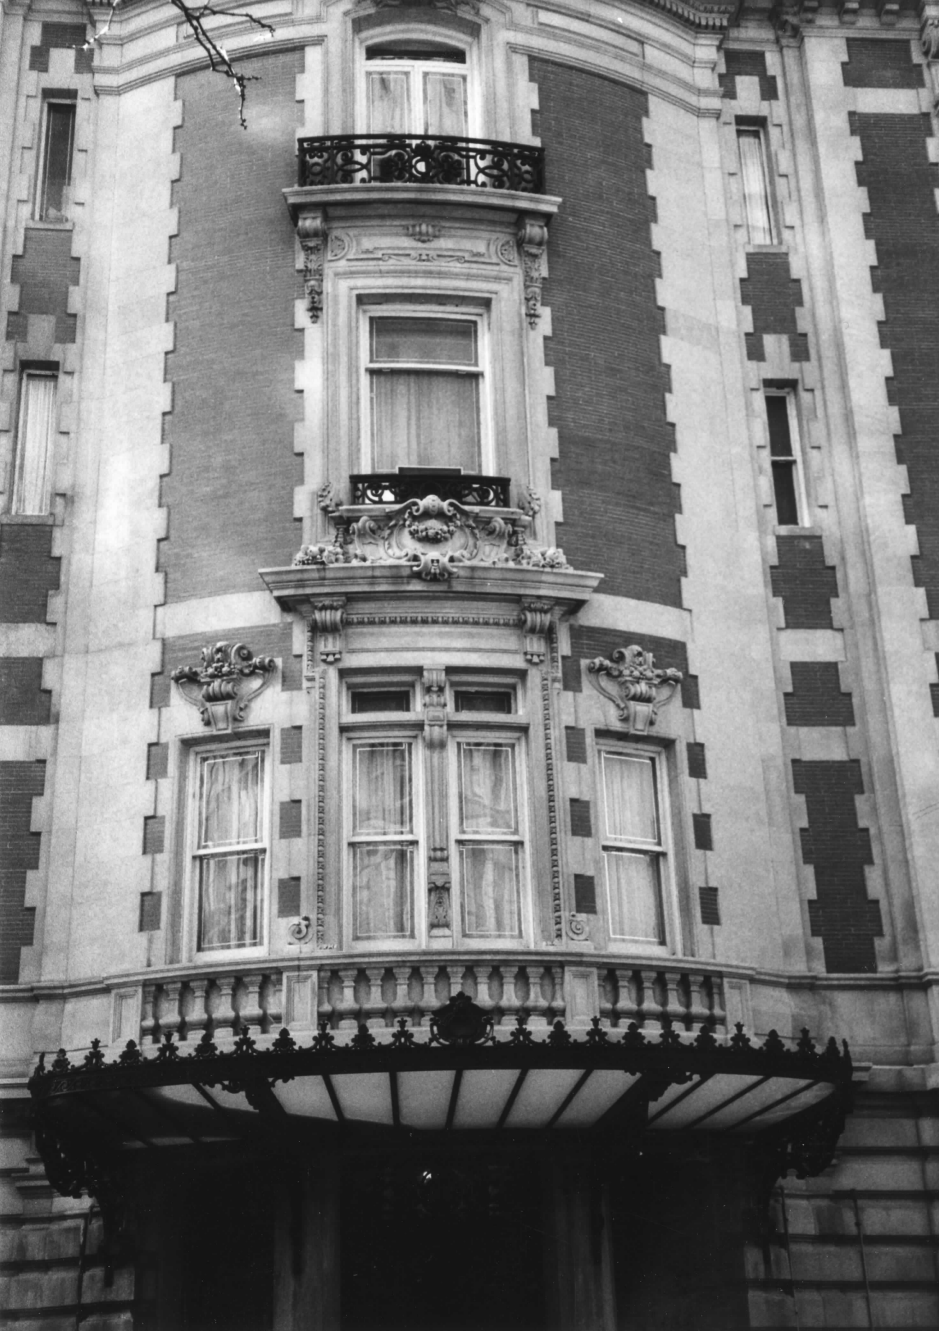
Photo 2

Detail of 2nd-3rd Floors above entrance, view from  
north

Stone balconies on carved brackets appear below all of the windows of the second floor. In the curved bay, the central window is flanked by two secondary windows that are capped by cartouches. Pediments and cartouches cap the French windows of the flanking pavilions. Limestone enframements link the windows of the third and fourth floors where low iron railings are used as window guards. Above the fourth floor there is a projecting continuous band course on brackets, a horizontal accent that is repeated with stronger emphasis by the elaborate modillioned roof cornice that runs above the fifth floor. The fifth floor contains limestone beltcourses and simple rectangular windows. The roof cornice is crowned by a stone balustrade, behind which rises the mansard roof, which is pierced by dormers, each with a segmental-arched roof ornamented by a cartouche. The roof is clad in red tile and is crowned by a copper cornice. The roof has two towers that rise at the ends of the main block of the house. These have an ornate copper cresting and tall finials that were restored in the 1980s.

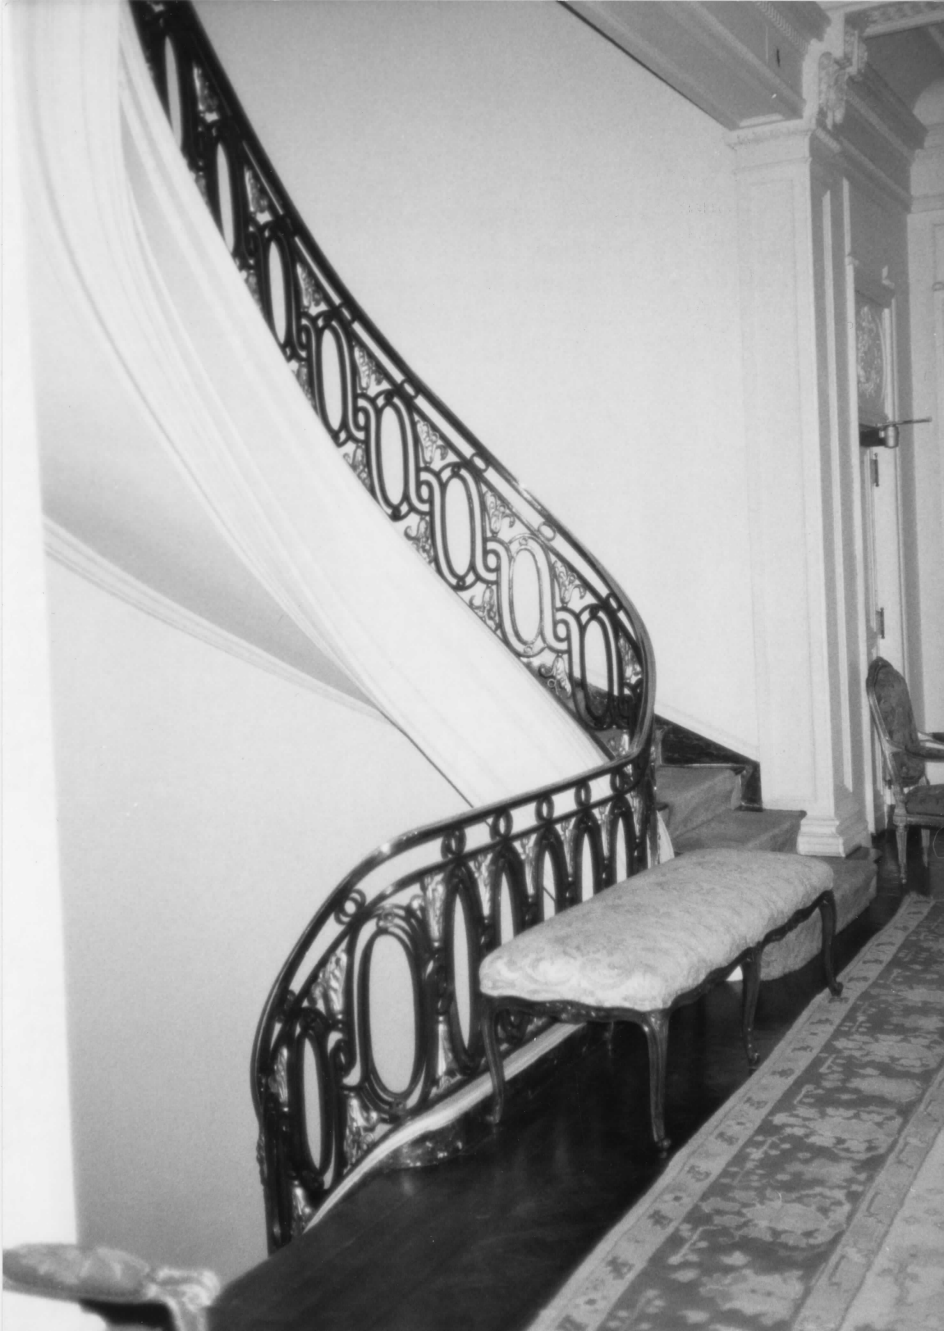
Photo 3

Stair on second floor, view from northeast

In contrast to the sculptural exuberance of the exterior is the refined simplicity of the interior. The interior retains its original plan, but most of the details date from a 1920 redesign. The main interior rooms have a cohesive quality, ornamented primarily with simple French Neoclassical style detail. The main entrance doors lead to a marble outer vestibule with doors that lead into the inner stair hall. The first floor is primarily a utilitarian level, now containing the stair hall and two offices. A beautiful curving stair with iron railing leads up to the main floor. This stair may date from the original period of construction.

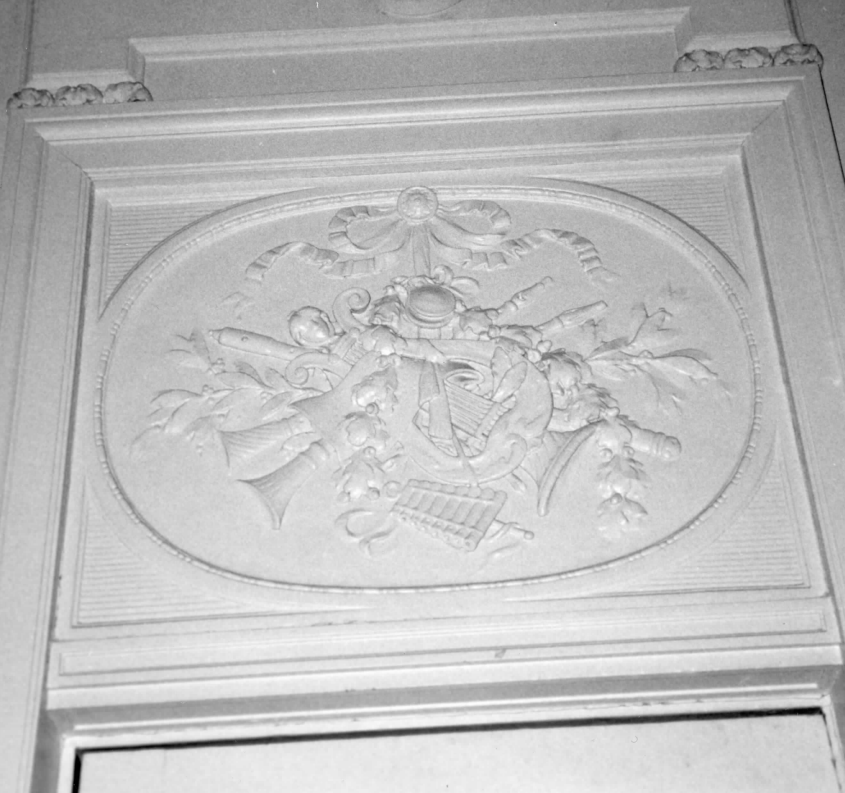
Photo 4

2nd floor Reception Room, detail above door, view from north

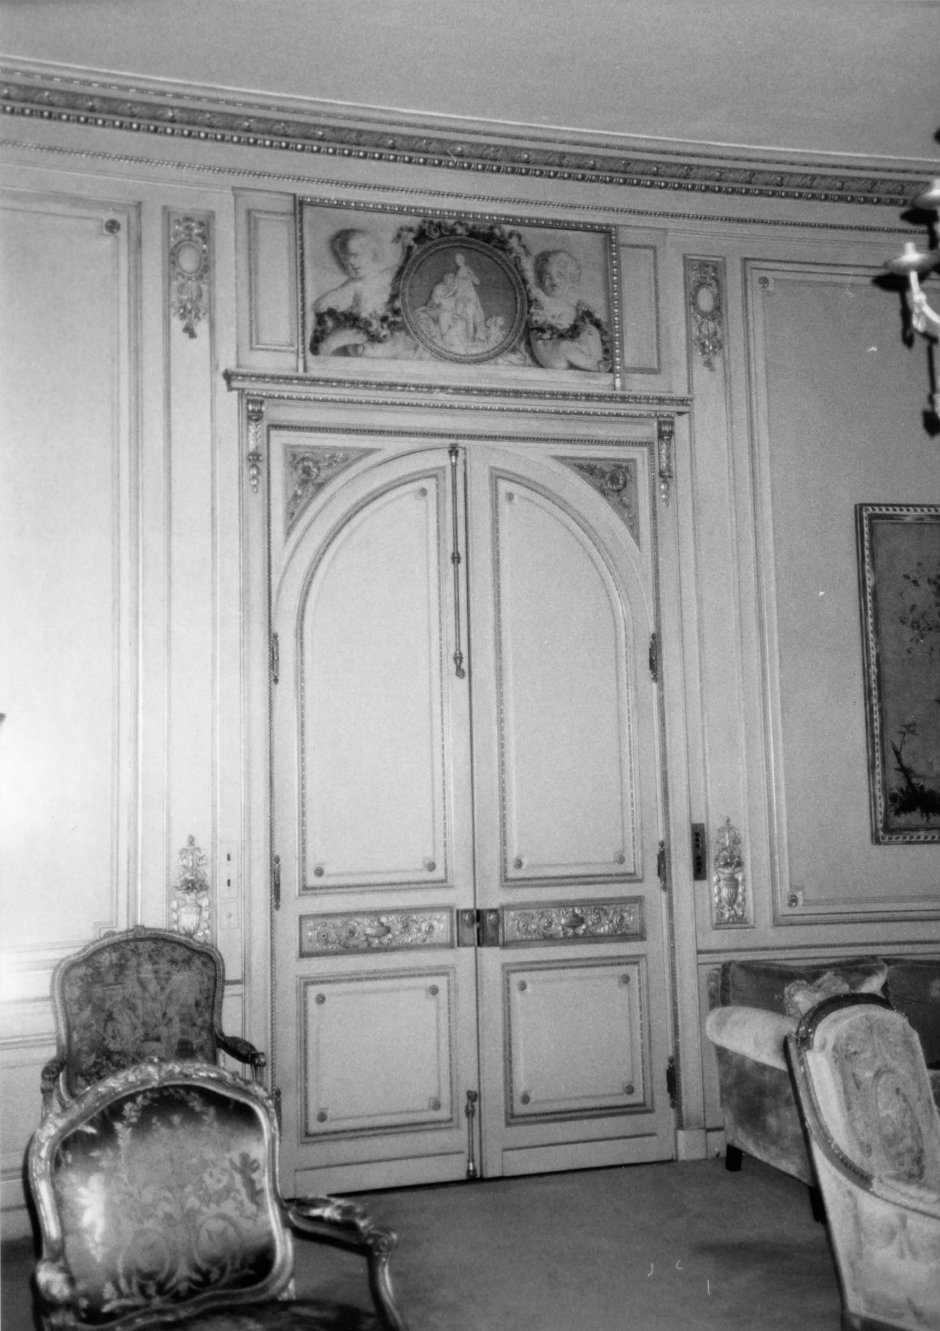
Photo 5

2nd floor Parlor entrance doors, view from northwest

The piano nobile consists of three large public rooms: a music room in the center, a dining room to the east, and a parlor to the west. The music room opens directly onto the stair. Its most notable ornamental features are the arched doorway enframements on the east and west walls and the pair of overdoor panels on the south wall, each detailed with a cluster of musical instruments. The panel to the east is set above the door to an elevator added in 1920. The dining room has simple wall paneling with painted canvas trompe l'oeil vines and roundels containing putti. The room has a simple white marble mantel. The kitchen is located to the east of this room. The parlor also has simple paneled walls. These are highlighted by cartouches, urns, and classical moldings. The windows of the curved bay overlooking Fifth Avenue have enframements capped by entablatures supported by brackets. This room has a white marble mantel with a guilloche frieze.

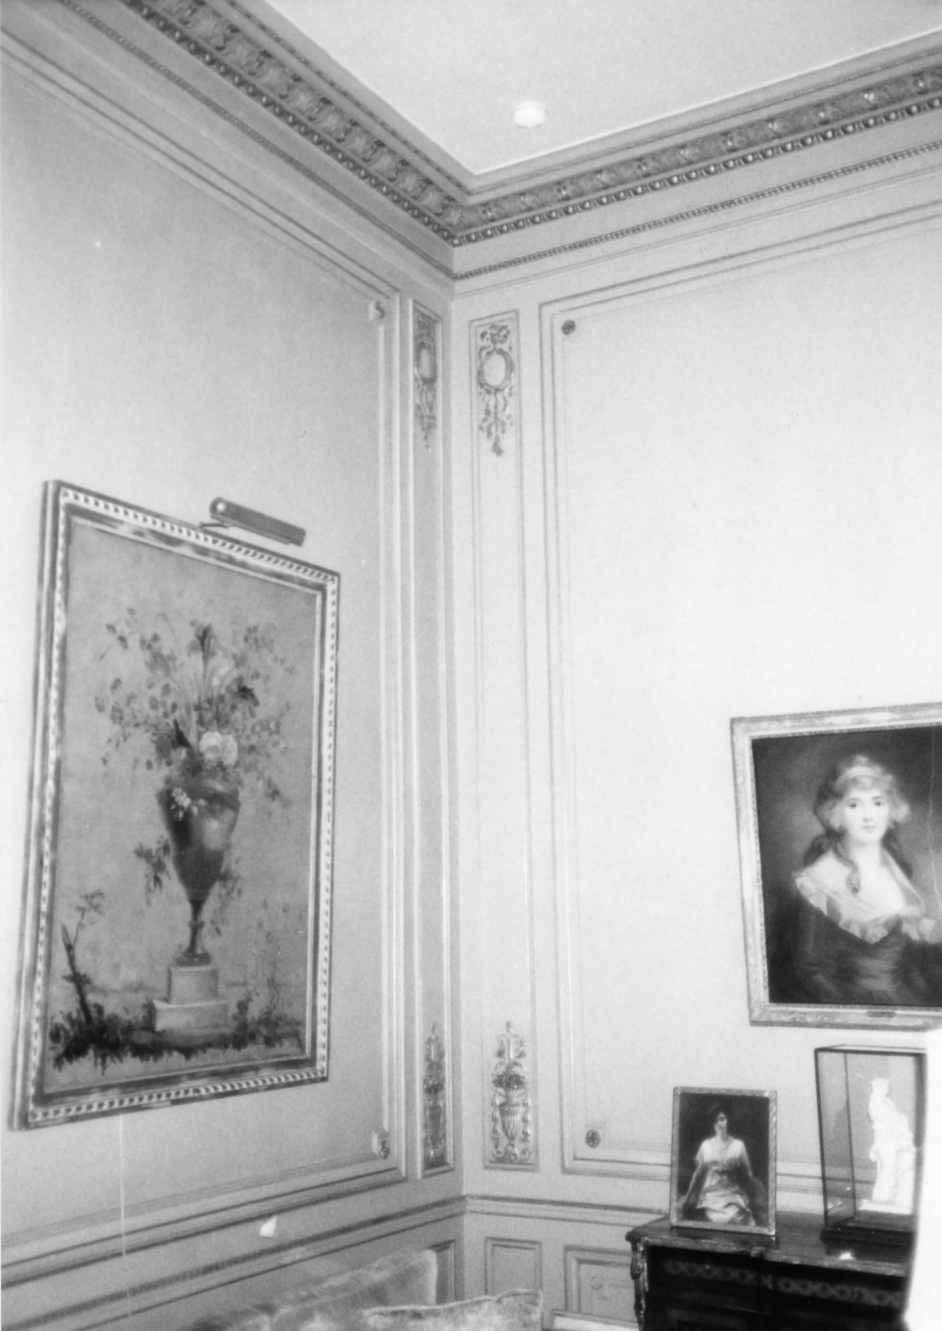
Photo 6

2nd floor parlor corner detail, view from northwest

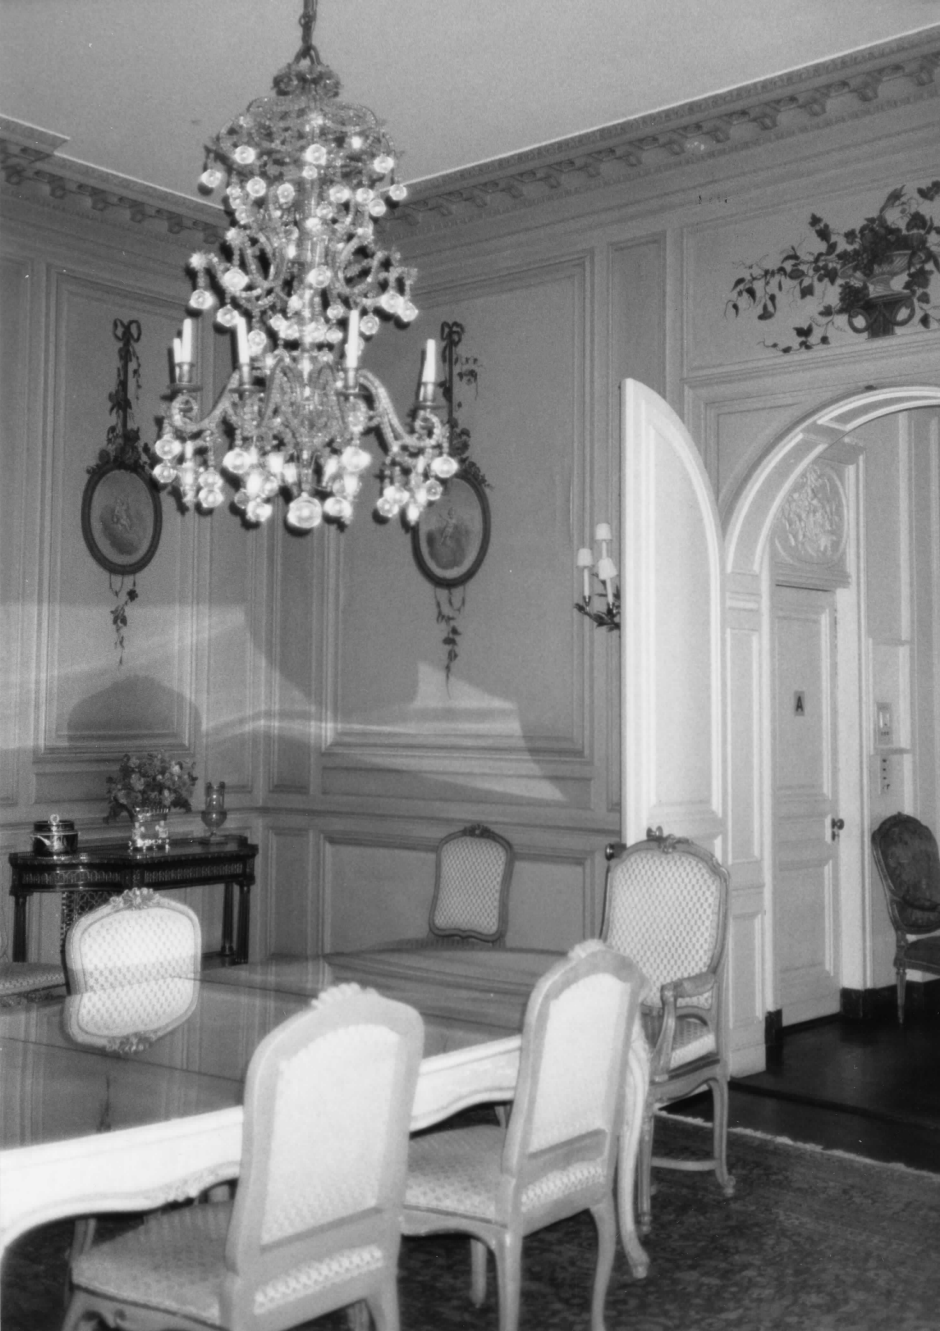
Photo 7

2nd floor dining room, view from northeast

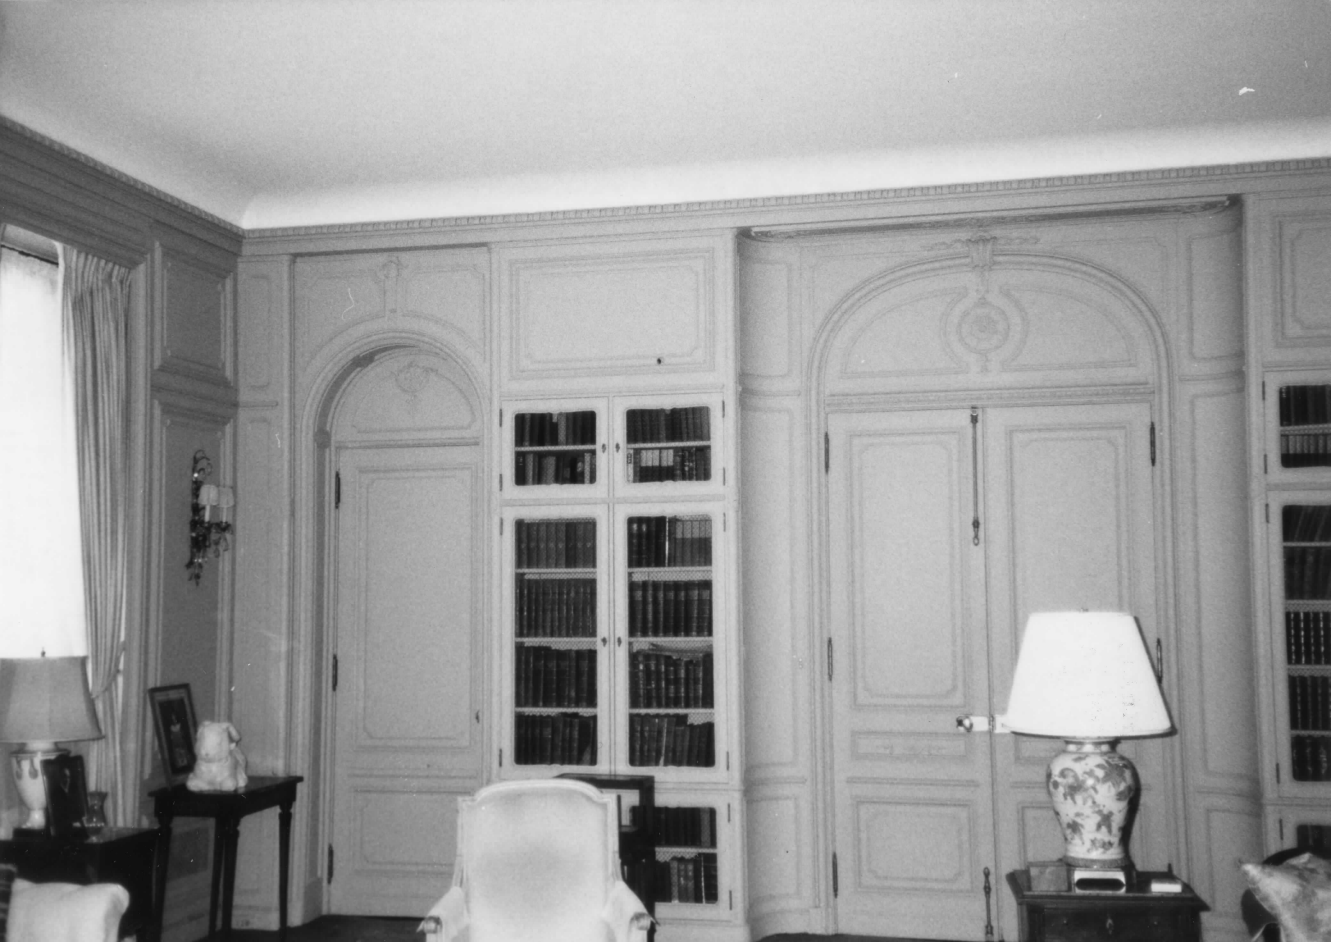
Photo 8

3rd floor sitting room, view from west

The master bedroom of the house is located on the east side of the third floor. This room has simple moldings and a modest marble mantel. The doorway enframements are ornamented with guilloche and foliate moldings. To the east of the main bedroom, in the wing at the east end of the house, is a small bedroom with very simple detail. At the west end of the third floor is the library, the most ornate room in the house. This room is decorated in a subtle Rococo manner with built-in bookcases and an ornate red marble mantel. Between the bedroom and library is the stair hall and behind it a bathroom and dressing room. The sixth floor mansard contains servants' rooms.

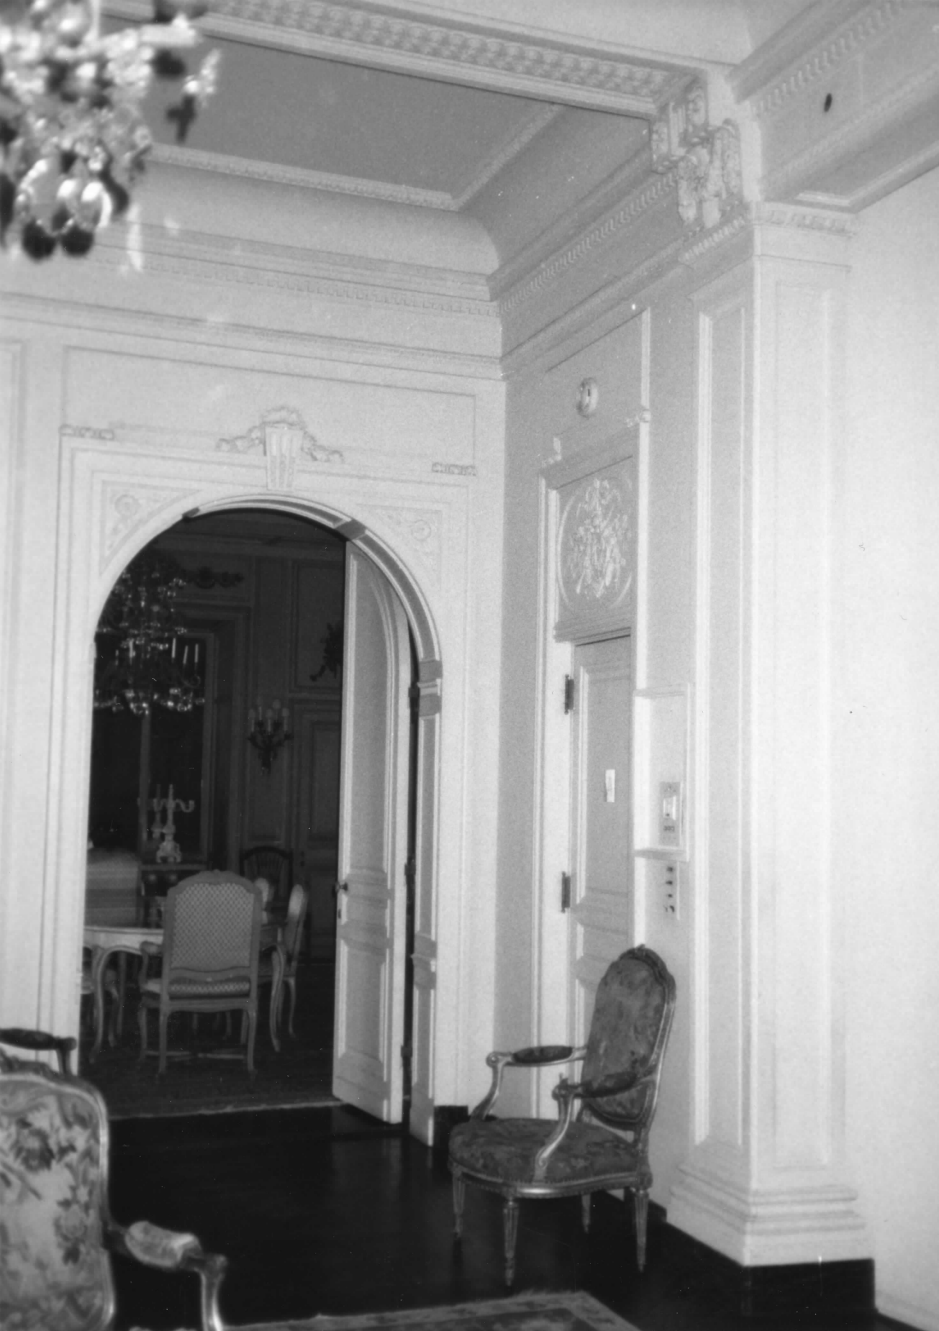
Photo 9

2nd floor Reception Room, view from west
