historic name BATES COBBLESTONE FARMHOUSE

street & number 5521 ROUTE 364 (Canandaigua Road) [ ] not for publication

town Middlesex [ ] vicinity

Cobblestone Architecture of New York State

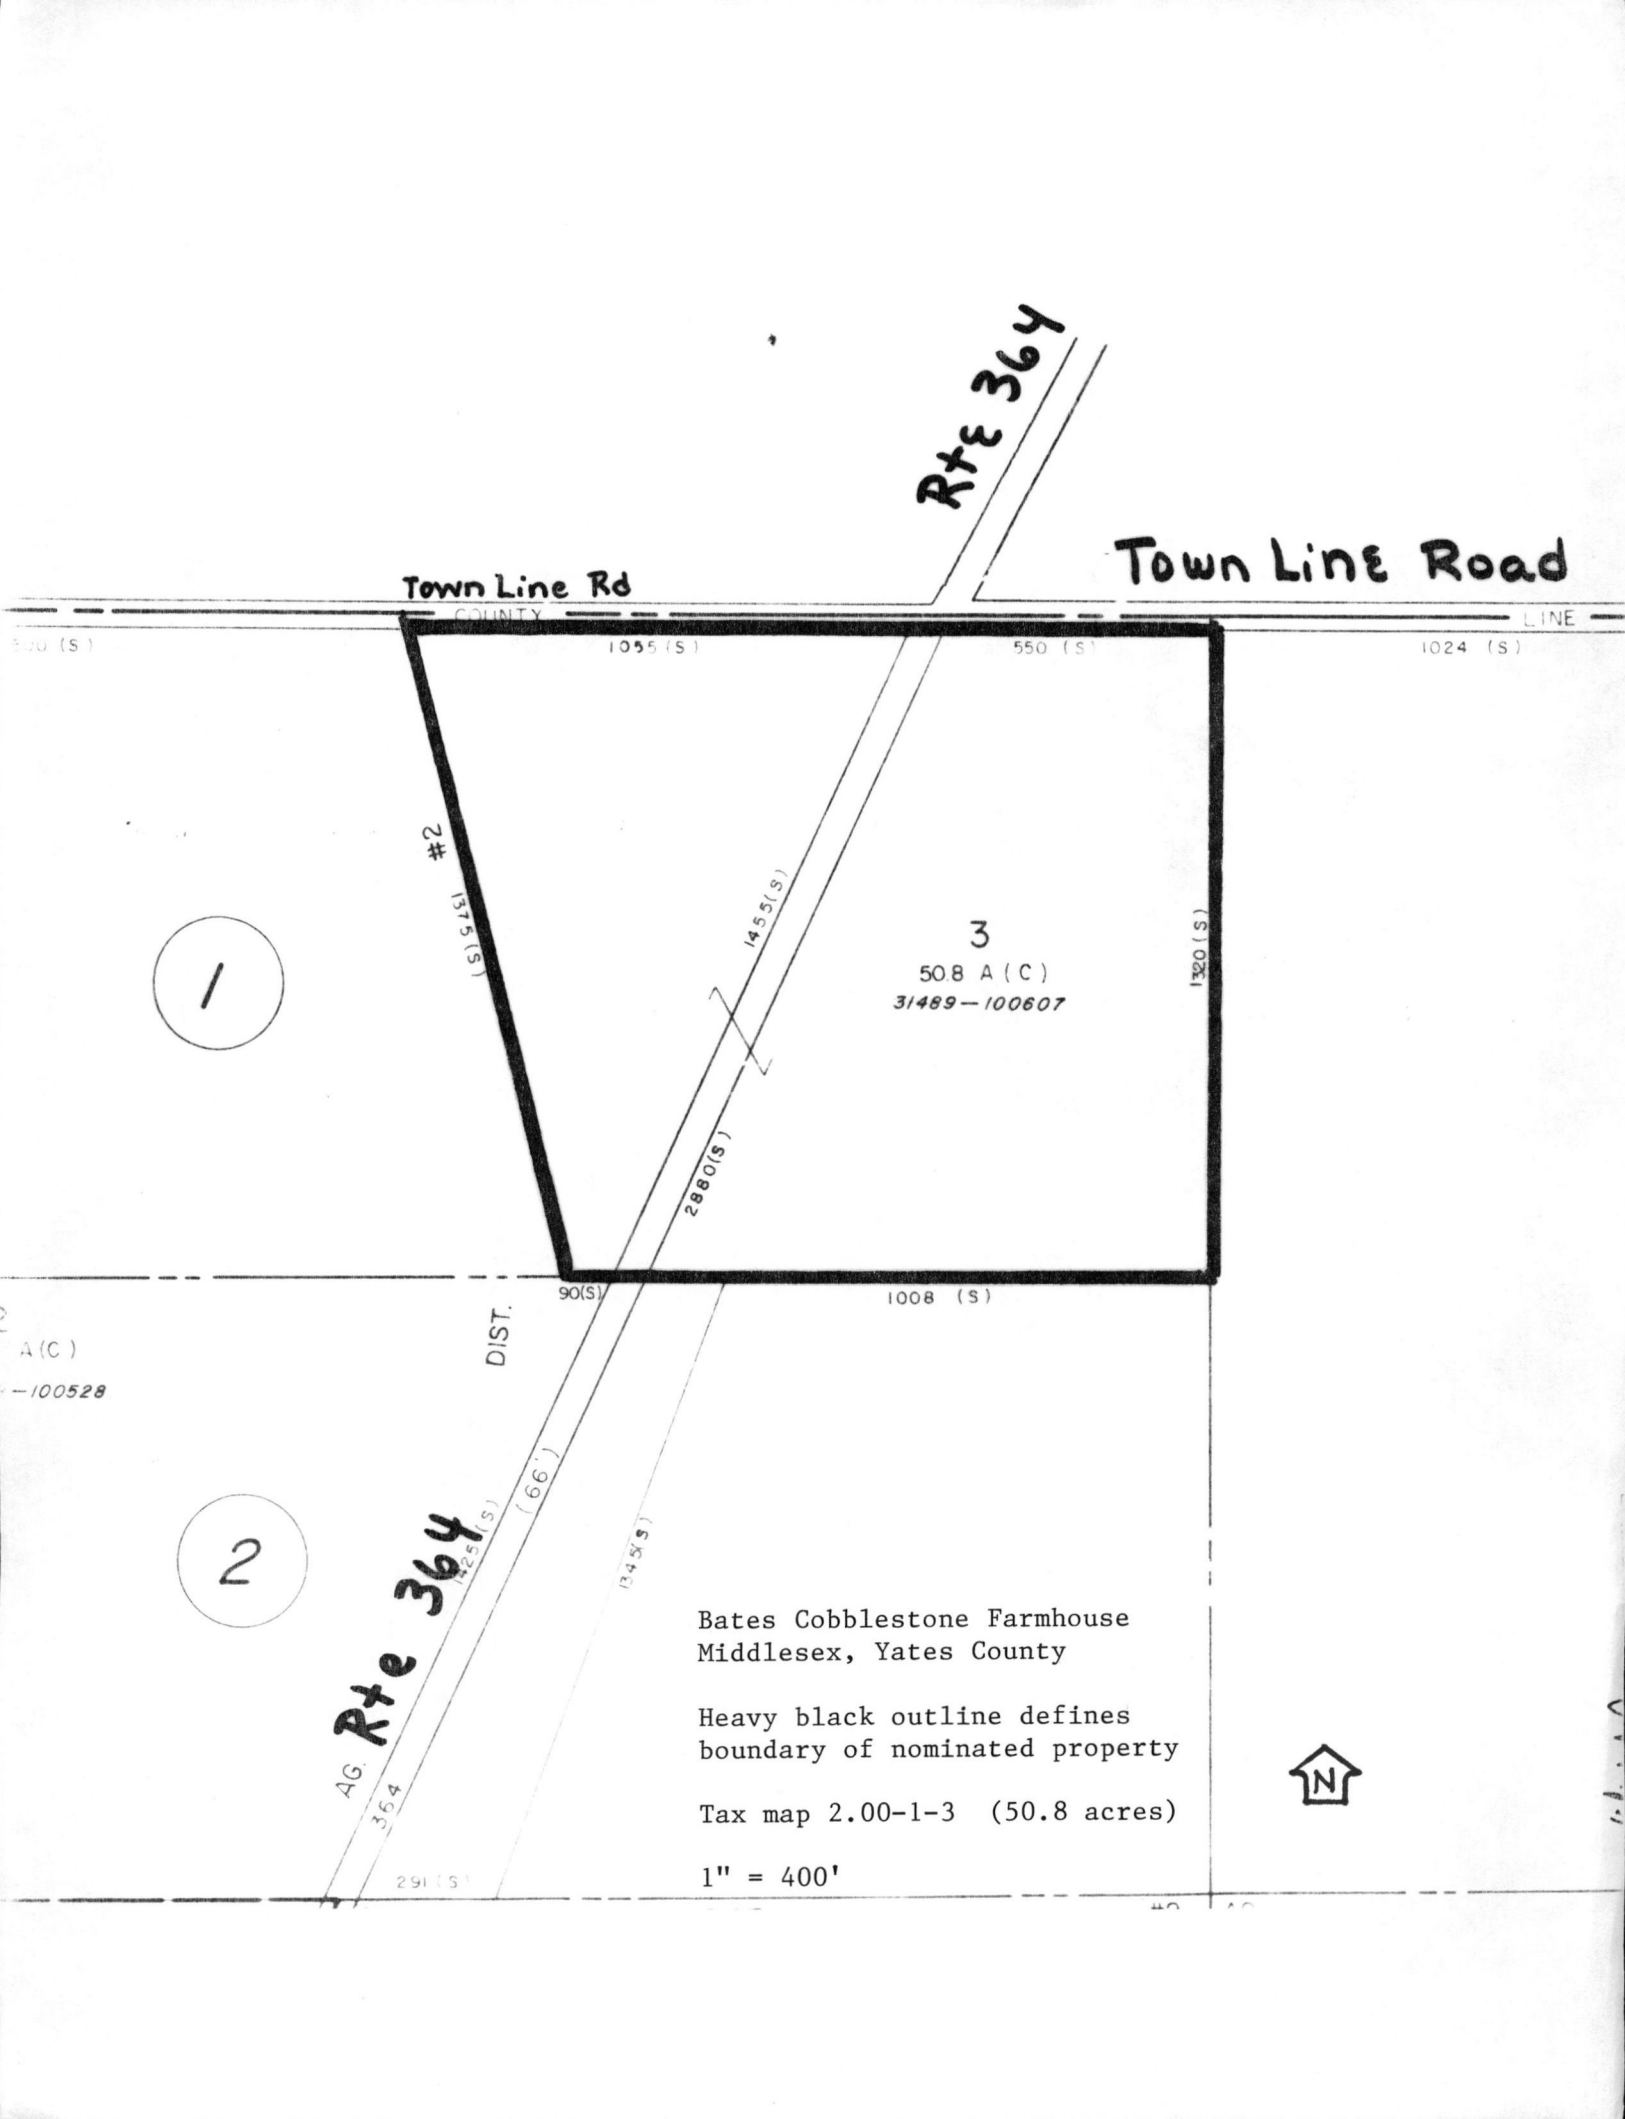
Tax map 2.00-1-3 (50.8 acres)

Heavy black outline defines  
boundary of nominated property

The boundaries of the property coincide with the legal lot lines presently associated with the nominated resources as identified on the attached county tax map.

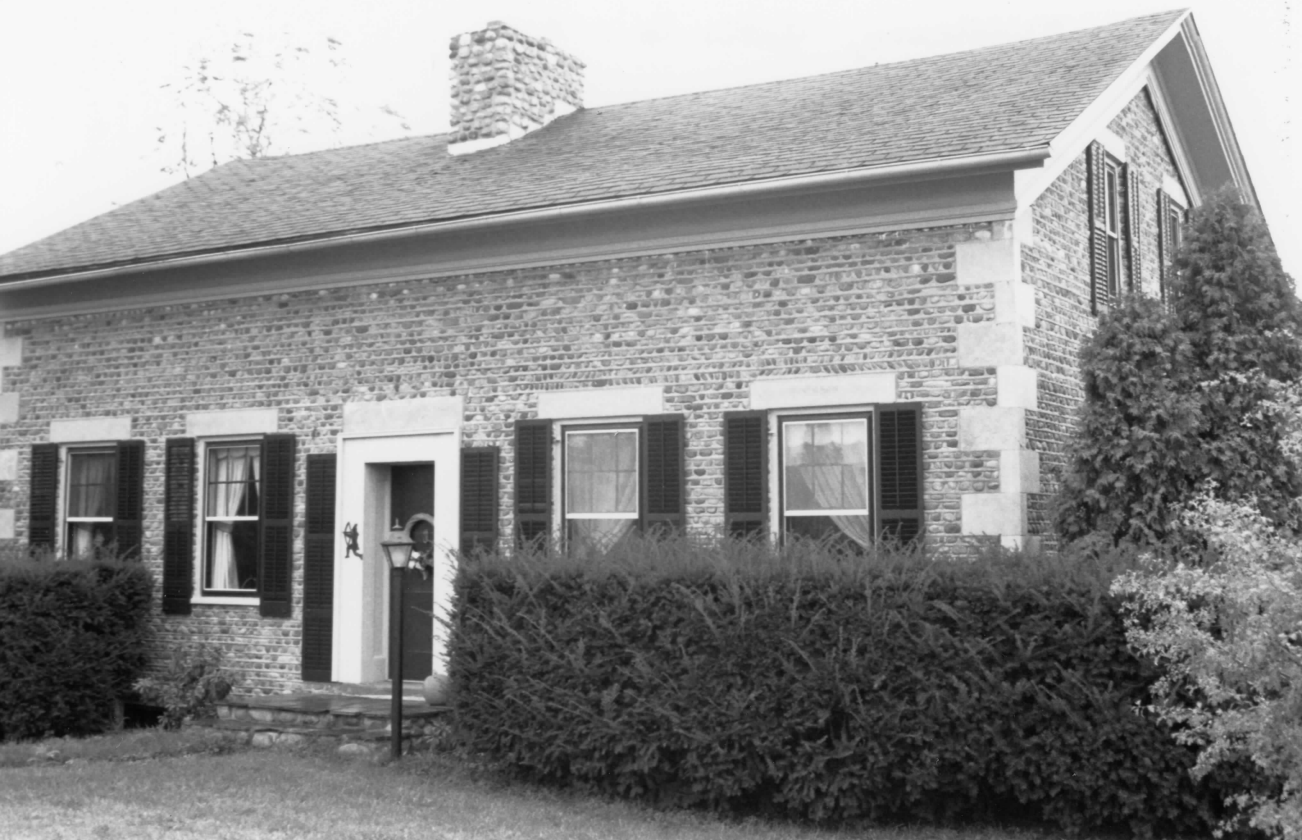
View 1: Front (north) facade

The Bates House, reputed to have been built as a tenant house in 1836, is a one-story, five-bay, rectangular cobblestone building with a one-story frame rear wing added during the early twentieth century. The gable-roofed superstructure rests on a slightly raised stone foundation. It is extremely restrained in ornamentation and simple in its cobblestone treatment, with relatively rough and irregularly shaped, sized and colored field cobbles laid four stone per quoin on the front facade and three stones per quoin on the side elevations. The limestone quoins, sills and lintels differ from those of most cobblestone buildings in Yates County in that they are not embellished with any kind of decorative tooling.

The gable roof features a narrow, unembellished wooden cornice characteristic of the Federal period. An off-center cobblestone chimney (presumably rebuilt during the twentieth century) pierces the roofline. The unembellished doorway also recalls vernacular Federal period building traditions, particularly among small-scale, rural dwellings of the period.

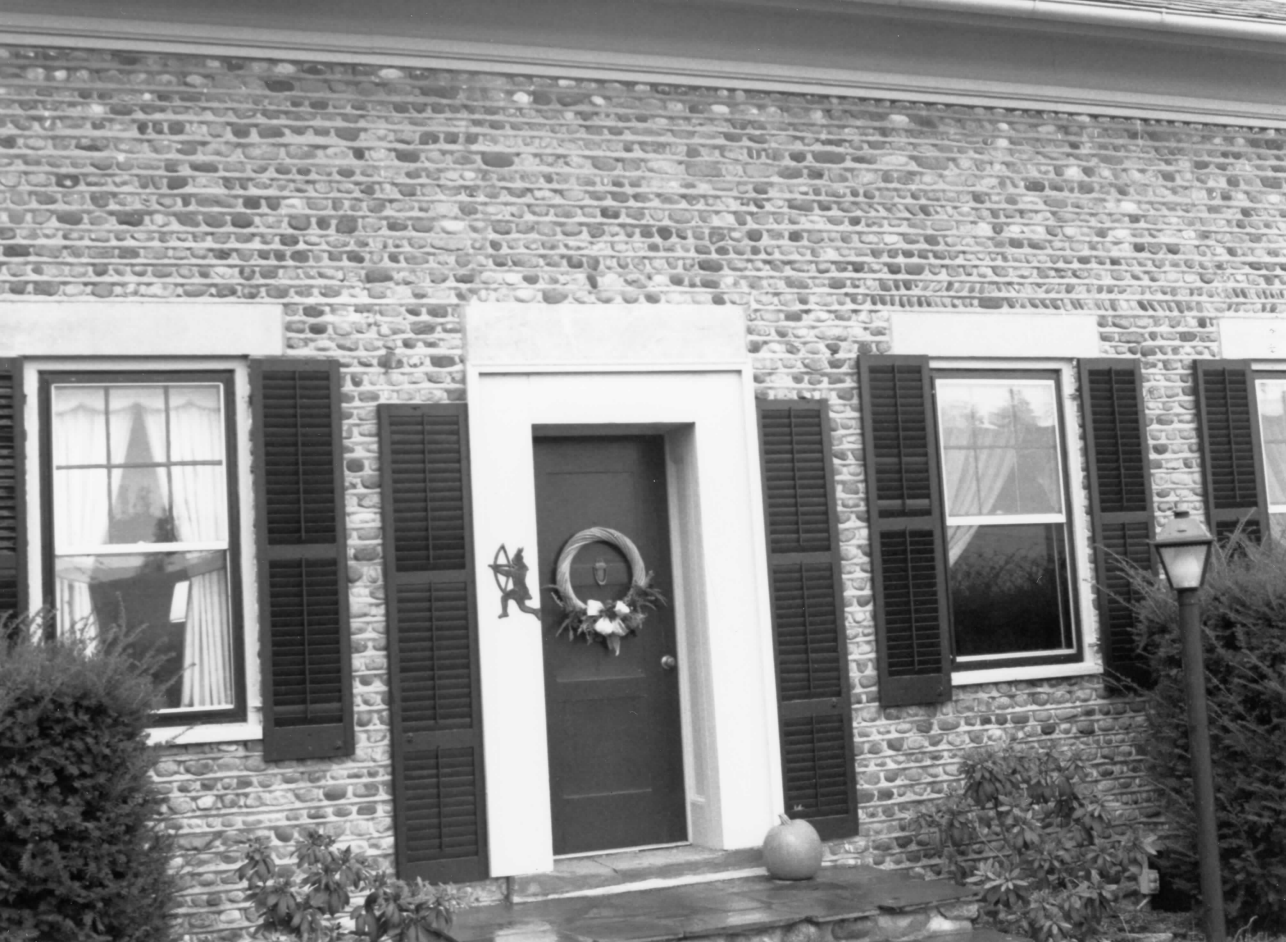
View 2: Front entrance

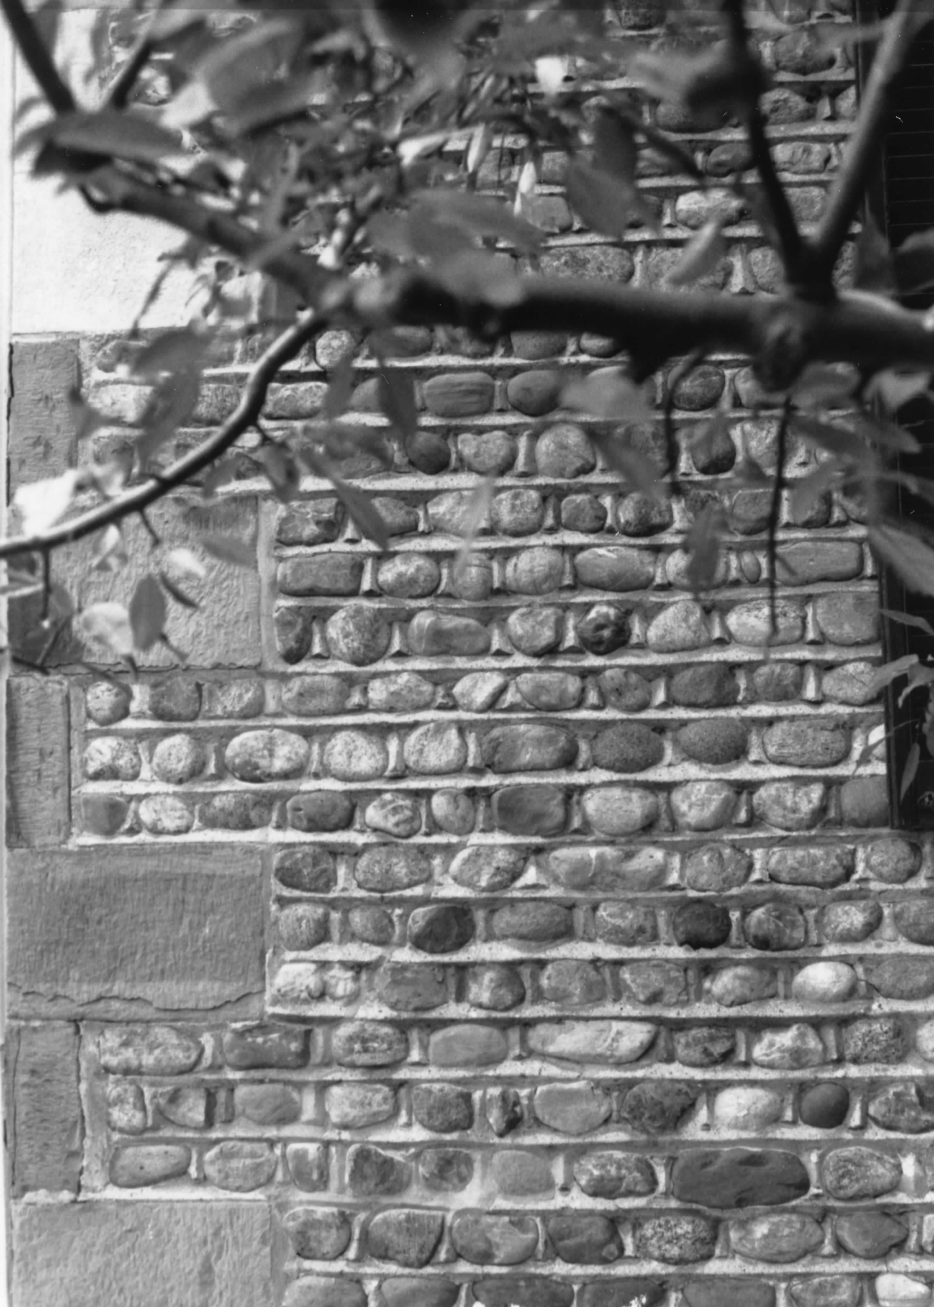
View 3: masonry detail,  
front facade

The Bates Cobblestone Farmhouse (ca. 1836) is architecturally significant as a largely intact example of the cobblestone method of construction in New York State, and as a representative example of nineteenth century vernacular, rural domestic architecture in the Finger Lakes Region. The former farmhouse embodies the distinctive characteristics of the cobblestone method of construction in the use of medium-sized field cobbles (2 1/2" -4") laid in horizontal rows and bonded with limestone mortar, the use of limestone quoins to decorate and stabilize the corners of the building and the use of limestone lintels to ornament and reinforce the door and window openings. Typical of the Middle Period (ca. 1835 - ca. 1845) of this particular method of construction, the building features irregularly shaped, variously colored stones laid four cobbles per 12" quoin on the front and side elevations. The horizontal mortar is tooled with an exaggerated V-shape typical of the Middle Phase of cobblestone construction, while the vertical joints are struck without the typical pyramid shape. Although most stones are randomly laid in horizontal rows, the mason experimented in several rows with the herringbone pattern, directly above the two front windows in the western half of the house. The herringbone pattern was not widely used until the Middle and Late Periods of cobblestone construction.

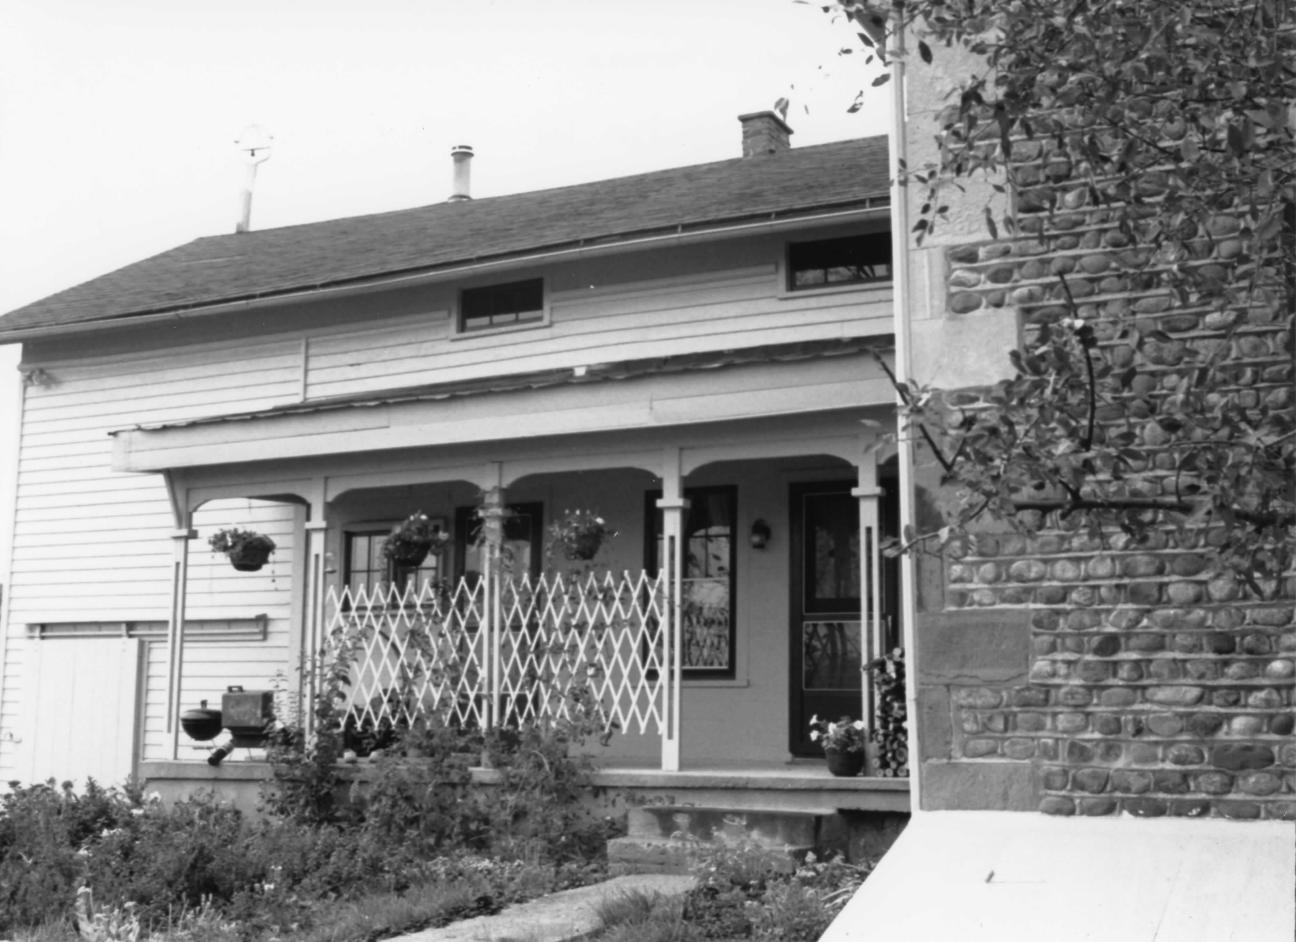
View 4: Rear wing, east elevation

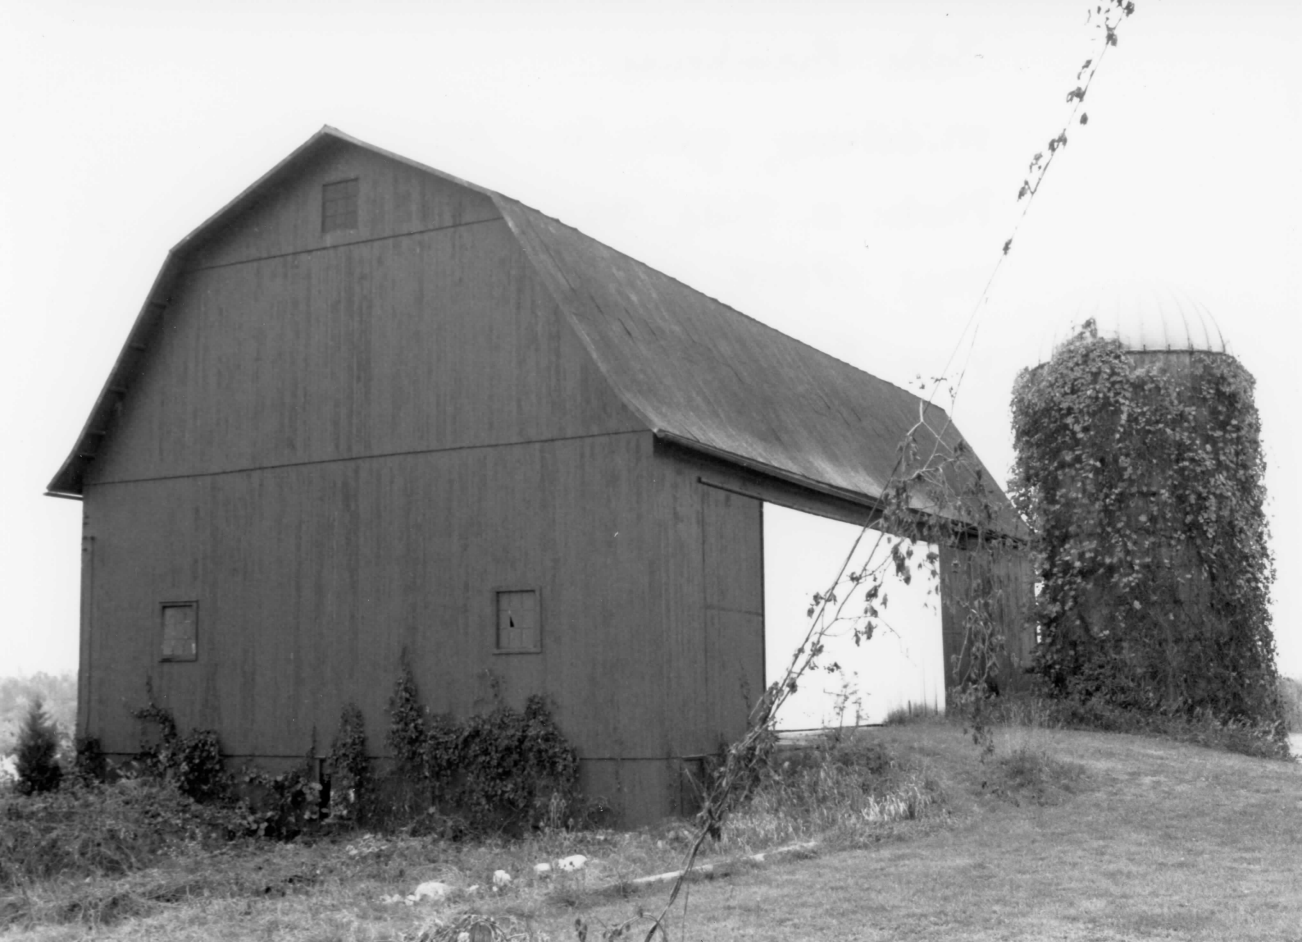
View S: Barn and Silo

There are three contributing early twentieth century support structures located behind the farmhouse and oriented towards Route 364. They are a gable-roofed frame garage, a large, gambrel-roofed frame barn with vertical board siding, and a wooden silo. The barn was built in 1932; the other two dependencies also probably date from the early twentieth century.
