UNITED STATES DEPARTMENT OF THE INTERIOR
NATIONAL PARK SERVICE
NATIONAL REGISTER OF HISTORIC PLACES
REGISTRATION FORM

historic name Callicoon Methodist Church & Parsonage

street & number Church St. (NYS Rte. 97), s. of Seminary Rd. [N/A] not for publication

city, town Callicoon (Town of Delaware) [N/A] vicinity

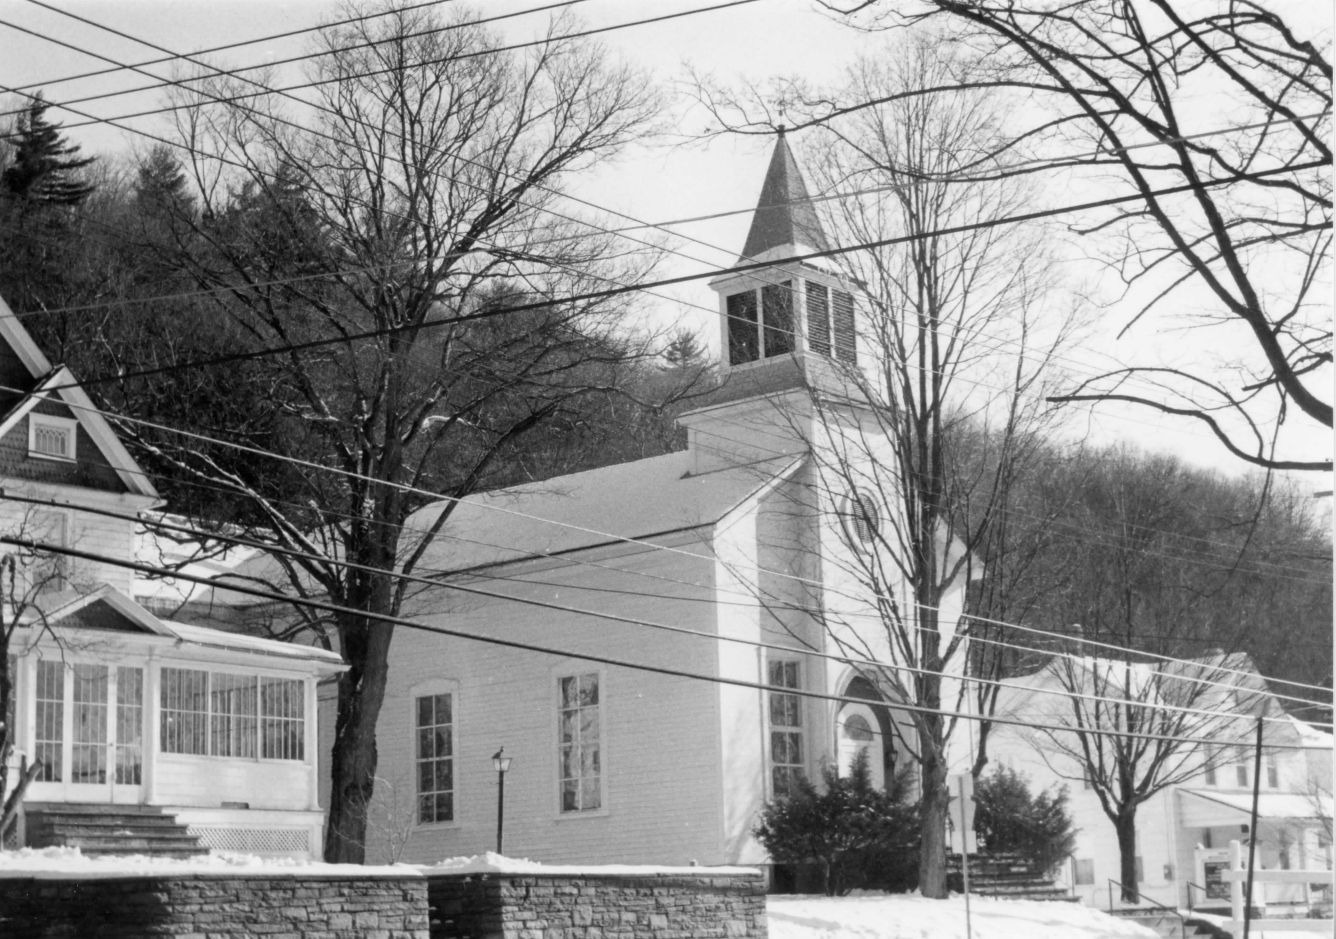
Photo #1

description: streetscape showing church (center)
and parsonage (right)

The Callicoon Methodist Church, built 1871, and Parsonage, built 1889, form a late nineteenth century vernacular church ensemble. They overlook Church Street (NYS Rte. 97), flanked by, and across the street from, residences, most of which were constructed 1890-1915. The wooded hillside to the east forms a backdrop. Although there were few buildings in the area when the church itself was constructed, the design of surrounding buildings and spatial relationship remains essentially unchanged from that revealed in early twentieth century photographs.

The church and parsonage are set back from Church Street, with a stone sidewalk slightly above street level, and steps leading up to the terrace on which the buildings are located. There are front and side lawns to the north and west of both church and parsonage. A paved driveway runs between the church on the north and the parsonage on the south, leading to garage/barn at the rear (east). Immediately behind the church and barn, there is a steep wooded hillside.

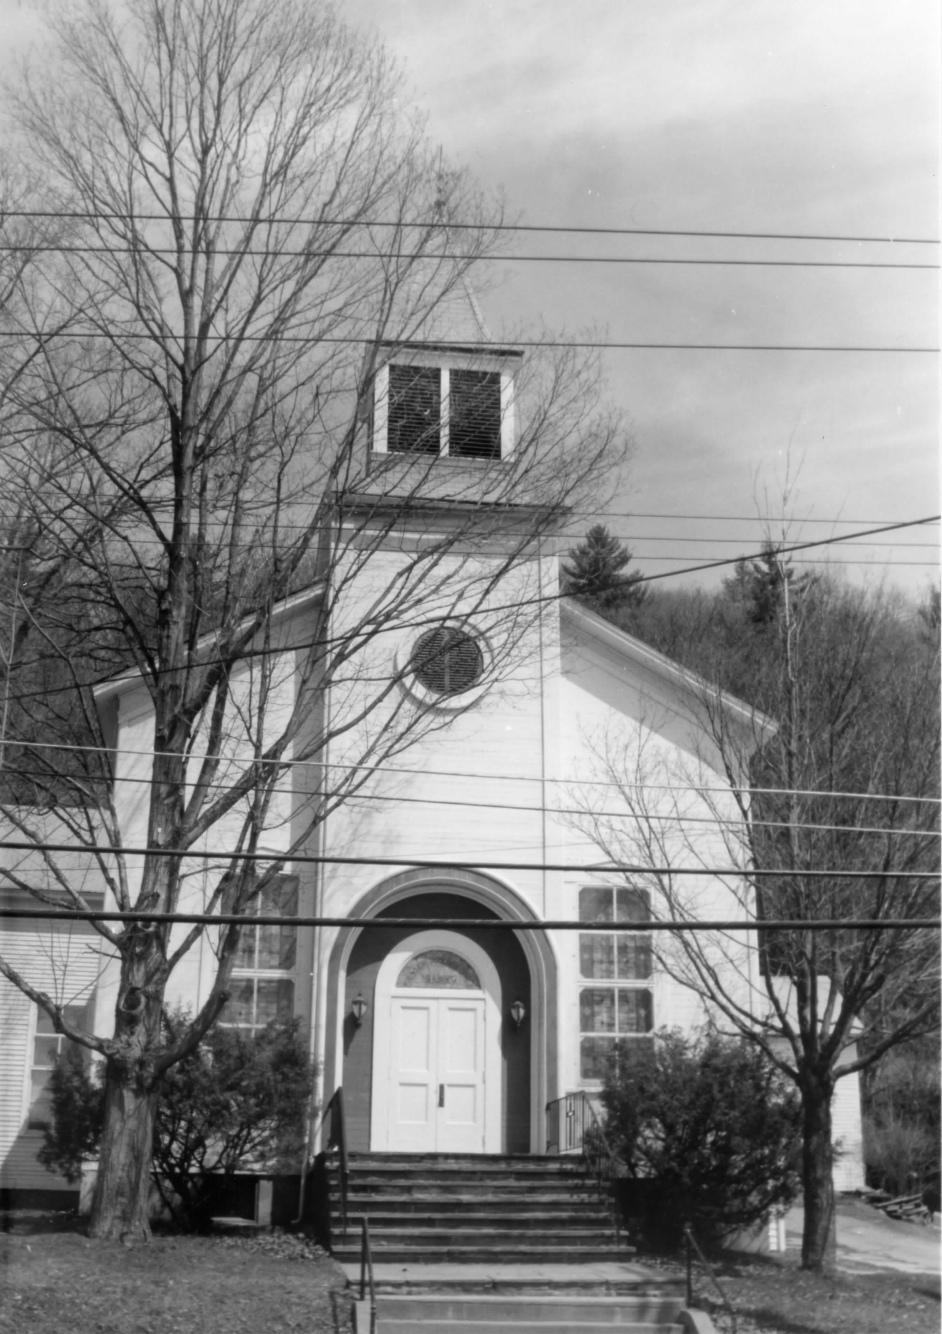
Photo #2

description: church front

The church building is a vernacular frame building, with modest details derived from the Romanesque Revival style. Facing Church Street, the front of the building is surmounted by a spire, a square steeple tower forming the central bay of the building. Exterior steps lead up to an arch, centered within the tower. Over the recessed double door, a semi-circular stained glass window is designed around the words "Methodist Episcopal Church." The body of the building is gable ended, with the central tower piercing the front gable. A two-story, cross gabled addition, at the rear, houses a parish hall, kitchen, lavatories, and Sunday school rooms. The roof is asbestos shingled. The concrete foundation was added with excavation of the basement and installation of the central heating system in 1905. There is an interior brick chimney between the sanctuary and parish hall sections of the building.

Three stained glass windows decorate each side of the church, and two stained glass windows are placed on the front (west) facade flanking the entrance. The windows, installed in 1914, match in size, general design, and iridescent coloring. Each of the side windows includes a central oval picture depicting a religious theme (e.g., cross and crown, Bible).

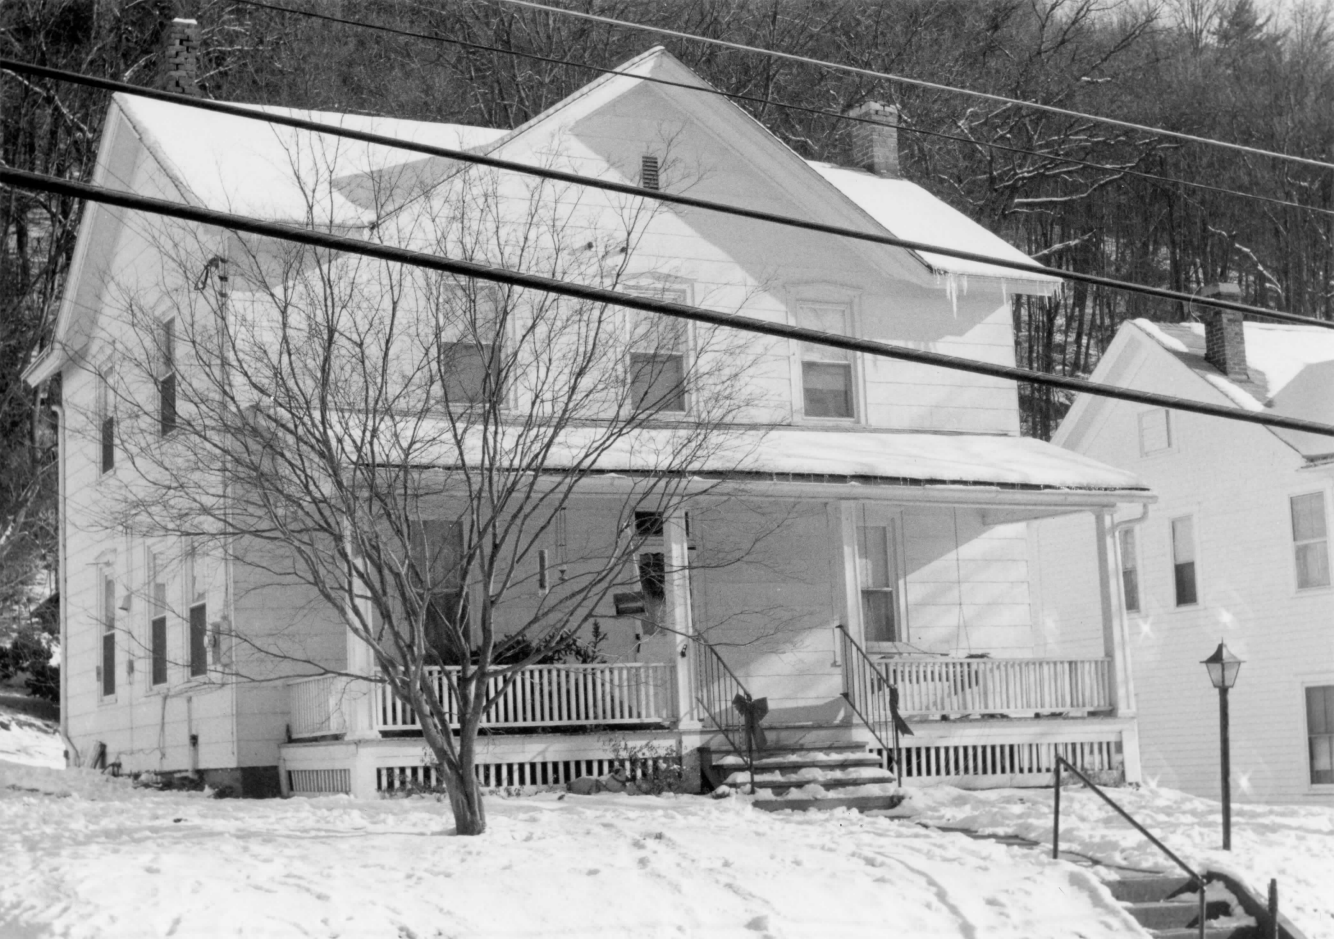
Photo #3

description: Parsonage Front
camera direction: East

The parsonage is a cross gabled, wood frame building, sided with white asbestos shingles. It is two-storied, three bays by two bays, with a one-bay extension at the rear. Center steps lead up to a one-story porch, with millwork balustrade and posts stretching across the front of the building. The centered entrance door is

surmounted by a transom light. Windows are one-over-one, double hung, with peaked wooden moldings. There are two brick chimneys. The foundation is of mortared stone. The rear one-bay addition is rectangular in configuration, with a north entrance, and no particular architectural distinction. The interior is largely unaltered. On the first floor, there is a living room, a dining room, a kitchen, and a pastor's study (in the rear addition). A central vestibule and stairway face the front entrance. Bedrooms and bath are on the second floor.
