UNITED STATES DEPARTMENT OF THE INTERIOR
NATIONAL PARK SERVICE
NATIONAL REGISTER OF HISTORIC PLACES
REGISTRATION FORM

historic name Cornelius S. Muller House

Cornelius S. Muller House
Claverack, Columbia County, New York

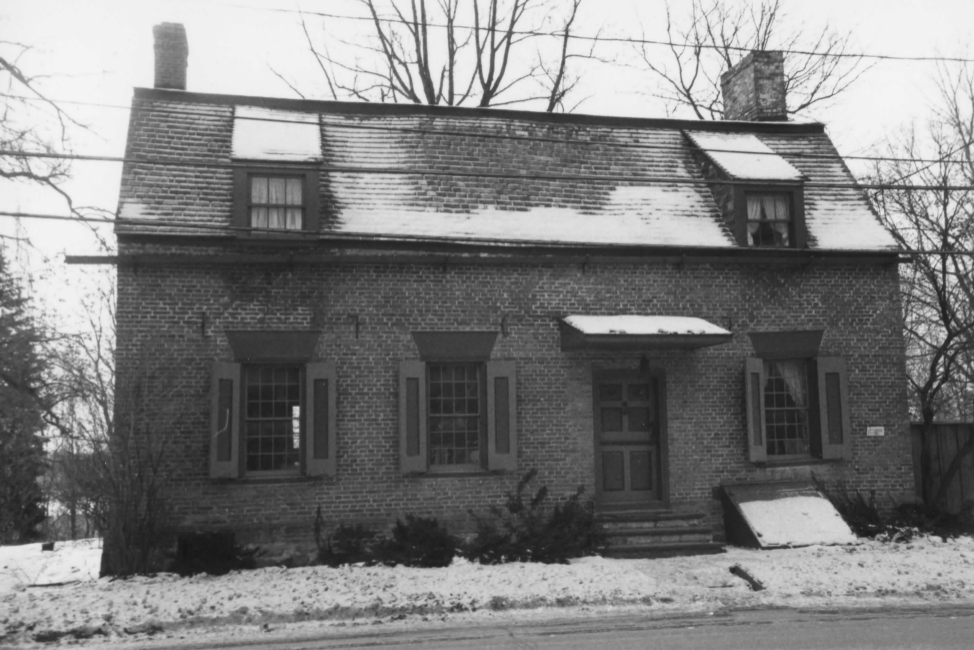
Photo 1

1. Cornelius S. Muller House
2. Columbia County NY
3. Ian Nitschke
4. January 1997
5. OPRHP
6. North facade, looking south

The facade faces Route 23B the historic main east/west route through the center portion of the county. This elevation is divided into four bays. The main entrance is located in the westernmost center bay. The entry is composed of a replica Dutch style door set within a simple molded frame. A replica stoop shelters the entrance. Windows in the remaining three bays of this elevation each contain twelve light double hung sash. The windows are surmounted by splayed wood lintels and are flanked by paneled wood shutters. The replicated shutters were copied from a surviving original found in the house. Spaced across the facade are four decorative wrought iron frame anchors, which form the date "1767." The roof on this elevation is pierced on the extreme east and west ends by single shed dormers, which were added to the house in the mid nineteenth century. A central dormer was removed in the 1970s.

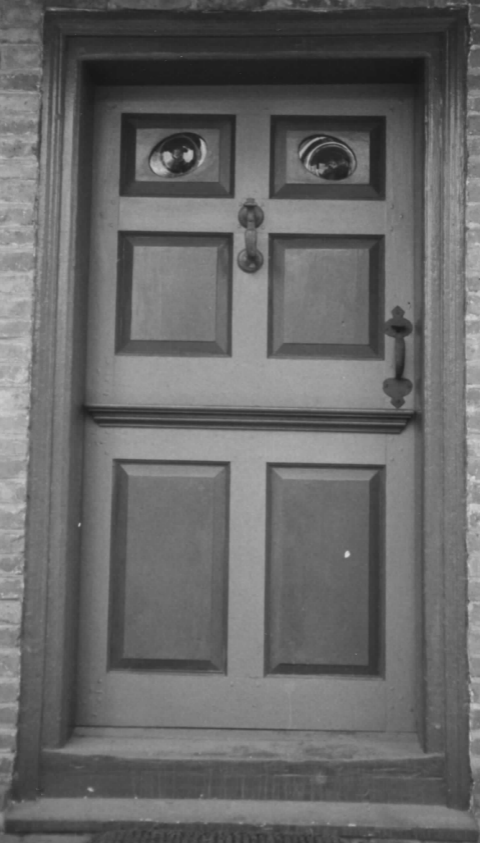
Photo 2

1. Cornelius S. Muller House
2. Columbia County NY
3. Ian Nitschke
4. January 1997
5. OPRHP
6. Front door on north facade,
looking south

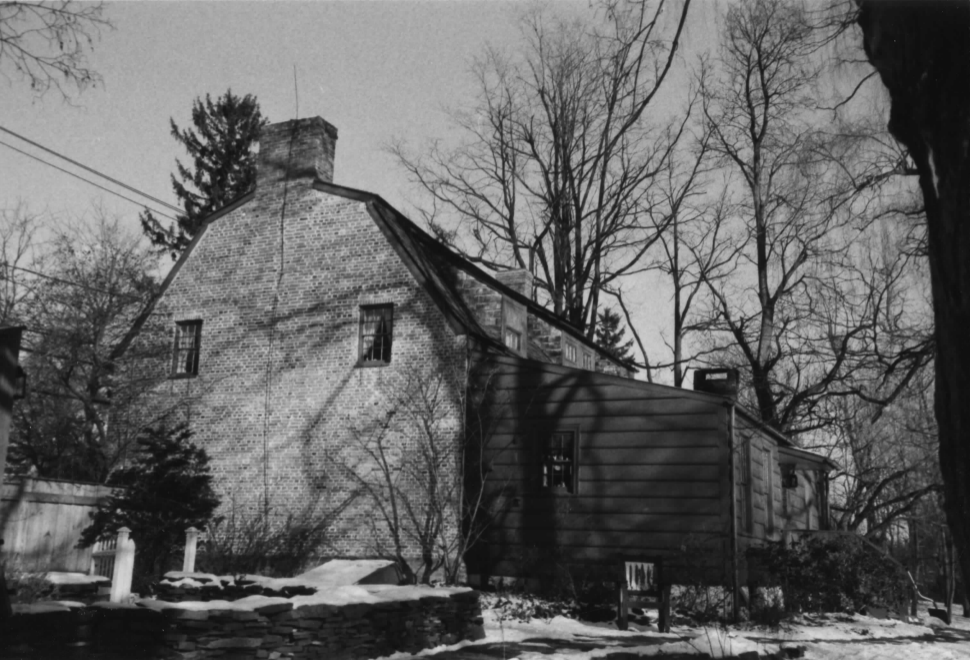
Photo 3

1. Cornelius S. Muller House
2. Columbia County NY
3. Ian Nitschke
4. January 1997
5. OPRHP
6. West elevation, looking north east

The side elevations are similar with no openings on the first floor. The attic story is enlivened with two widely spaced windows containing six-over-six light sash.

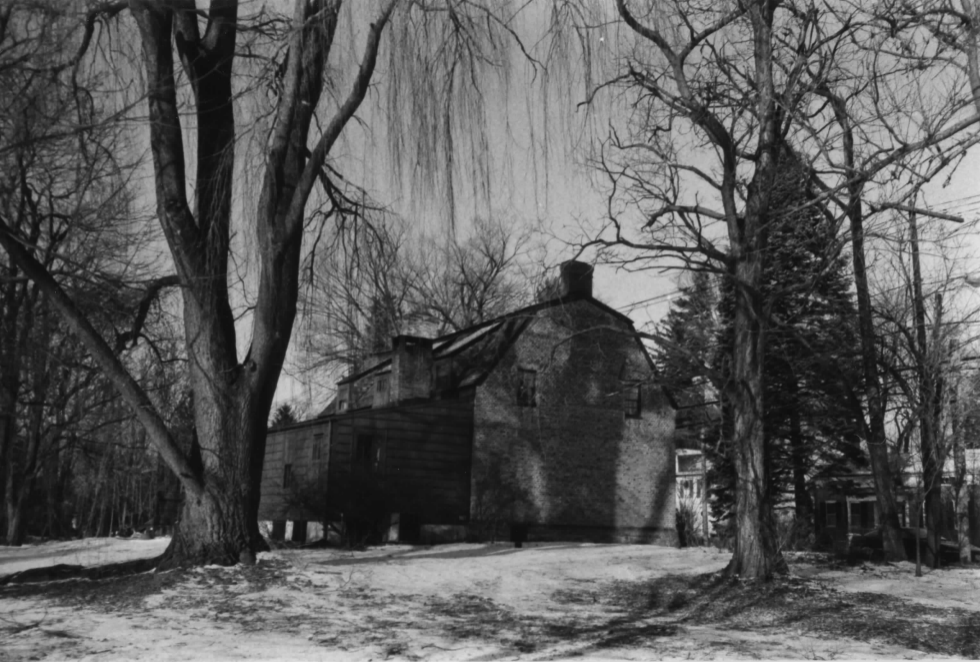
Photo 4

1. Cornelius S. Muller House
2. Columbia County NY
3. Ian Nitschke
4. January 1997
5. OPRHP
6. East elevation, looking
north west

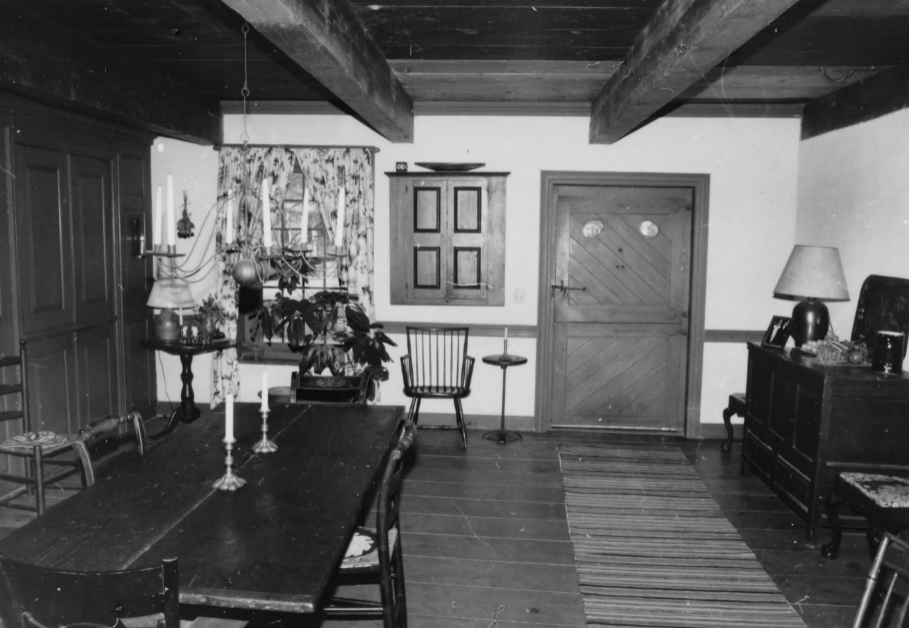
Photo 5

1. Cornelius S. Muller House
2. Columbia County NY
3. Ibi Hindrichs
4. January 1997
5. OPR HP
6. North wall of dining room,
showing front door, looking
north

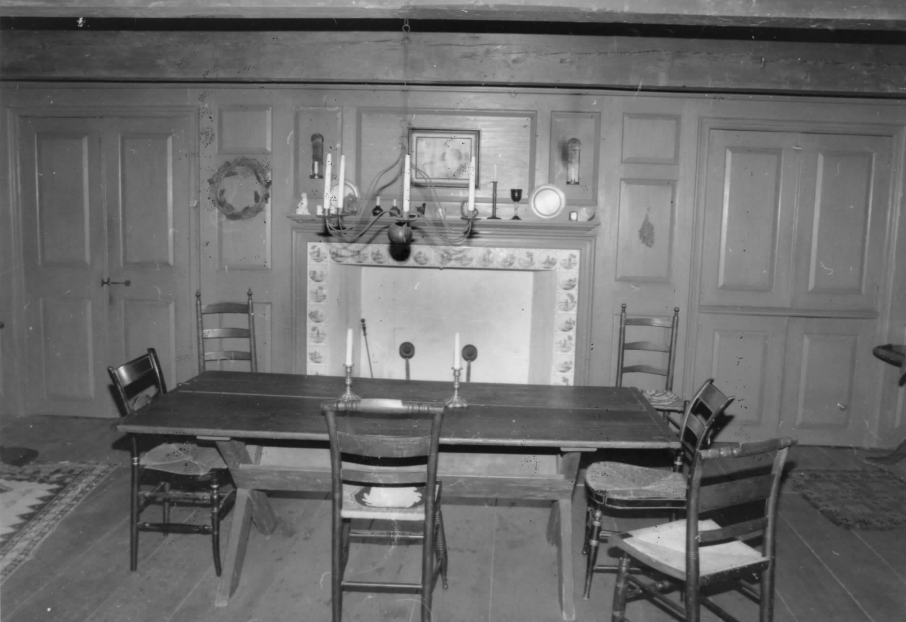
Photo 6

1. Cornelius S. Muller House
2. Columbia County NY
3. Ibi Huidrichs
4. January 1997
5. OPRHP
6. West wall of dining room,
looking west.

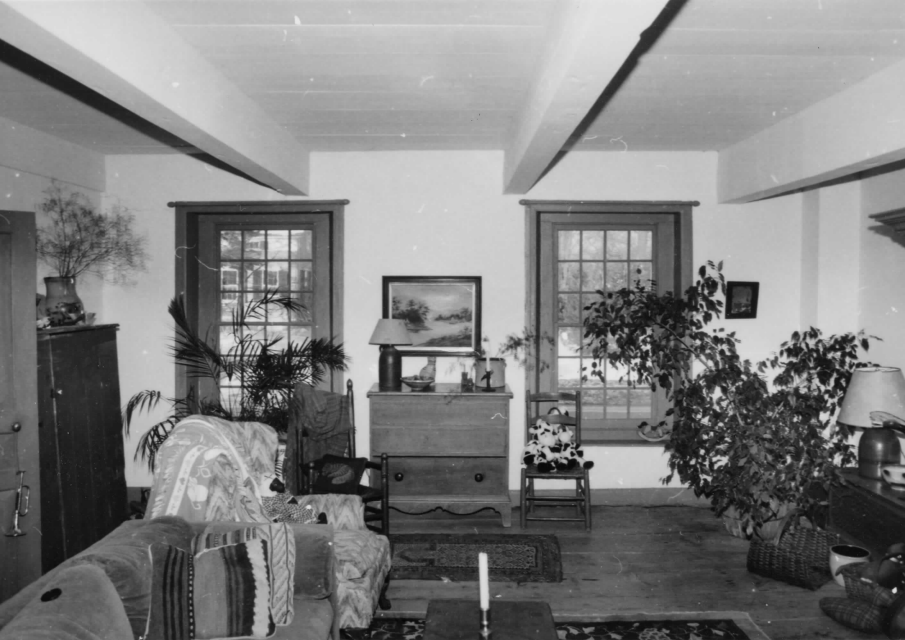
Photo 7

1. Cornelius S. Muller House
2. Columbia County NY
3. Ibi Hindrichs
4. January 1997
5. OPRHP
6. North wall of living room
(original kitchen area),
looking north

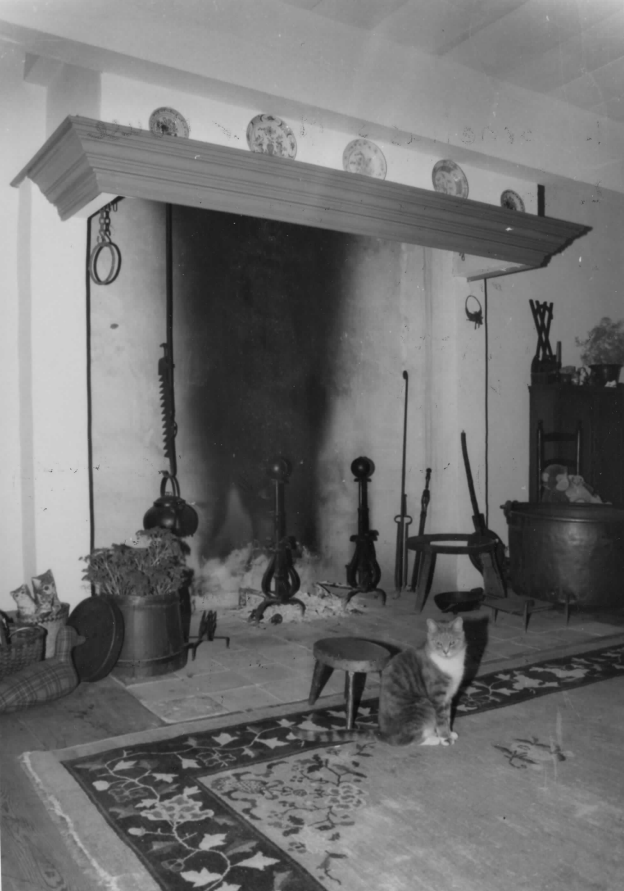
Photo 8

1. Cornelius S. Muller House
2. Columbia County NY
3. Ibi Hindrichs
4. January 1997
5. OPRHP
6. Original kitchen free hung fireplace with partial jambs (now living room fireplace), looking east

The interior of the Cornelius S. Muller retains a high degree of integrity. The original section of the house is composed of two rooms. To the east is the main parlor with exposed beaded ceiling beams and a restored partial jamb fireplace. The large hearth includes a few original red clay tiles found in the restoration process. The front entrance door opens into the west room of the house. An enclosed staircase is built into the southeast corner of the room. The west wall of this room includes a central fireplace, which is surrounded by raised wood paneling. The finely crafted panel work was installed as part of an extensive restoration of the house in the 1970s. The details for this replica paneling were taken from the ca.1770 Nicholas Schenck House exhibit at the Brooklyn Museum.

Additional architectural significance is derived from the dwelling's intact interior. Most notable of these features are the finely planed, wide plank flooring and the restored partial jamb fireplace.
