UNITED STATES DEPARTMENT OF THE INTERIOR  
NATIONAL PARK SERVICE  
NATIONAL REGISTER OF HISTORIC PLACES  
REGISTRATION FORM

historic name Jacob P. Mesick House

street & number 68 Van Wyck Lane [n/a] not for publication

city, town Claverack [n/a] vicinity

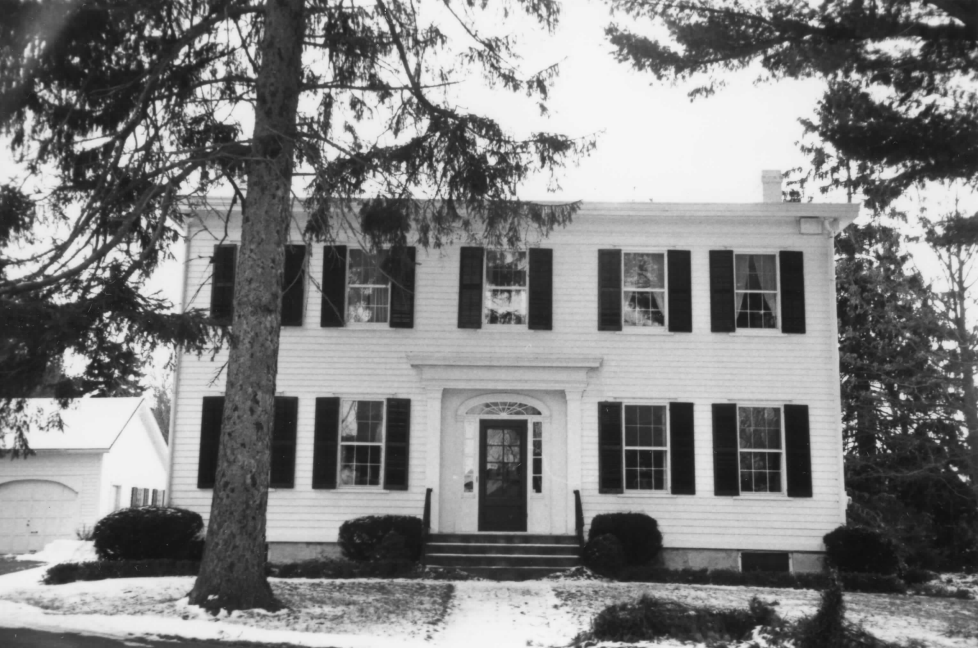
Photo 1

1. ~~John Mesick House~~ JACOB P. MESICK HOUSE
2. Columbia Co. NY
3. Ian Nitschke
4. January 1997
5. OPR HP
6. West facade, looking east

The front facade of the house, oriented westward, is highlighted by a central entrance. The entry is framed by flat pilasters supporting a molded entablature. Set within this frame is a slightly recessed entry. The original Greek Revival era entry and three bay portico were altered in the late nineteenth century. At that time the Greek Revival portico and entrance was replaced with a Victorian style entry and porch, which spanned the full width of the facade. In the mid-twentieth century the Victorian renovations were moved and the Greek Revival entry surround was restored. Also at that time the Victorian entrance was replaced with the present Colonial Revival style entry. This current Federal inspired arrangement is composed of a paneled door flanked by sidelights and surmounted by a fanlight. The roof line is highlighted by a molded frieze that encircles the building.

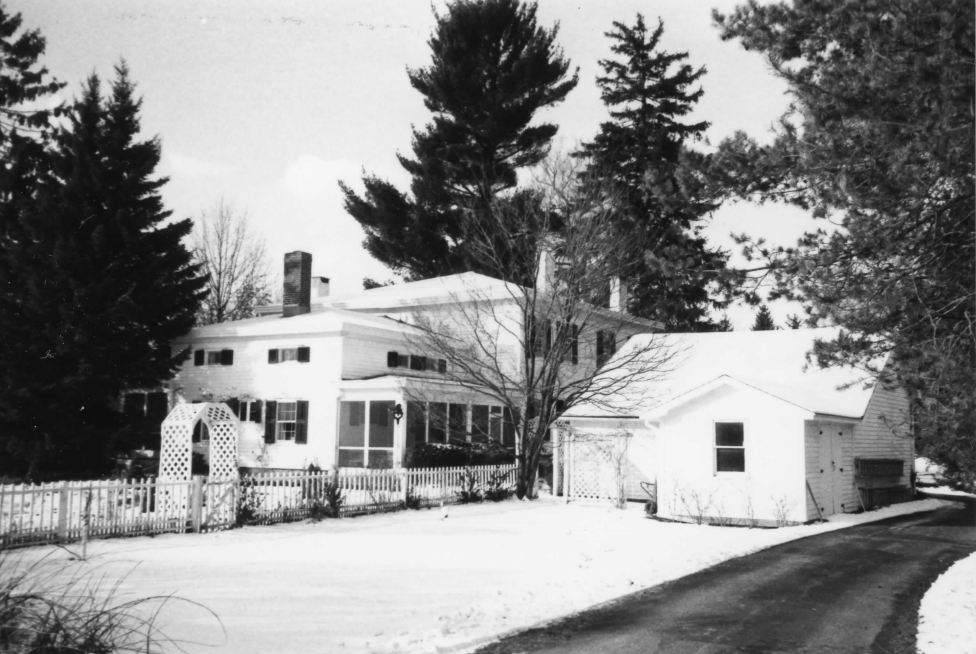
Photo 3

1. ~~John Mesick House~~ JACOB P. Mesick House
2. Columbia Co. NY
3. Ian Nitschke
4. January 1997
5. DPRHP
6. East and north elevations of house and garage,  
looking south west.

The east elevation is dominated by the rear wing. The south elevation of the wing features a single story porch, which shelters an entrance. Narrow eave windows are located above the porch roof just below the eaves. The east elevation of the wing features two windows on the first floor and two eave windows above. The north elevation

of the wing is similar to that of the east. A single story porch spans the full width of this elevation.

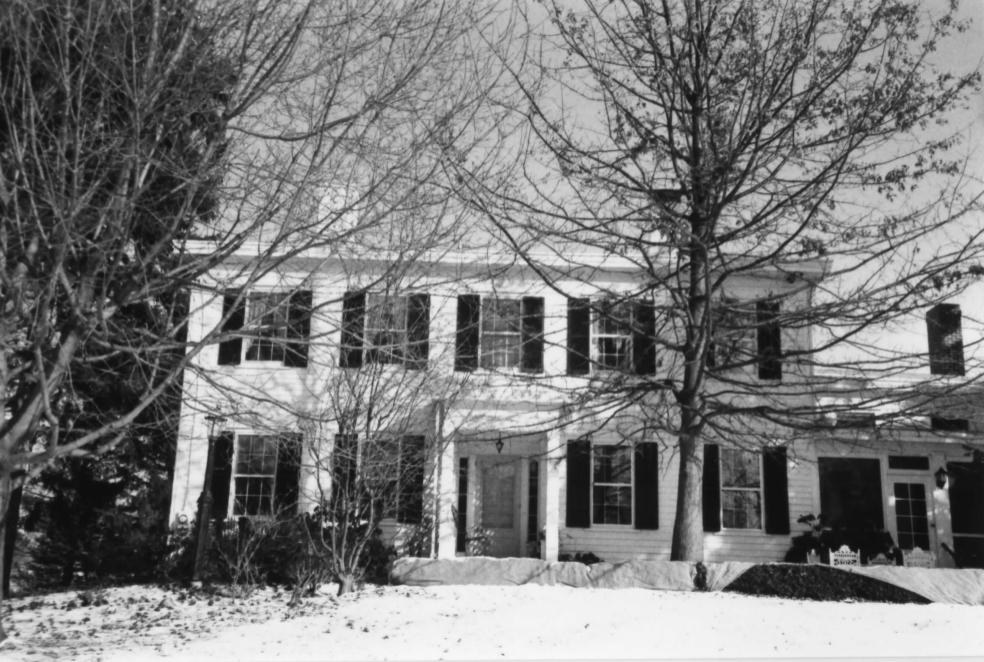
Photo 4

1. ~~John Mesick House~~ Jacob T. Mesick House
2. Columbia Co. NY
3. Ian Nitschke
4. January 1997
5. OPRHP
6. South elevation, looking north

The south elevation of the house is highlighted by four windows on the first and second floor of the house.

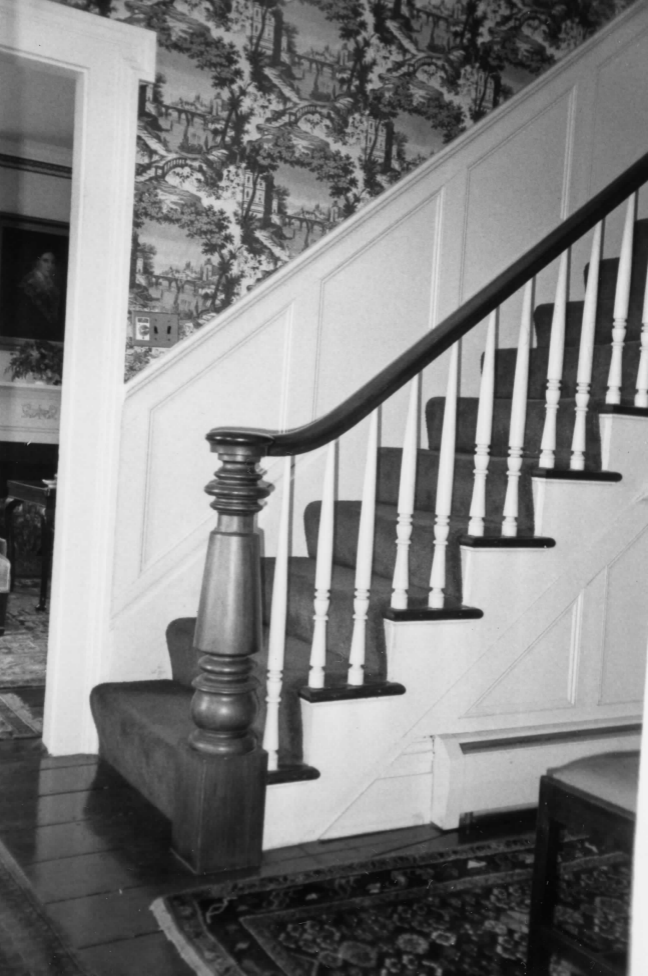
**Photo 5**

1. ~~John Mesick House~~ **Jacob P. Mesick House**
2. Columbia Co. NY
3. Ian Nitschke
4. April 1997
5. Newel post and stair case, looking north

On the interior of the house the room configuration and much of the nineteenth century detailing survives. The main entrance opens into a wide center stair hall. Of particular interest in the hall is the intact ca.1840 French print wall covering. Flanking the hall on each side are large parlors. Each parlor retains most if not all of its original woodwork, floors and wall finishes. Behind the two large parlors are smaller rooms. These spaces also retain virtually all of their original finishes. In the mid-twentieth century an archway was established between the front and rear rooms on the north side of the house. The second floor of the main block of the house contains four chambers and a modern bathroom. These spaces also retain original moldings, mantels, doors and hardware. The rear wing of the house features a first floor kitchen. This space is composed of a large front room with a cooking fireplace and oven on its east wall. Behind the fireplace is a small space now used as the kitchen. This area once contained a massive baking oven. The oven was removed in the mid-twentieth century. Also located in this room is an iron heating kettle. The large vessel is set into the brickwork of the fireplace mass. Beneath the kettle is a firebox. Piping from the cistern beneath the floor of this space rises through the chimney mass and exists above the kettle. The pump that once supplied water to this system is no longer in place. A box stair leads from the front kitchen room to servants quarters above the kitchen. Throughout the residence molding, mantels, flooring, wall finishes, architraves, doors and hardware survive through the residence in high state of preservation.

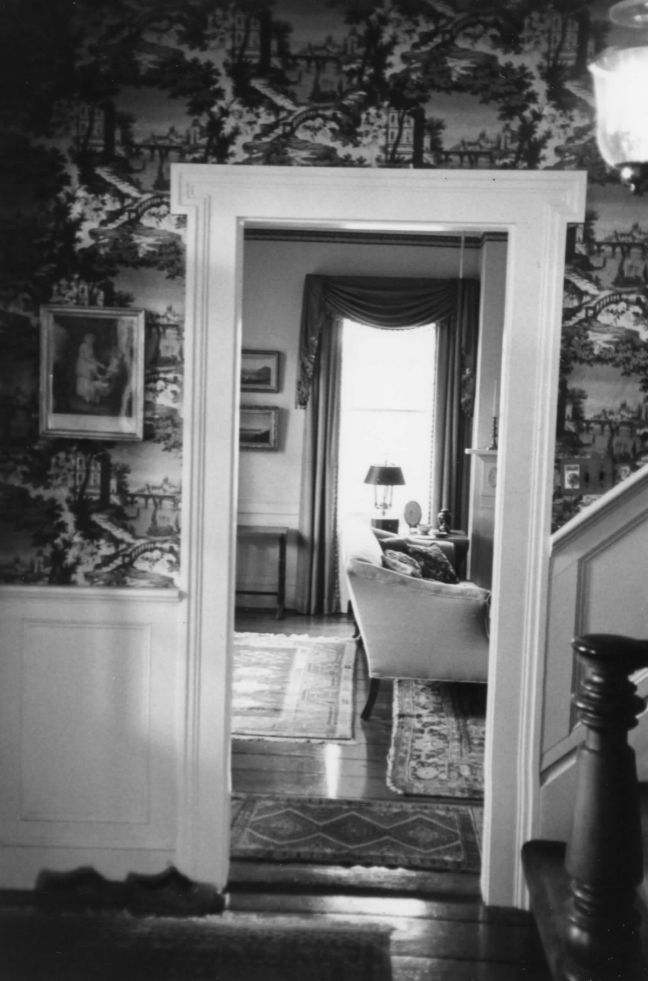
Photo 6

1. ~~John Mesick House~~ JACOB P. Mesick  
Howe
2. Columbia County NY
3. Ian Nitschke
4. April 1997
5. Doorway from hall to north parlor,  
looking north

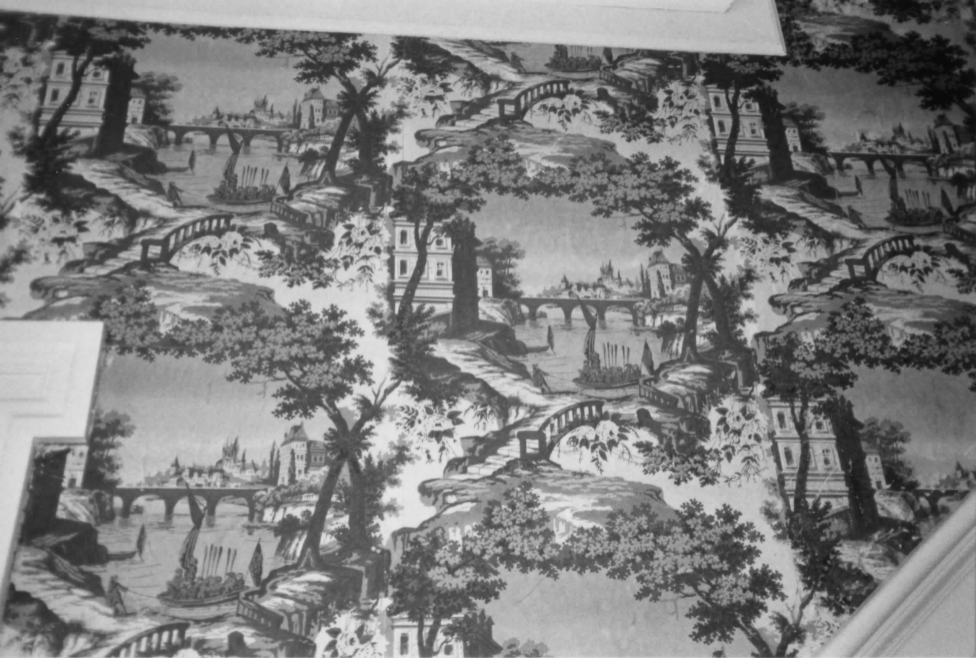
Photo 7

1. ~~John Mesick House~~ Jacob P. Mesick House
2. Columbia Co. NY
3. Ian Nitschke
4. April 1997
5. Original French wallpaper in hallway, looking north

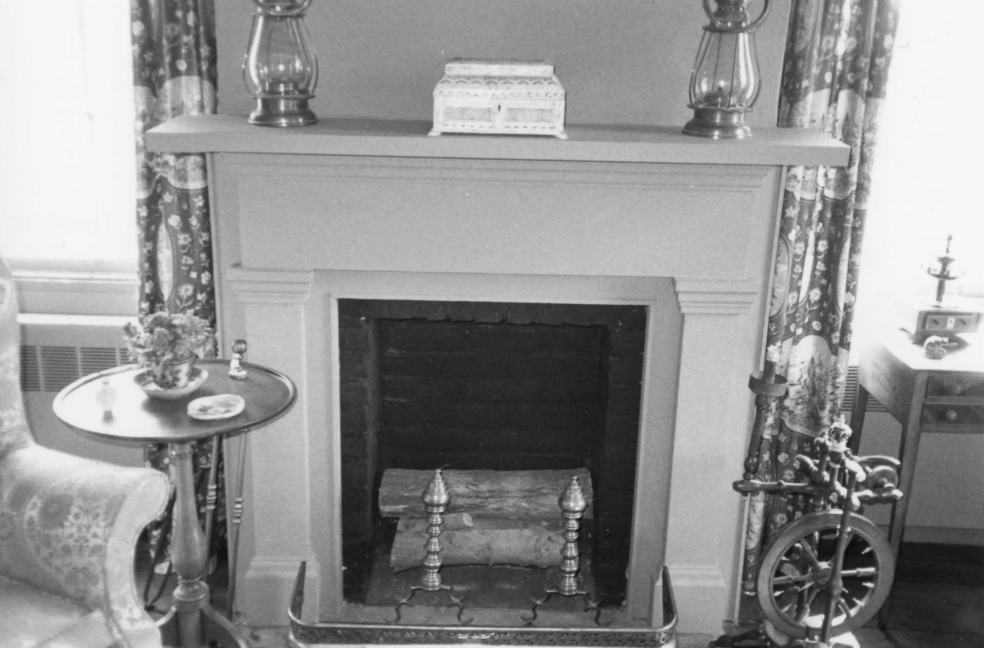
Photo 8

1. ~~John Mesick House~~ Jacob P. Mesick House
2. Columbia Co. NY
3. Ian Nitschke
4. April 1997
5. Mantel South parlor mantel, looking south

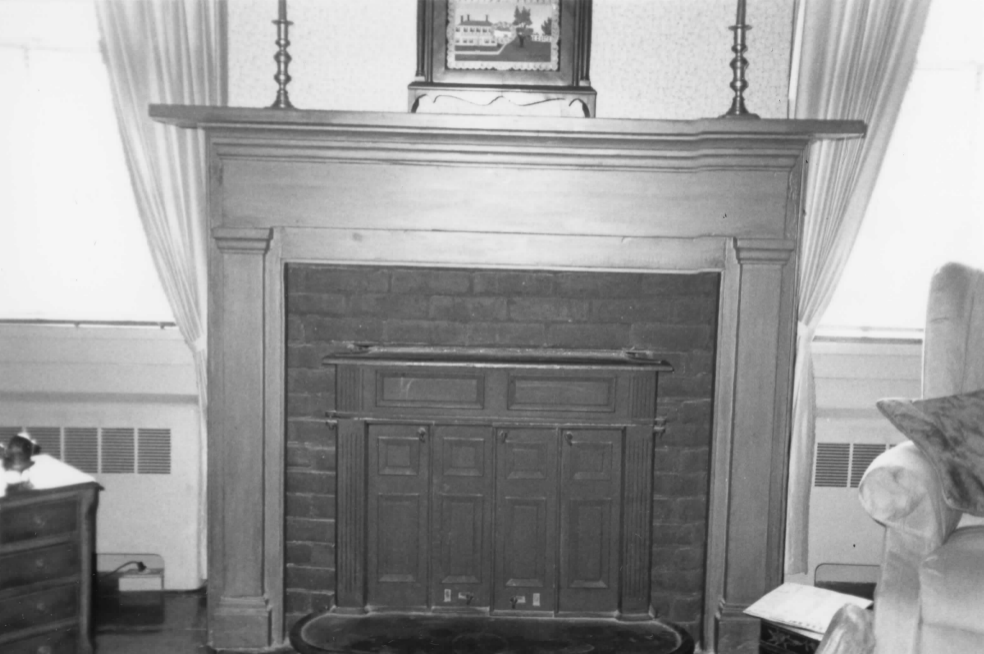
Photo 10

1. ~~John Mesick House~~ JACOB P. Mesick House
2. Columbia Co. NY
3. Ian Nitschke
4. April 1997
5. South middle room mantel, looking south

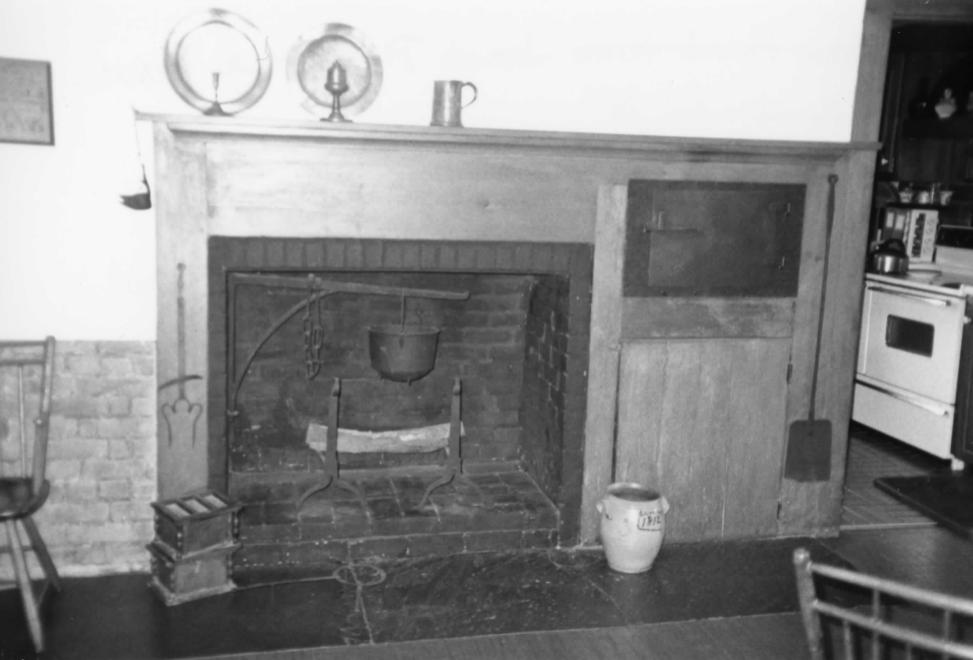
Photo 11

1. ~~John Merick House~~ Jacob P. Merick House
2. Columbia Co. NY
3. Ian Nitschke
4. April 1997
5. Original kitchen fireplace, looking south east
