NPS Form 10-900 OMB No. 1024-0018 (Rev. 10-90) United States Department of the Interior National Park Service NATIONAL REGISTER OF HISTORIC PLACES **REGISTRATION FORM** 1. Name of Property historic name Antioch Dependent School District #15 other names/site number Antioch School; Johnnie Guthrie McWhirter Senior Center

SUMMARY

The Antioch Dependent School District #15 is a brick two-room school built in 1928. It is situated on its original site on Antioch Road one half mile west of Antioch. The school is sited close to and perpendicular to the road. The two-room school building is constructed of red brick with poured concrete foundation. The gabled roof is covered with asphalt shingles. A break in the roofline, or drop wing, on the south part of the building marks the stage area inside. The west elevation boasts a large porch with four steel support columns. There are two original wooden doors which enter into the two classrooms. The doors have transoms. The school has double hung windows. The north end has an exit door and just outside a hand pump. Just to the east of the pump is a large concrete cellar with two entrances one on the west and one on the east. A metal building, ho

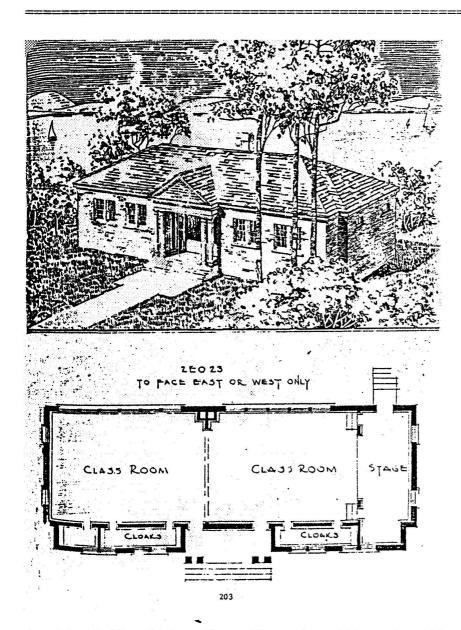
The Antioch schoolhouse was built according to plans probably supplied by the Oklahoma Department of Public Instruction. It closely matches plans for a two-room school that is to be oriented with the long axis facing east/west. Plan #2EO23 is depicted below. The plans come from a 1937 publication titled School Buildings, Miniature Plans and Perspectives published by the agency.

From <u>School Buildings</u>, <u>Miniature Plans and Perspectives</u>. Oklahoma City: Oklahoma Department of Public Instruction, Division of Schoolhouse Planning. 1937.

It is built of red brick; the walls are three bricks deep with a cavity in the middle serving as insulation from the cold and heat. No wood was used to frame the exterior walls which are all load bearing walls. Wood was used in the construction of the school building walls only to frame the windows and in the gables and roof.

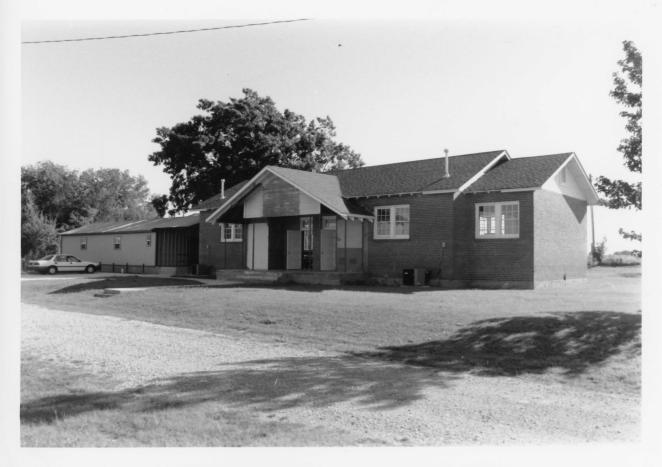
Antioch Dependent School District #15 Garvin County, Oklahoma Jim Gabbert Sept 9, 2004 SHPO Facing NE Front & Side # 1 0 7

The facade of the building, the west elevation, contains the primary entrance and three paired six-over-six, double hung windows. (photo #1) The entry porch, roughly centered in the main body of the building, has a gabled roof and a concrete floor measuring 16'6" by 10'6. The roof is supported by four steel columns. The original gabled porch roof was extended on each side to cover exterior restrooms that were added in the 1950s. The restrooms, once flanking the entry doors, have been removed. Interior plaster from the restrooms is still visible on the exterior brick walls. The two wooden, five-panel doors with rectangular windows are original and enter into the two classrooms. The recently replaced windows were hand crafted with wooden sashes and are copies of the originals. The middle and north pair of windows open into the cloakrooms, while the south pair lights the recessed stage area. The east elevation has twelve nine-over-nine double hung windows (six in each class room) with a red brick chimney centered between the window sets. (photo #3) The original playground consisting of swings, merry-go-round and see-saws was on this side of the building. The south elevation has the off set gable roof over the stage area. There are no windows and only a louvered vent in the gable. The brick walls extend only to the eave line; the gables are clapboard with three inch reveals. A small vent opening is centered on the wall, just above the concrete foundation. This vents the crawl space. (photo #1 & 3) The north elevation has no windows, matching the south elevation, but has a single, offset door. The original, wooden door, offset on the east side of the elevation, was replaced with a larger, metal door to conform to

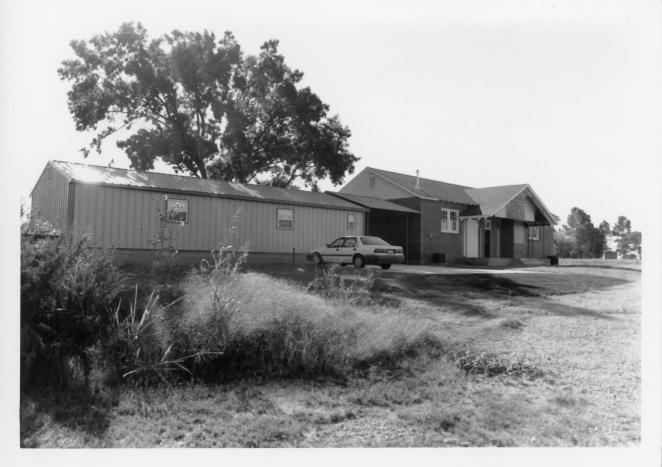
Antioch Dependent School District # 15 Garrin County, Oklahoma dim Gabbert Sept 9, 2004 SHPO Facing SE - New metal bldg & School #2 of 7

For the most part, the grounds of the school are open, with a semi-circle driveway leading from the road to the west side of the building. Adjacent to the school, directly north, is a new, metal walled building. (photo #1 & 2) This building was constructed in 2003 to house bathroom and kitchen facilities. A covered porch shelters the area between the buildings, but is not attached to the school. This new building is a noncontributing resource. Also located between the two buildings is an original hand pump. This pump has a perforate pipe extending from it, creating a drinking fountain that could be utilized by a number of children. This pump is a contributing object. To the east of the school is a concrete storm shelter. (photo #7) This poured concrete shelter is rectangular and sits just above grade. Two entrances, on the east and west ends, are accessed by bulkhead doors. The shelter is a contributing structure.

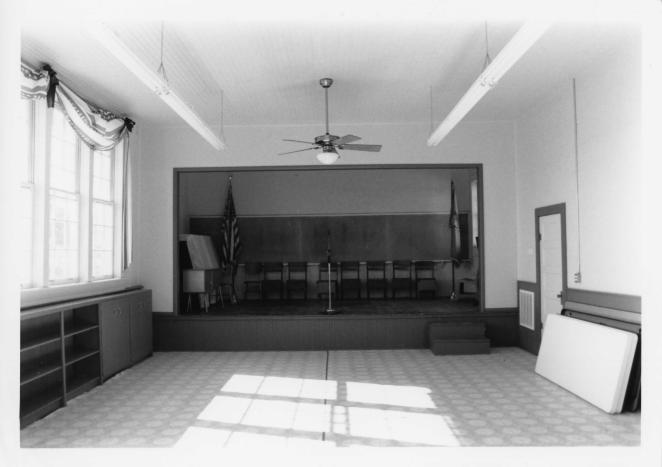
Antioch Dependent School District #15 Garvin County, DK Sept g. 2004 Stipo Facing South - South Classroom showing stage #4 of 7

The south classroom is dominated by the stage. (photo #4) The stage floor is raised two-and-a-half above the classroom floor. The stage has original flooring. The entry from the exterior is located near the central dividing wall. The entry has simple, 4" surrounds, as do the cloakroom and closet doors. The beaded wainscot has a simple, squared cap.

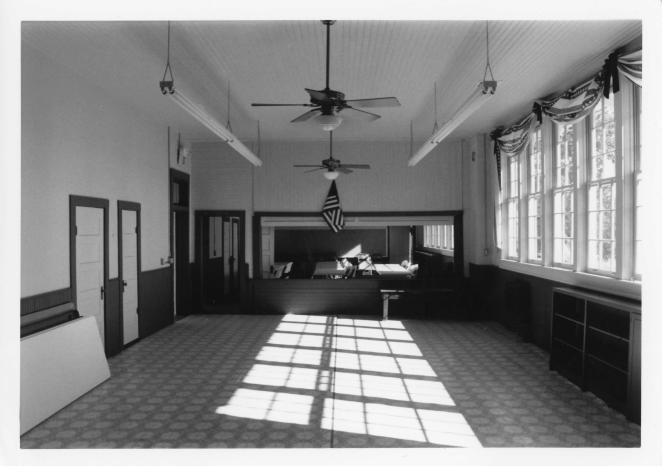
Antioch Dependent School District # 15 Garrin County, OK Sept 9, 2004 SHPO Facing Storth From Stage - S. Classroom & Partition #5 of 7

The dividing wall consists of a retractable chalkboard that rises vertically into a pocket. (photo #5 & 6). Above the pocket is vertical beadboard, below is horizontal. An entry door is offset to the west.
