**NATIONAL REGISTER OF HISTORIC PLACES
INVENTORY -- NOMINATION FORM**

DEPRESSION-ERA BUILDINGS

NAME: Cascade Locks Work Center

LOCATION: Mt. Hood National Forest, Columbia Gorge Ranger District;
Congressional District 2; Cascade Locks, Oregon (41); Hood River
County (027)

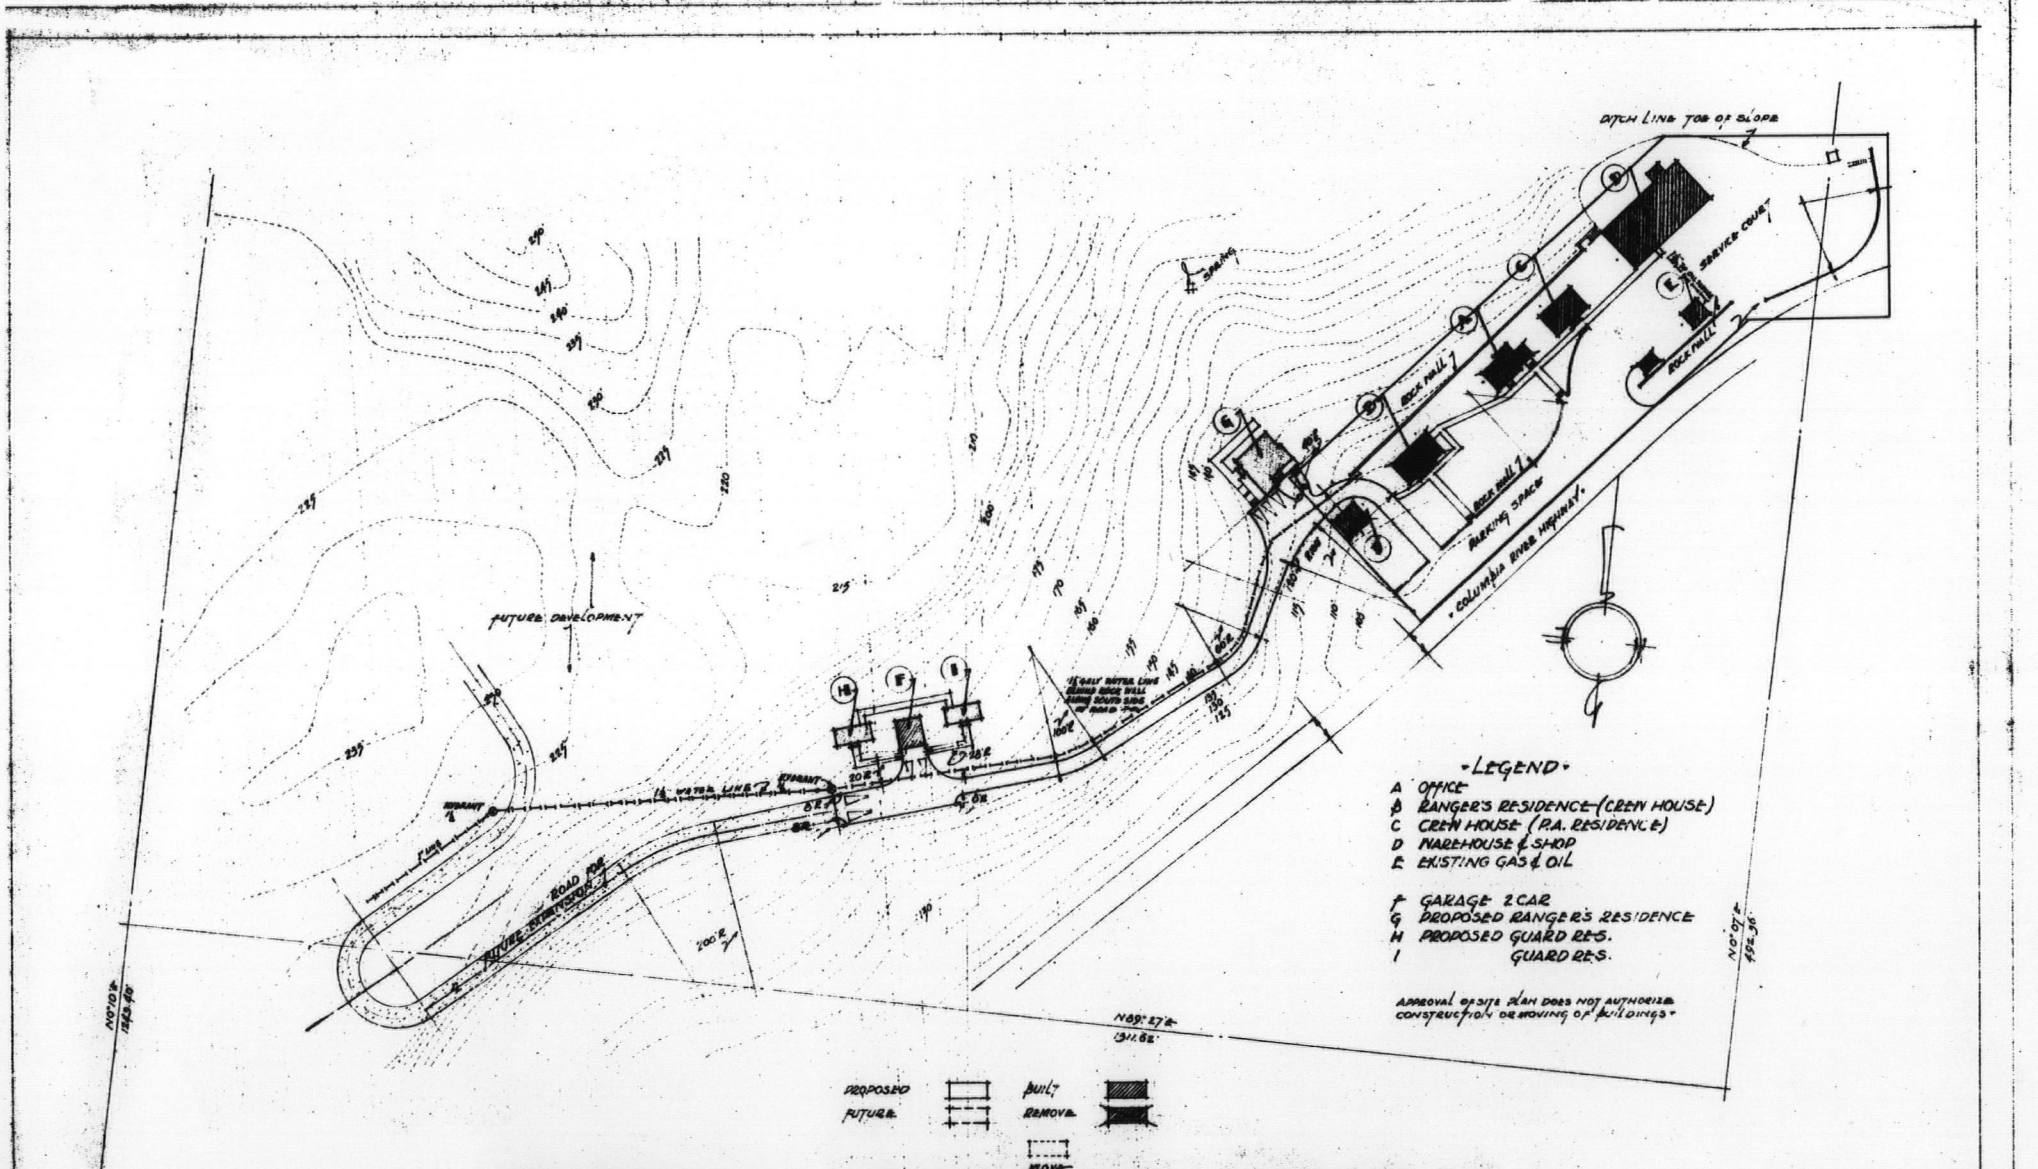
SITE PLAN
 COLUMBIA GORGE N.G.
 SEC. 3, TEN. R.G.B.
 SCALE 1"=50'-00"

- LEGEND-**
- A OFFICE
 - B RANGER'S RESIDENCE (CREEN HOUSE)
 - C CREW HOUSE (P.A. RESIDENCE)
 - D WAREHOUSE (SHOP)
 - E EXISTING GAS & OIL
 - F GARAGE 2 CAR
 - G PROPOSED RANGER'S RESIDENCE
 - H PROPOSED GUARD RES.
 - I GUARD RES.

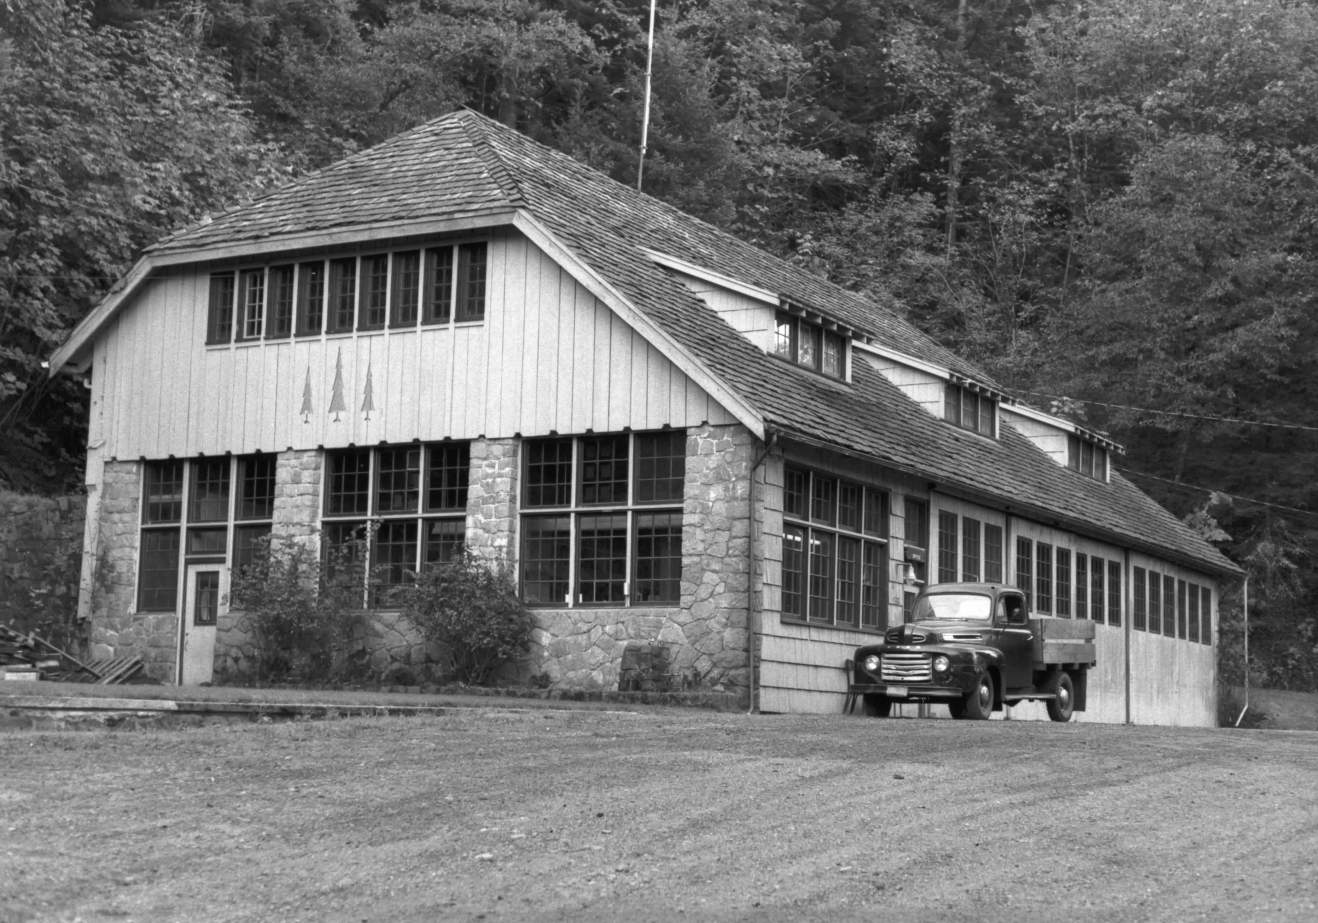
- 1) Name of Property: Cascade Locks (WC)--Warehouse
- 2) City and State: Cascade Locks, Oregon
- 3) Photographer: Susan Marvin
- 4) Date: 10/05/83
- 5) Negative Location: USDA Forest Service, Regional Office, Recreation Unit, CRM Files
- 6) Description: Looking southwest at left and main north-facing elevations
- 7) Photograph Number: 06-04-MHCGD-1

Columbia Gorge Work Center: Warehouse: 1936-38 Rectangular, 1 1/2 story, wood frame, poured concrete foundation, wood shingled medium hipped gable roof, eaves project, rafters exposed, three shed-roof dormers on north slope of roof. Six bays in length. Exterior walls on main facade and rear elevation, and dormer cheeks are wall shakes, ground level on east and west gable ends are broken-coursed rubble masonry, gable ends are vertical boards, battens every other board. Mullion windows, with two, three, and four divisions, single sash, of six, nine, and twelve lights on ground level; mullion windows with nine divisions of eight lights in vertical arrangements on each gable end. Single leaf two-panel doors with window panels are located to the right of the easterly most bay on the main facade, and offset to the left on the east gable end: five horizontal slide-opening vertical board vehicle doors, each with three 12-light windows, enclose the remaining five bays on the north (main) facade. Three well-shaped tree-logo cutouts in horizontal arrangement, are centered on each gable end. No apparent structural additions or alterations; no obvious material modifications.

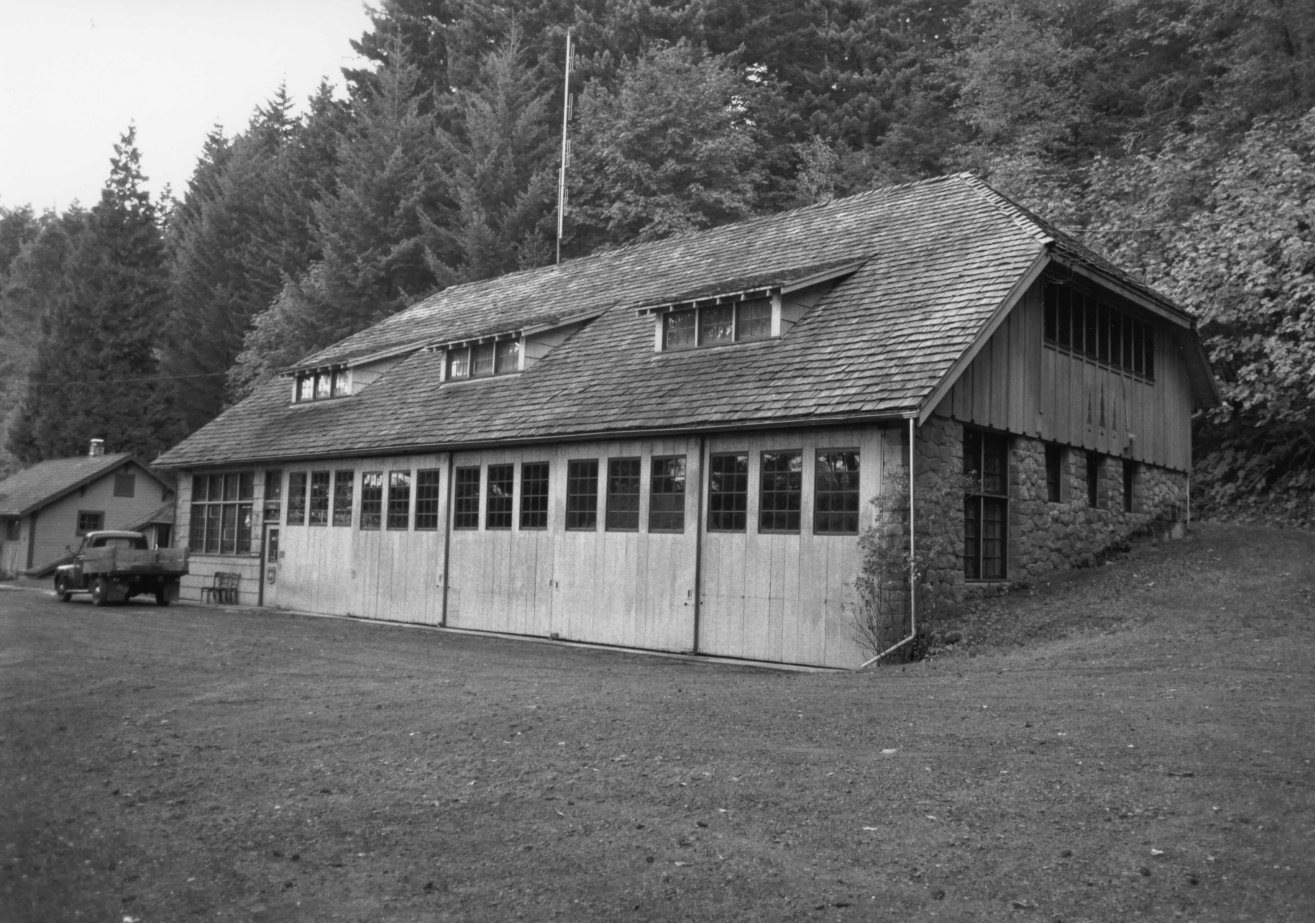
- 1) Name of Property: Cascade Locks (WC)--Warehouse
- 2) City and State: Cascade Locks, Oregon
- 3) Photographer: Susan Marvin
- 4) Date: 10/05/83
- 5) Negative Location: USDA Forest Service, Regional Office, Recreation Unit, CRM Files
- 6) Description: Looking east at main north-facing and right elevations
- 7) Photograph Number: 06-04-MHCGD-2

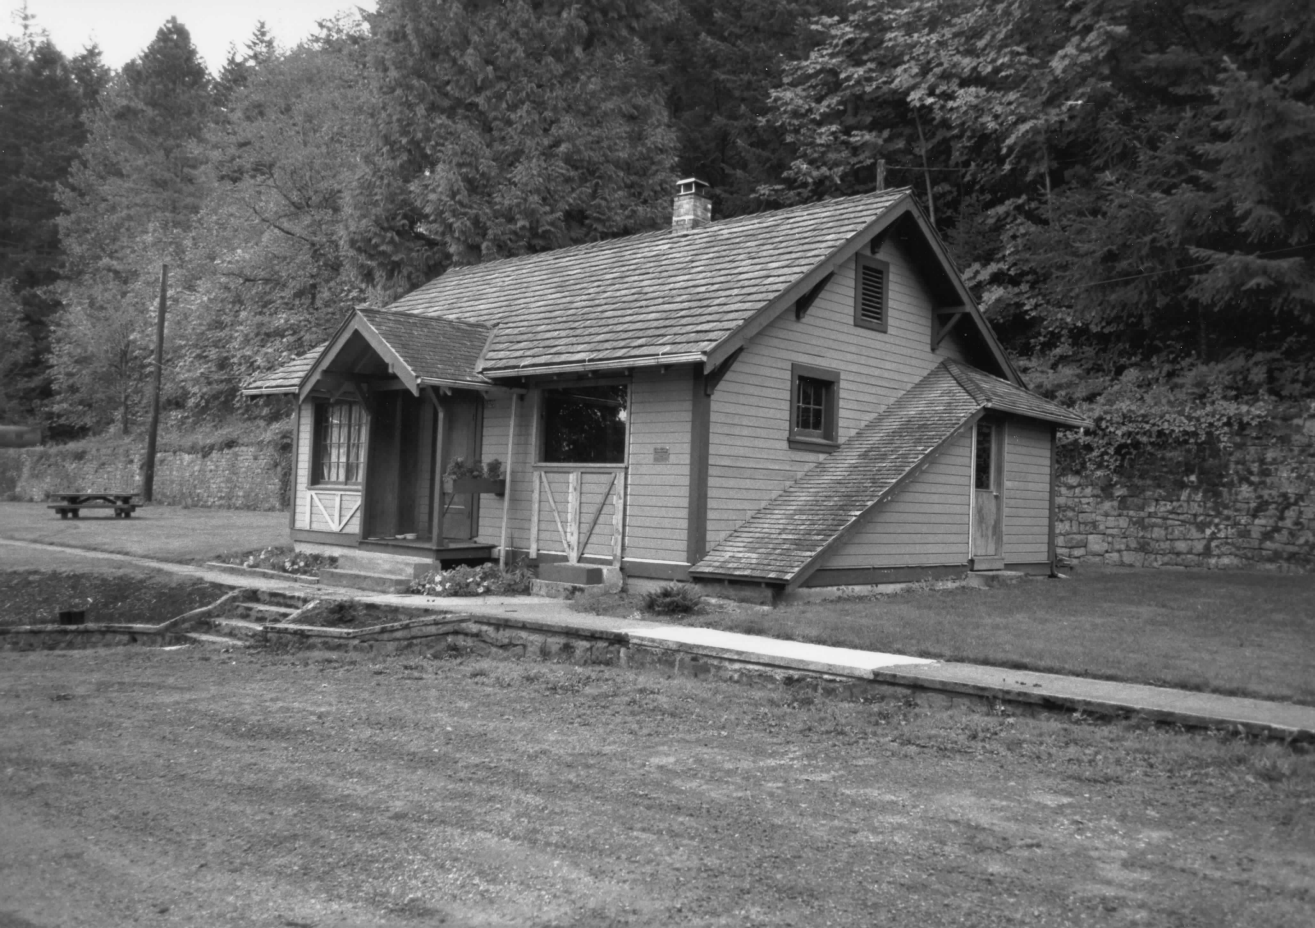
- 1) Name of Property: Cascade Locks (WC)--Protective Assistant's Residence
- 2) City and State: Cascade Locks, Oregon
- 3) Photographer: Susan Marvin
- 4) Date: 10/05/83
- 5) Negative Location: USDA Forest Service, Regional Office, Recreation Unit, CRM Files
- 6) Description: Looking east at main and right elevations.
- 7) Photograph Number: 06-04-MHCGC

Prevention Assistant's Residence: Rectangular, 1 1/2 story, wood frame, poured concrete foundation, split shake medium gable roof, eaves project, rafters exposed, verges project, fascia alone, supported by plain brackets, stretcher bond brick interior chimney, center of ridgeline, center gable porch on north (main) facade. Exterior walls are flush siding with end boards. Windows are

twenty-four light single sash on the main facade, and six light sash on gable ends and rear. Main entry is a single-leaf door, accessed by two straight steps and an open plank platform, at the center of the main facade. A hip roofed structural addition, clad with similar flush siding, abuts the west gable end. The large multi-light window to the right of the main door has been replaced with a single pane sash of smaller dimension. No decoration.

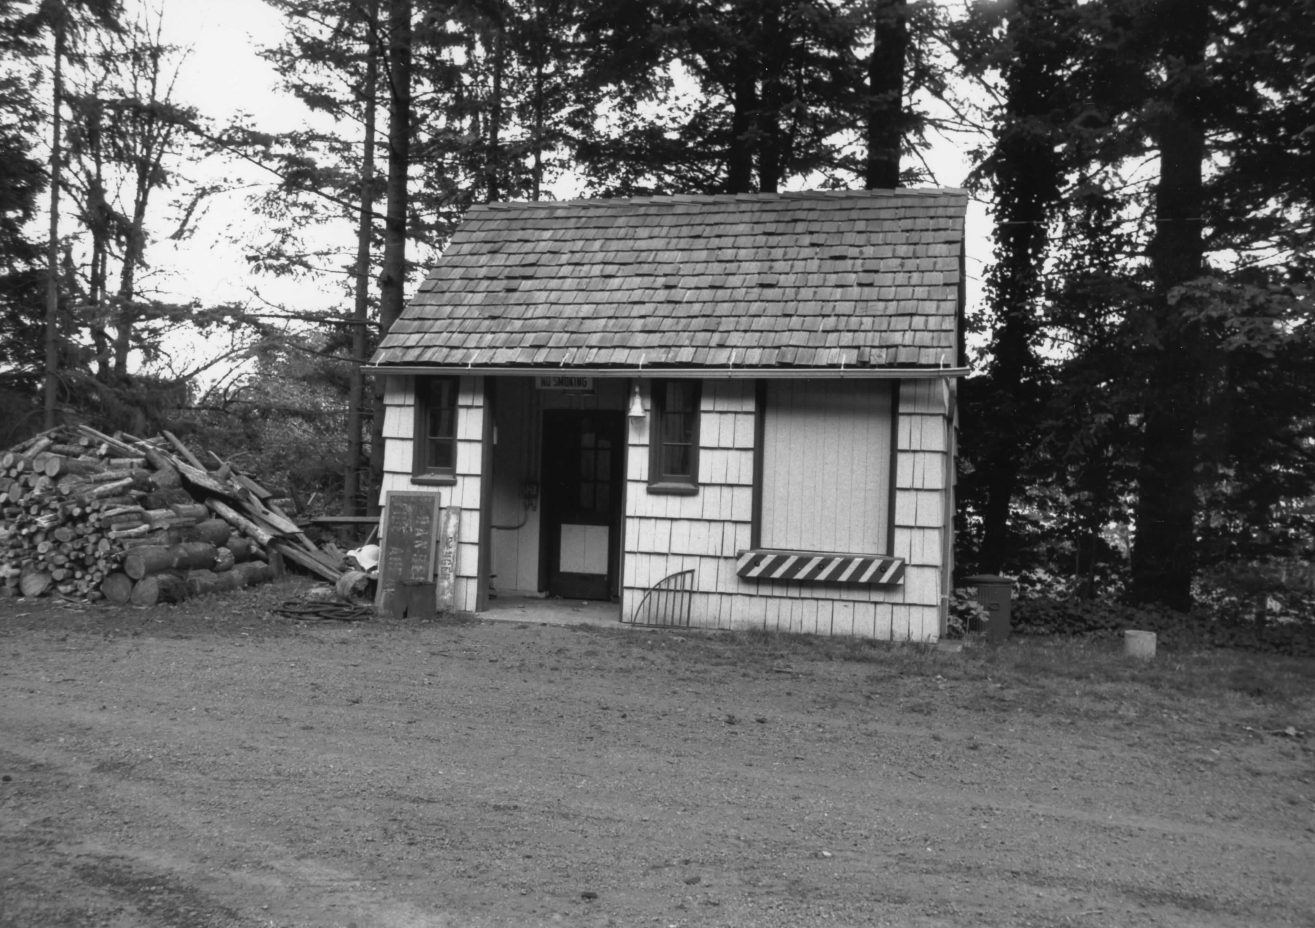
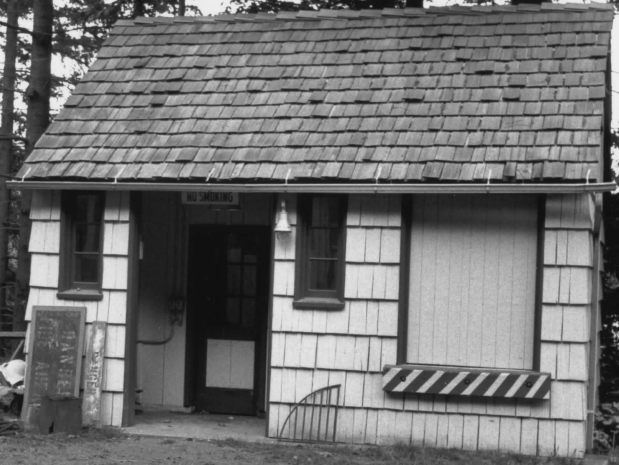
- 1) Name of Property: Cascade Locks (WC)--Gas and Oil House
- 2) City and State: Cascade Locks, Oregon
- 3) Photographer: Susan Marvin
- 4) Date: 10/05/83
- 5) Negative Location: USDA Forest Service, Regional Office, Recreation Unit, CRM Files
- 6) Description: Looking northwest at main elevation.
- 7) Photograph Number: 06-04-MHCGE

Gas House: Rectangular, 1 story, wood frame, poured concrete foundation, wood shingled medium gable roof. Exterior walls are covered with wood shingles. Windows are single sash with three lights in vertical placement. Main entry is slightly off-set to left on south (main) facade. Single leaf two-panel door with 12-light window is recessed in anterior wall: enclosure also protects gas pump. A horizontal slide opening vertical board door, centered in wall, is off-set to the right on the main facade: opening is elevated to facilitate loading. No apparent structural addition or alteration; no obvious material modification. No decoration.
