National Register of Historic Places Inventory—Nomination Form

historic Delta Historic District

HISTORIC DISTRICT MAP

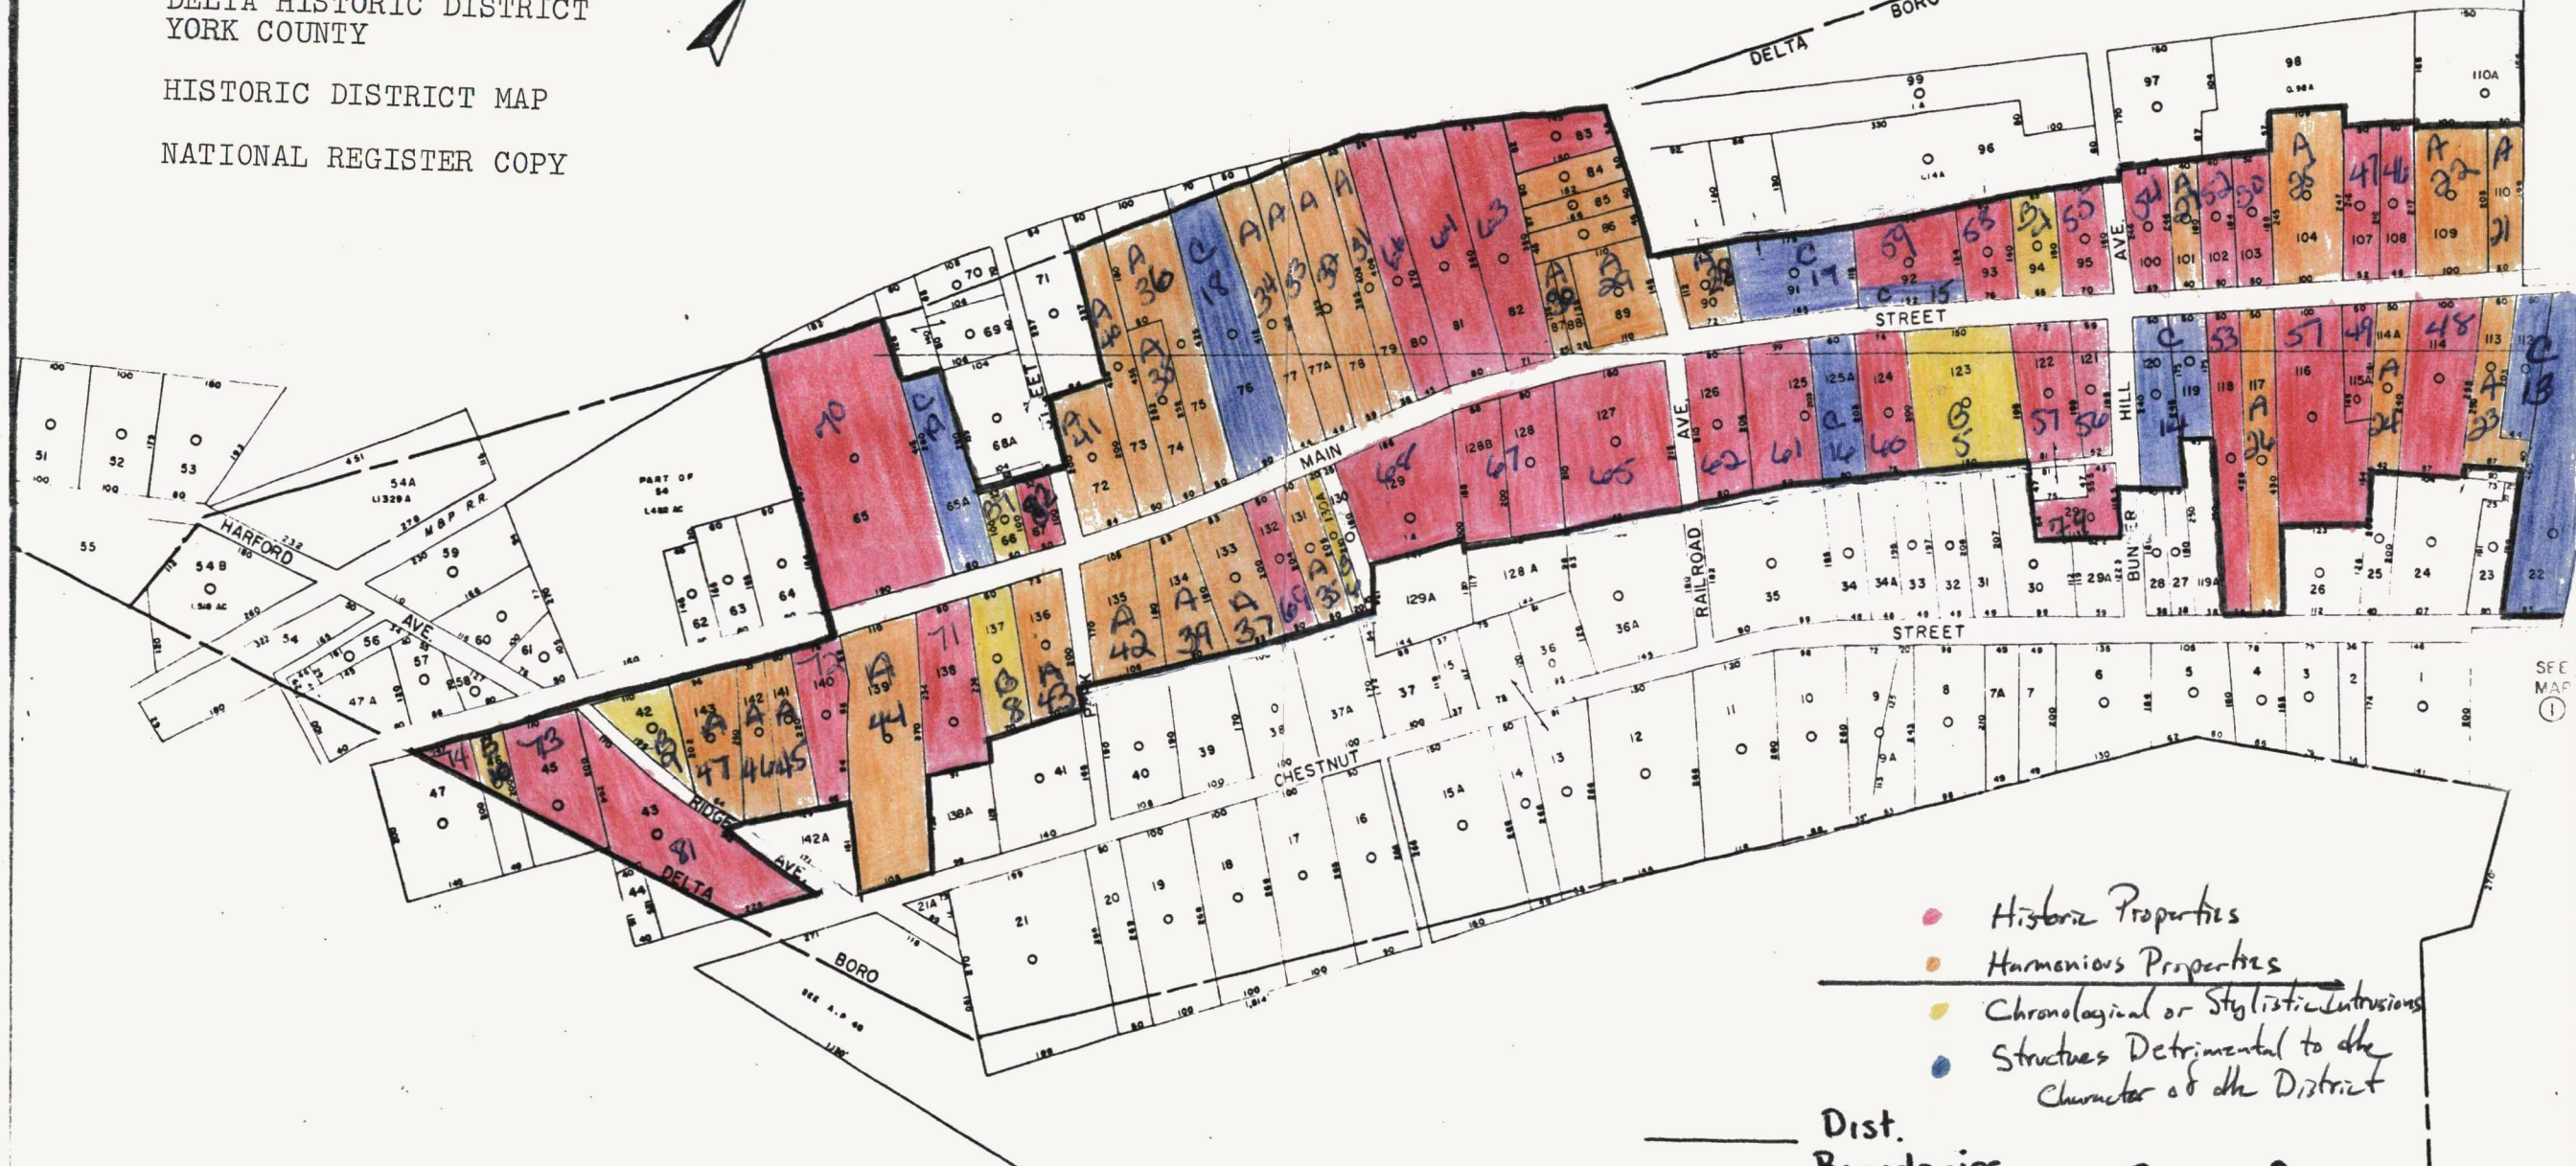
- Historic Properties
- Harmonious Properties
- Chronological or Stylistic Intrusions
- Structures Detrimental to the Character of the District

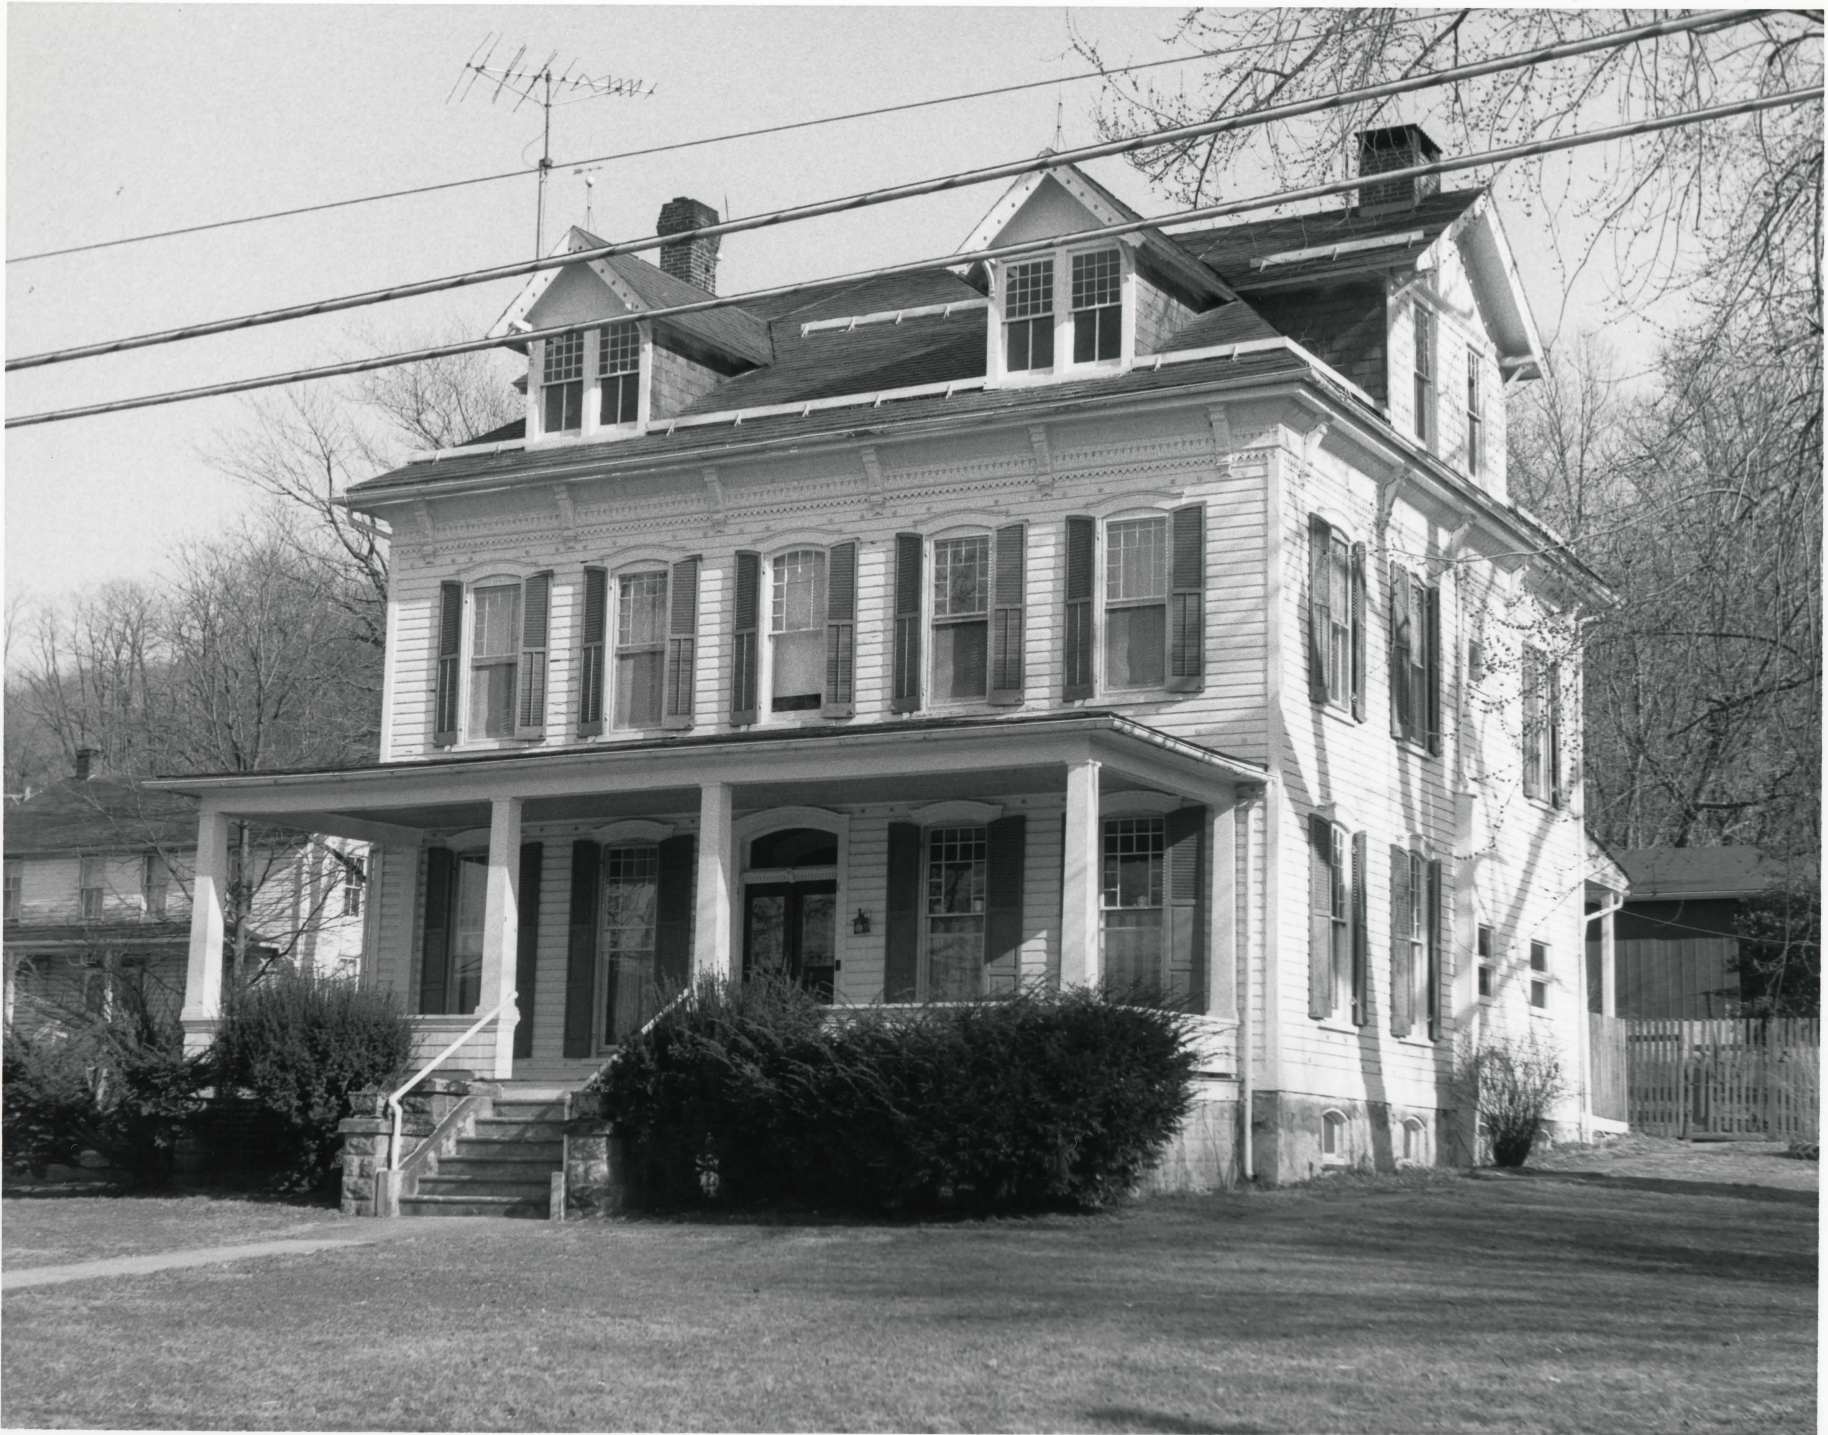
I. Delta Historic District
104 Main St. (133.7.73)
York County
PD: 1982 PC: T. Schneider
PV: facade and west wall, looking S.
NW: Historic York, Inc.

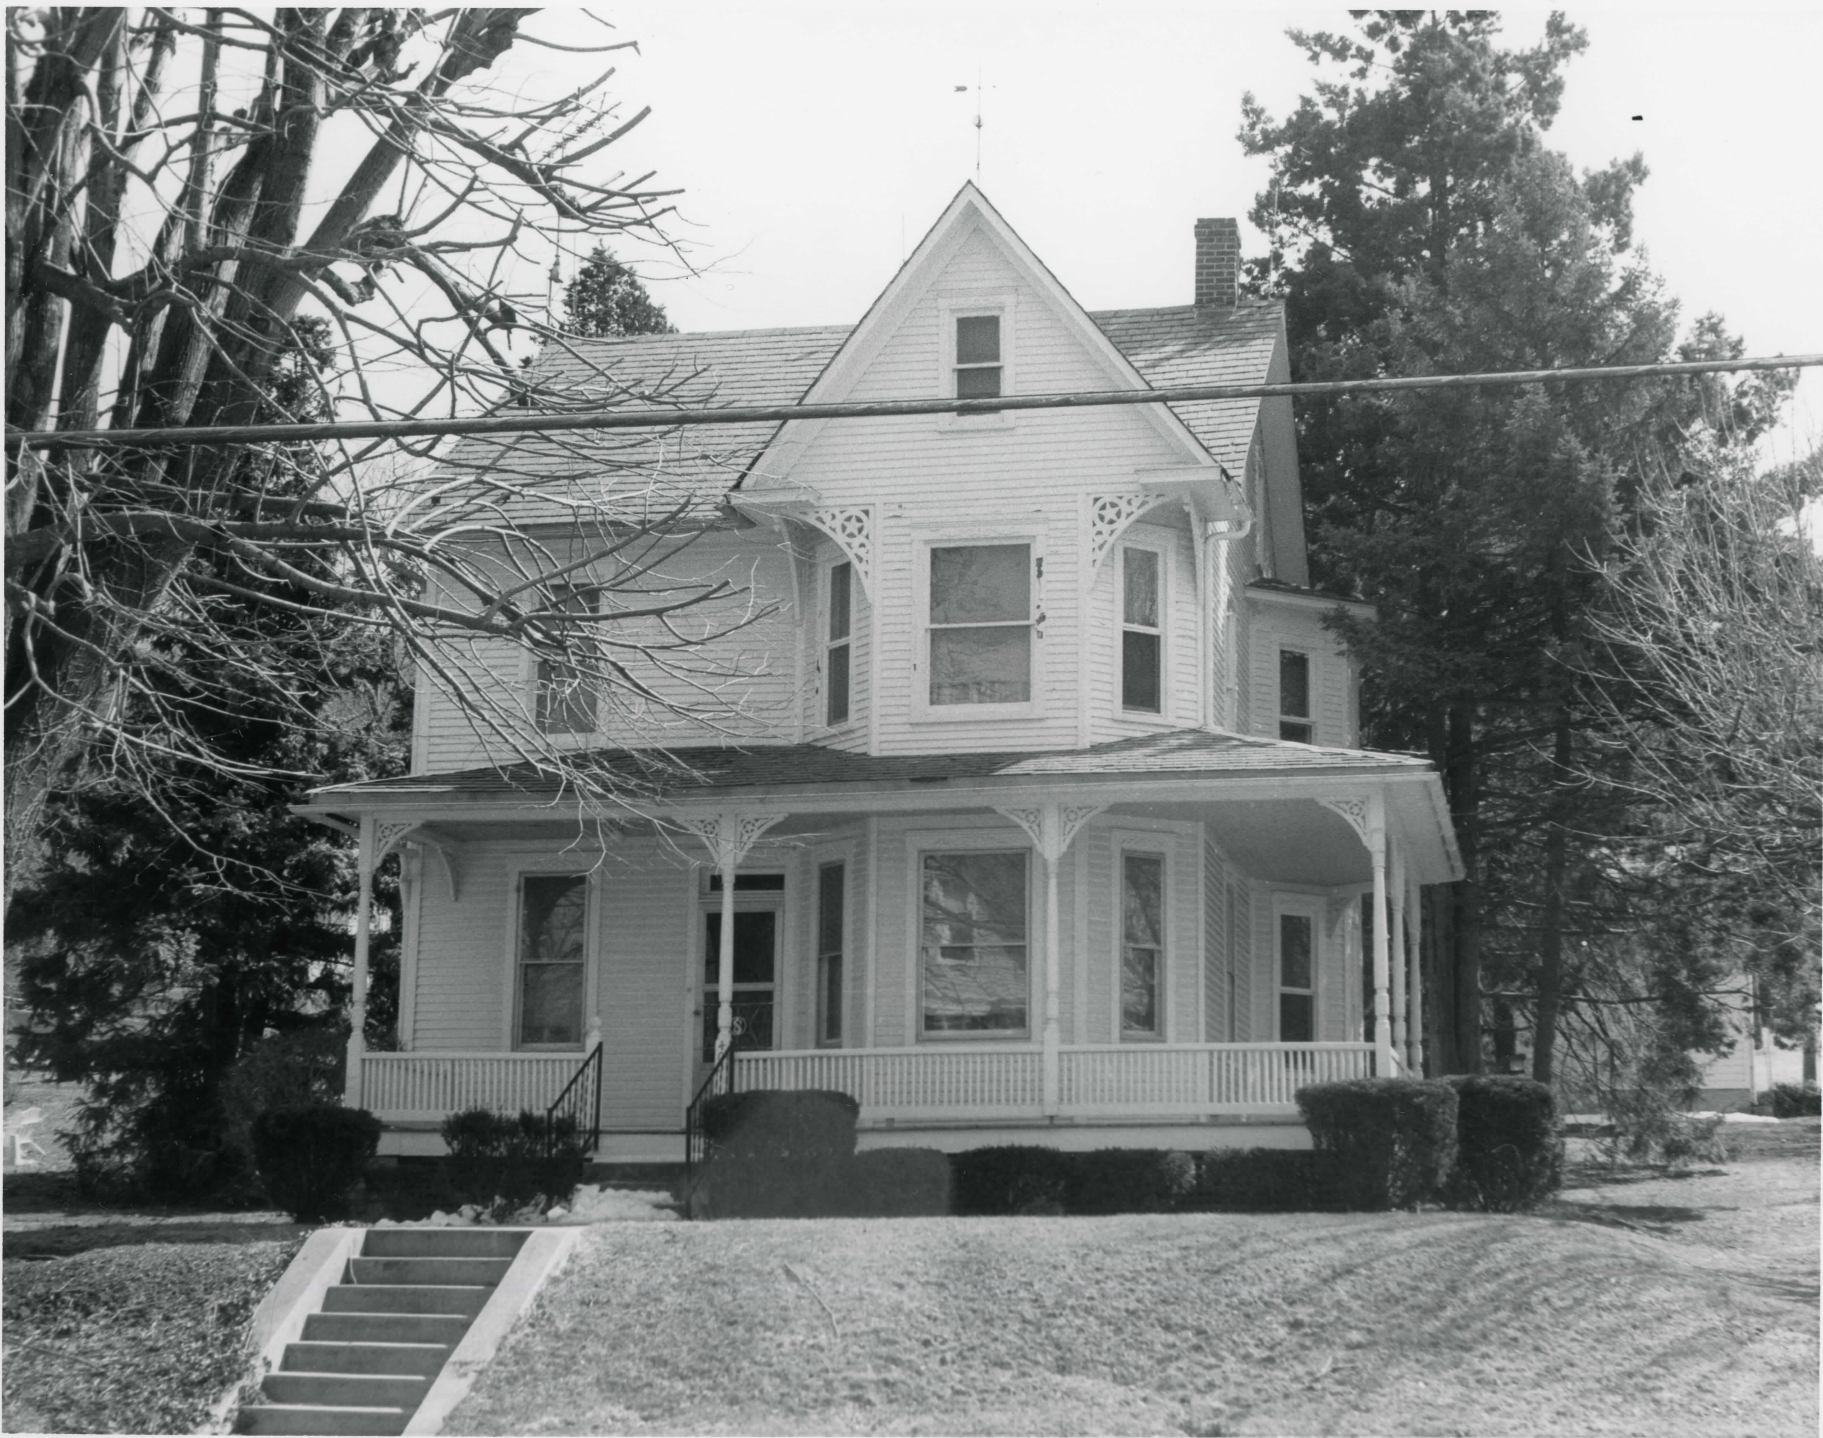
II. Delta Historic District
400 Main St. (133.7.62)
York County
PD: 1982 PC: T. Schmeiser
PV: Friends, looking S.
NL: Historic York, Inc.

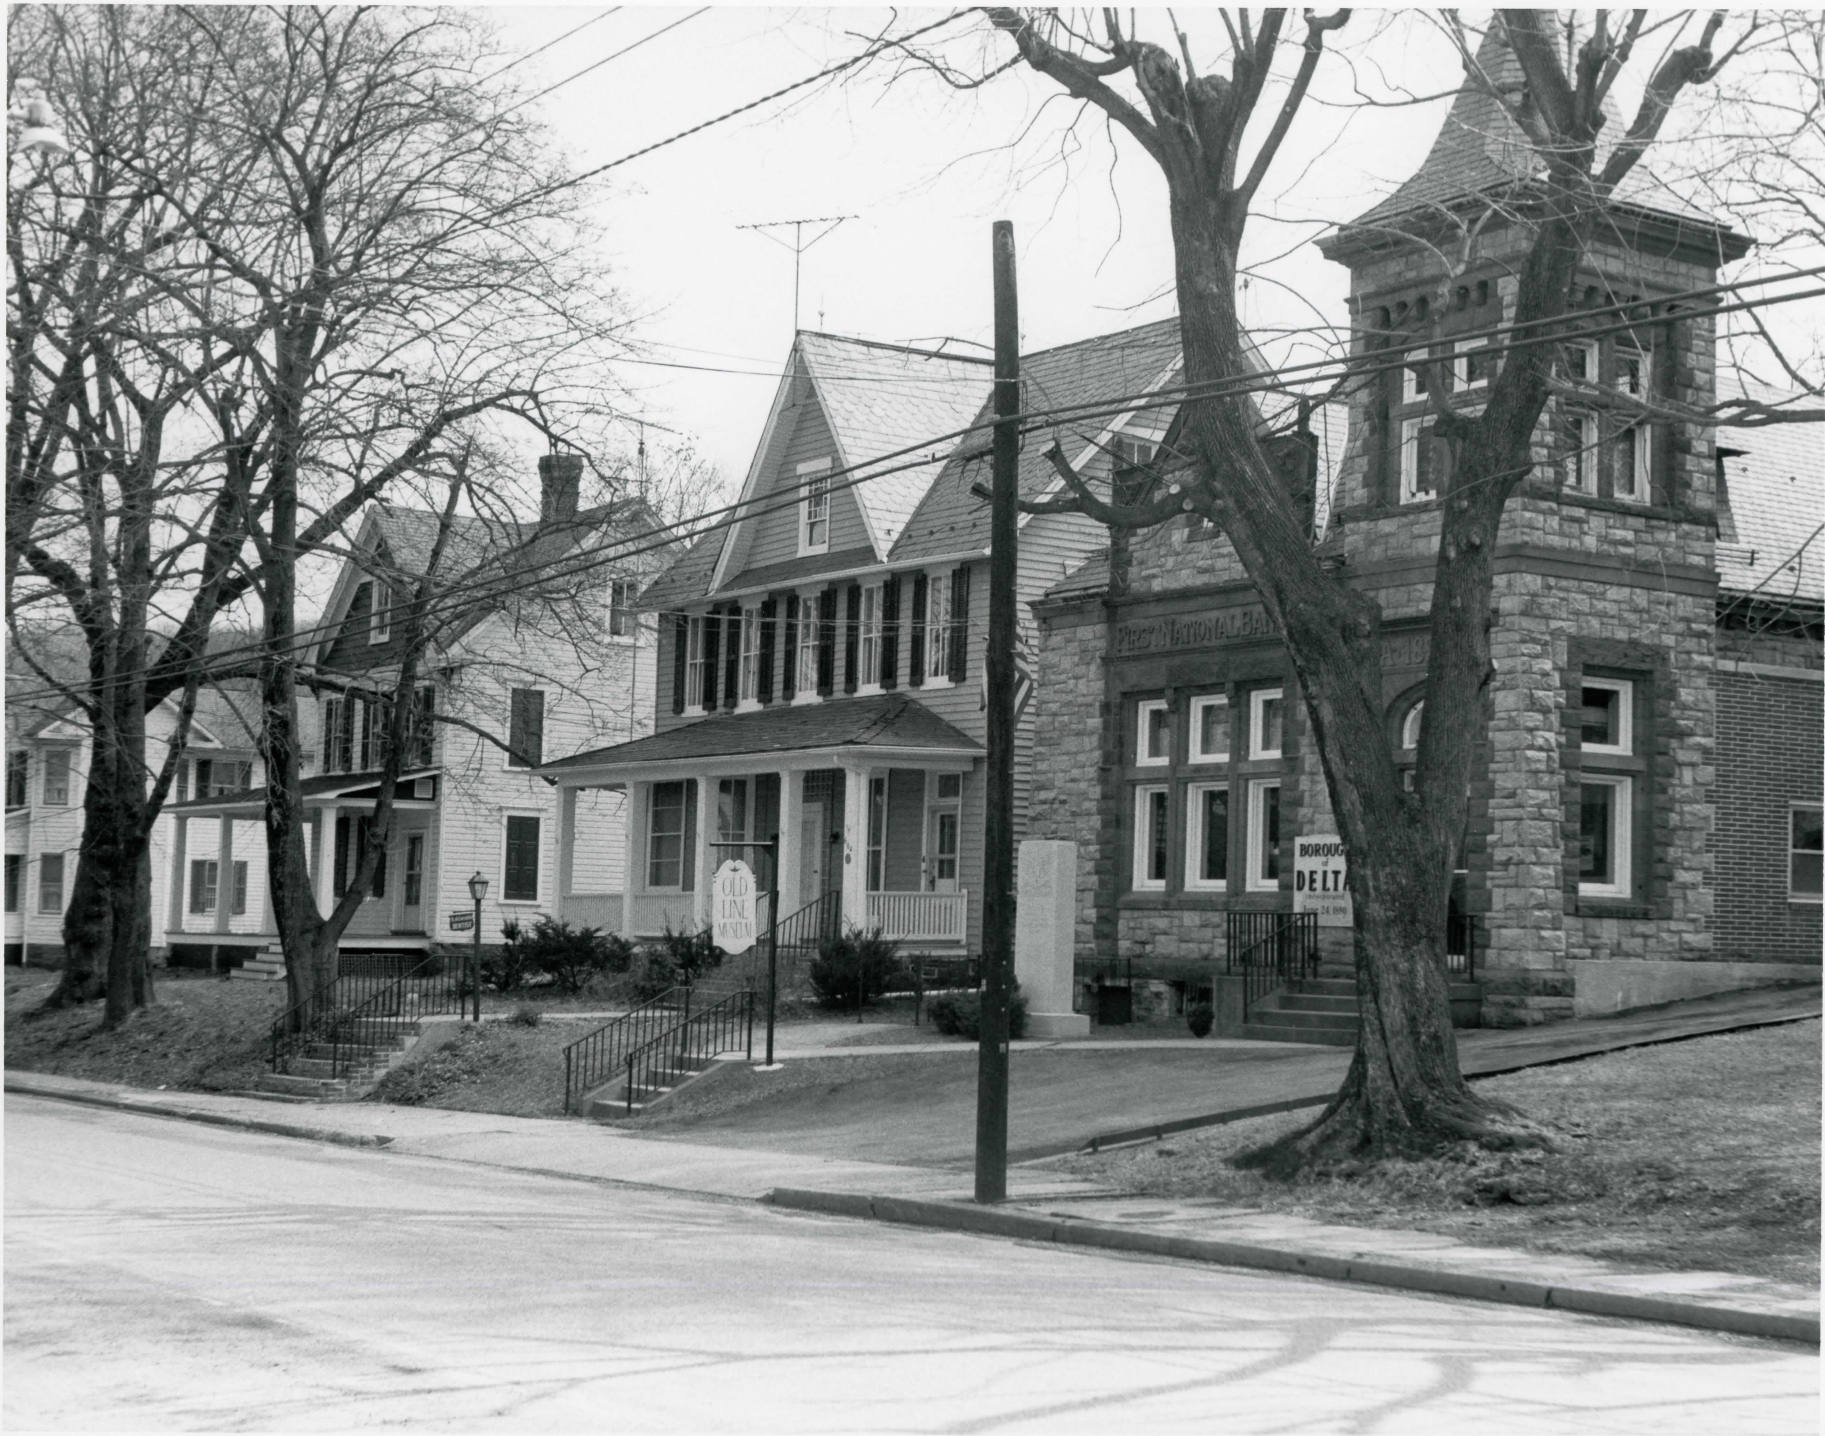
III. Delta Historic District
600 Block, Main St, south side
York County
PD: 1982 PC: T. Schreiber
PV: looking S.E. including Rich. Perry Bank
NL: Historic ~~is~~ ^{is} ~~the~~ ^{the} ~~inc.~~

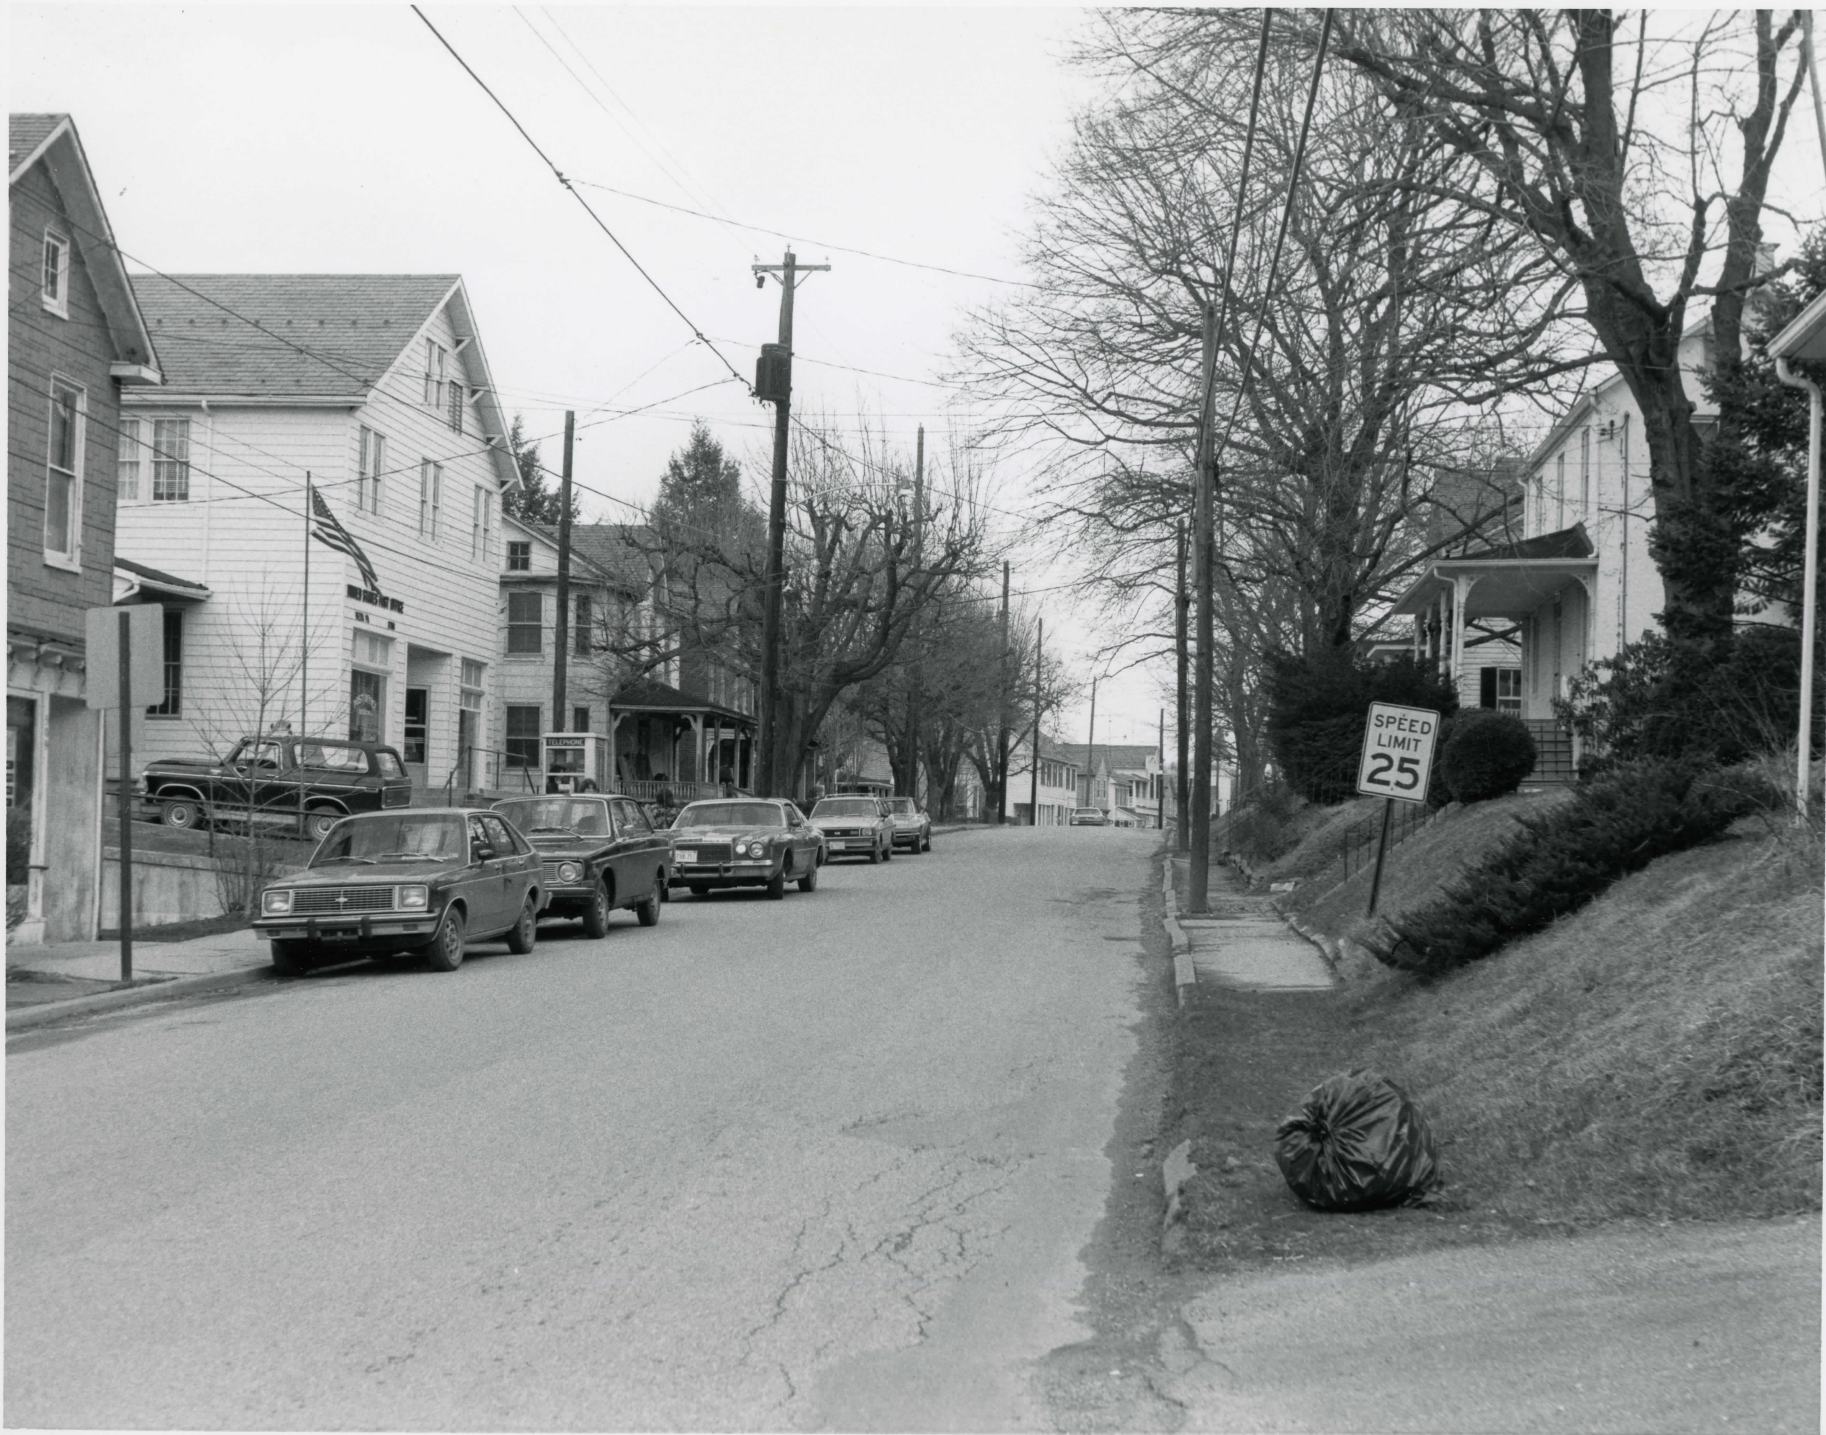
IV. Delta Historic District

PV: N+S sides of 500 Block, looking E.

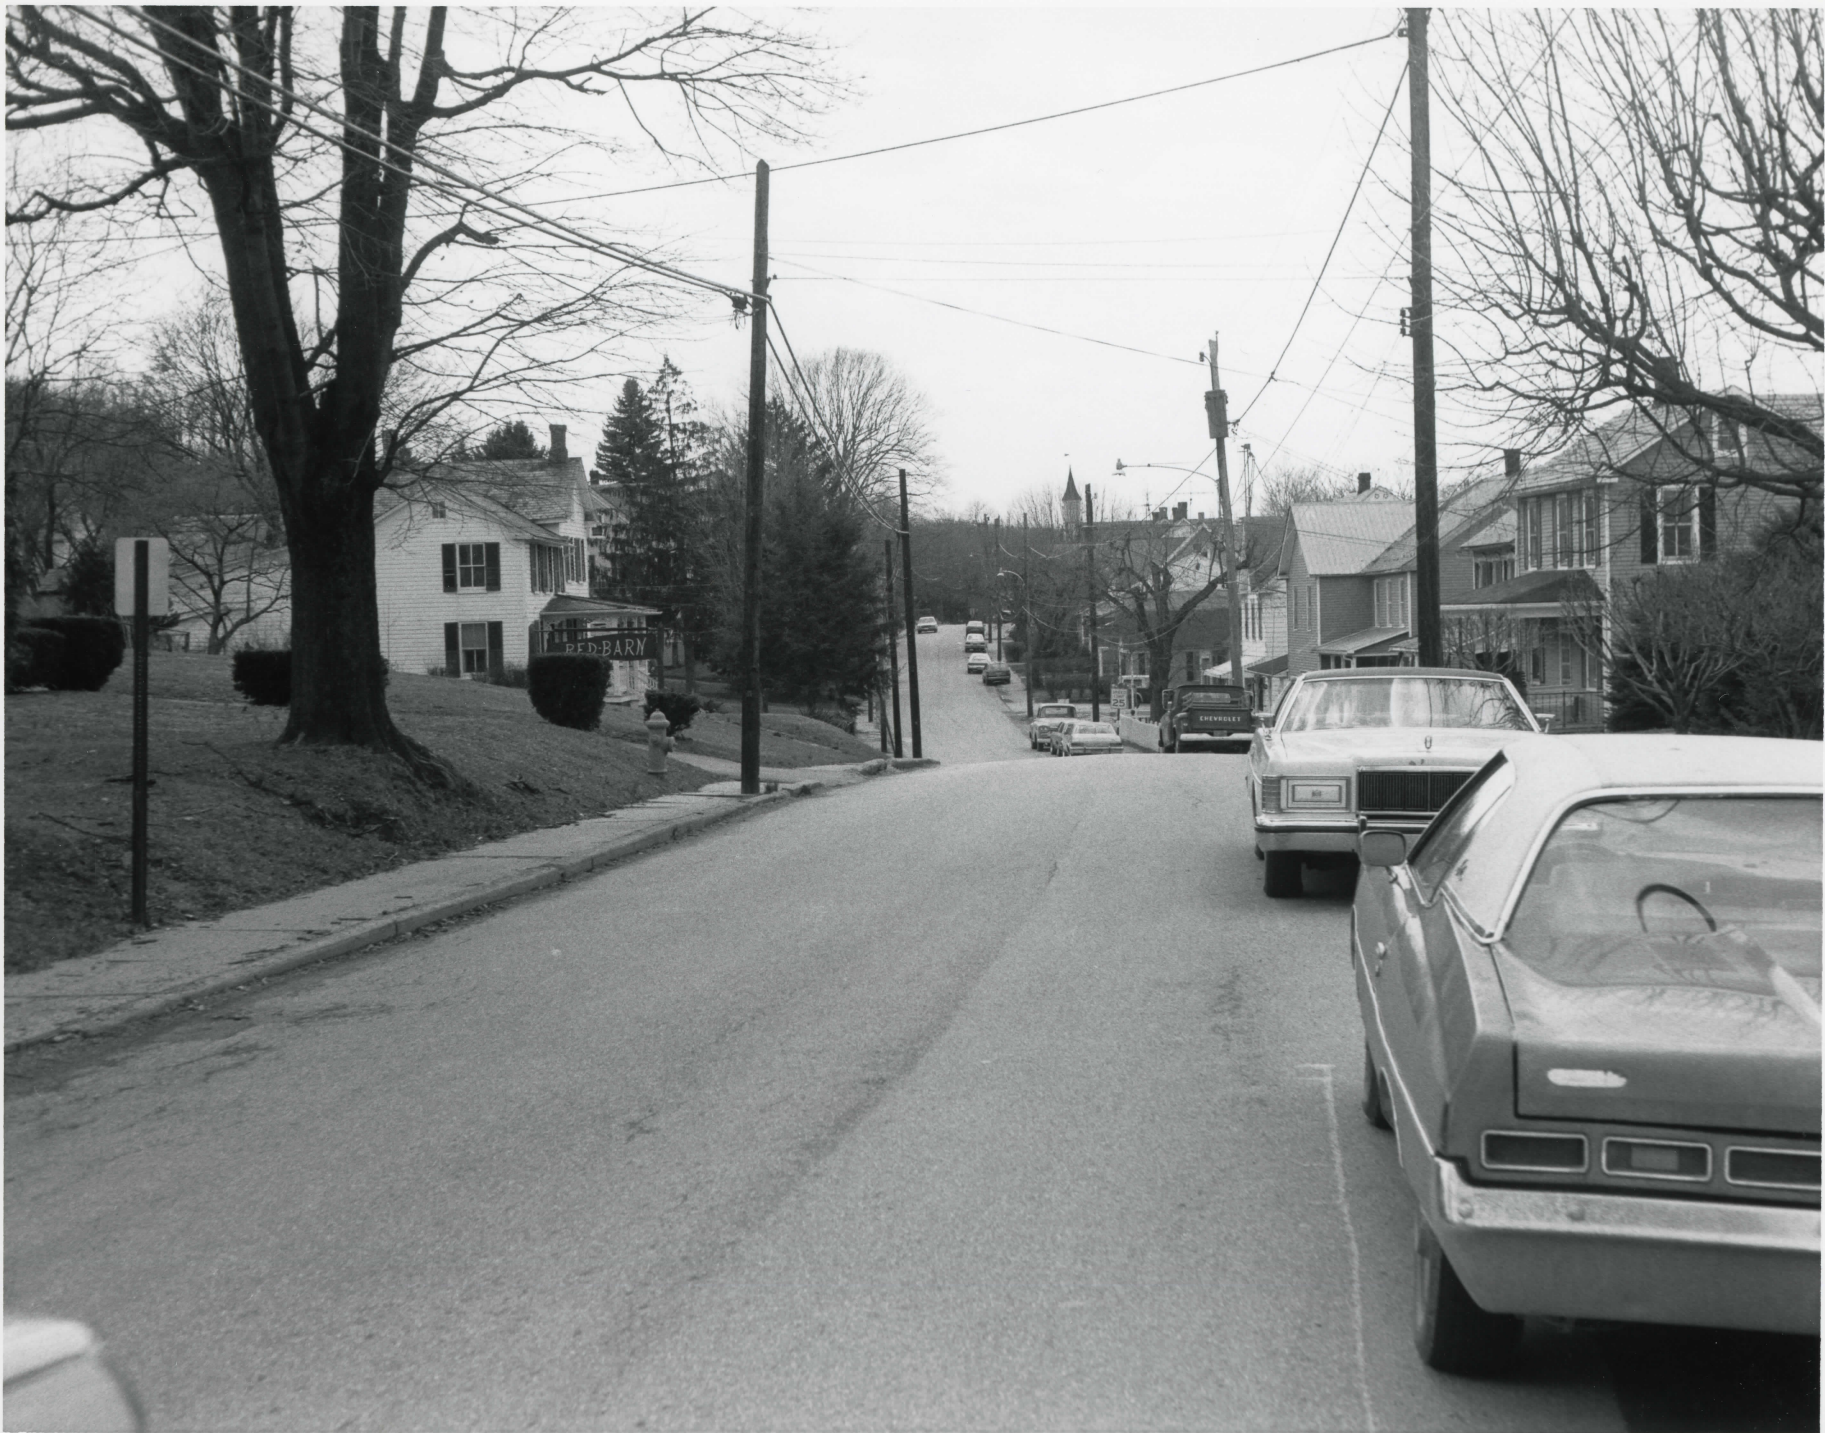
V Delta Historic District
300 Block, Main St
York County
PD: 1982 PC: T. Schaefer
PV: N + S Sides 300 Block, York Co. W.
NL: Historic York, Inc.

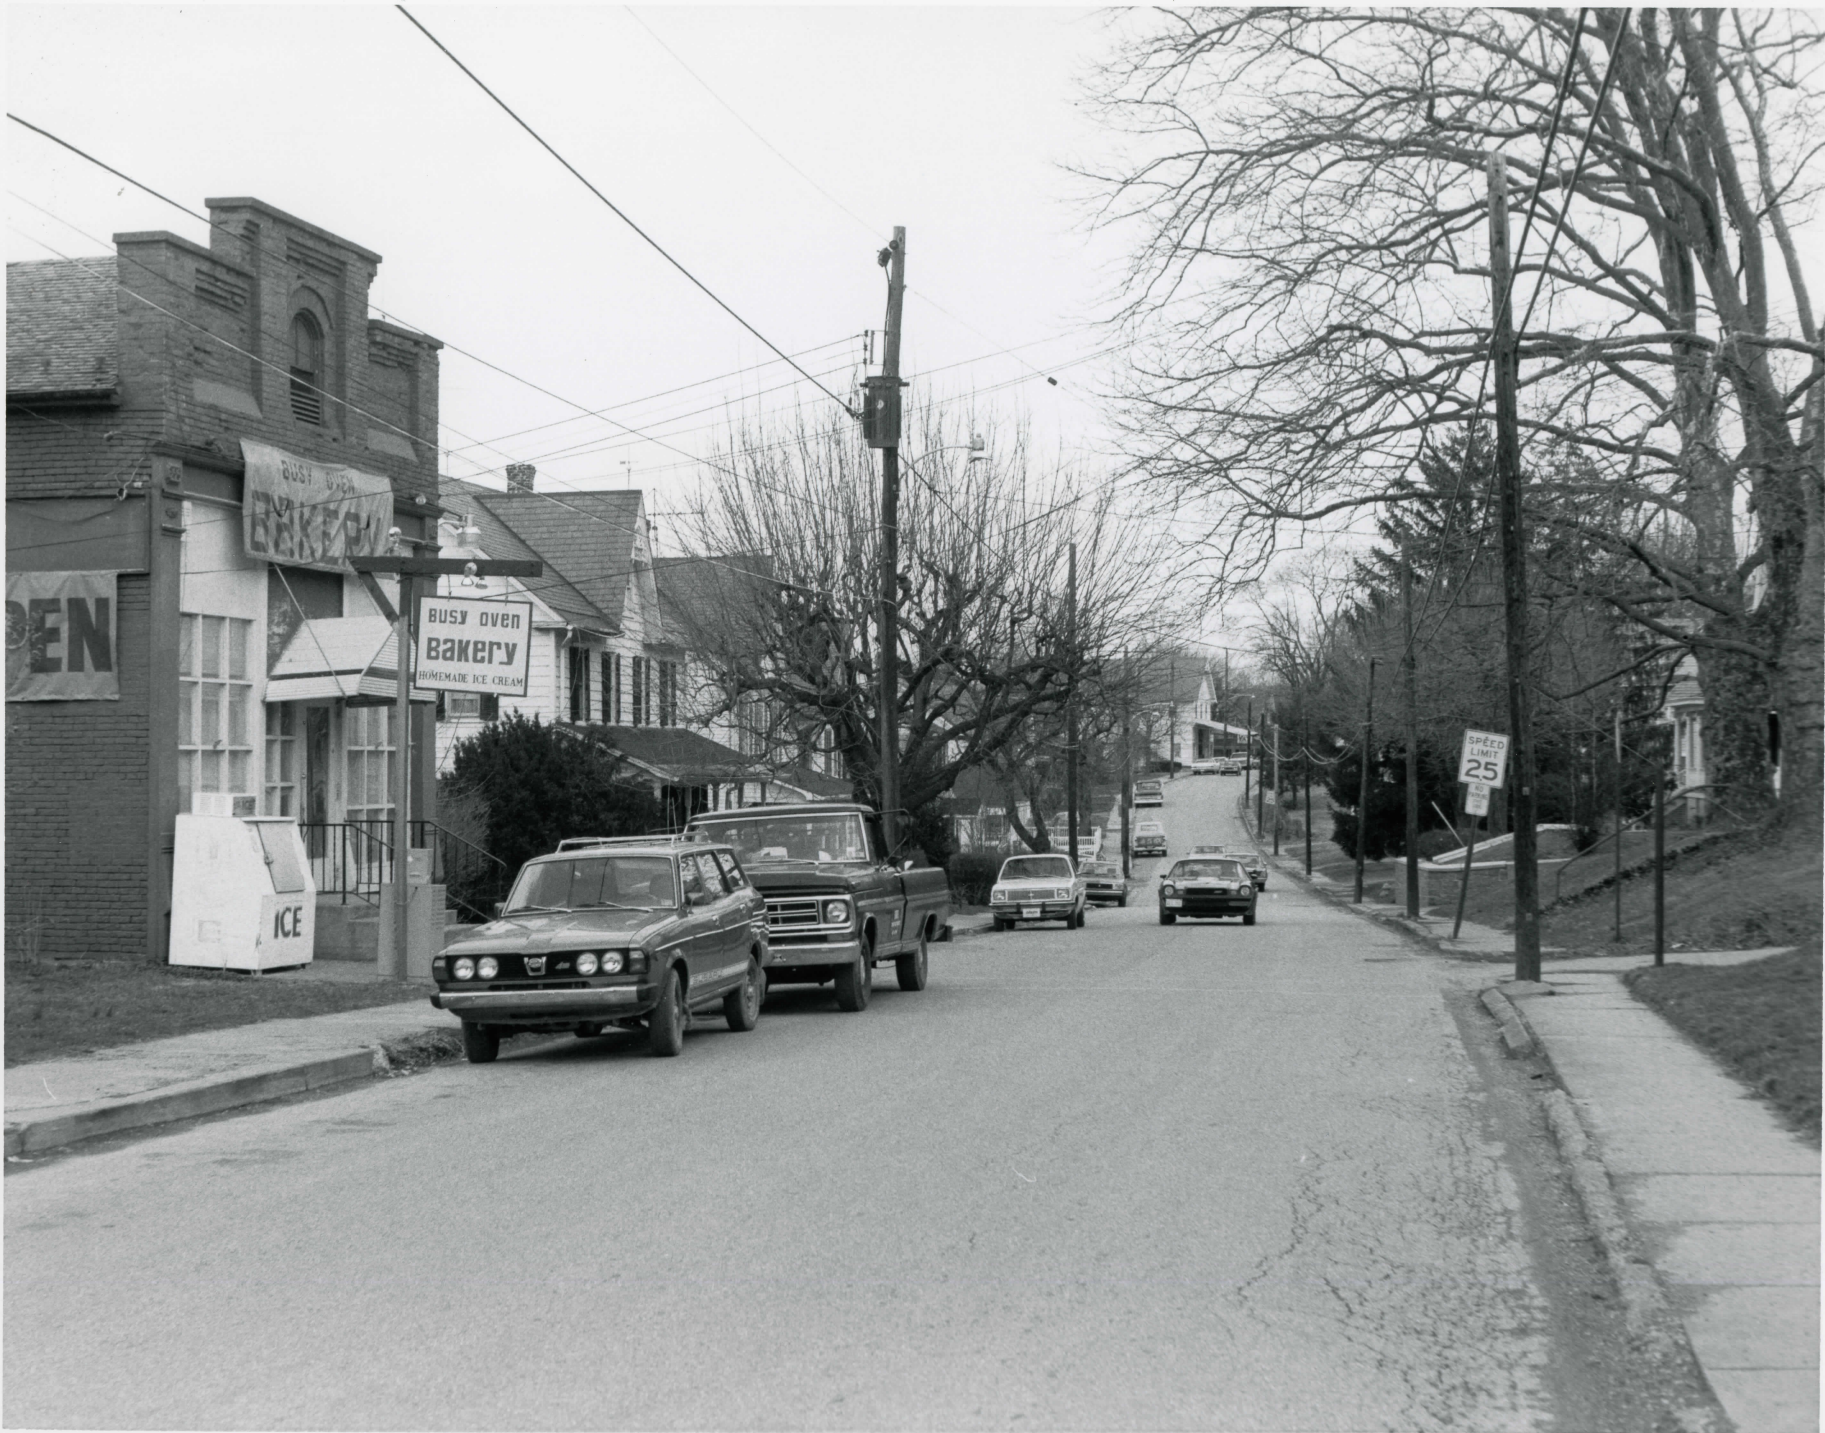
VI. Delta Historic District
300 Block, Main St.
York County
PD: 1982 PC.T. Schreier
PX: N. side, 300 Block, looking E.
W: Historic York, Inc.

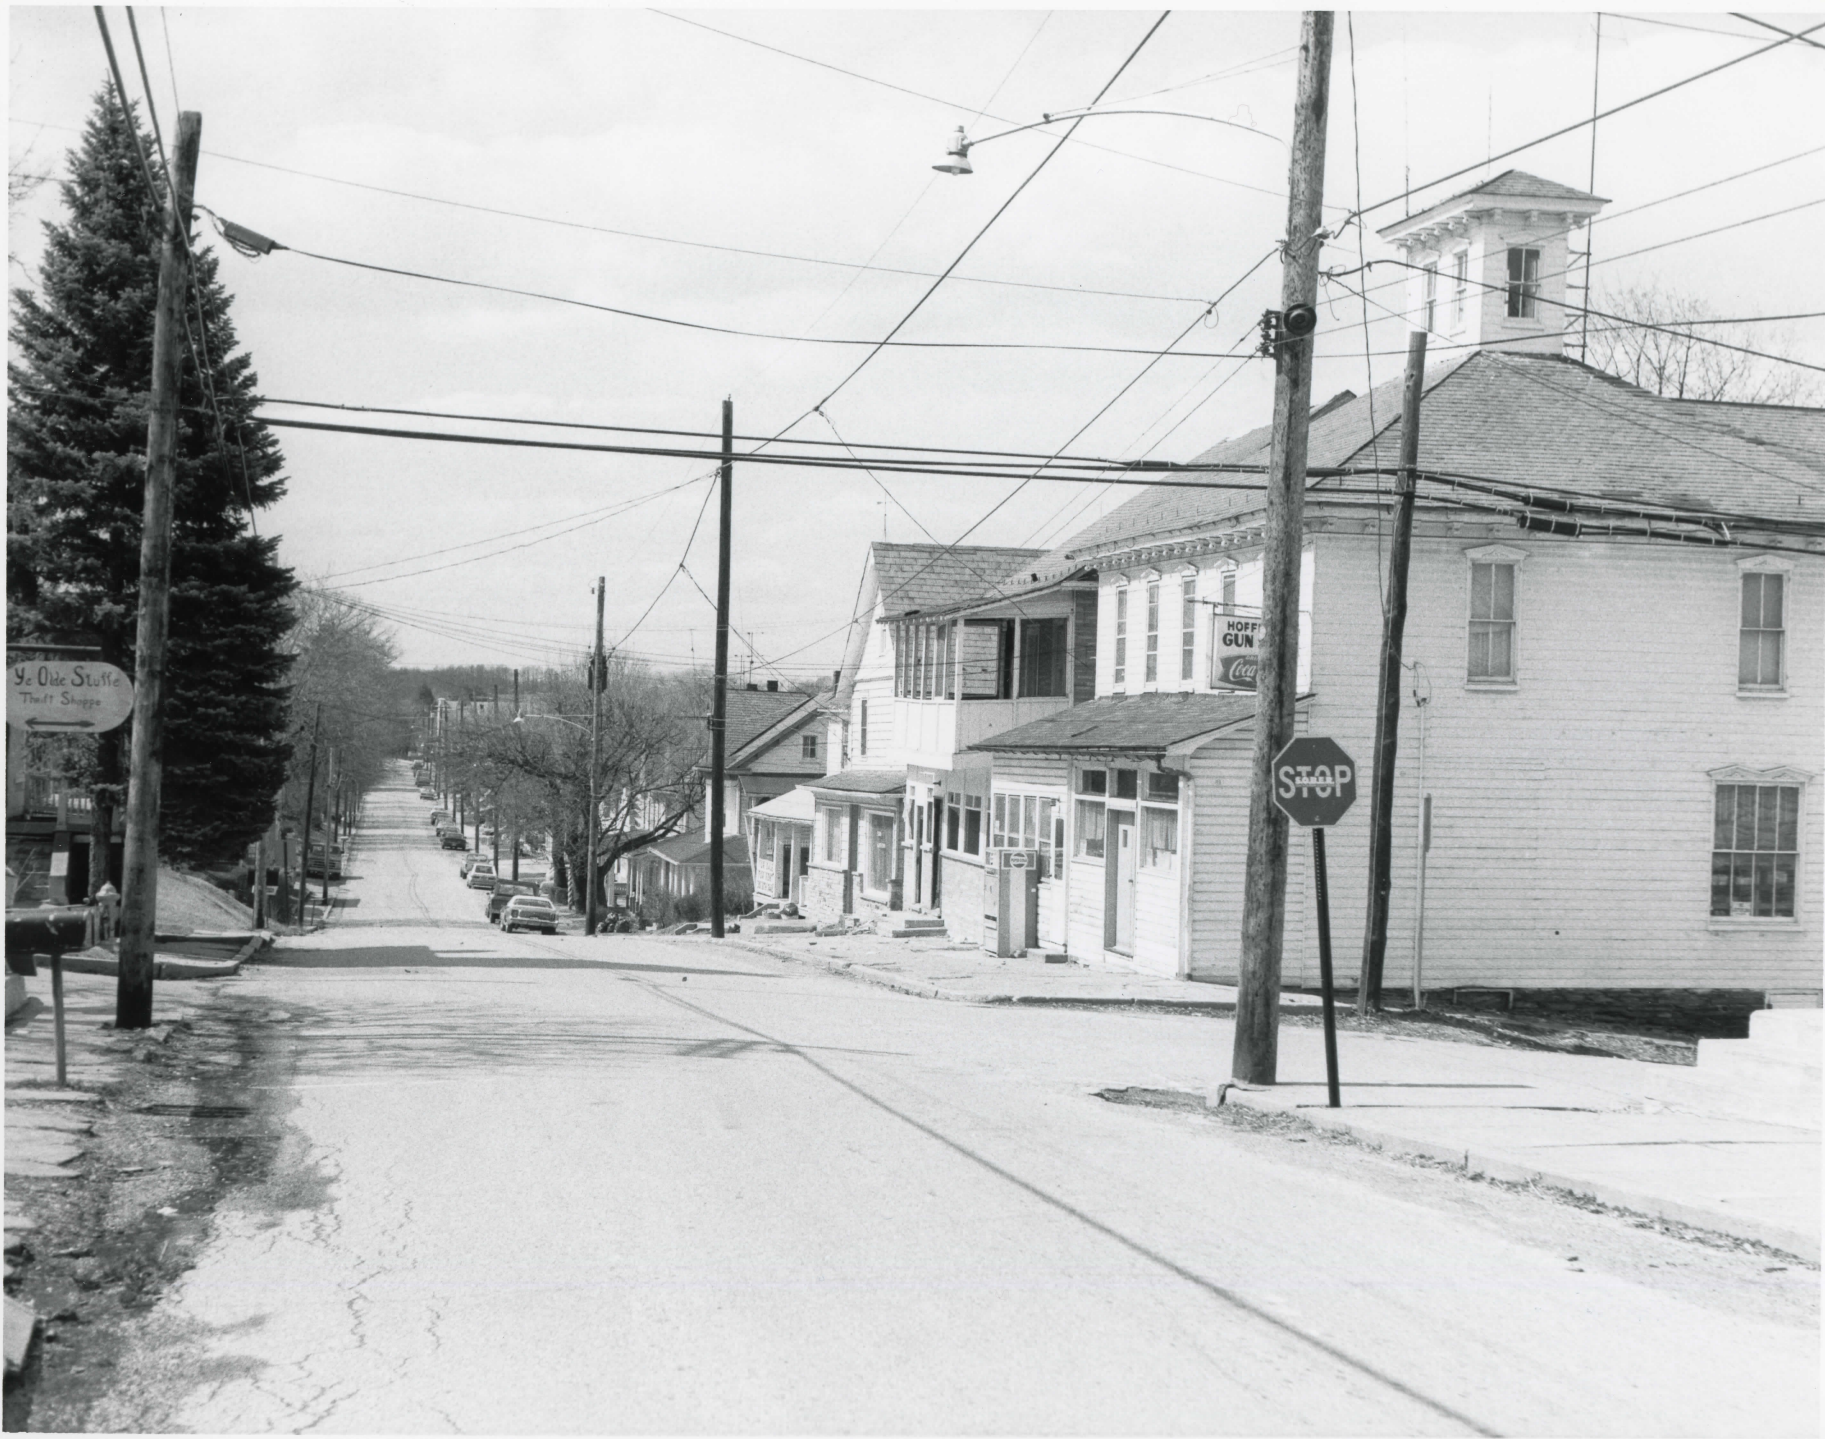
VII Delta Historic District
800 Block, Main St.
York County
PD: 1982 PC: T. Schuster
PV: N. Side Main St., looking W.
NL: Historic York, Inc.
