National Register of Historic Places Inventory—Nomination Form

historic Delta Historic District

HISTORIC DISTRICT MAP

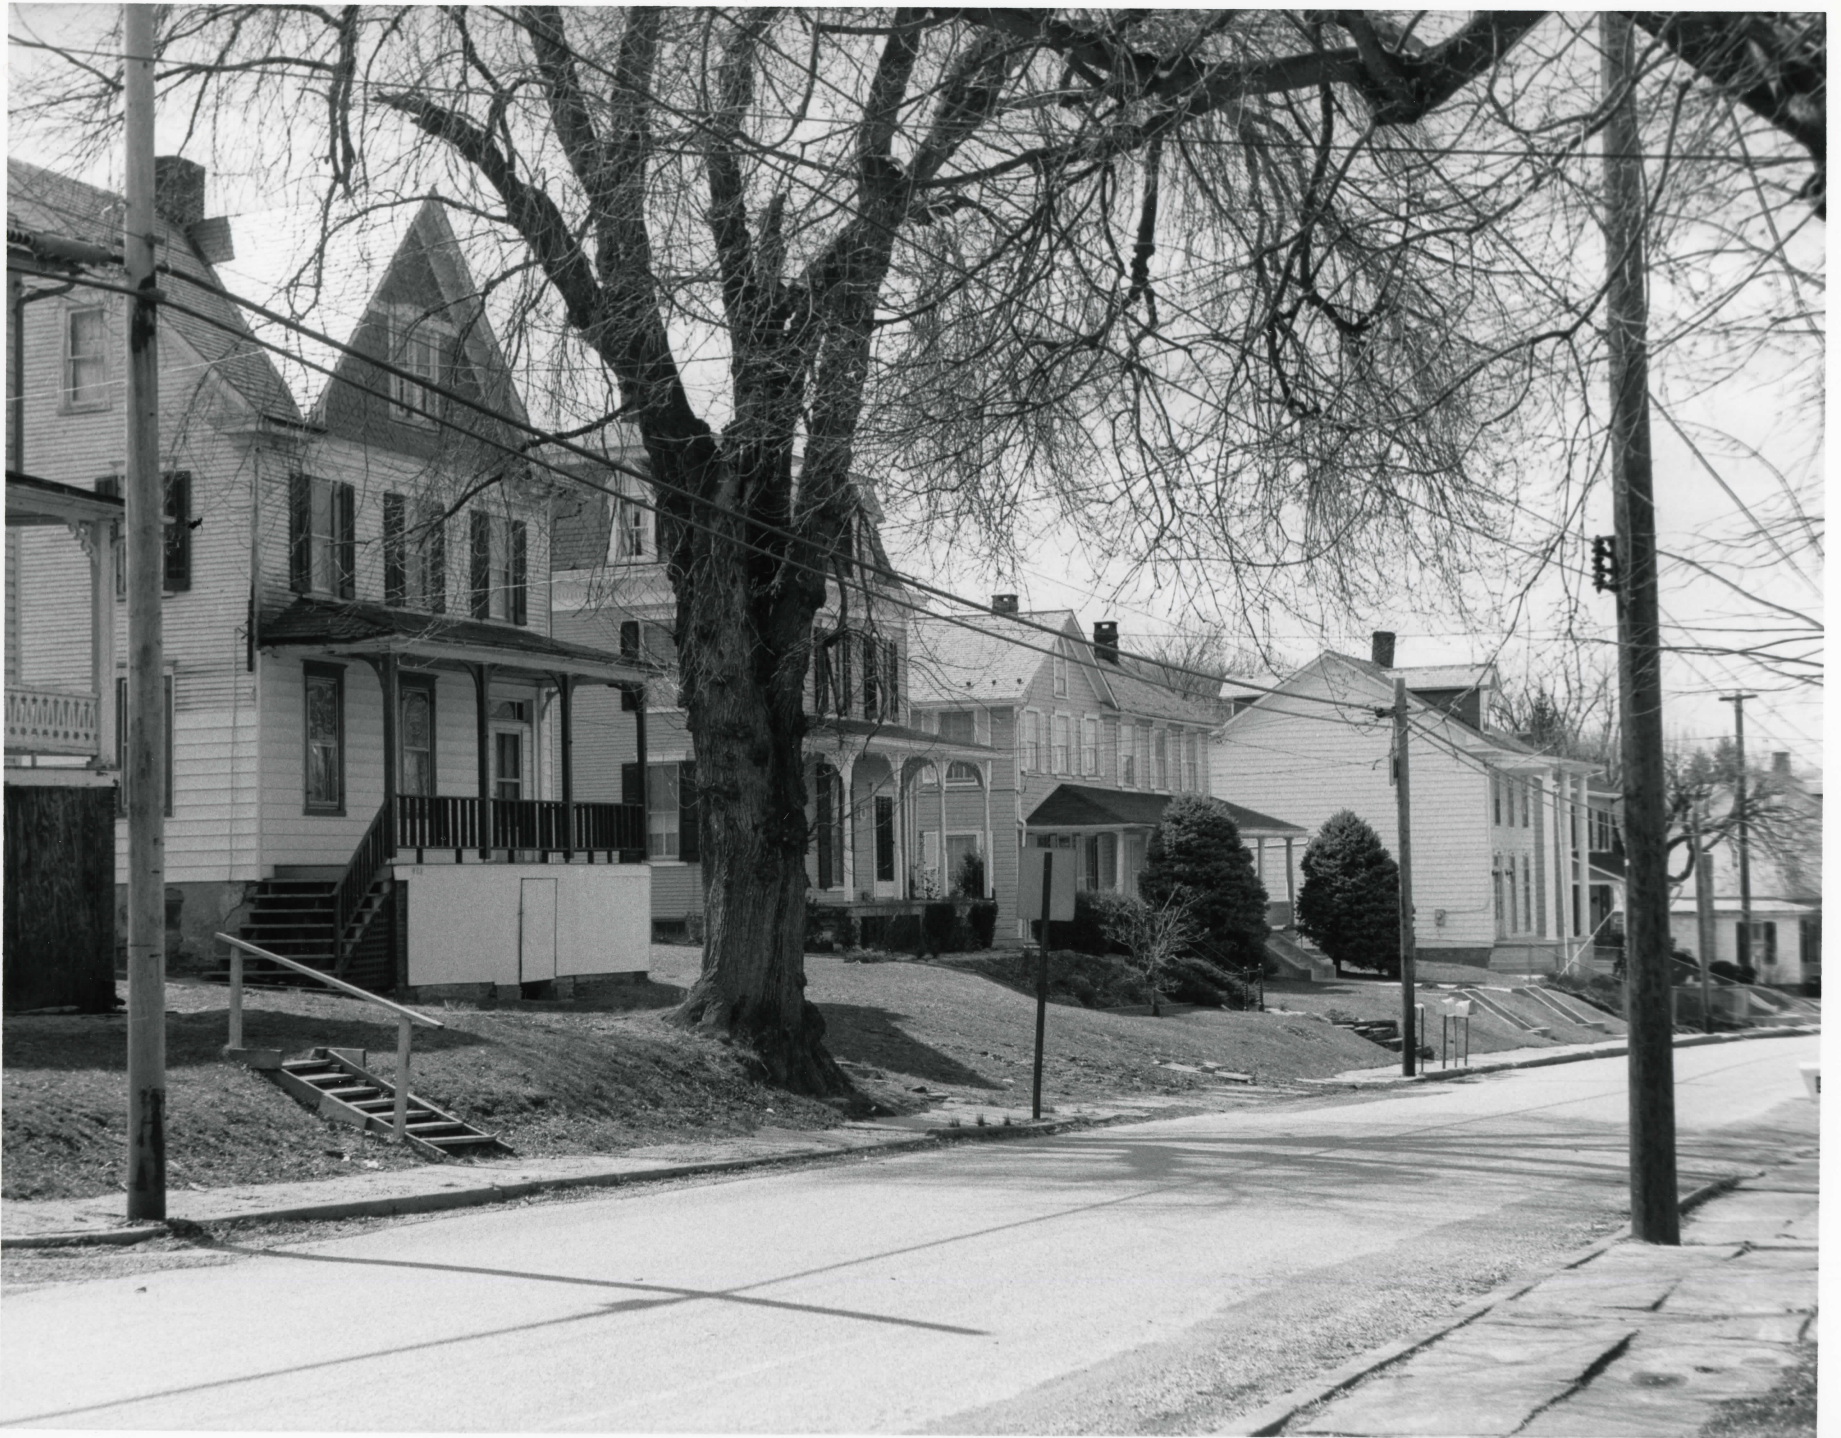
VIII Delta Historic District
900 Block, Main St.
York County, NH; Historic York, Inc.
PD: 1982 PC: T. Schneider
PV: S. side, 900 Block, looking W.

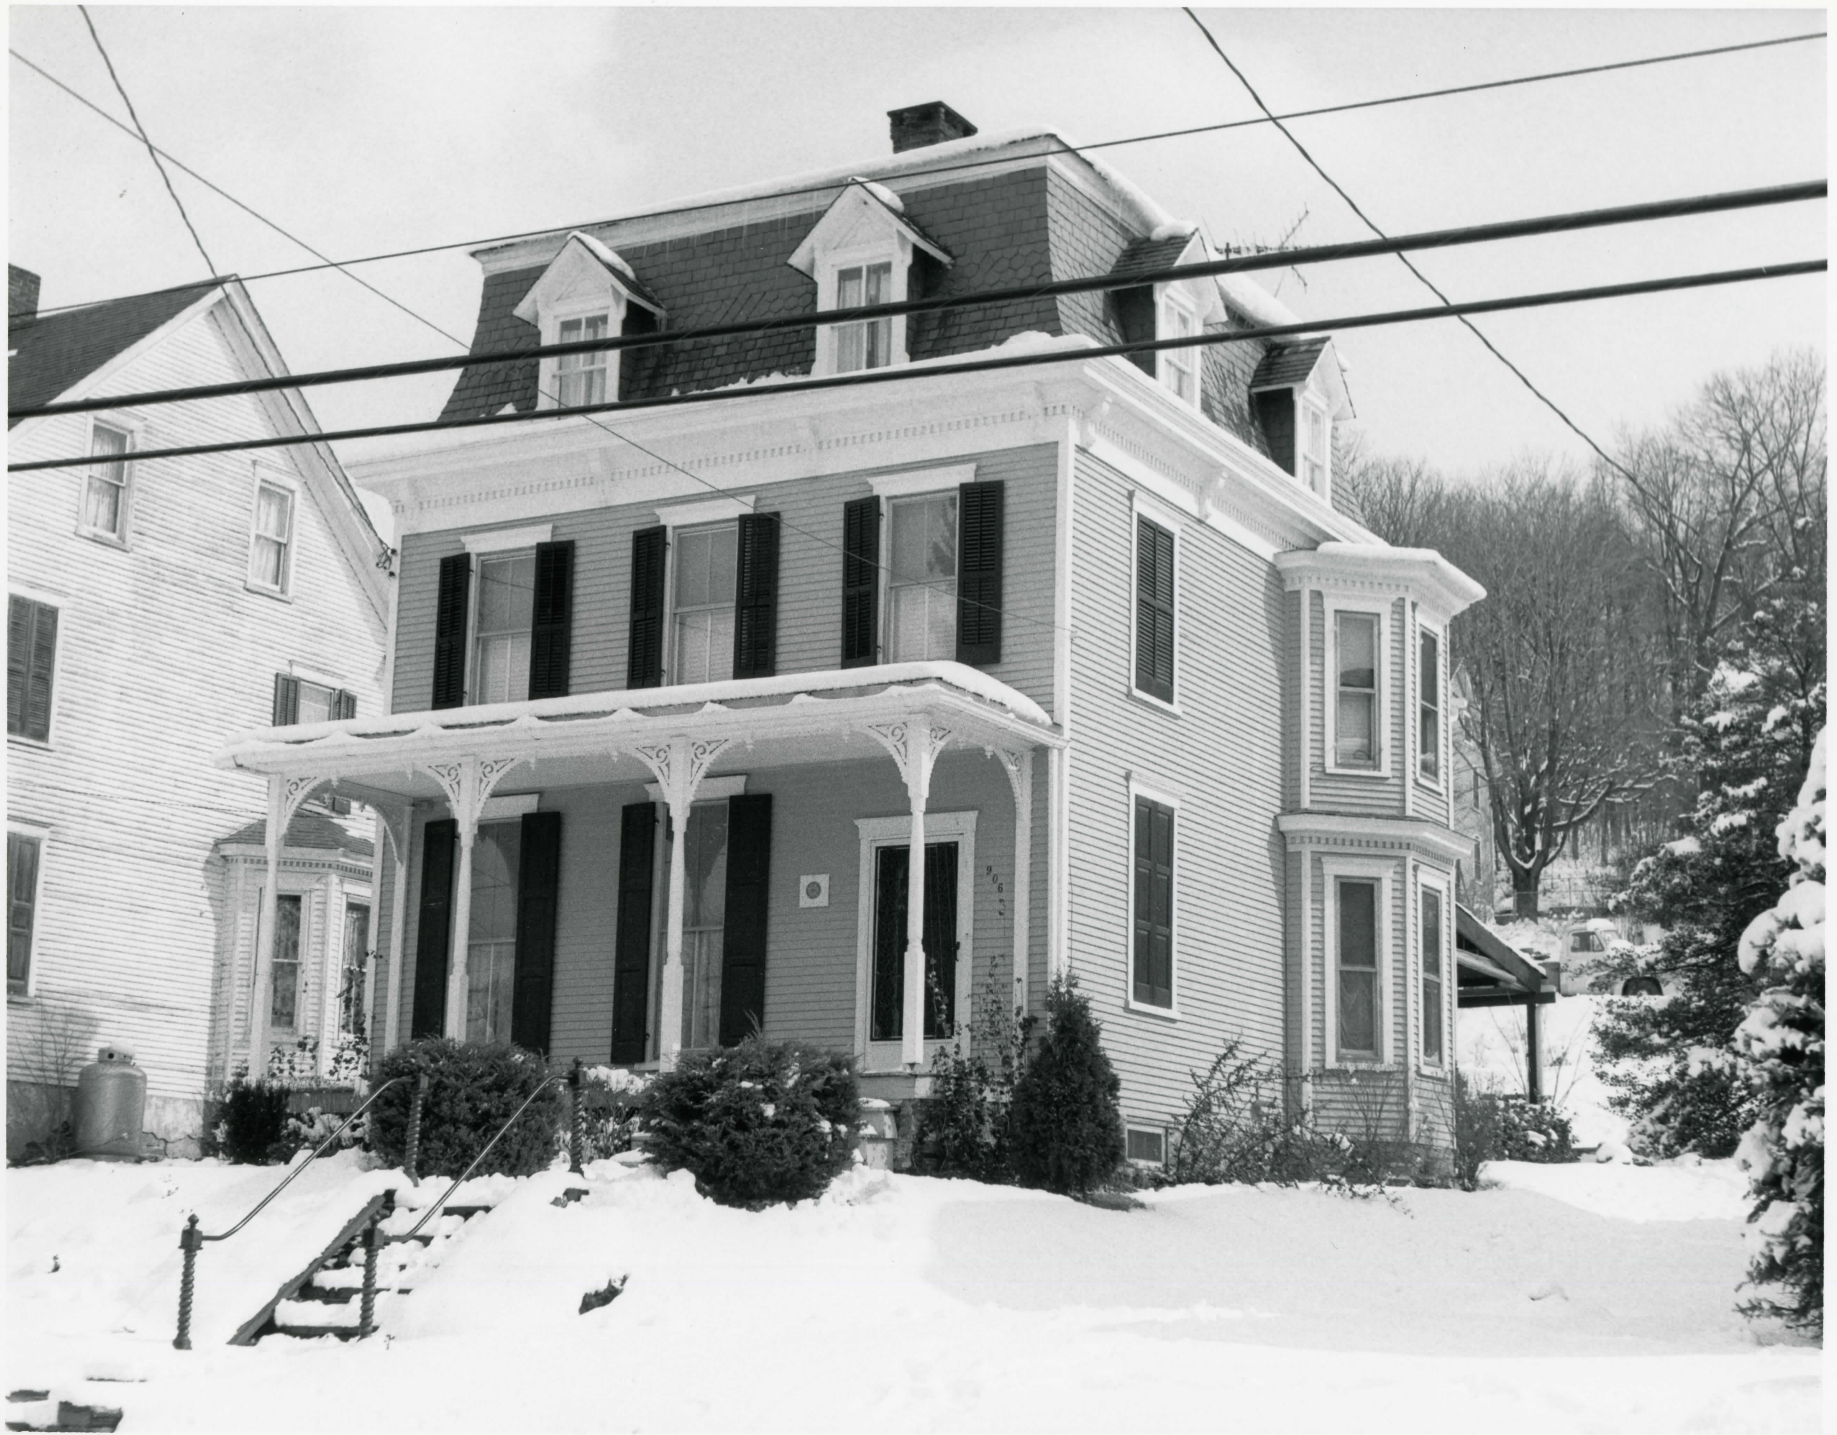
IX Delta Historic District
906 Main St. (133.7.10)
York, County
PD: 1981 PC: T. Schneider
PV: Facade and west wall, looking
NW: Historic York, Inc. S.

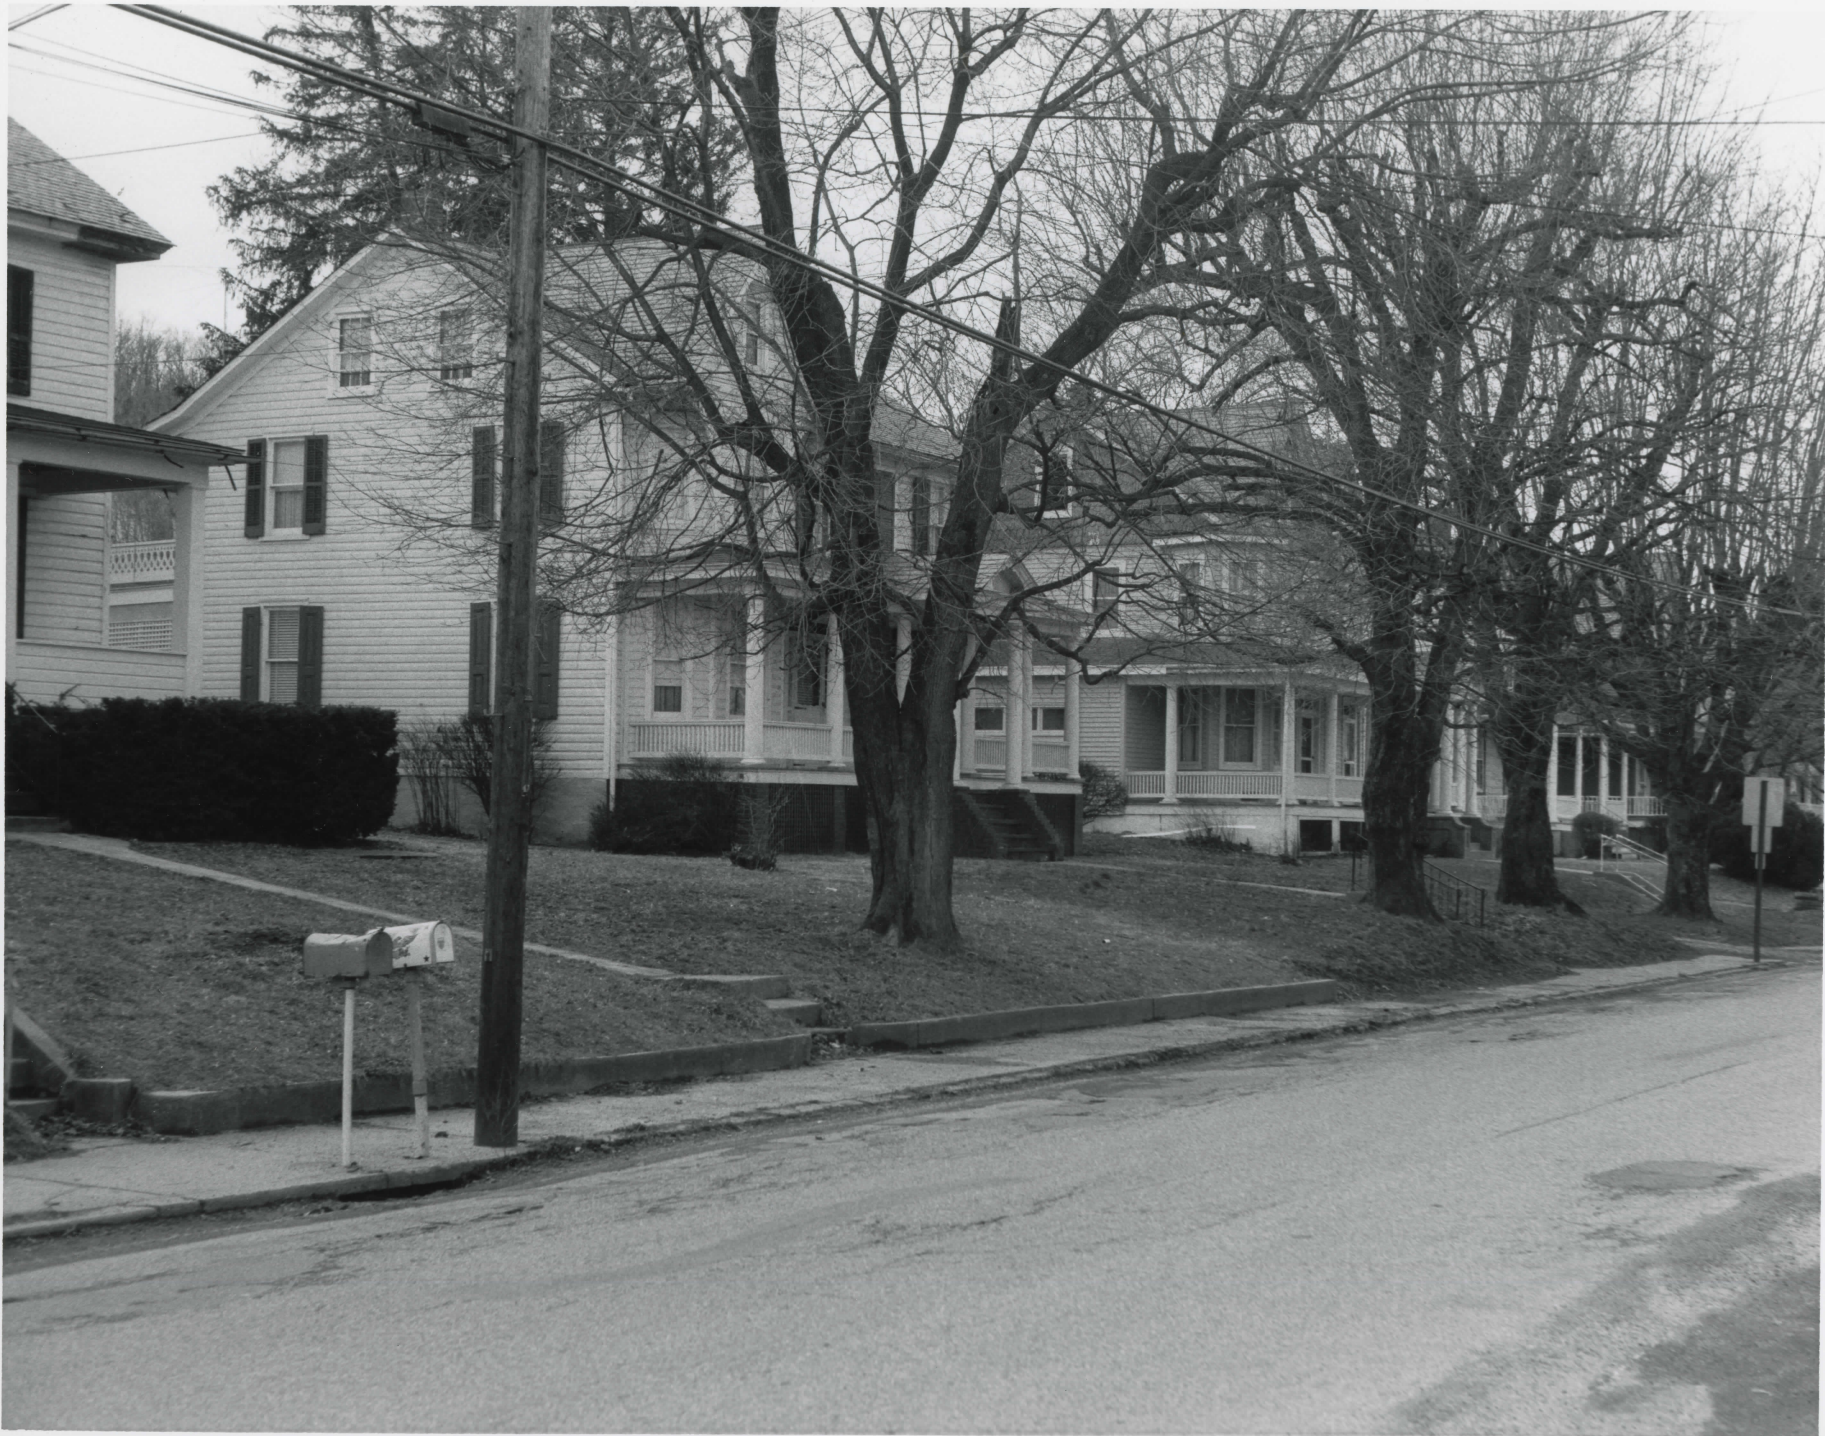
X Delta Historic District
1700 Black, Main St.
York County N.H. Historic York, Inc.
PD: 1982 PC: T. Schaefer
PV: S. side, 1700 Black, looking E.

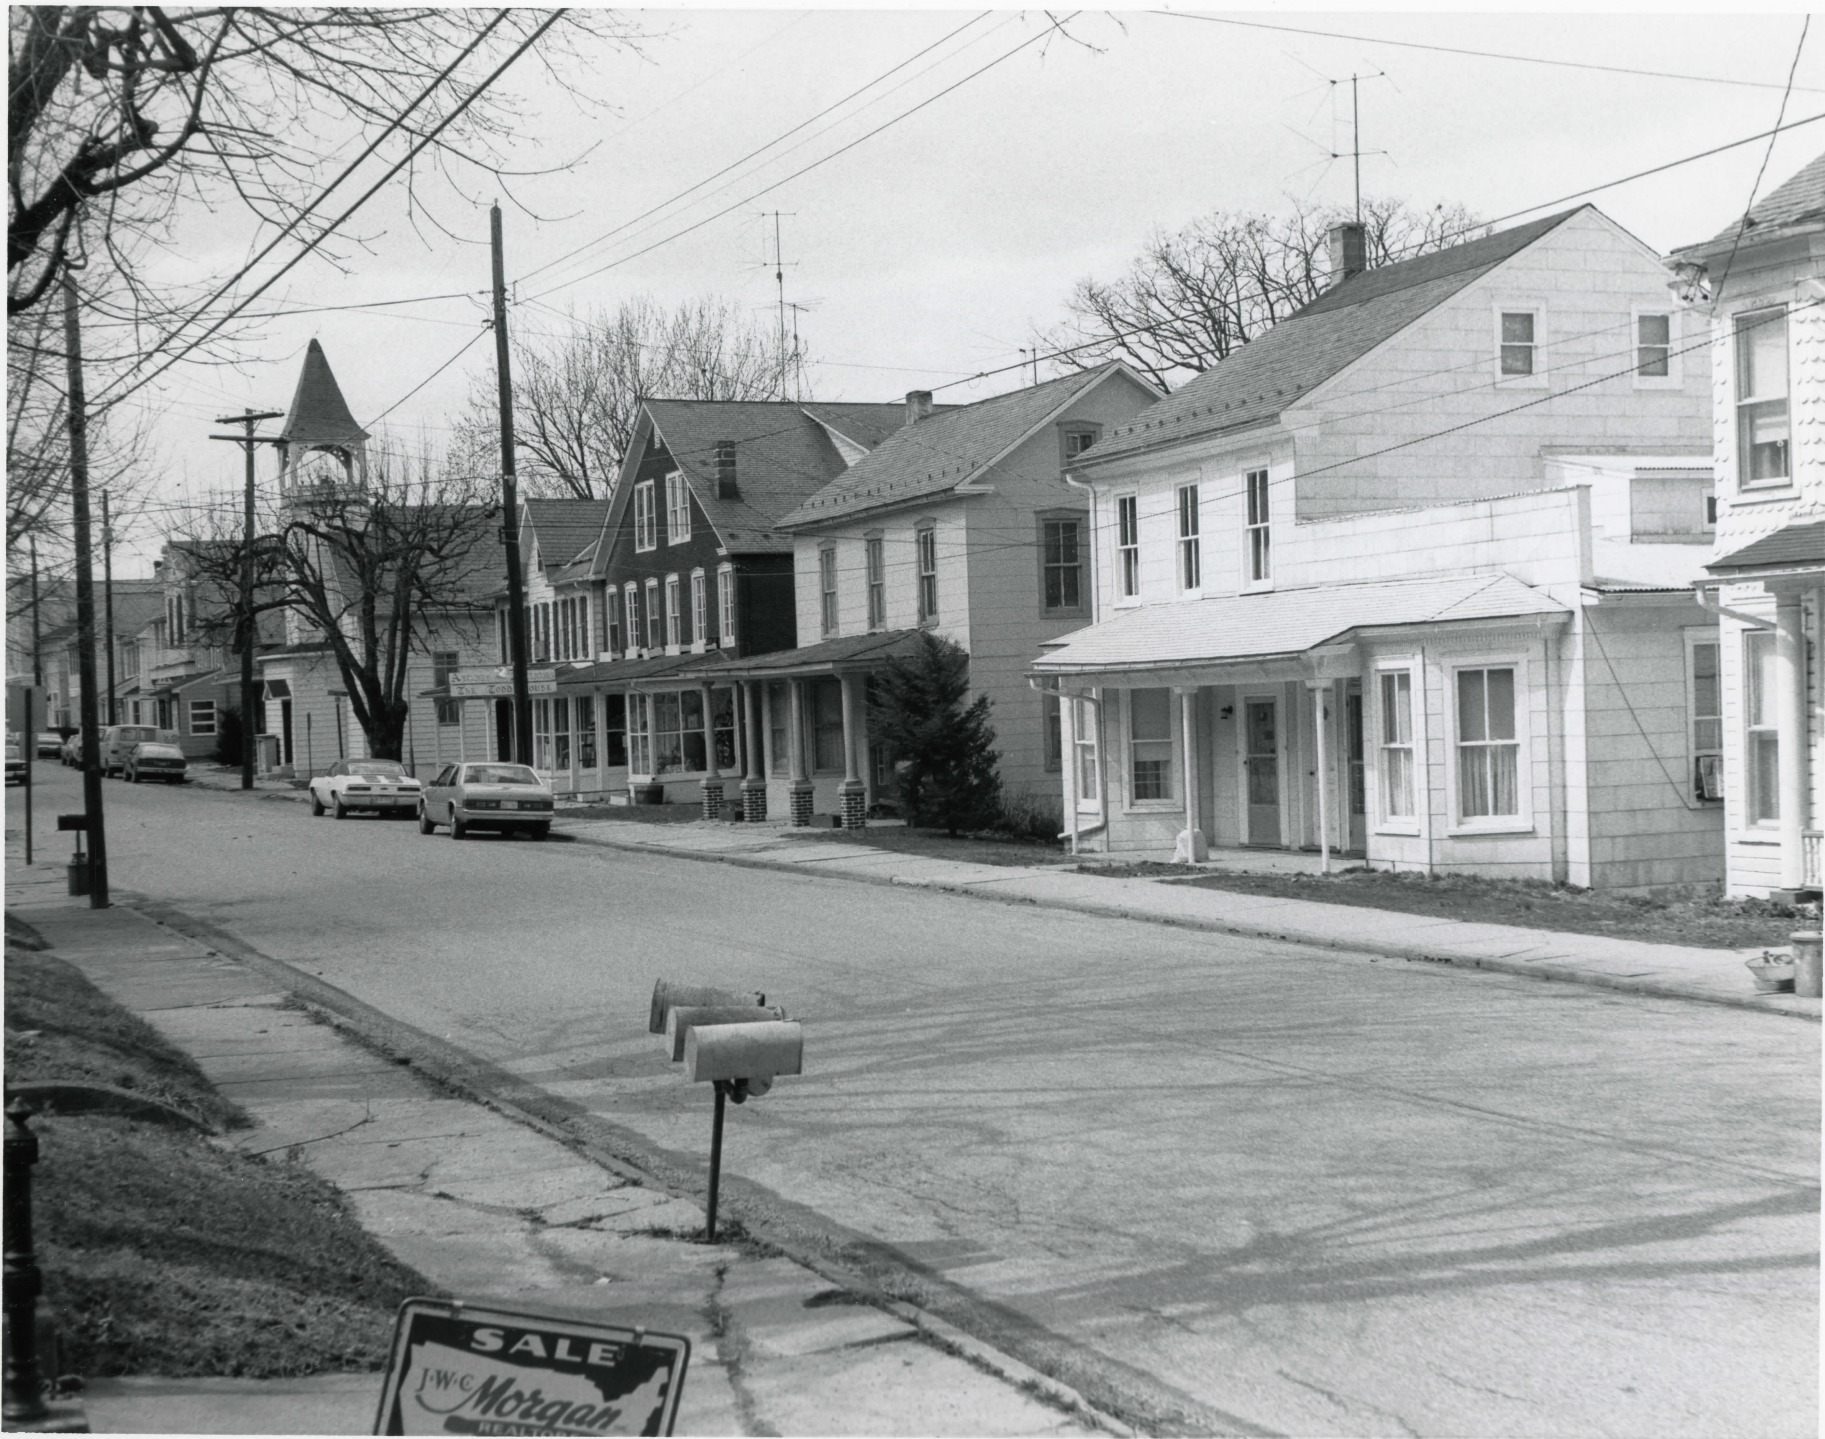
XI Delta Historic District
600 Block, Main St.
York County N.H.: Historic York, Inc.
PD: 1982 PC: T. Schaefer
PV: N. side, 600 Block, looking W.

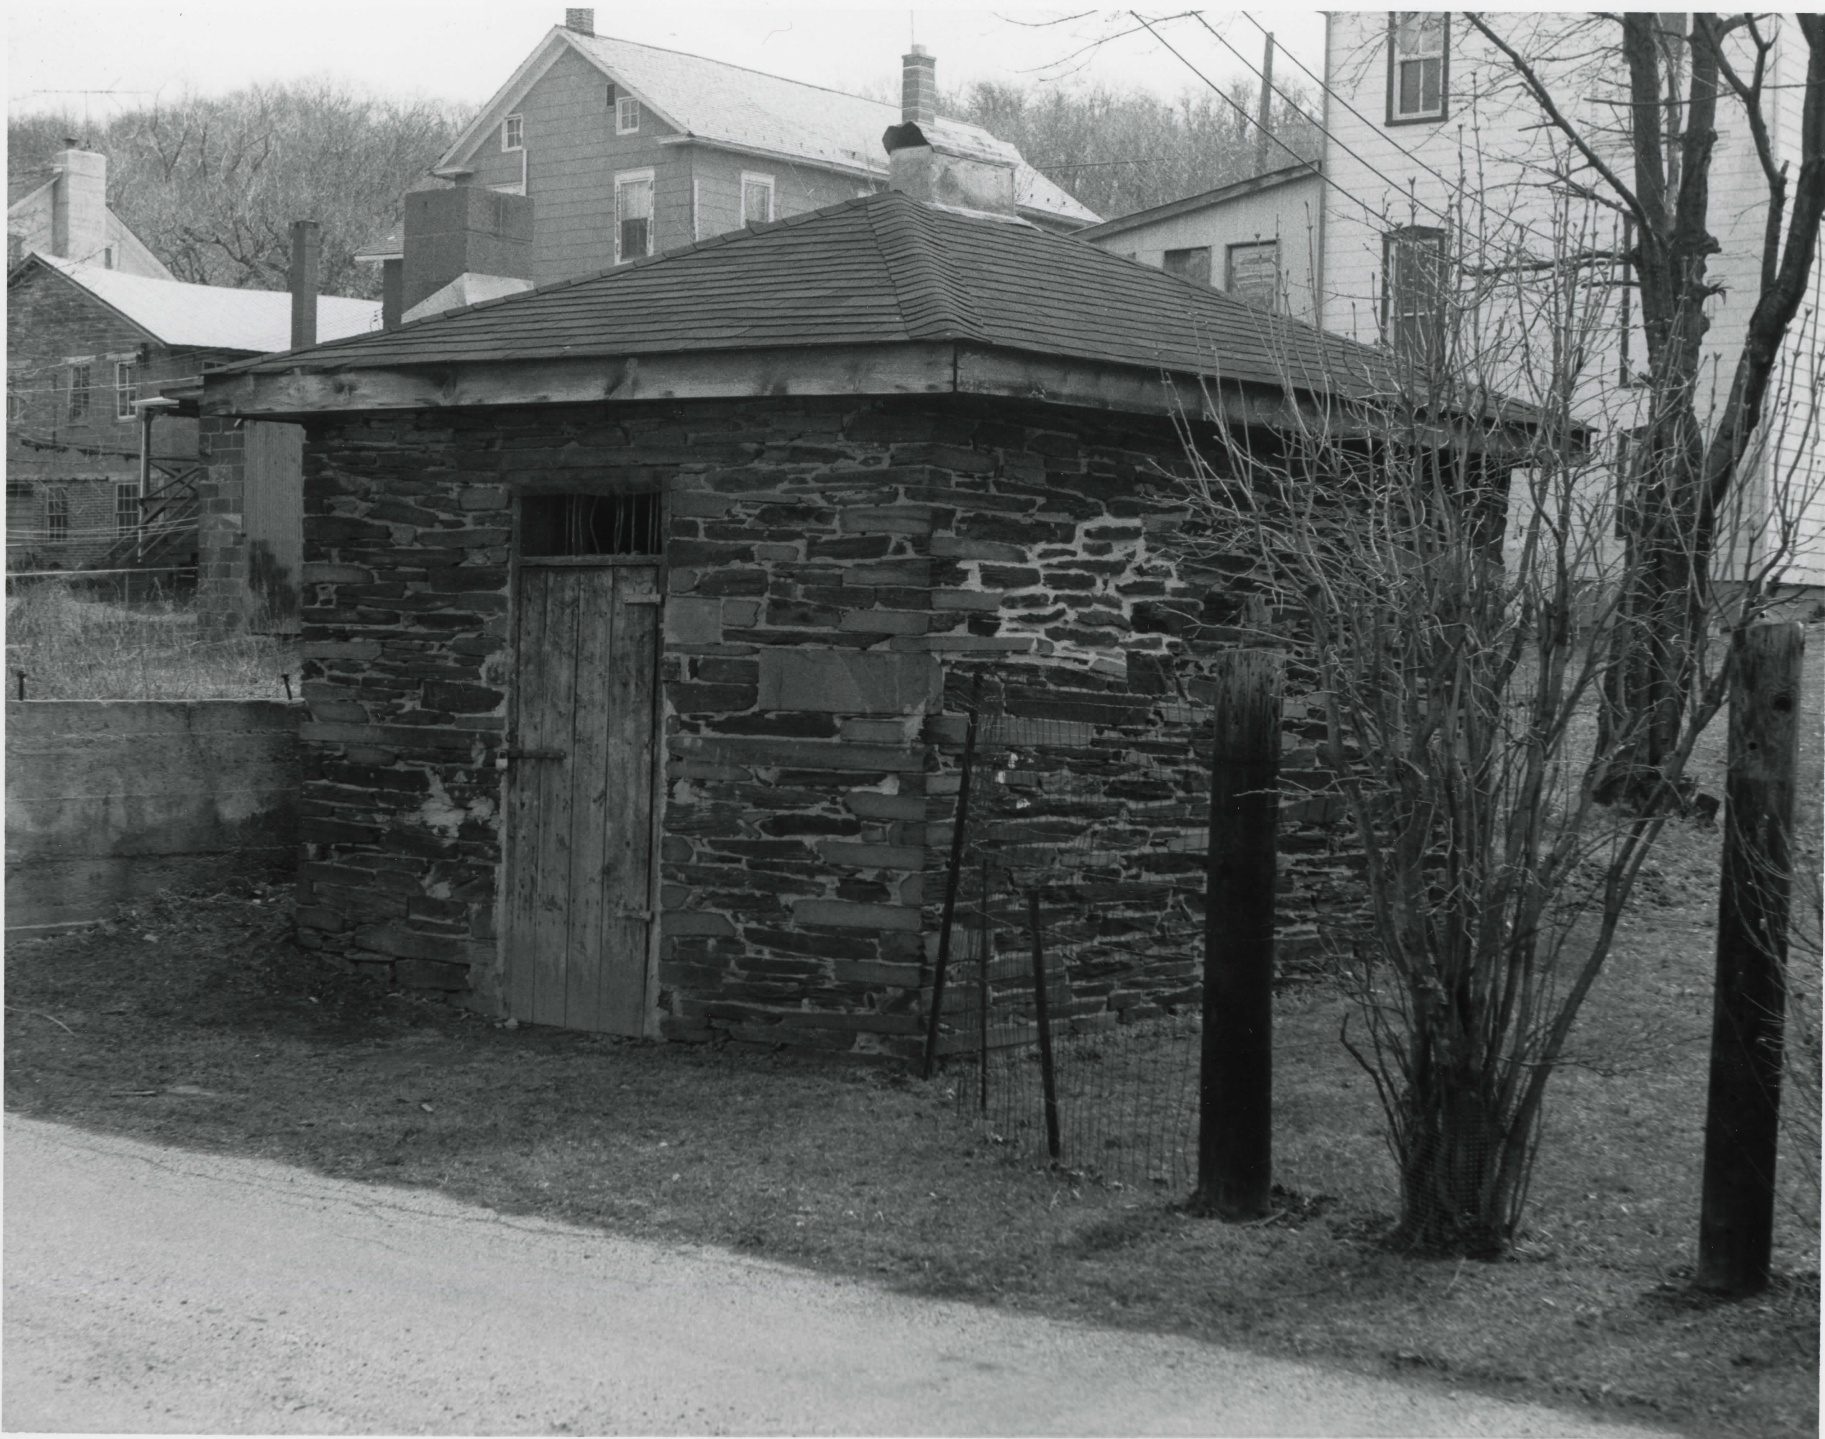
84 Delta Historic District
Delta Soil (coursed slate)
York County NL: Historic York, Inc.
PD: 1982 PC: T. Schaefer
PV: rear of 805 Main St., looking S.E.

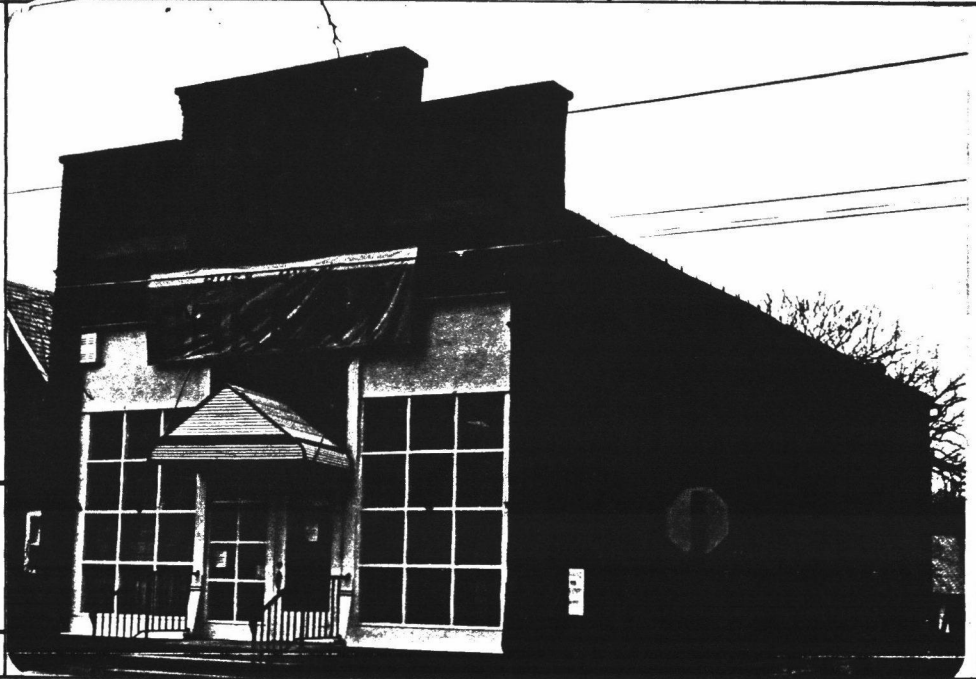
24. photo notation

Present 1 story structure was originally 3 story structure. Facade is cast iron with aged pilasters. Rectangular 3 bay building has shallow peak roof with boomtown roof at facade. Main structure is brick with large recessed rectangular areas on side walls & upper area of facade. (Forms a sort of water table on sides). Side windows have been bricked in. Decorative course of bricks runs length of structure. Boomtown has semi circular window which has been partially replaced by a vent, and has radiating voussoirs surrounding it. all 3 bays of boomtown are recessed & have corbelled caps & slanted lower portions. Roof itself has slight overhang & snowbirds.

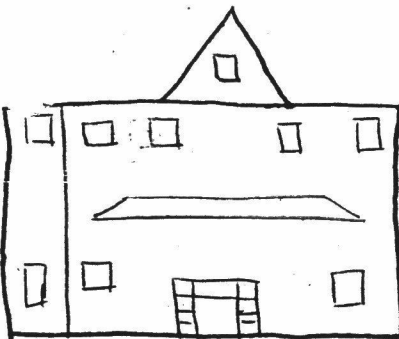
519 MAIN STREET

2 1/2 story, rectangular with L-shaped rear addition;
 4 over 3 bays, (unusual bay relationship), central
 doorway; slate roof, snow stops removed; chimneys
 removed; added r-dormer with returns, single
 2/2 sash with wide plain frame w. the lintel with
 corbelled head - same appliques at fascia; bay

frames are narrow, beveled at interior line; sashes 2/2; doorway
 has 3-light transom, 2-panel side lights, panels below have double
 (continue on back if necessary)

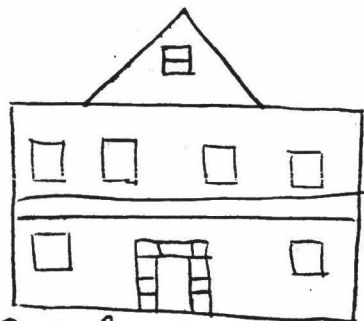
46

2 1/2 stories, rectangular with L-shaped rear addition in frame; 4 over 3 bays with central doorway; added small V-dormer; slate roof; double-end chimneys, E. gable chimney is corbelled, W. gable chimney has been truncated and repointed; shallow board-shaped cornice + returns, dormer also has returns; dormer filled with U-shaped fish scaling, has single 2/2 sashed window with plain, wide frame; bay frames - lugged lintels, originaling plain - *must

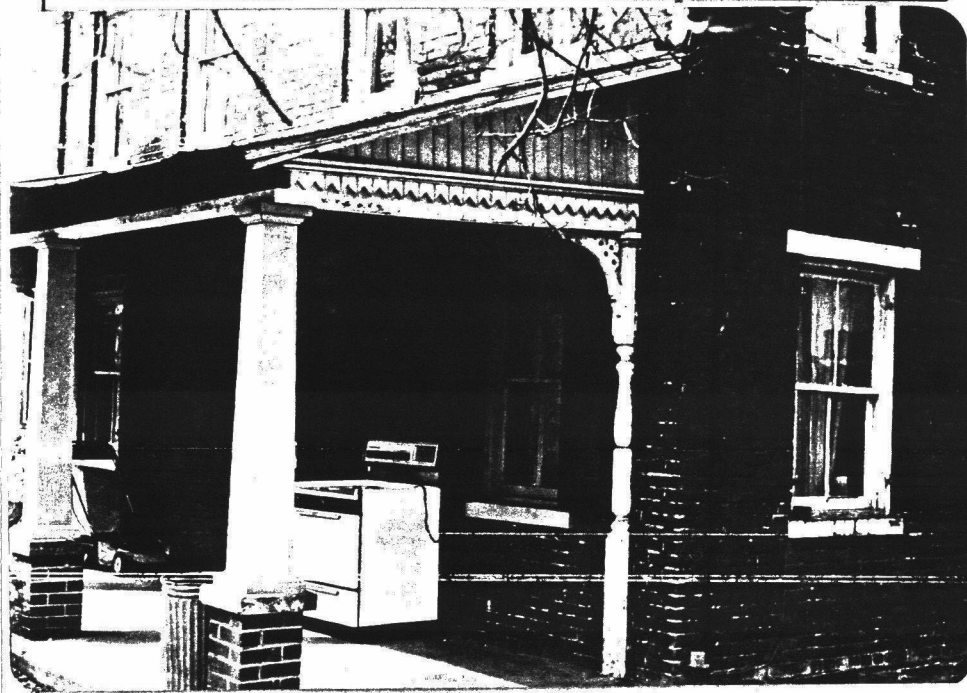
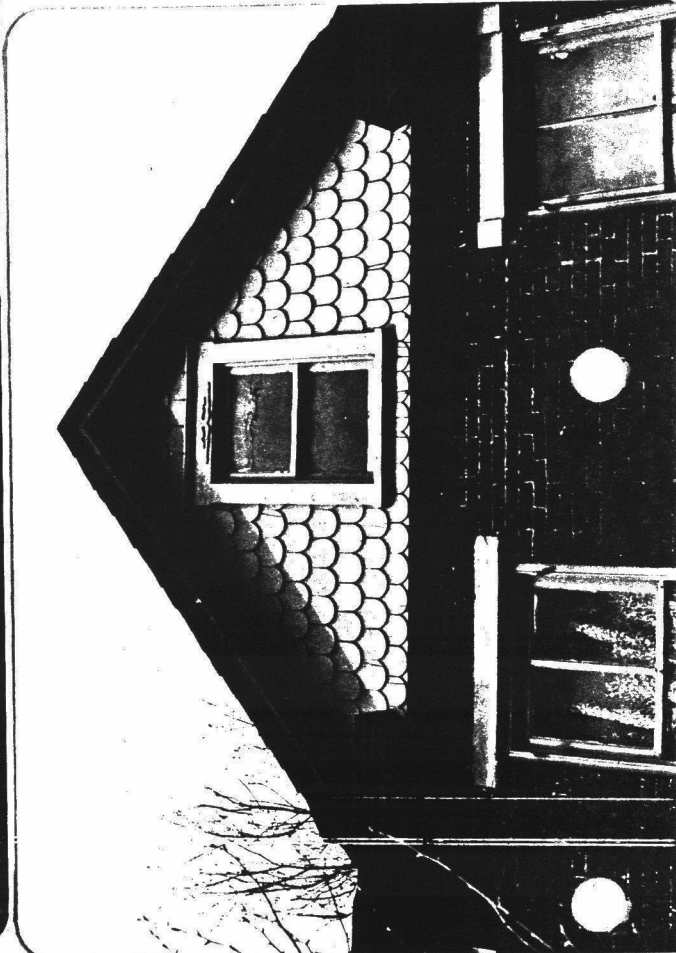
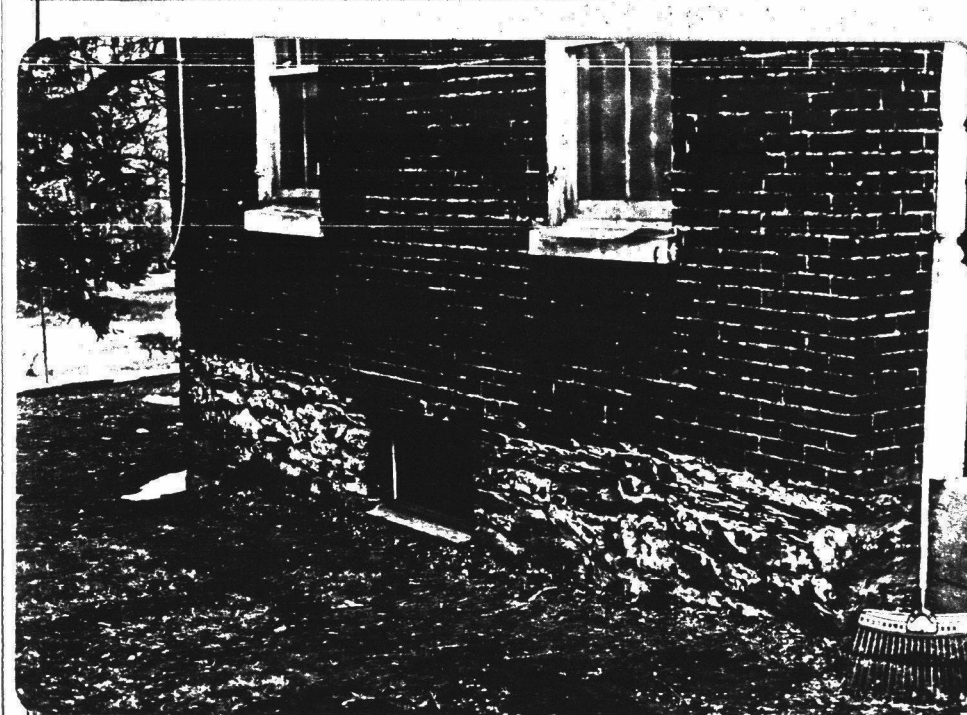
obtained most of the
 illusion of up grading
 the green marble p^l with
 at the pier bases and the
 shallow A.A. dome
 other examples of the
 owner's quest for archite
 ural status
 - new money no doubt.

N.B. the un-crossed Intel is
 made of a cut slab of slate,
 this structure was built before
 the slate pits were fully
 developed, by the time the
 original wooden Intel rotted
 away, it was easier to
 replace the pier with slate
 than it was to have a new
 Intel same, because the pier
 was stone, the end blocks were
 brickwork, the gump was writing

← N.B. course of headers at wall
 sill line, rather unusual

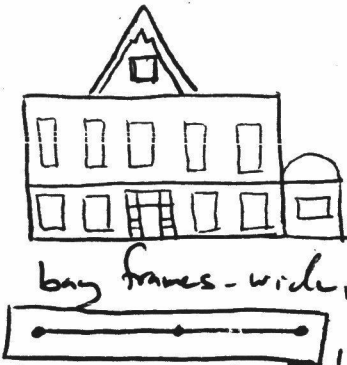
45

2 1/2 stories, rectangular with cross-gables; slate roof with snow stops; moulded cornice + returns; cornice ^{consols extend under returns}
 plan frieze with sawn consols under; facade dormer has frieze extending to gable peak, this meets with Gothic peaked moulding over the dormer window, 2/2 sash; bay frames-wide, plain board, lintels decorated with incision into fascia; lintels also have small caps; sashes 2/2; central doorway has 3-light transom; 2-panel sidelights, moulded panels under narrow hood
 (continue on back if necessary)

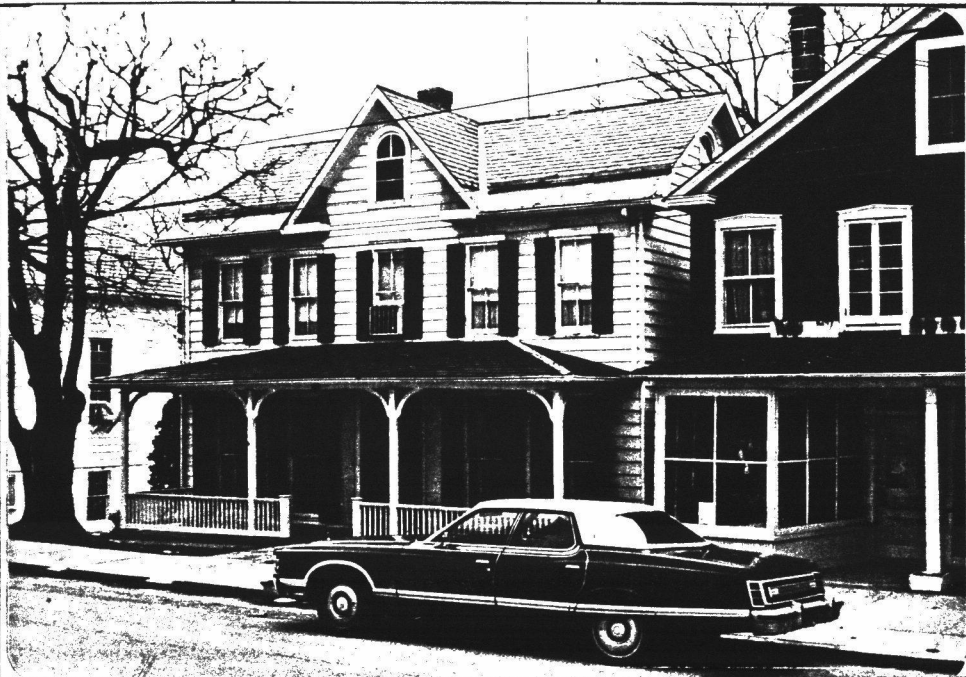
35

23. site plan with north arrow
 * x - pale violet globes on lightning rods - copper strands resembling corn tassels
 project from top of rod

2 1/2 story, rectangular with L-shaped rear addition; 5 over 5 bays, central doorway, V-dormer with returns, round headed window, 2/2 sash; slate roof, snow stops intact; box cornice + returns, returns at dormer are rather long in proportion to the height of the pediment; bay frames - plain, wide; 2/2 sash; lower story bays elevated to floor, these bays have lintels with small corbelled caps; doorway has 2-light transom, sidelights are very narrow; pediment window - central round headed 2/2 sash, each gable end; hip roofed porch supported by thin posts

with single-piece sun brackets; shallow angled 2 story bay window added to W. gable, foundation of it is slate ashlar blocks
 tips of lightning rods have rather unique treatment:

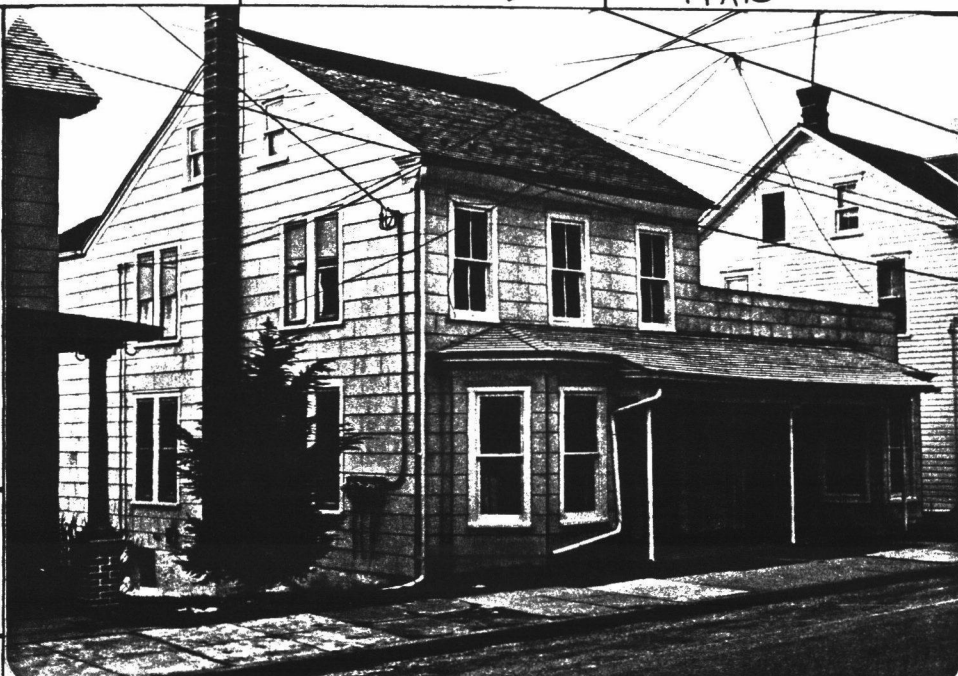
#29

2 1/2 stories, rectangular, deep mass with rear addition; originally 3 over 3 bays; slate roof with broad slope, snowbirds intact; moulded cornice + returns, unusual angled frieze with small row of dentils in sawn relief under ridge; eaves flush with gable ends, 2-board rake at eaves; bay frames - plain, wide with small cap at top of lintel; sashes - elongated 2/2; main doorway has 2-light transom, with wide architraves

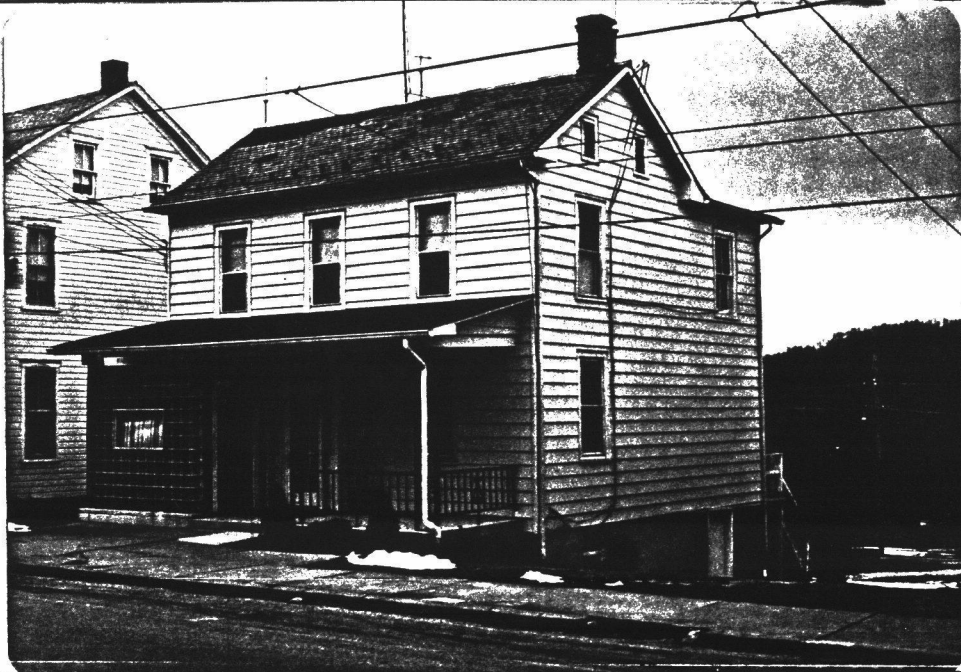
2 1/2 stories, rectangular, tall, narrow proportions, with vew addition, originally 3 over 3 bays; slate roof, snow steps intact; tall, corbelled single end chimney; box cornice + returns (presently hidden in siding); bay frames - plain, wide board; sashes 1/2; window bays elongated; dormery has 3-light transom 3-paneled side lights + moulded panels, recessed, very narrow; roofline of porch has sited-in cornice returns; pediment windows, pair of small

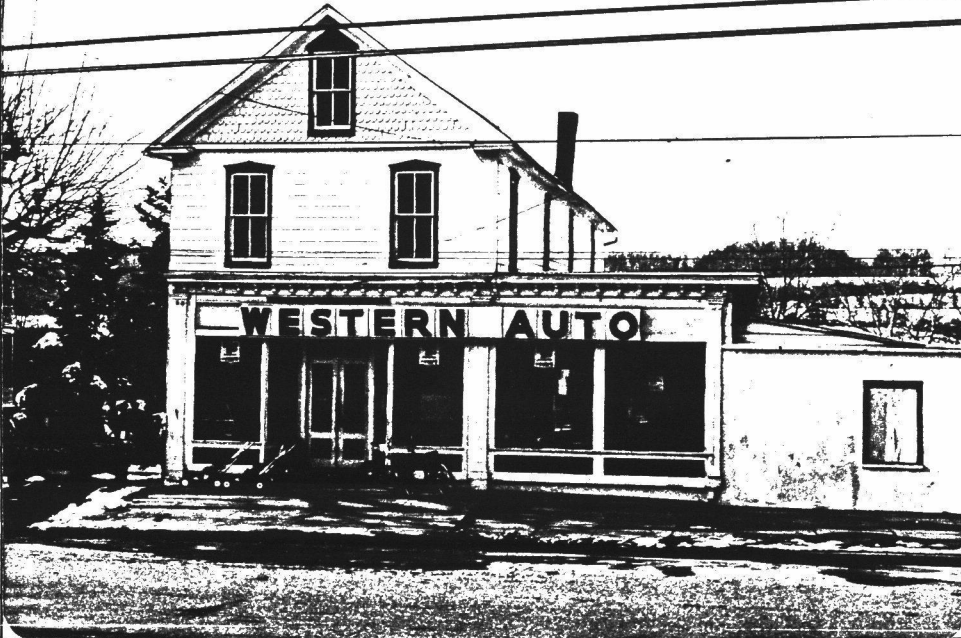
#10

2 1/2 stories, rectangular, gable end to street, has basic Greek Revival placement and proportions with the exception of the roof pitch, structure is 2 bays wide, 4 bays long; has extended shop front to E.; shallow moulded cornice + returns, fascia board under gable eaves; pediment window is tightly positioned under the roof peak, its Gothic peak engages the frieze line, has sawn applique in the pediment, sash 2/2; pediment decorated with U-shaped fish scaling (Washington cut)

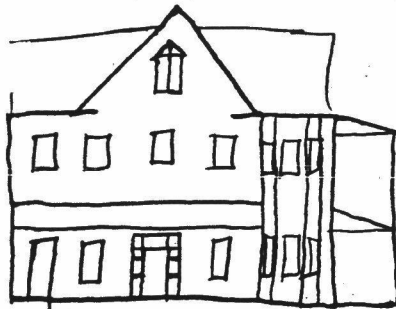
#15

2 1/2 stories, rectangular, with rear additions; cross gables; 5 over 5 bays, central doorway; slate roof, snow board removed; single-end chimney; moulded cornice and returns, facade gable has cornice returns; deep freeze with plain, solid brackets (no decoration), freeze and brackets extend under cornice returns, across facade pediment, and under gable eaves; added two story bay window on facade; bay frames - wide, plain board with shallow peaked lintels with corbelled hood; sashes - large pane 1/2; central doorway has 3 light transom, wide 3 part side lights, panes are flush; facade gable window

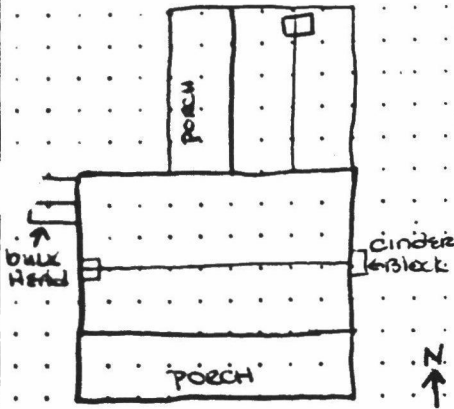
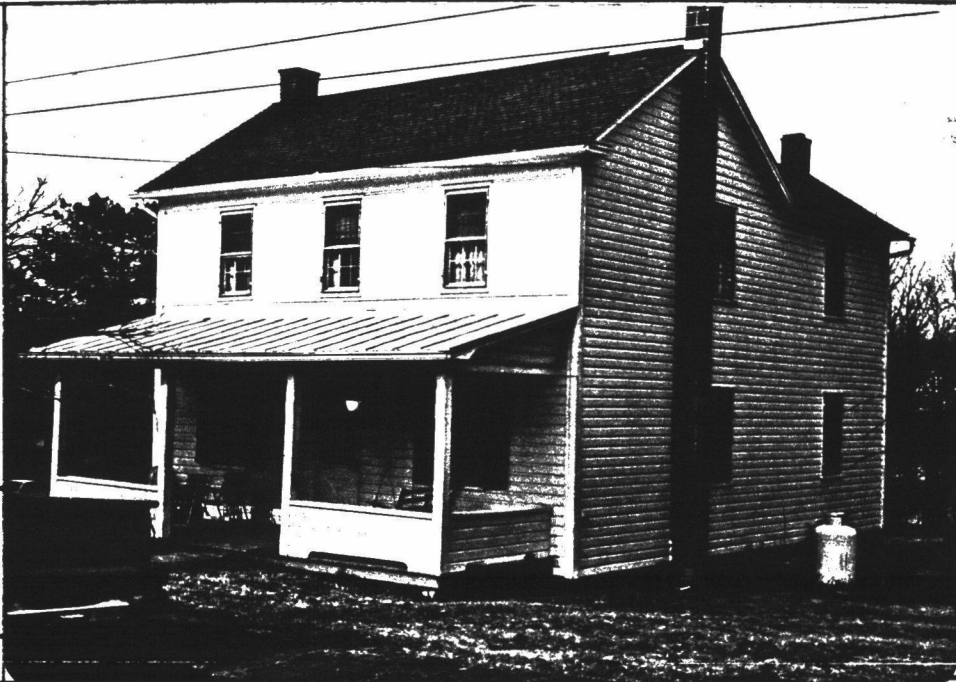
24. photo notation
 #3

18. primary building mat./construction
 COURSED SLATE FOUNDATION
 Frame

21. condition
 Good

22. integrity
 Good

2 1/2 story, rectangular 3/3 construction with central bay window. Door has single room light, windows are 6 over 6 double hung sash. Original single chimney on west end. Later exterior cinder block chimney added on east end. One story front porch has standing seam metal roof and angled cornice returns. main roof has narrow, slightly molded cornices and returns. Foundation is coursed slate. west gable of the I. house has 2 openings: 1 is 4 pane casement window, other casement has been replaced by louvred vents. East gable has no windows.
